Preliminary assessment of roof related repairs and recommendations for repairs

30 HACKAMORE LANE, BELL CANYON

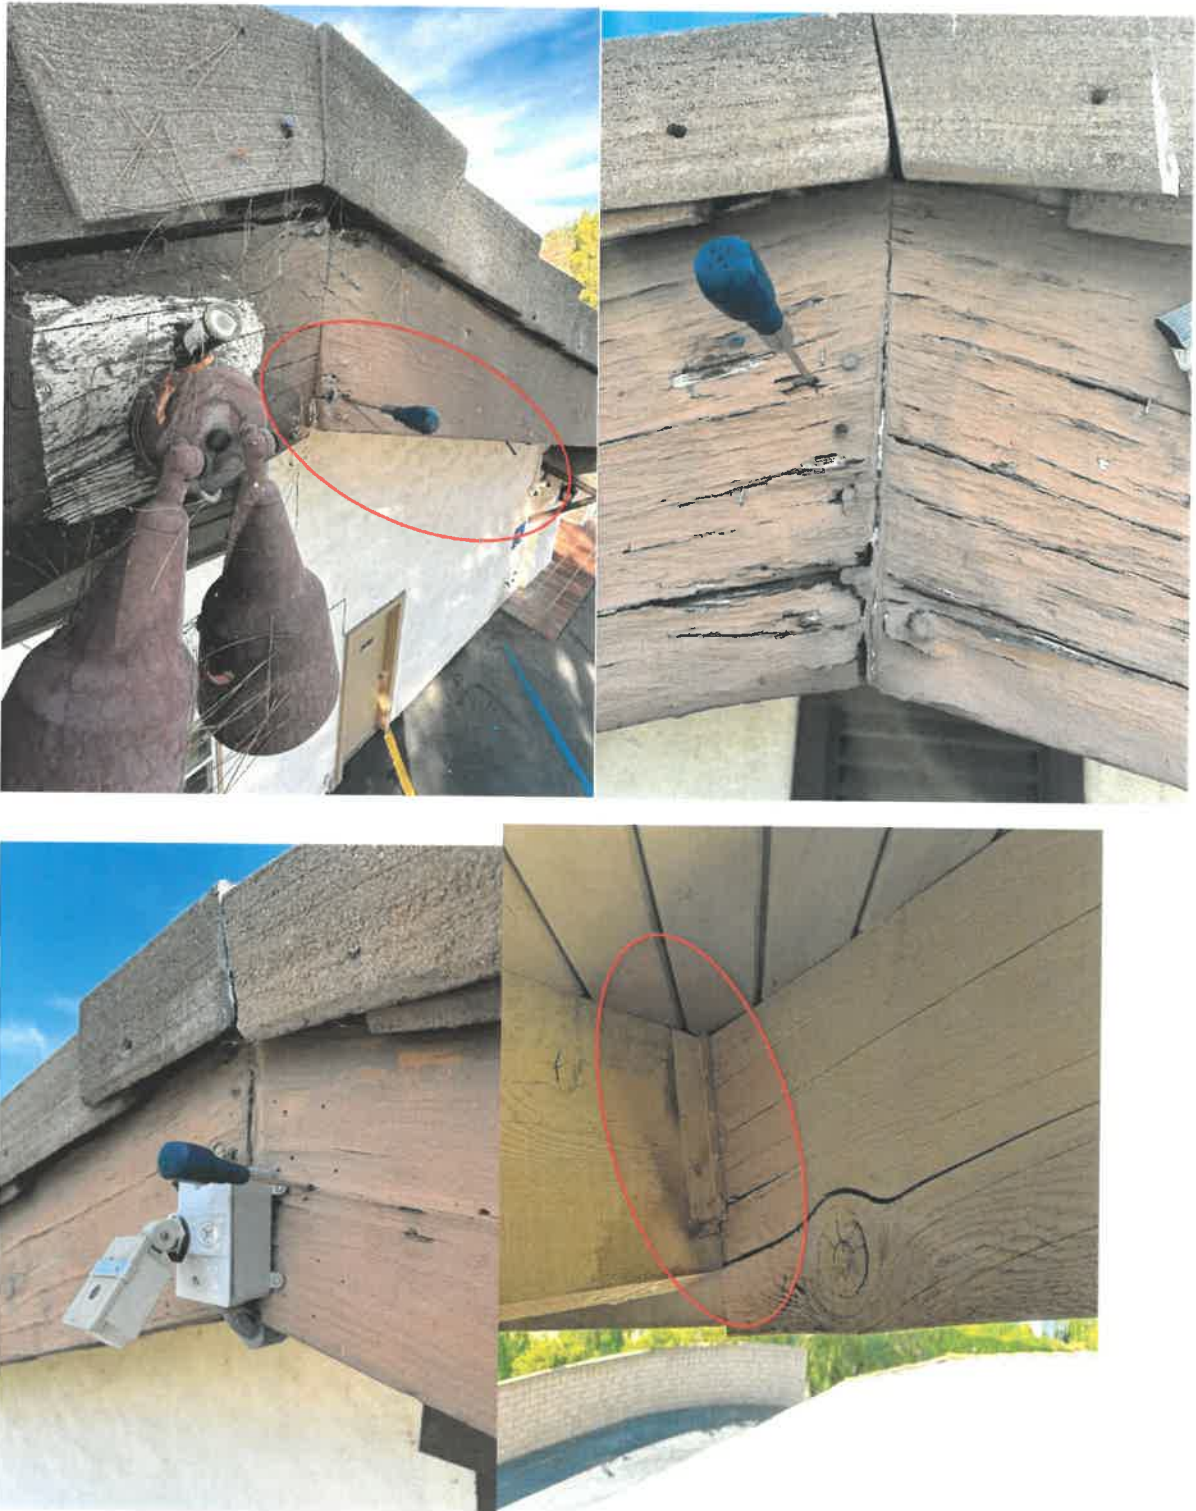
The scope of the work includes the shortening of these overhangs and for that the existing fascia boards need to be removed regardless of if they are damaged or not. They are attached to the fly rafters by inverted joist hangers. These are nailed off. Reusing these are not recommended and they are relatively inexpensive. After the existing roofing materials will be stripped off and the roof sheathing and/or T&G will be exposed damaged sections will be replaced by the roofing contractor. At or around this phase of the roofing project the shortening of the overhangs will take place. The existing fascia boards will be removed and only after that the fly joists will be cut back. These fascia boards are heavy, long and cannot be cut away together and in one piece with the rafters due to their size and weight. While these fascia boards might look acceptable from ground level, they are not worth reinstalling. (See attached closeup pictures on pages 2 and 3) Some of them have dry-rot, fungi and termite damage and some others are cracked and twisted. None of them were properly primed and painted to protect them from the elements. During previous paintjobs these boards were repaired, (caulked and patched with Bondo) but these repairs are failing, and the boards are getting worse.

This picture shows the HU410 inverted hanger installation
Note all pictures with dry rot. The extent of the owl is inside the wood is proportional to the damage.

During the installation of the new fascia boards new heavy duty joist hangers will be installed in a reversed position to match the existing installation and per the requirements of the manufacturer.

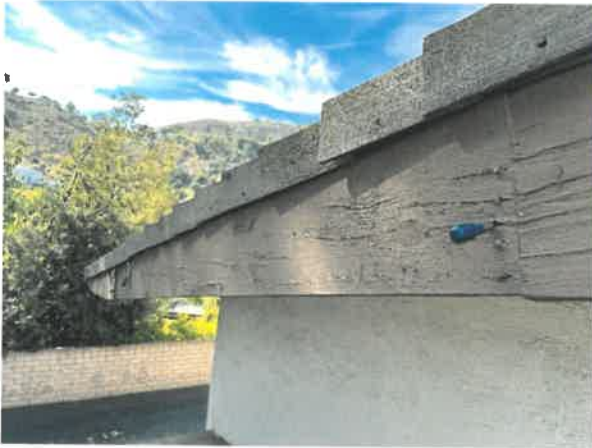
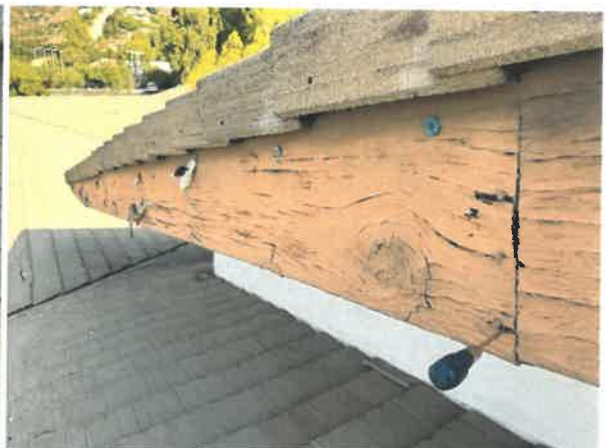
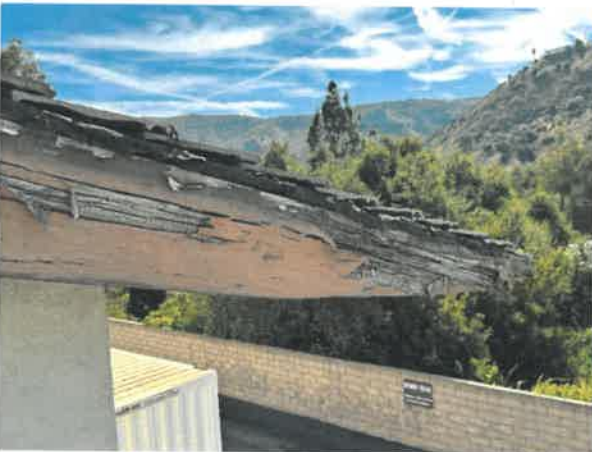
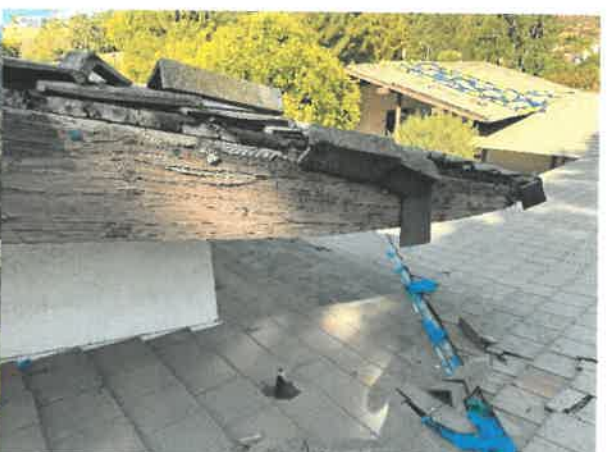
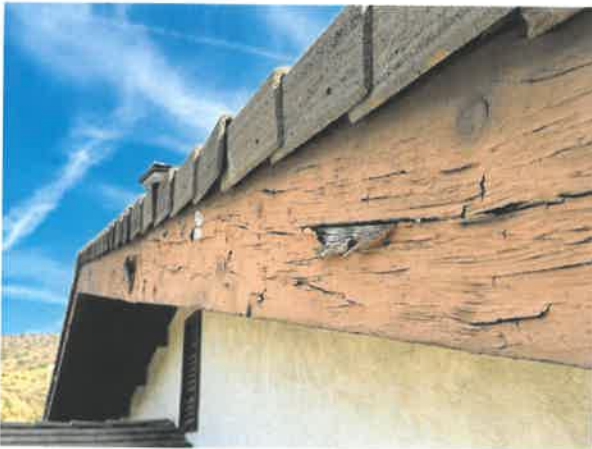
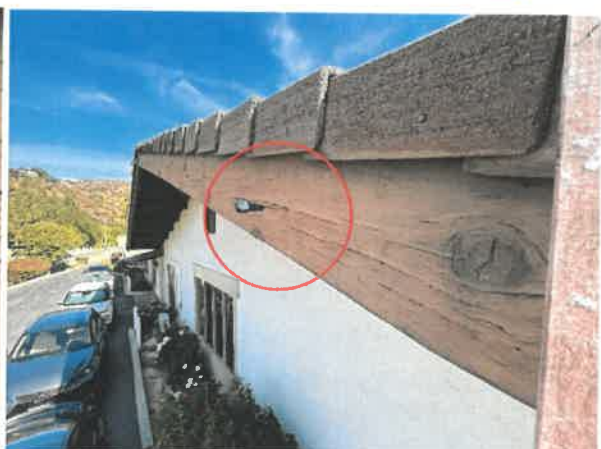
The paint no longer provides protection

Previous repairs on cracks are deteriorating

There are a total of 16 pieces of Fascia boards that need to be replaced varying from 15' to close to 34' in length. Some of them are crafted from multiple sections. After the roofline is shortened, new rough sawn fascia boards would be installed. To maintain the historic look of the structure, finished (smooth) lumber is not suggested. At the NW corner of the building one fascia board was replaced previously by using finished lumber and difference is noticeable. It also has rounded edges instead of sharp edges.

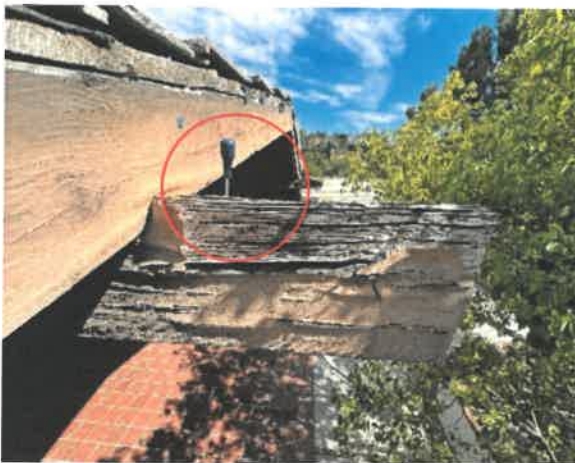
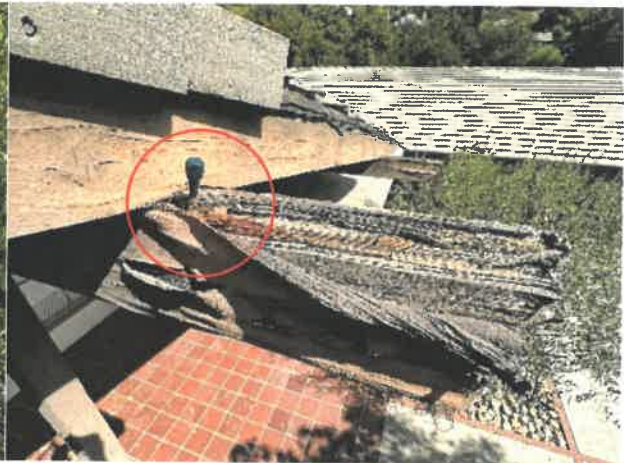
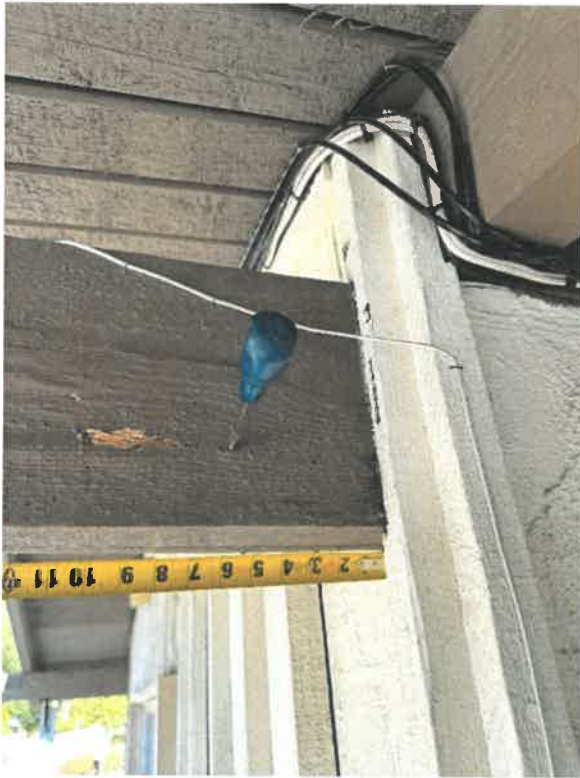
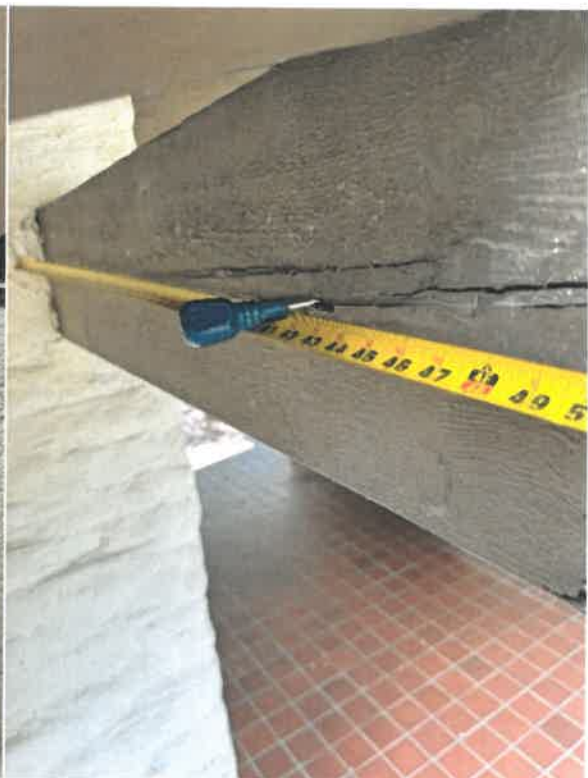
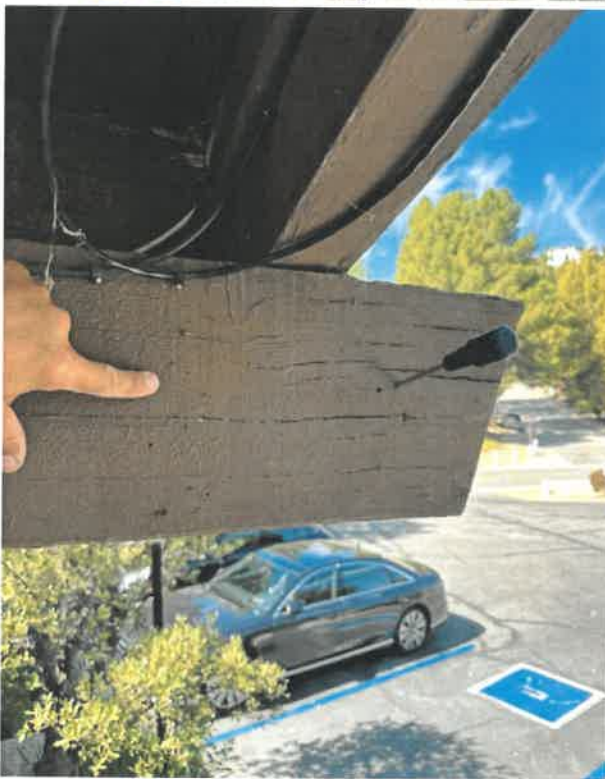
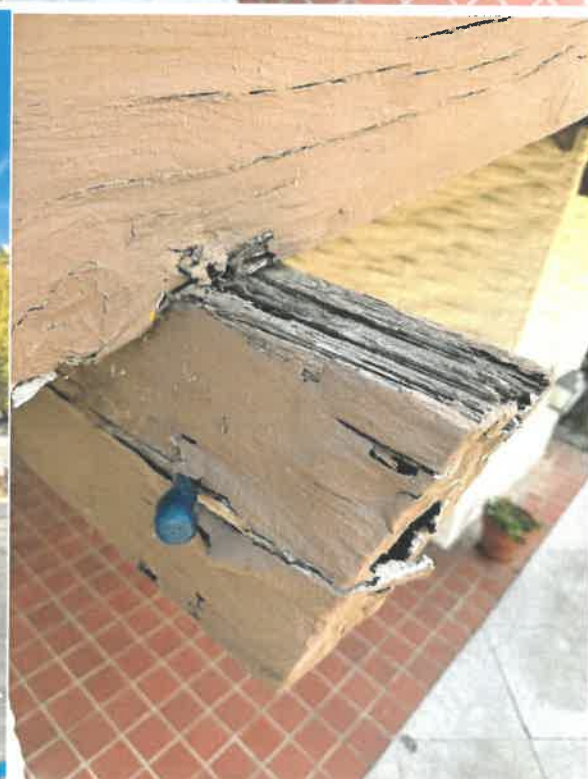
Roof Beams

Almost all exposed locations have water damage. By cutting off the damaged ends of the roof beams will preserve the remaining runs and save cost by eliminating the need for full replacements. All discussed locations have been inspected up close and throughout. The only areas that could not be inspected at this time are the top of these beams and the mating surfaces with seat cuts. The top of wood surfaces, where T&G meets the beam tend to take on water and susceptible to dry rot. These types of damage would be hard to identify before work begins.

To keep a uniformed look, all beams need to be shortened evenly. The governing length will be decided on site and during the work to ensure that all damaged sections would be removed. It appears that this will be around 2' – 3' on each beam. Cuts will be treated with "Copper-Green" wood preserver. As stated previously, we are trying to reduce the necessary work by having to replace the entire runs of the beams which would require additional shoring and work. From the inside of the soffit area of the gym I was able to see that these go back about 6'- 7'. The new beam then would need to be connected through the wall and to the double top plates, end of members and blocks, rafters as well as the sheathing boards under the existing stucco as well as around the beam. (Stucco repair, waterproofing, working inside a confined space, additional shoring, etc....)

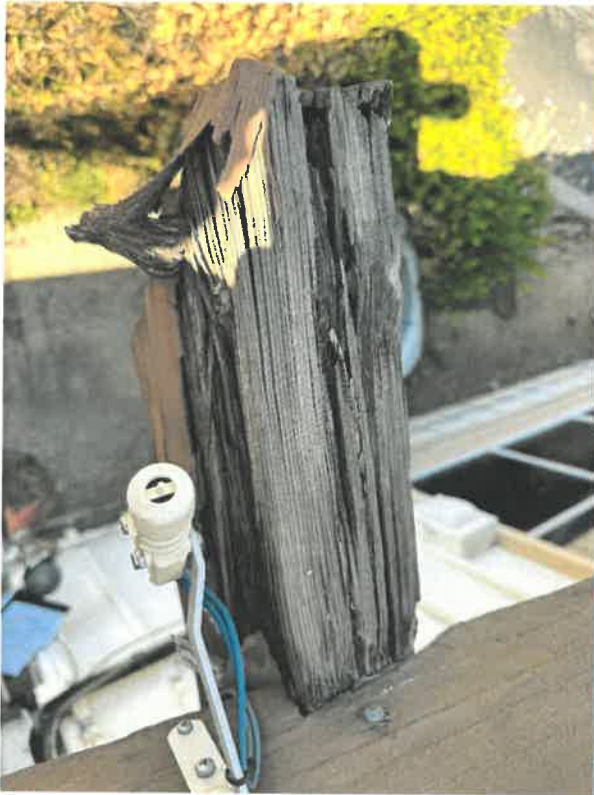
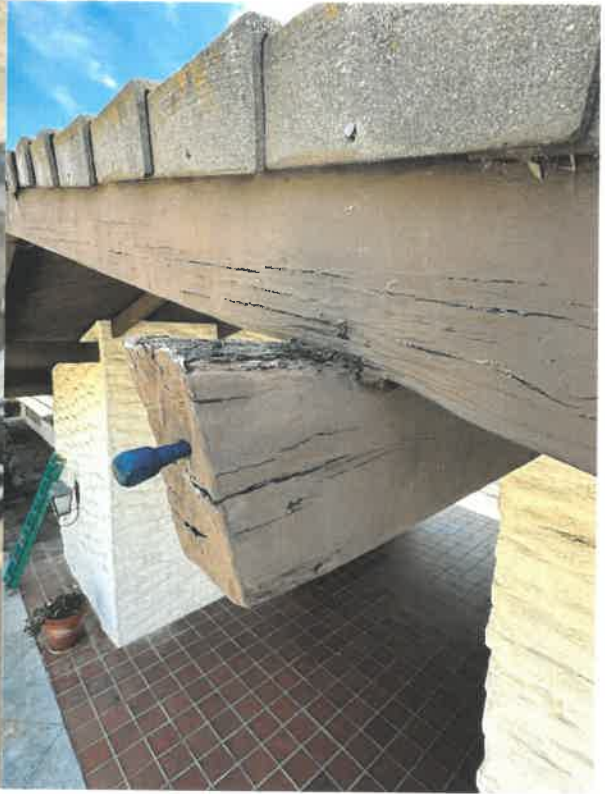
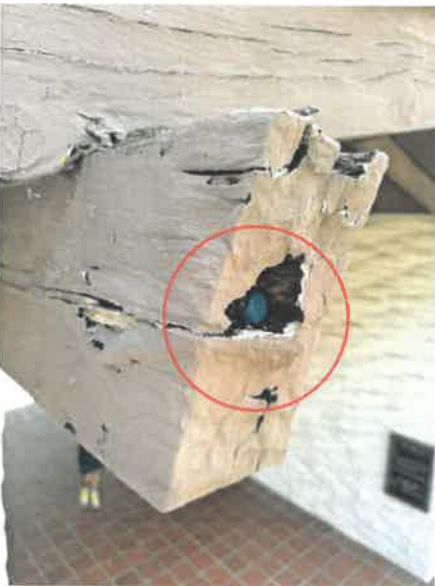
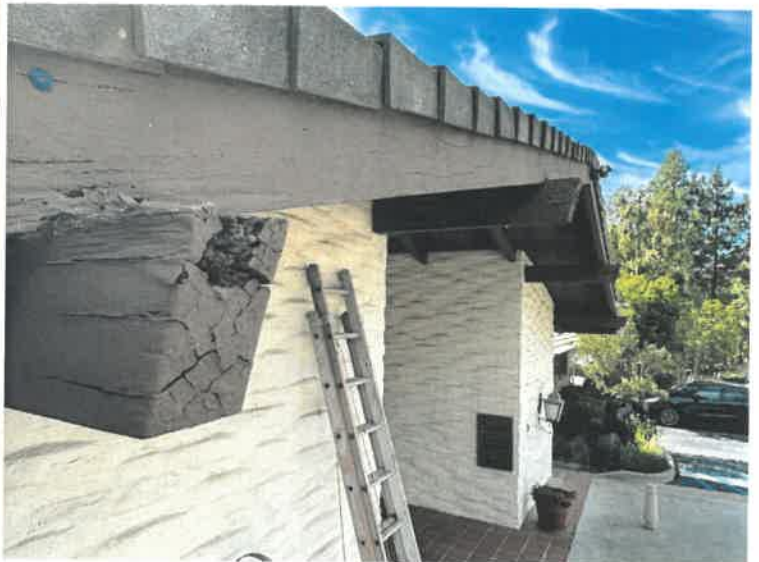
Toenailing is no longer keep members attached. If these fasteners are not already corroded away, they can be pulled out by hand.

The second-best option IMO is to replace the end of the beams with new lumber using a custom fabricated steel sleeve. It is a hinge connector type hardware that is used to couple two pieces of lumber at the ends. There is no manufacturer who makes them in this size, and they are not very aesthetic either. These would be fastened with large through-bolts at the end of each lumber and the new fascia boards would sit on the new sections. (We could add beam seats if needed, but I think these splices would fall behind the Fascia boards) The beveled and exposed tips of the new work would be covered with a copper cap to shield from water and the sun.

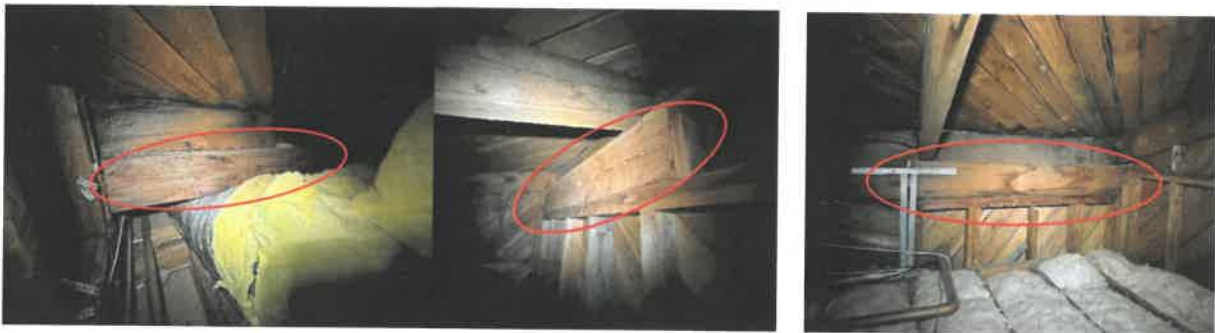
Roof beams inside the attic space

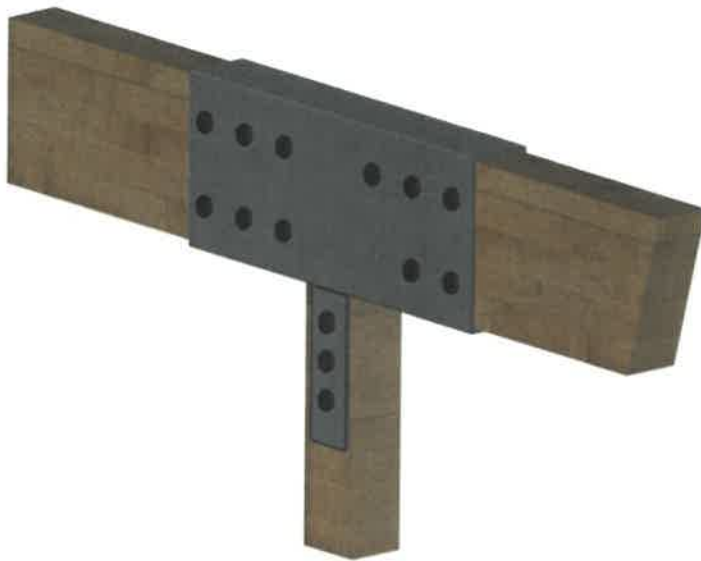
Projected look on the courtyard side where the replacement would fall on the post.

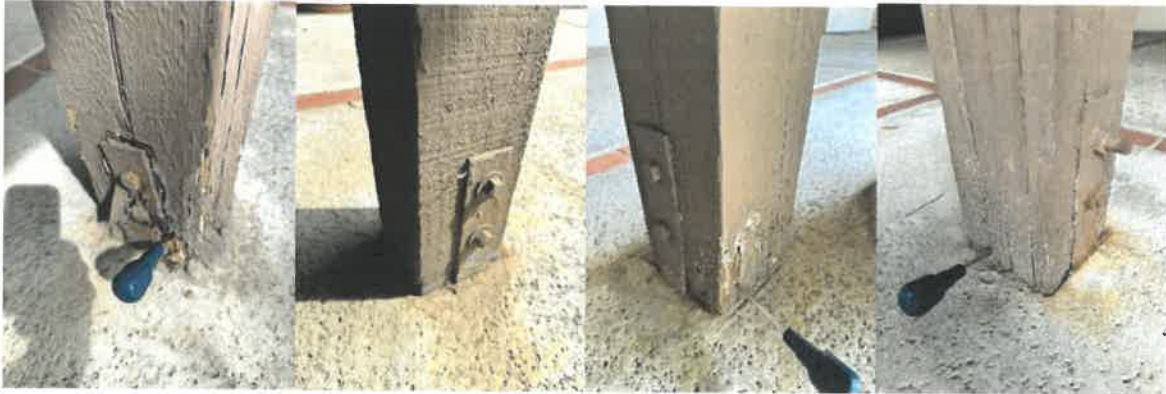
Most of the 6x posts that are supporting the overhang in the courtyard are also damaged. Either the post base has corroded away or in the process of doing that or the lumber has dry rot and disintegrated, cracked and bolts are too close to the sides. Pictures are shown in numerical order from left to right and from top to bottom. (See floorplan for locations)

Location 1

Location 2

Location 4

Shore up support beams resting on posts during repair. Remove post and framing angles at top. Cut off and grind off the remnants of the post bases. Set new adjustable retrofit ABU5-5 post base. Drill into existing slab/pad. Clean holes, blow out and brush to eliminate dust. Set new 5/8" epoxy anchors in ground. Install galvanized bolts and nuts through posts. (Epoxy anchors unaffected by dampness while wedge type anchors will corrode eventually). Install new columns, treat bottom ends and sides of the bottom part with "Copper-Green" to extend the life expectancy of the new work.

Shore up support beams resting on posts during repair. Remove post and upper framing angles, cut off post bases to gain access for core drilling. Remove remnants of old post bases by core drilling the center of the pad. It is faster, more cost effective and less intrusive than having to demo out the entire 24" x 24" pad which would leave large sections of visible signs of repair work around each post. Set new CB66PC or CB66 column bases with CPS6 standoff bases to keep columns high enough to minimize water intrusion. Pour and finish high strength 4000psi concrete in holes. The 11'-12" hole diameter will provide the required 3" side cover for full load. Install new columns with galvanized through-bolts, treat bottom ends and sides of the bottom part with "Copper-Green" to extend the life expectancy of the new work.

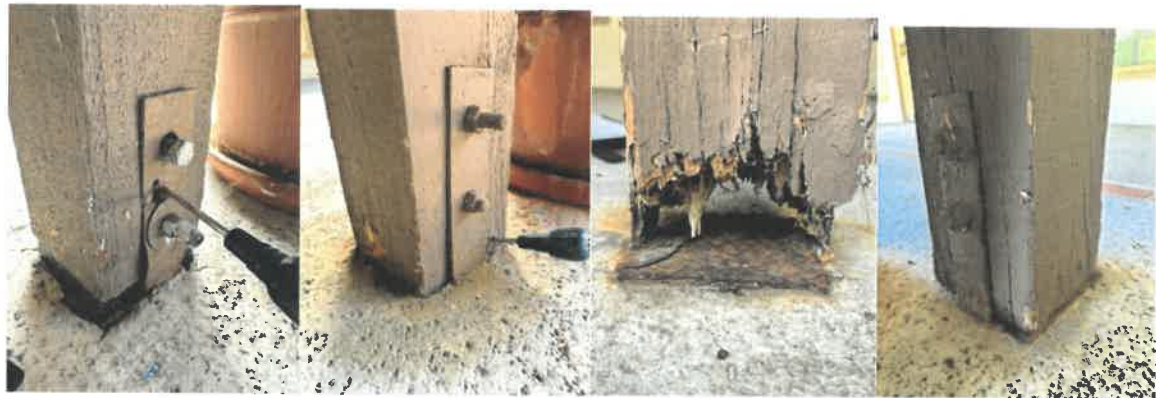
Location 5

Location 6

Location 7

Location 8

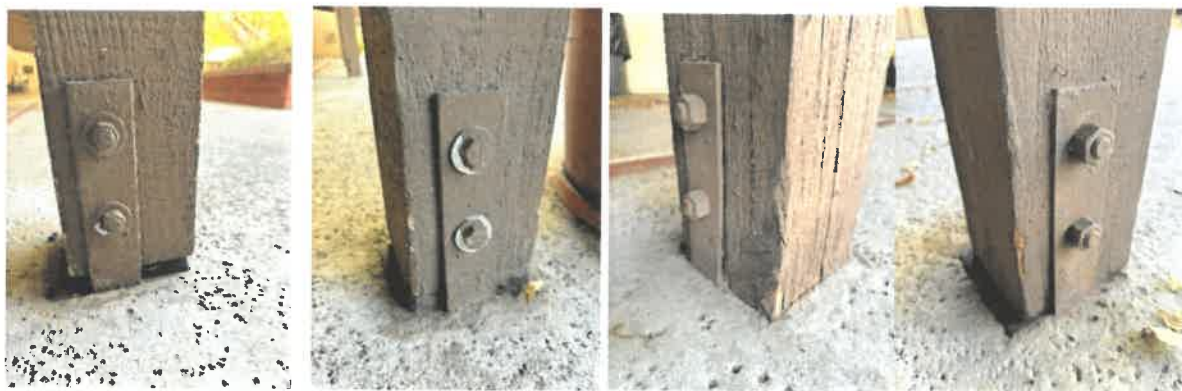
Location 9

Location 10

Location 11

Location 12

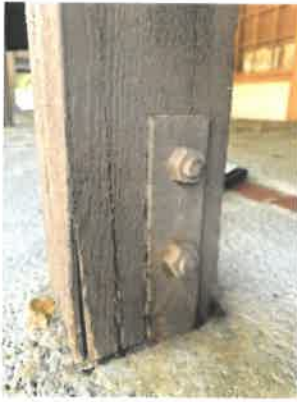
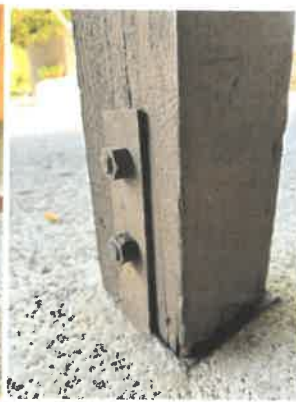
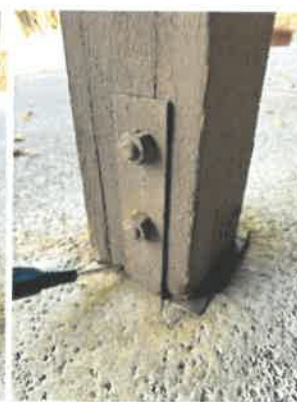
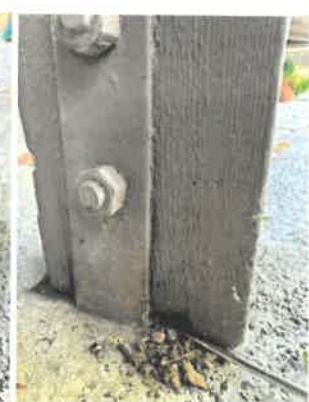
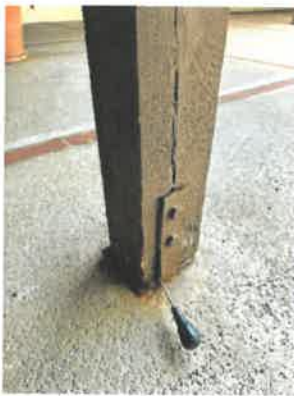
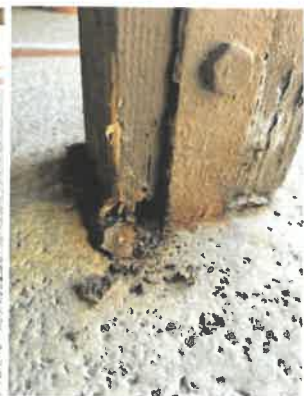
Location 13

Location 14

Location 15

Location 16

Location 17

Location 18

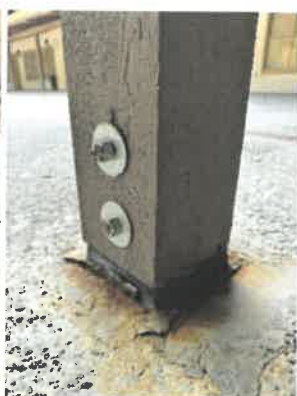
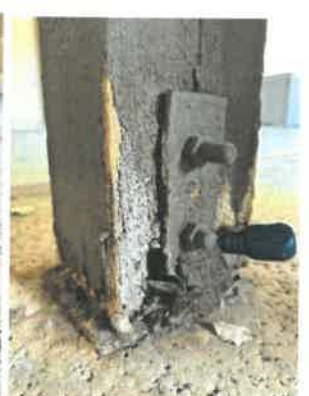
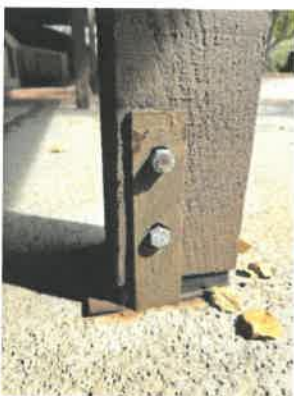
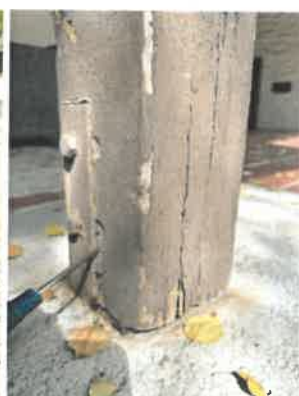
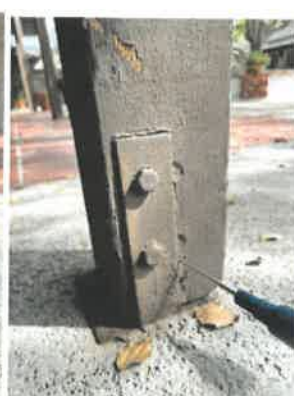
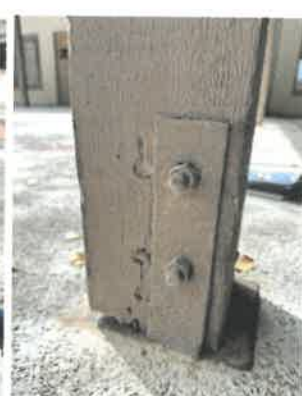
Location 19

Location 20

Location 21

Location 22

Location 23

Location 24

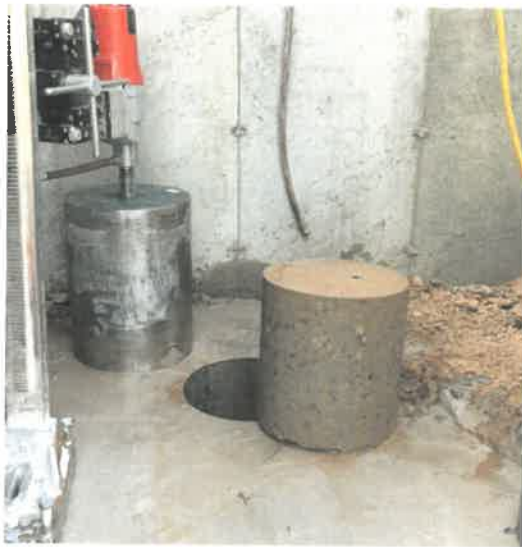
Typical core drilling

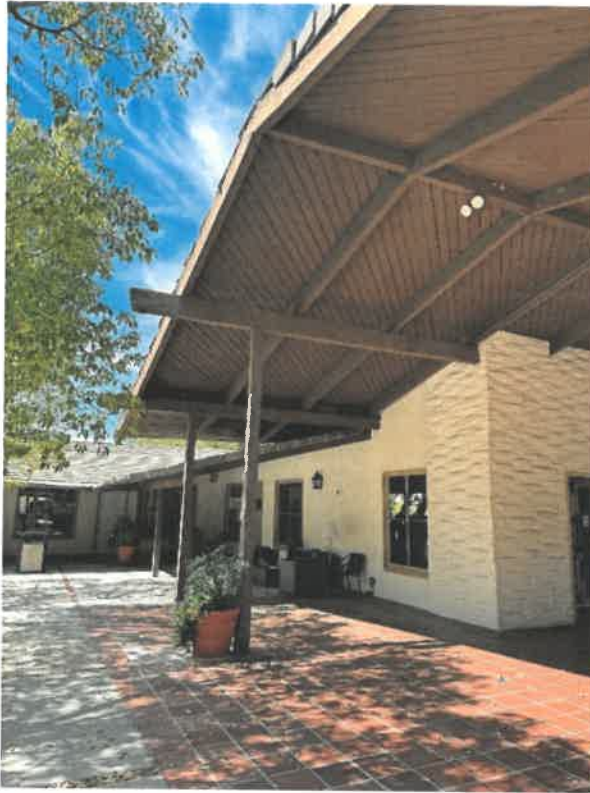
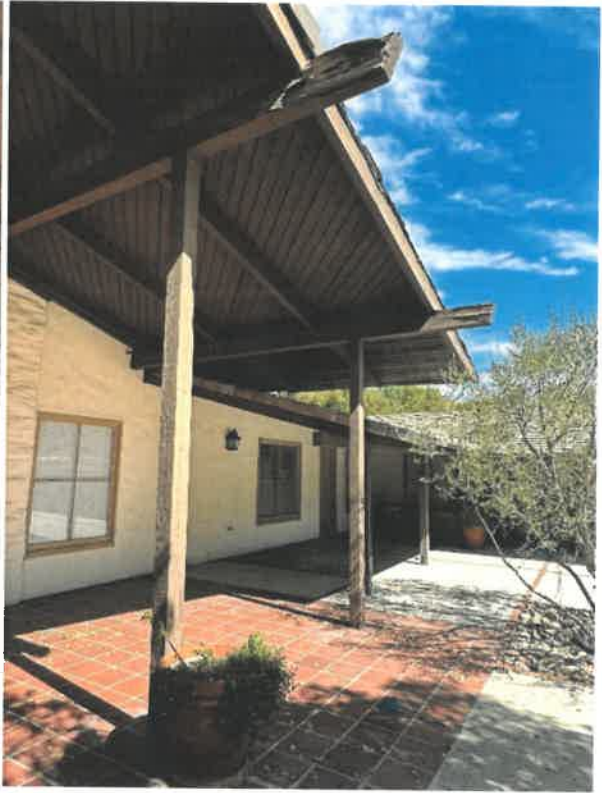
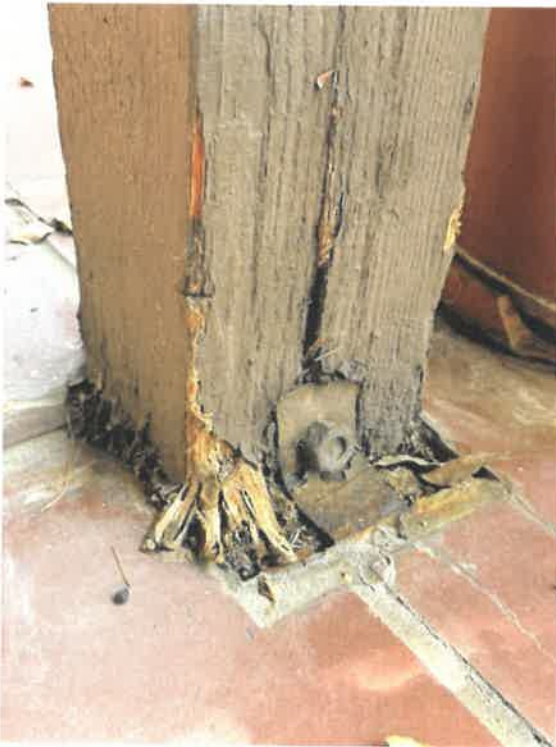
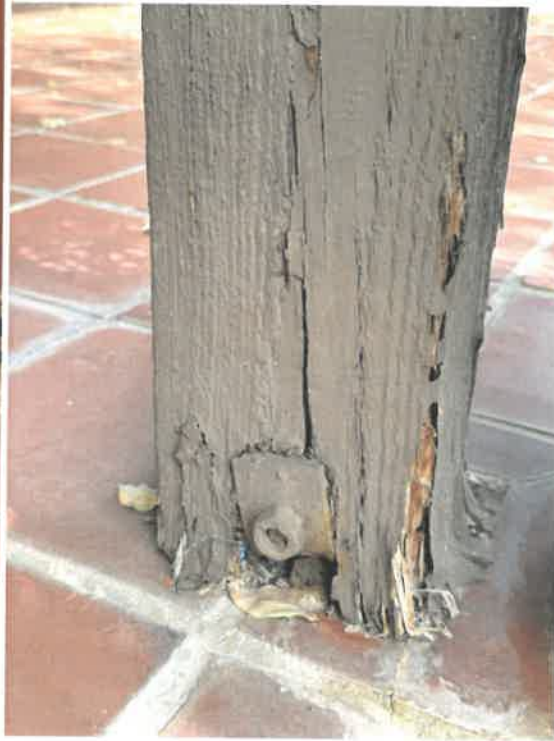
Additional 4 posts for the main entrance

These 4 longer posts would require a similar approach then the ones would be used for the breezeway posts. However, at these locations I would not feel comfortable using "Option 1" since these are taller, more spread out and support larger loads. I think Here need to install in-ground post bases even if it means replacing the pads. (See pictures next page)

Temporary shoring of roof structure as needed to transfer loads during the removal and placement of new work. Removal and disposal of old materials. Demo out existing 3'-0" x 3'-0" x 1'-6" post bases. Set and tie new rebar in holes. Set CB66 post bases, pour and finish 4000psi high strength concrete in each hole. Cut new rough sawn posts to size, treat the bottom of each with copper-green wood preservative, prime and paint all sides before installation. Install and secure new post with exterior grade hot dipped galvanized 5/8" bolts, washers and nuts as needed. Install new CPS6 plastic spacers between bottom of treated bases of the posts and the top of the steel post bases, (which are flush with the ground) to keep all lumber from being in direct contact with the ground and to minimize water intake and lengthening the life of the new work. All labor, materials, equipment and cleanup.

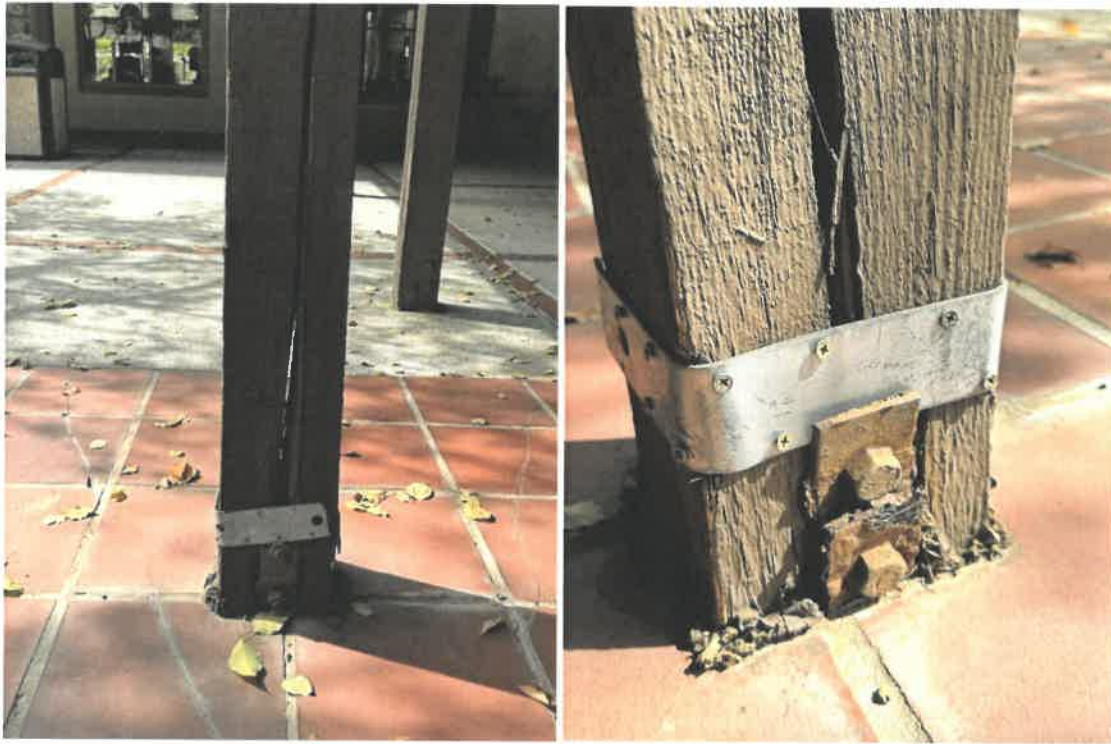
Additional posts for NE corner, lower roof.

There are two 4x4 posts supporting the lower roof overhang at the NE corner of the complex.

In addition, the support beams are also damaged past the fascia boards and need to be either replaced or repaired by splicing as discussed earlier for the main entrance area. One of the pads shows signs of cracks.

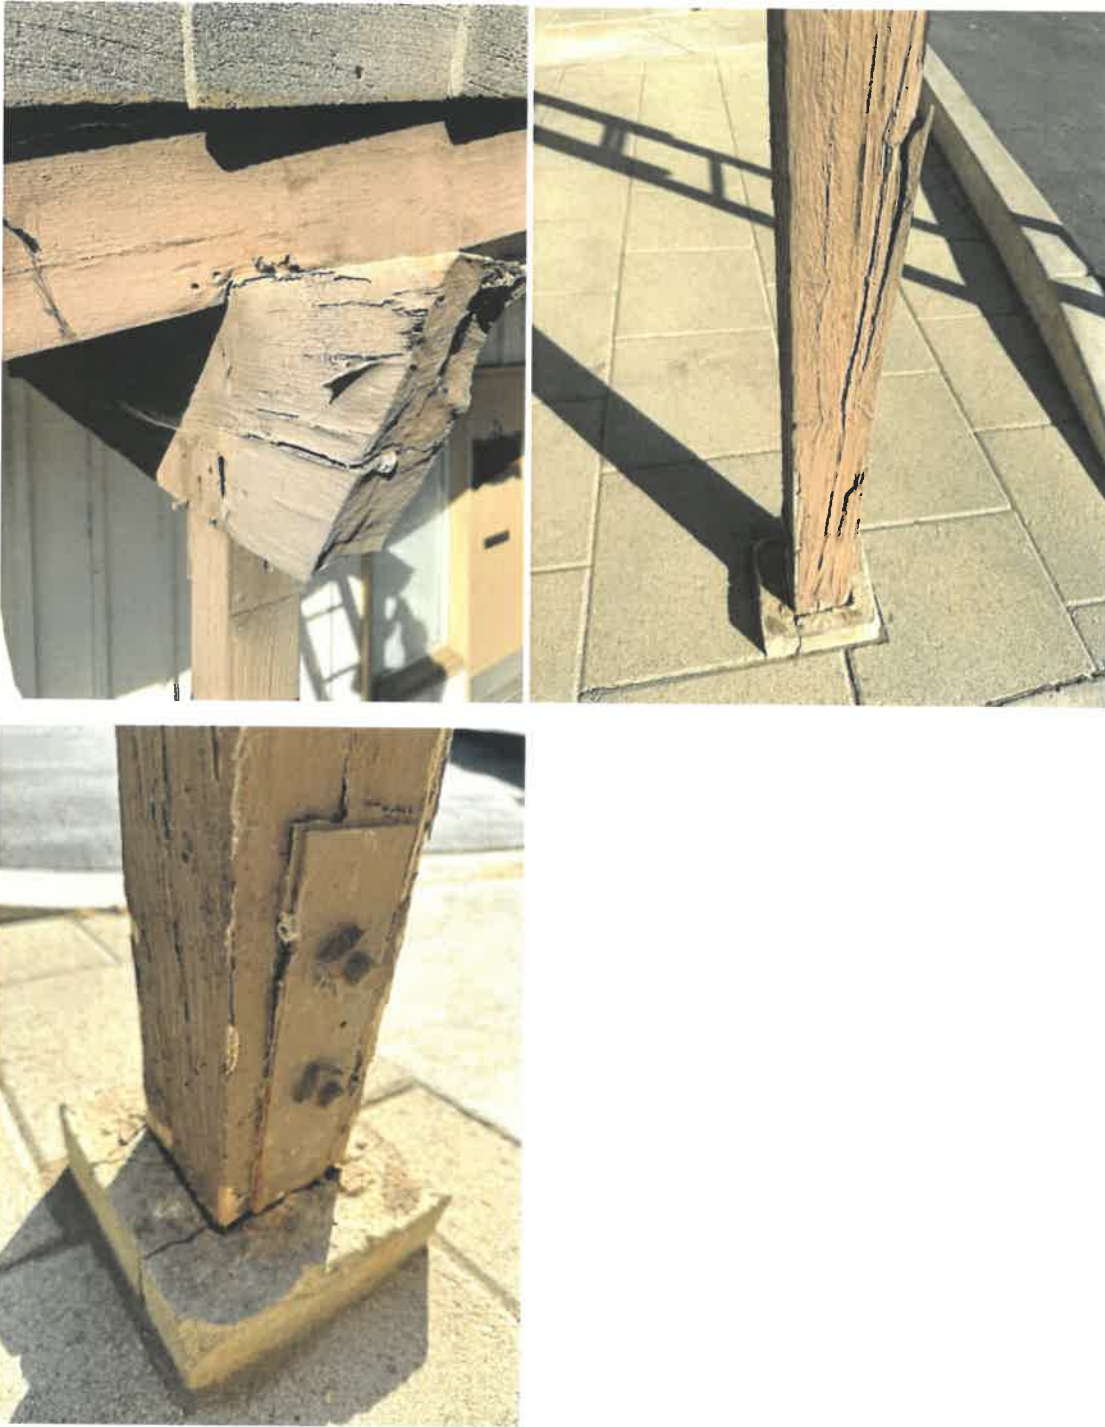
Temporary shoring will be needed at all locations where posts or beams will be replaced and/repared to transfer loads from the members during construction.

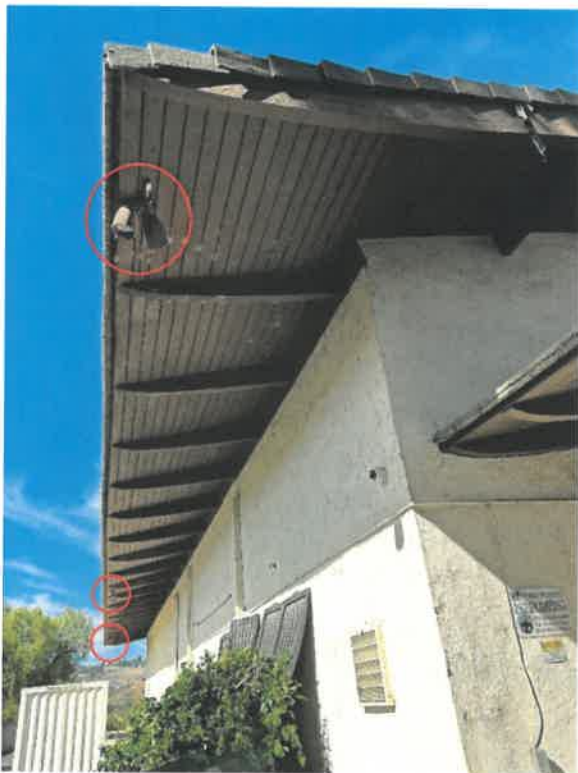
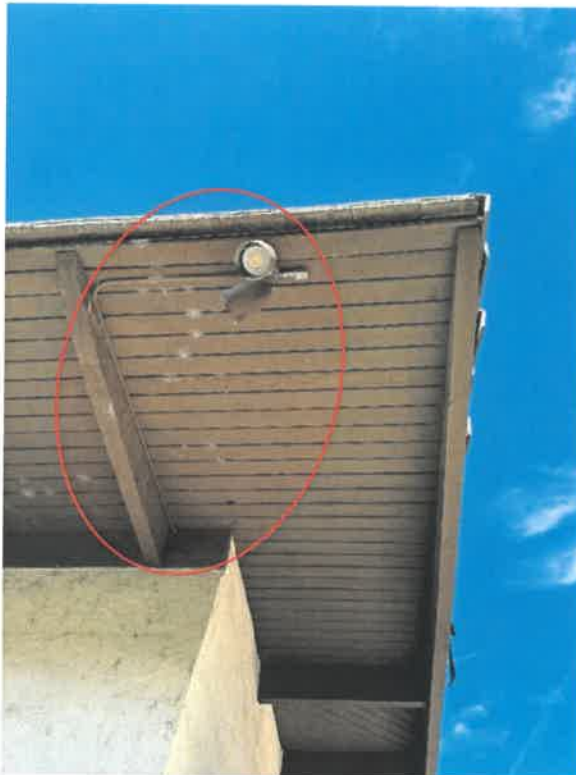
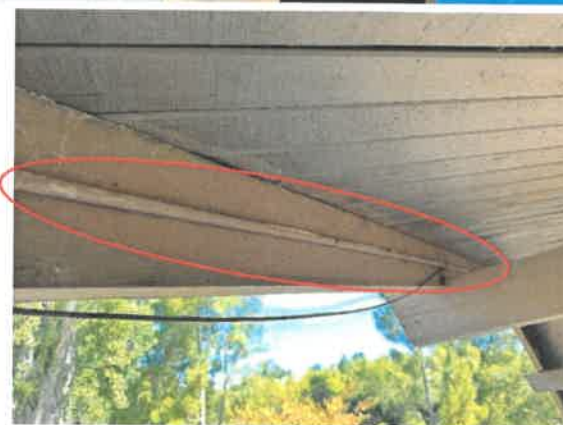
Existing electrical distribution needs to be removed, relocated or modified at some of these and some other additional locations where fascia board replacement and shortening of the overhang will take place even where fascia boards are not being replaced. EMT and flexible liquid tight conduits, fixtures and installations would need to be temporarily disconnected. After the framing is done, run conduits, pull and splice wires as needed to reestablish service for each location. Installing new LED fixtures and lighting control is recommended

Typical locations of electrical work that need to be relocated or modified for the roofing project.
