TS-940 LCD Display – LED installation kit & Clock Battery Replacement

TS-940 LCD Display LED Installation and Clock Battery Replacement

Internal Battery Replacement

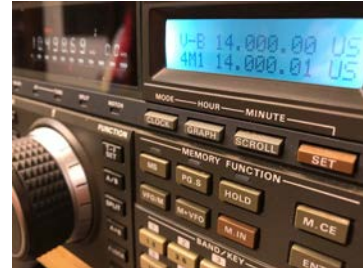
- 2 ea. 3mm White High Brightness LEDs
- 2 ea. 510 ohm resistors
- This instruction manual
- 2 CR-2032 Batteries with solder tabs – (If ordered)5

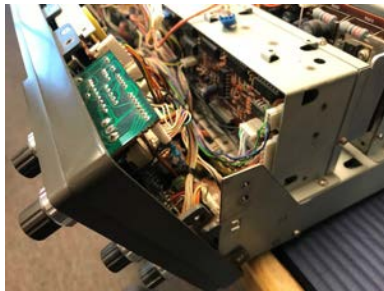
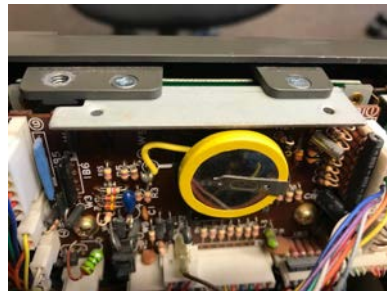
Remove these 2 screws

1. First, remove the top and bottom covers of the radio and set them aside
2. Next, remove the left and right side Philips head screws to tilt the front panel down to access the LED display

Be careful when tilting the front panel. There are a few things that get in the way. You only need to tilt it enough to remove the LCD display.

3. Once the front panel is tilted down, remove the 2 screws that hold in the clock/timer & LCD display modules. (see image of the 2 screws just above the battery. You can then tilt out the Timer module and LCD display.
4. There are 4 screws holding the LCD display to the timer module. We suggest using a magnetic screw holding Philips screwdriver to remove the screws. Being careful not to drop any screws inside the radio! They are very hard to find! Remove the four screws, then unplug the 2 pin black and orange wire from the right (Front) side of the display.

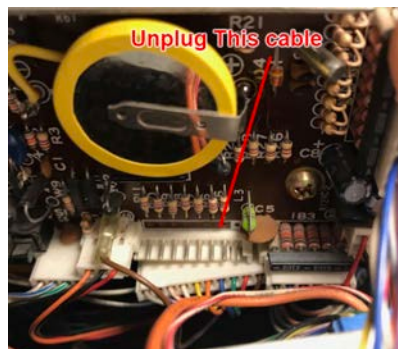
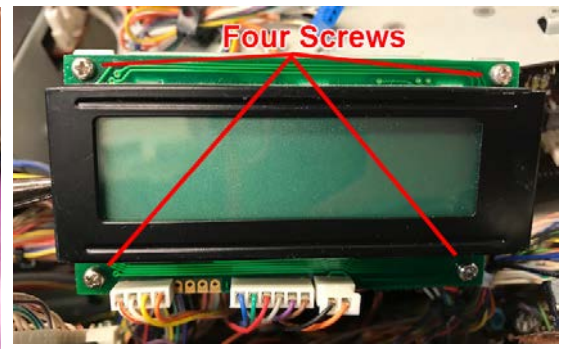
5. Finally, unplug the 10 pin cable as shown below on the battery side of the clock board. Now, the LCD display should be completely free and ready for the LED upgrade. Be sure to handle the LCD display carefully and it is a good idea not to touch the glass on the front.

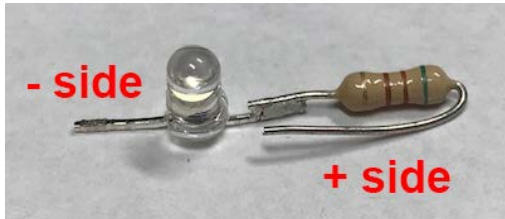
- Once you have the display detached from the clock board, lay it down with the display down and the circuit board facing up. Use a small pencil type iron to remove the 2 existing incandescent light bulbs from the circuit board side of the display. There are 2 small pads on each end of the display. Simply heat each pad very quickly and lift up the wires from the light bulbs. You can also choose to just cut the wires on the bulb and lift them out. Pull straight up on the light bulbs and they will come right out.
- To install the new LEDs, bend the - side (Short wire) at a 90 degree angle and cut it to about 1/4" as shown. Then, solder one side of the 510 ohm resistor to the + side of the LED as shown.

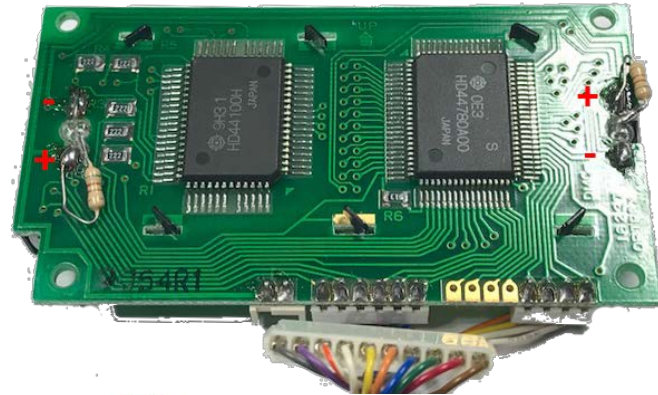
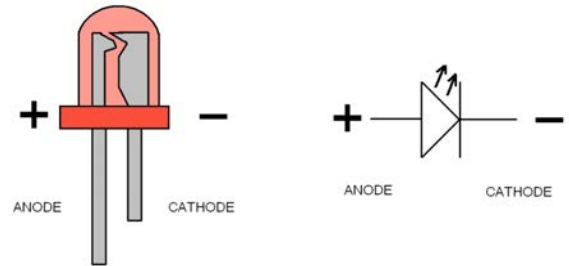
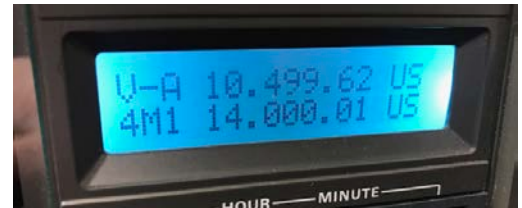
- Next, just insert the LED into the space where the old lights came out and solder as shown. NOTE: Pay attention to which side is + and -. They are mounted in different directions on the board as you can see so make sure that you have the polarities correct. Once you have the LEDs correctly mounted on the LCD display, re-mount the LCD to the clock board using the 4 screws that were removed in step 4.

- Be sure to plug in the 2 conductor cable that was removed in step 4 and the 10 pin connector from Step 5.
- Remount the LCD Display and Clock module using the 2 screws that were removed in Step 3. It is a good idea to test the display to make sure the LEDs were installed correctly. The LCD display should have a great looking Blue color with nice high brightness!

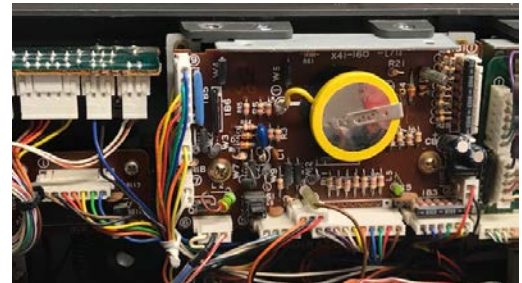
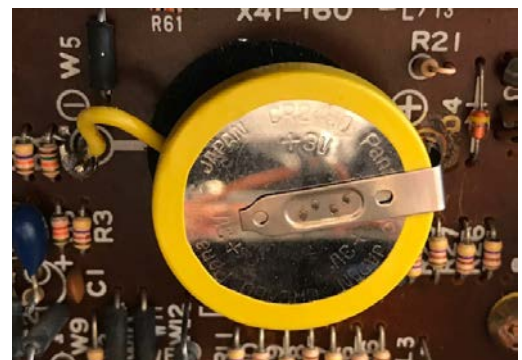
- Look at the existing battery and its orientation. The positive side (+) is on the top normally. On most batteries, it is clearly marked.
- It is a good idea to check the voltage across the battery with the power unplugged from the radio. If it is +3V or above, the battery is still good.

- NOTE: Some TS-940s have 2 batteries soldered into the clock module. You can replace these with one. The 2 batteries were apparently an optional way of extending the battery life but to our knowledge, there was no other reason since they were in parallel.

- To replace the battery, simply unsolder both sides of the battery and remove it. Re-solder the new battery making sure that the + and - terminals are oriented correctly.

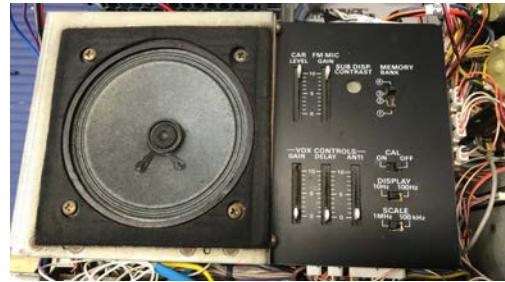
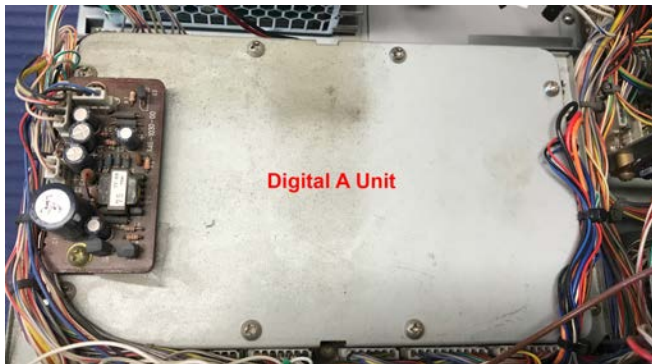
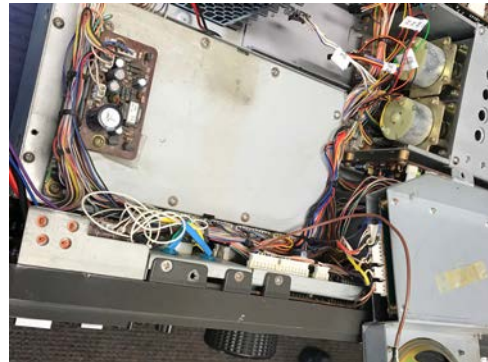
1. There is a 2nd battery that should also be replaced. It is located under the speaker and then inside an RF Can (Digital A Unit). On the left and right sides of the speaker assembly, you will find two screws that need to be removed on each side. After you remove these, the entire speaker assembly can be pulled up and moved out of the way to the right.
2. Next, remove all 8 screws from the cover over the Digital A Unit. Once the cover screws are removed you can carefully swing the cover to the left and out of the way. This exposes the battery so it can be replaced.

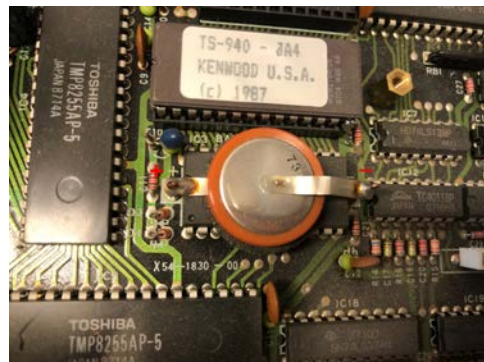
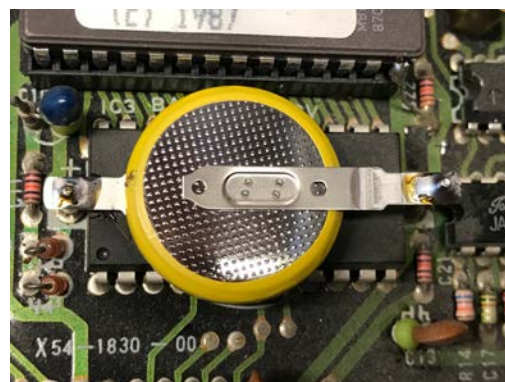
3. Remove the old battery with a low wattage soldering iron by simply heating up the tab until the solder melts then lift the tab straight up and off of the board.
4. Install the new battery and make sure that the + side of the battery goes to the left and the - side goes to the right. The new battery (Yellow) is installed just like you found the original.
5. Carefully re-install the cover to the Digital A Unit with the 8 screws and then re-secure the speaker with the 4 screws that were removed in Step 1

NOTE: These batteries should last at least 5 years but should be checked occasionally to make sure they are at a voltage of +3V or more. If the TS-940S has to be continually reset using the A=B key on power-up, it is an indication that the Digital A Unit battery is defective.

If the TS-940S time changes from your initial settings, it is an indication that the Clock/Timer battery is defective and it should be replaced.
