Palmerton Memorial Pool Association Community Meeting May 7, 2025

Pool Condition Assessment

Concept Options

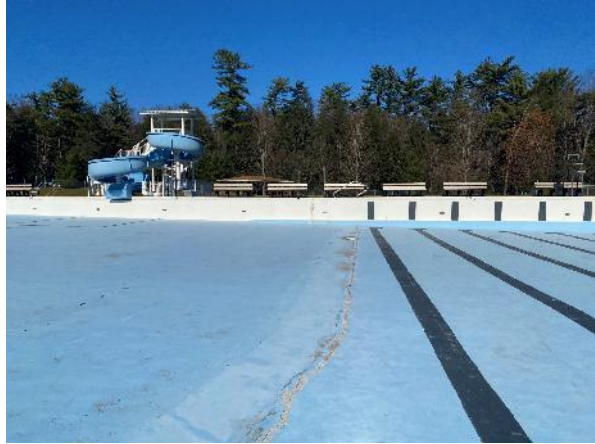
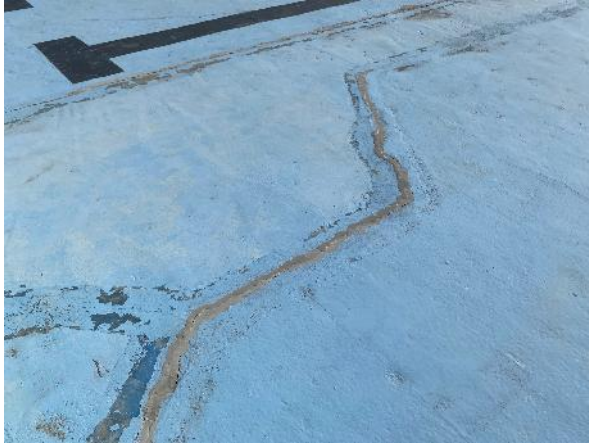
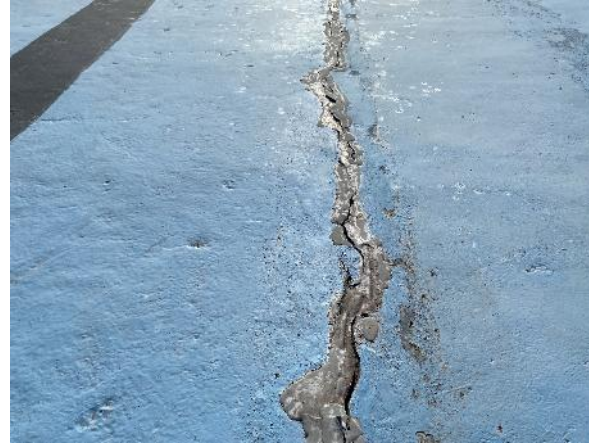
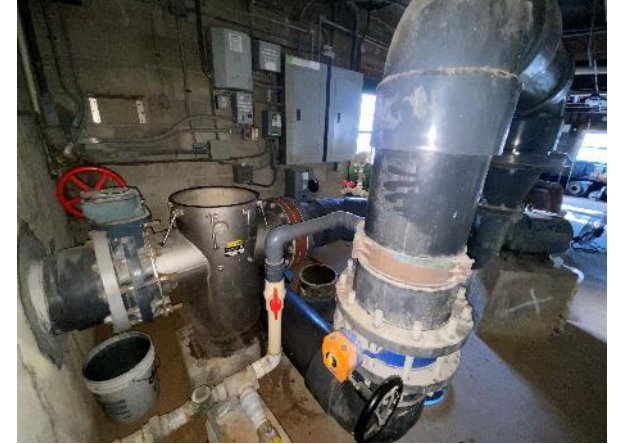
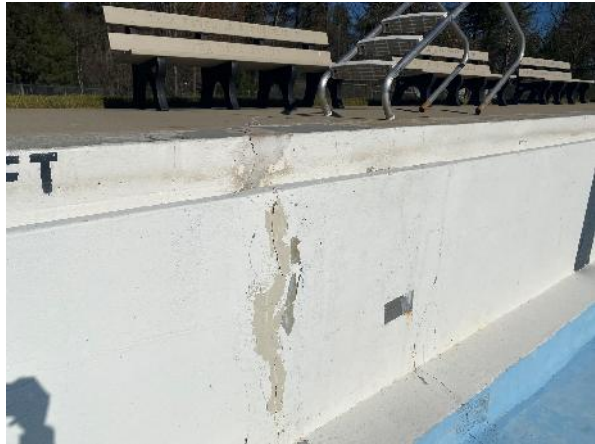
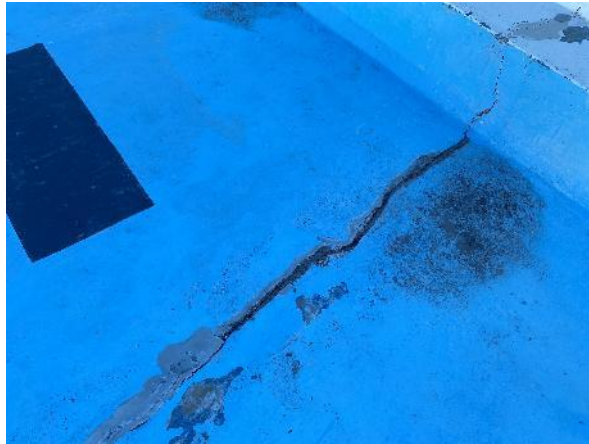
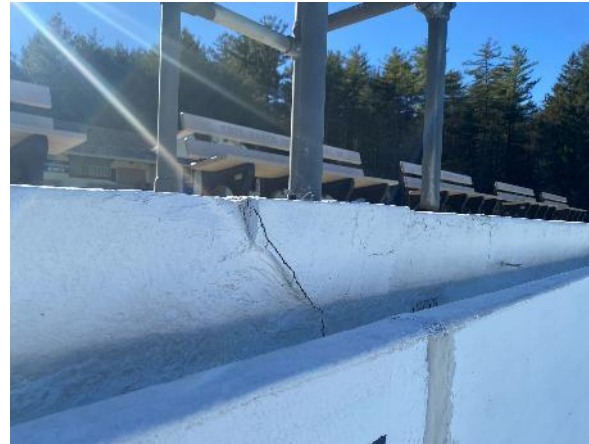
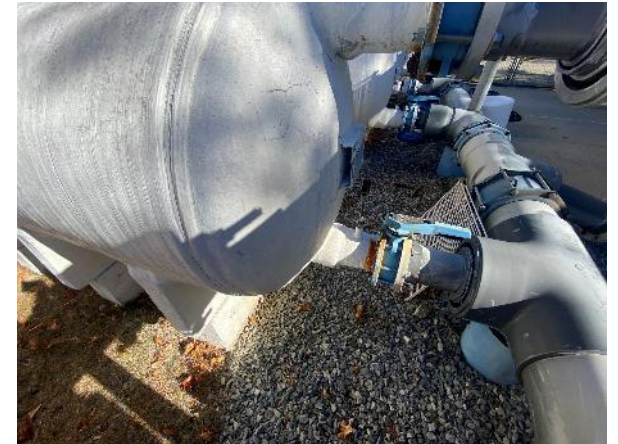
Pool Condition Assessment

- Large crack spanning across the entire swimming pool due to pool shifting causing structural cracks
- Shallow end wall crumbling and bubbling with areas of exposed rebar on pool walls and stairs
- Pool stair entries have crumbling and delaminating concrete leaving exposed rebar
- Several areas of the pool's coping stone is in poor condition with cracking and delaminating concrete and jagged edges that pose safety issues for pool users
- Pool mechanical equipment last replaced in 1991 during renovation
- Pool contains original cast iron piping and corrosion exists on mechanical system components
- Main pool and children's pool are on the same recirculation system
- Pool needs two accessible means of entry to meet ADA standards

- Address pool structure for cracking, delaminating concrete, water loss and gutter capacity
- Repair or replace pool deck
- Renovation of pool mechanical system
- Address ADA accessibility

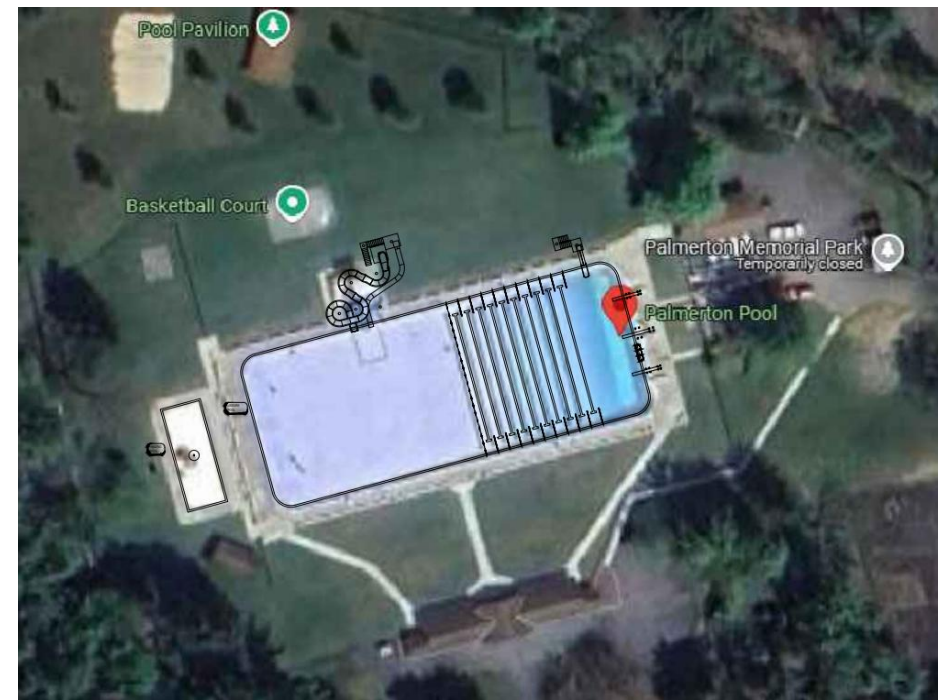
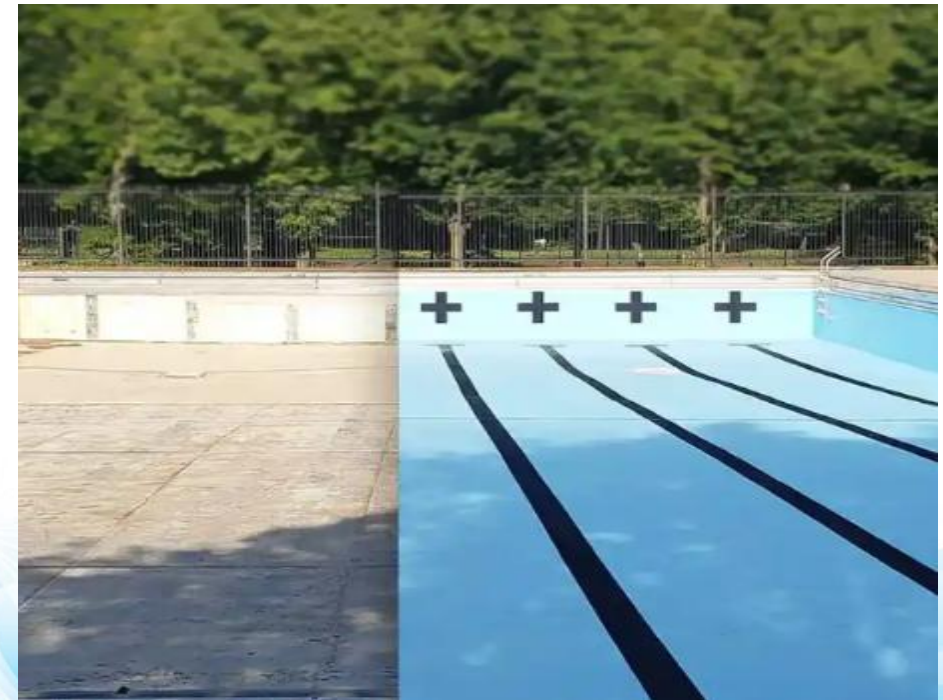
Repair

- **Install pool liner**
 - Keeps existing layout and size of pool
 - PVC or vinyl liner/membrane to line the pool floor and walls
 - Maintains water tightness in the pool structure
 - No renovation to pool mechanical equipment
 - Provides a 5-to-7-year solution
 - Ongoing maintenance of other aging components required
- Project budget: \$600,000 to \$800,000

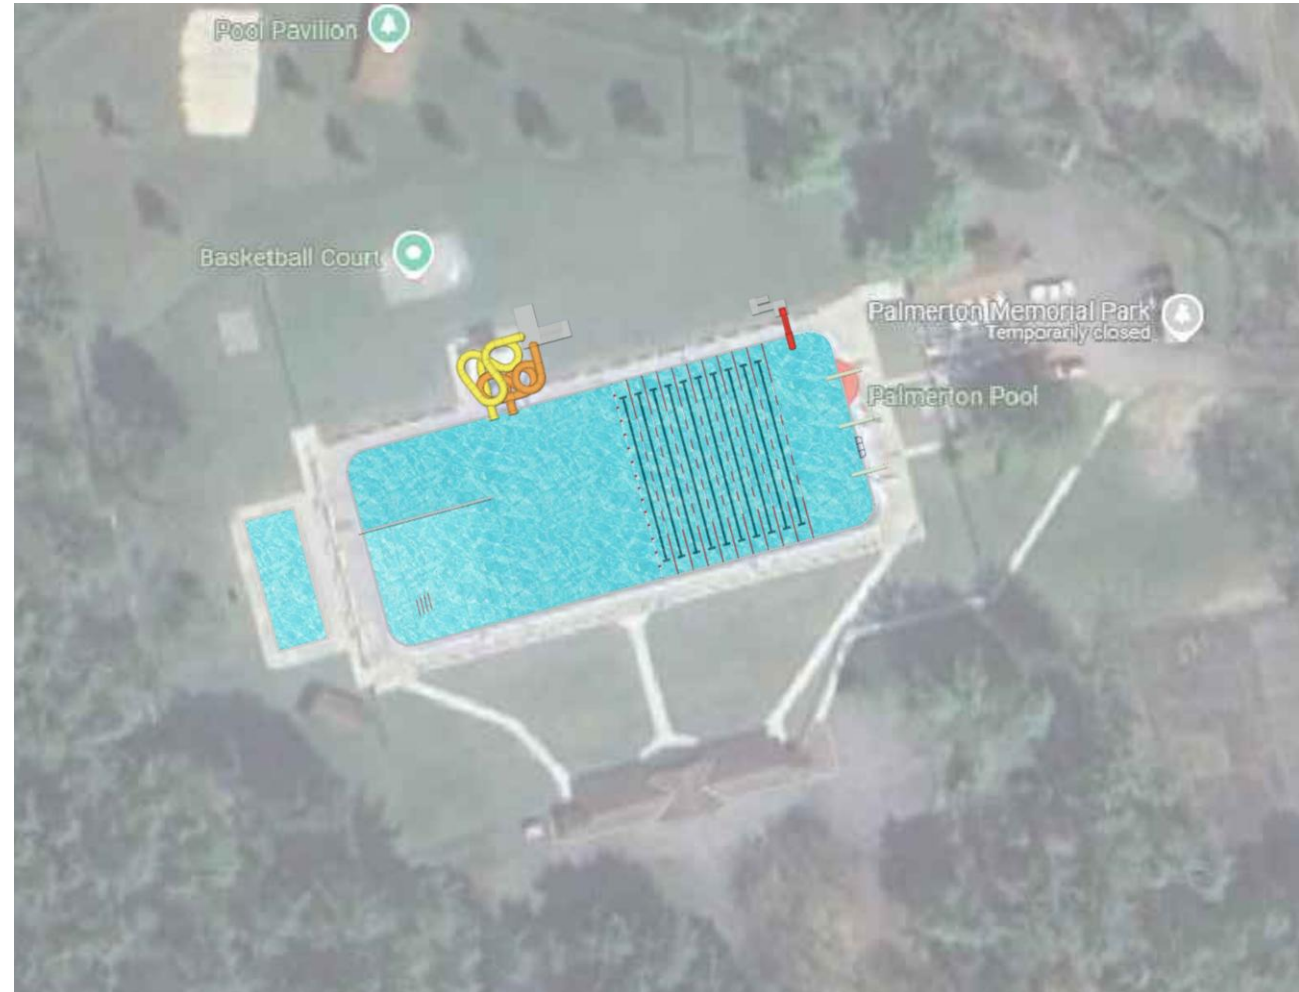
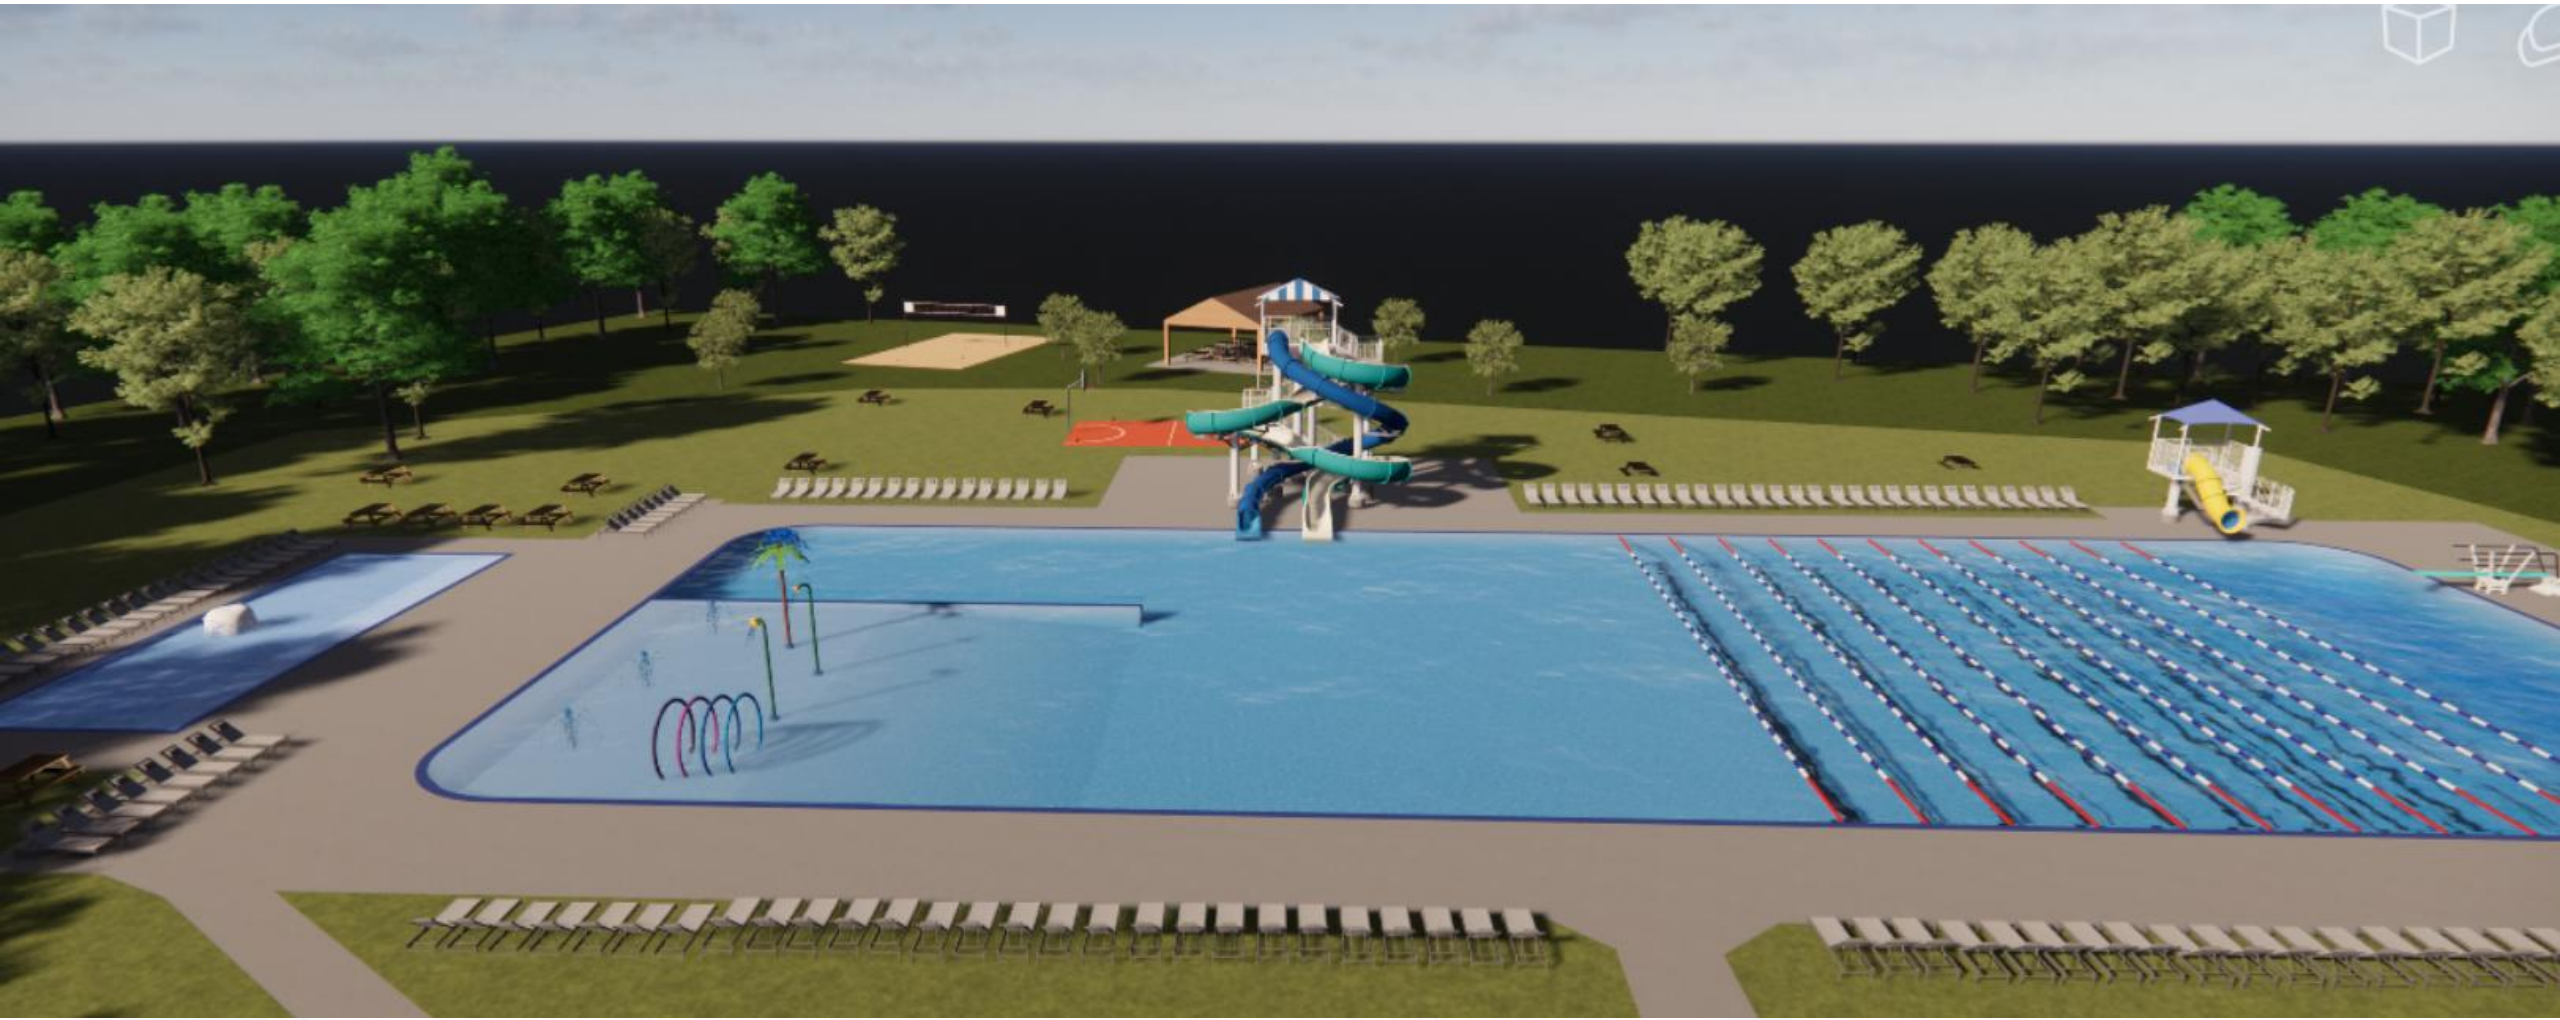
- Renovation existing pool structure utilizing Myrtha RenovAction panels and addition of zero-depth beach entry
 - Keeps existing layout and size of pool
 - Incorporates a new zero-depth beach entry
 - New stainless-steel wall panels installed inside of pool wall to reinforce existing concrete walls
 - Installation of new stainless-steel gutter overflow system
 - PVC liner attached to new panels and existing pool floor to maintain water tightness in the pool structure
 - Explore abandoning existing piping, specifically cast iron main drain piping and replace with perimeter pool piping
 - Provides a 20+ year solution

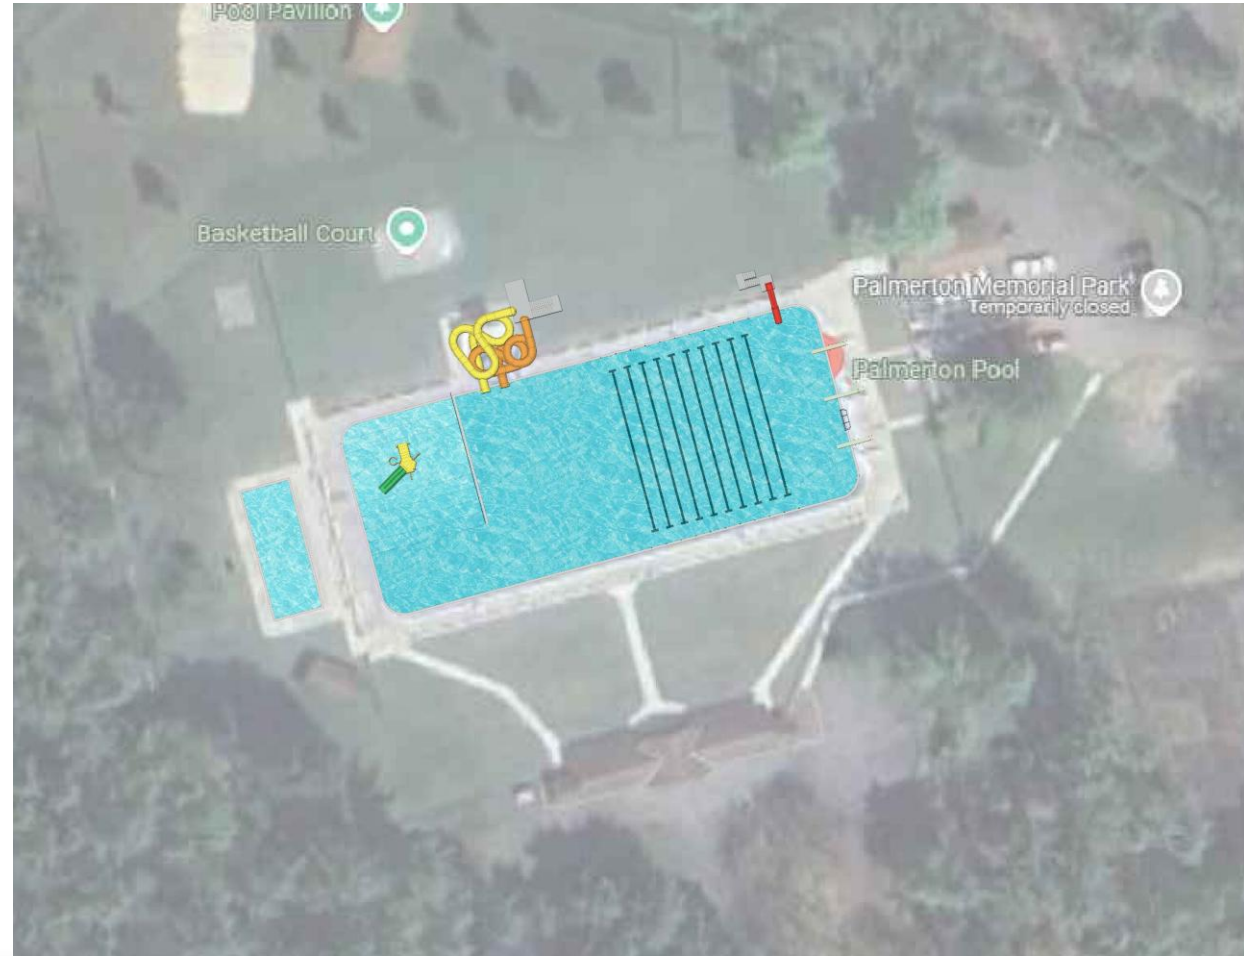
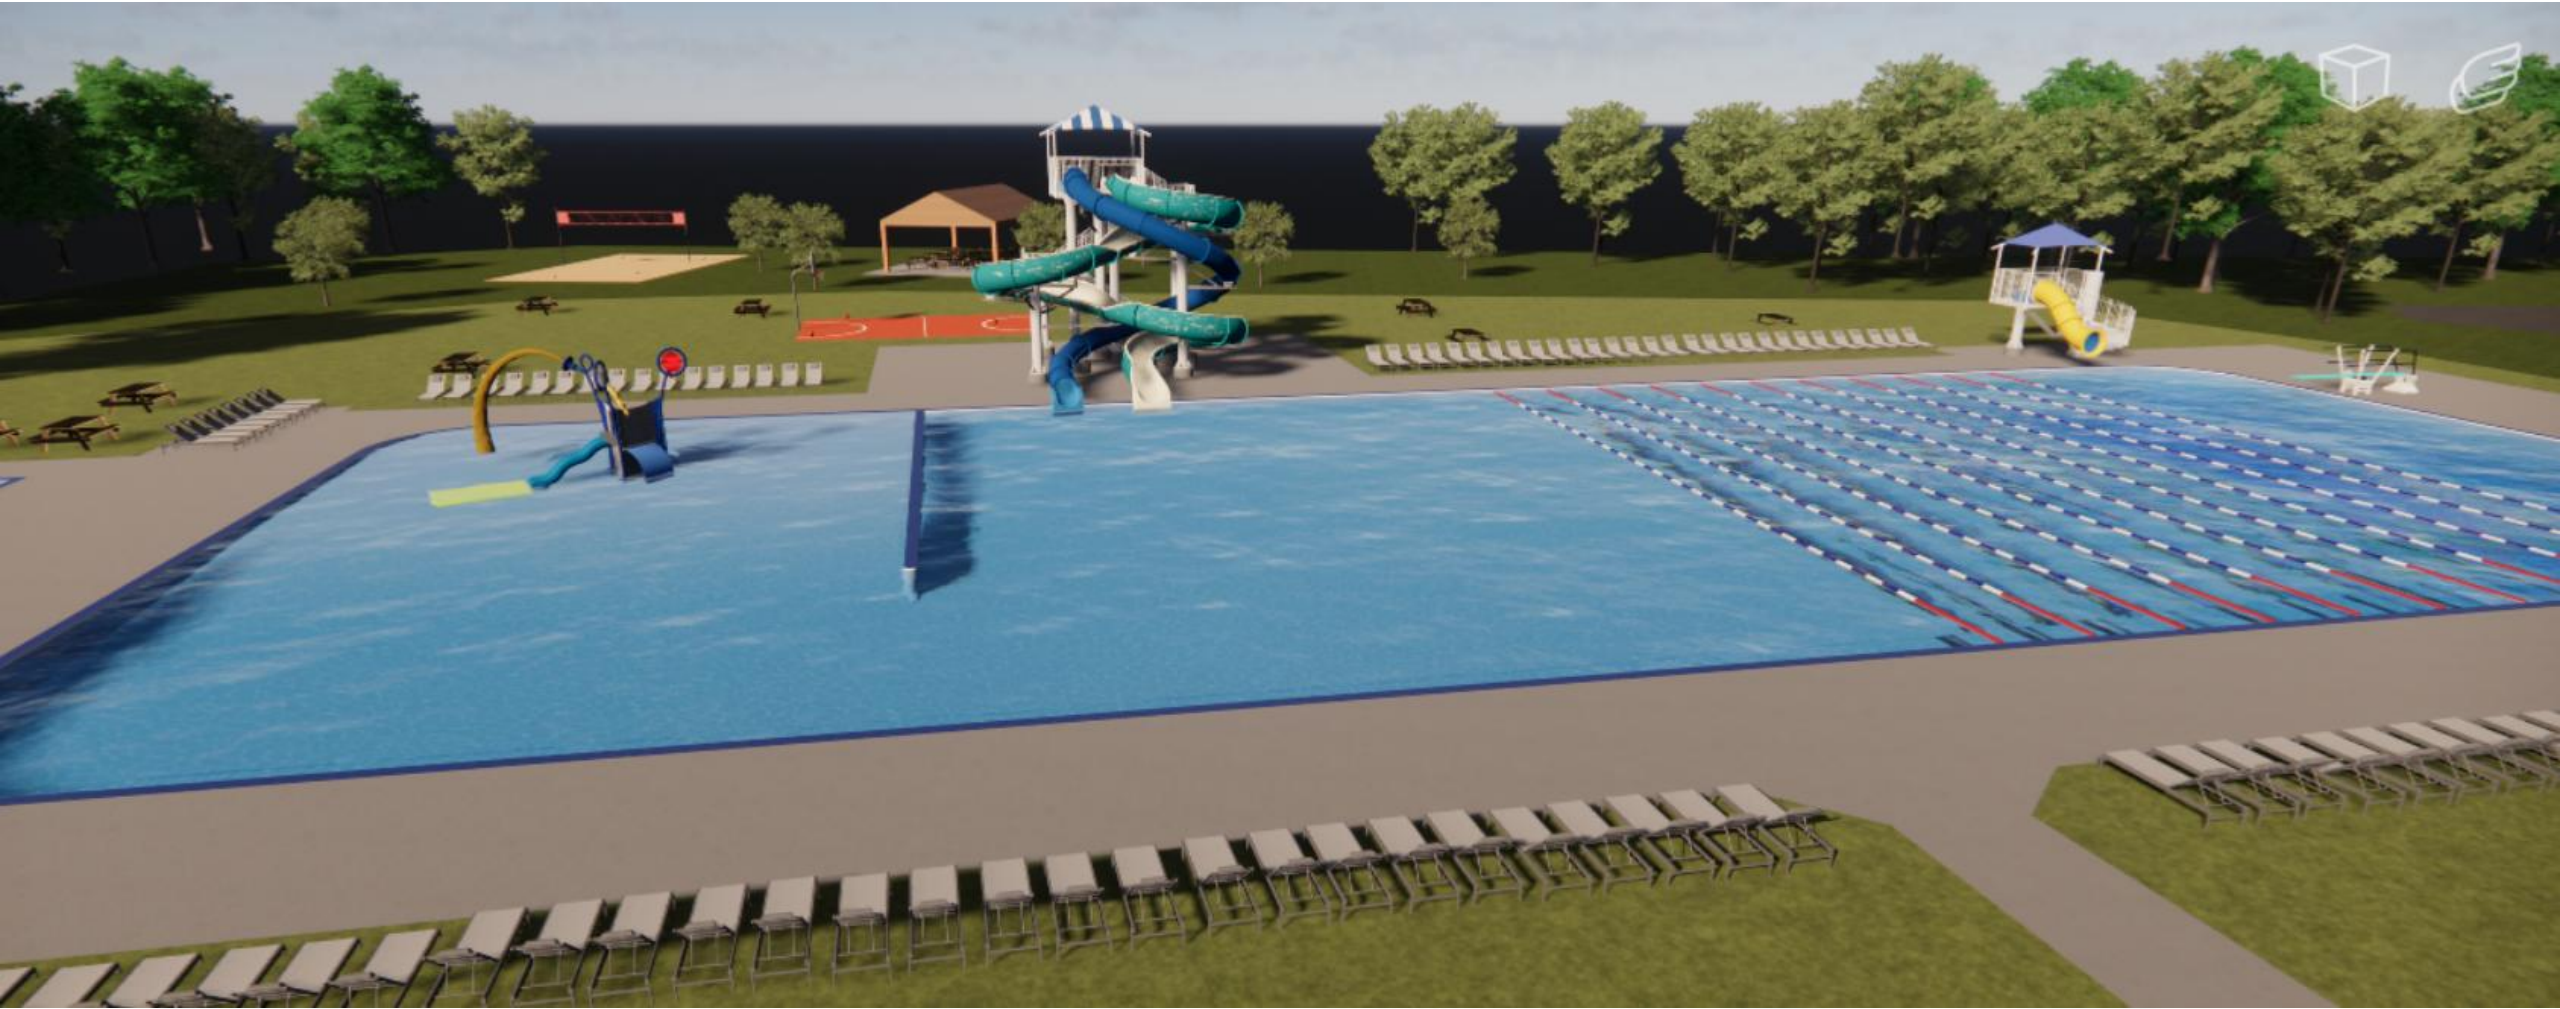
- Renovation existing pool structure utilizing Myrtha RenovAction panels and addition of zero-depth beach entry
 - Keeps existing layout and size of pool
 - Incorporates a new zero-depth beach entry
 - New stainless-steel wall panels installed inside of pool wall to reinforce existing concrete walls
 - Installation of new stainless-steel gutter overflow system
 - PVC liner attached to new panels and existing pool floor to maintain water tightness in the pool structure
 - Explore abandoning existing piping, specifically cast iron main drain piping and replace with perimeter pool piping
 - Provides a 20+ year solution

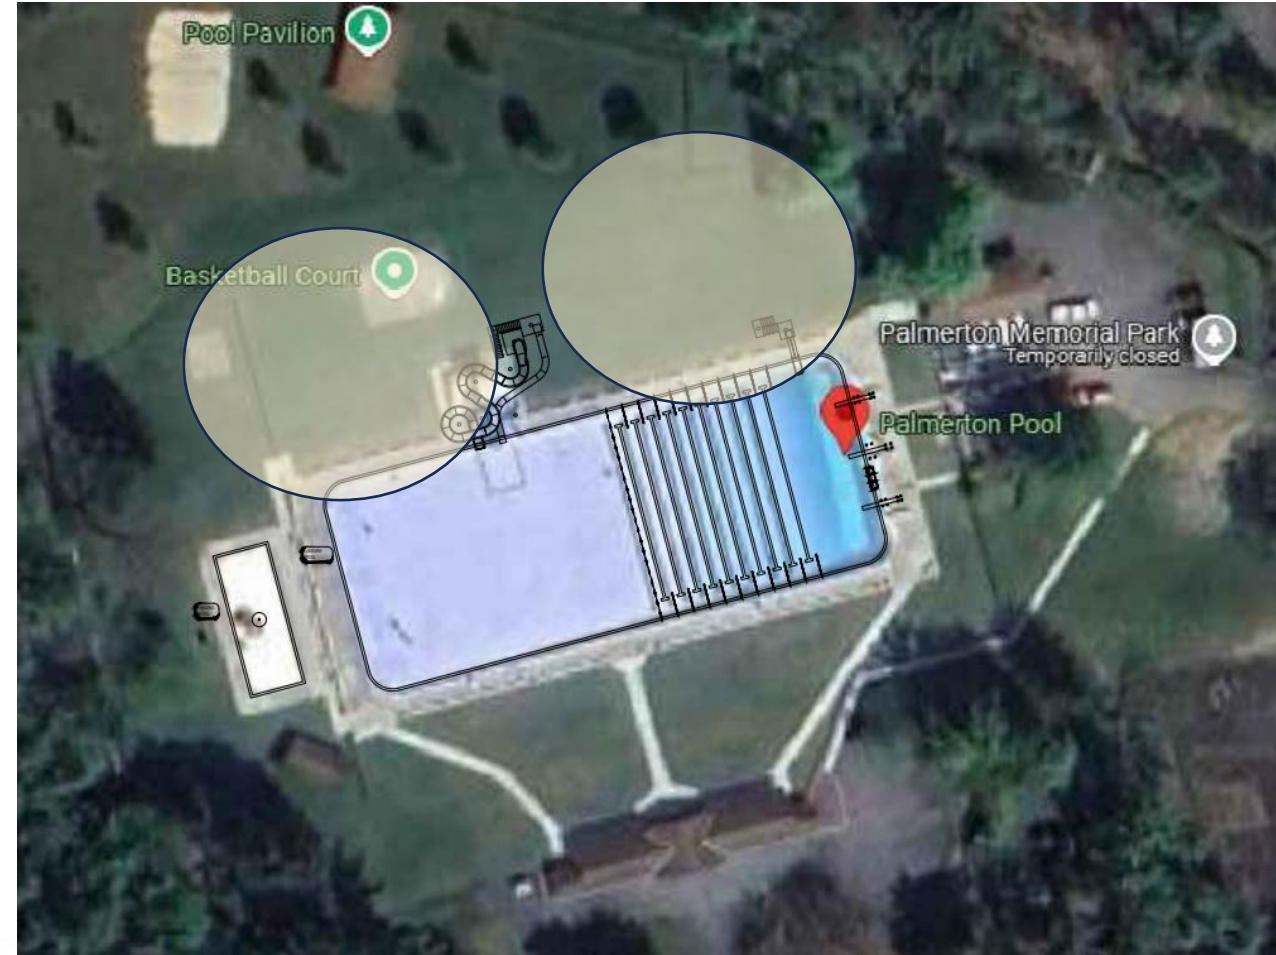
Renovation | Addition

- **Renovation existing pool structure utilizing Myrtha RenovAction panels**
 - Keeps existing layout and size of pool
 - New stainless-steel wall panels installed inside of pool wall to reinforce existing concrete walls
 - Installation of new stainless-steel gutter overflow system
 - PVC liner attached to new panels and existing pool floor to maintain water tightness in the pool structure
 - Explore abandoning existing piping, specifically cast iron main drain piping and replace with perimeter pool piping
 - Provides a 20+ year solution
- **Possible addition of other aquatic features**
 - Children's pool
 - Activity pool
 - Waterslide tower
 - Sprayground

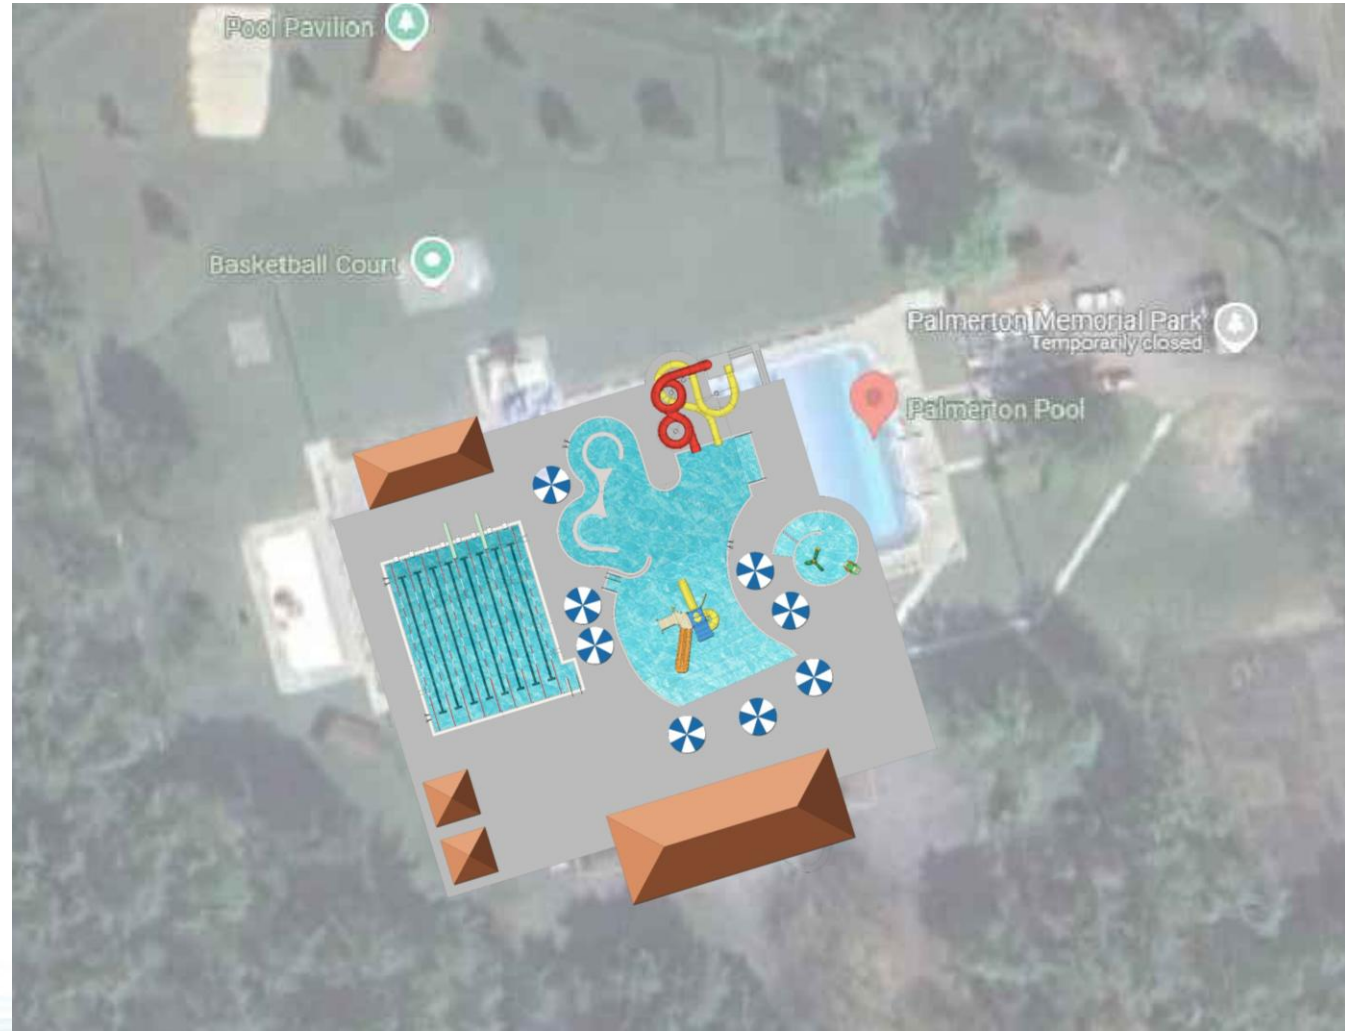
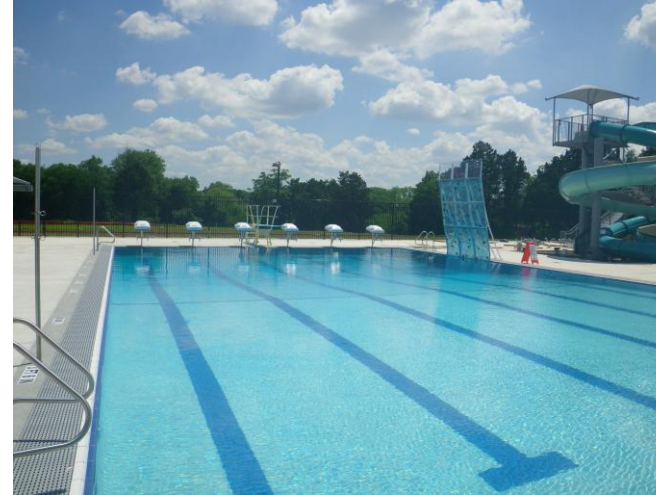
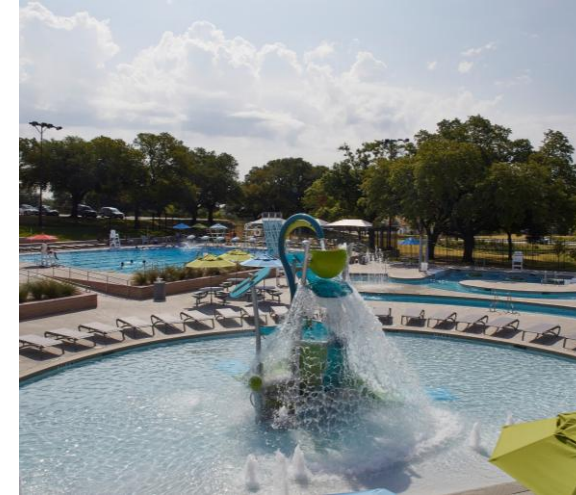
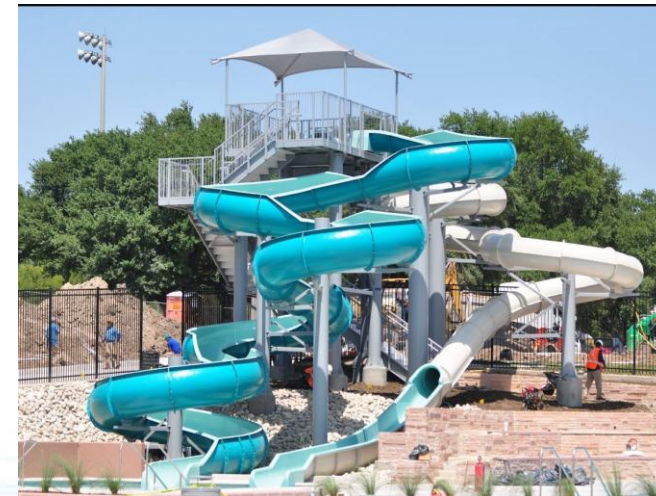
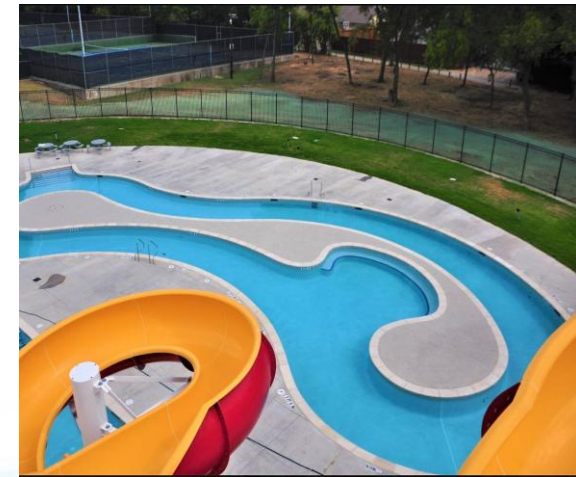
New Swimming Pool (1)

- 6,366 sq. ft. Leisure Pool
 - Zero beach entry with children's play structure
 - Current channel
 - Two waterslides into plunge area
- 700 sq/ft tot pool
- 4,560 sq/ft Lap Pool
 - 8, 25-yard lap lanes
 - 1 meter diving boards

- 6,366 sq. ft. Leisure Pool
 - Zero beach entry with children's play structure
 - Current channel
 - Two waterslides into plunge area
- 700 sq/ft tot pool
- 4,560 sq/ft Lap Pool
 - 8, 25-yard lap lanes
 - 1 meter diving boards

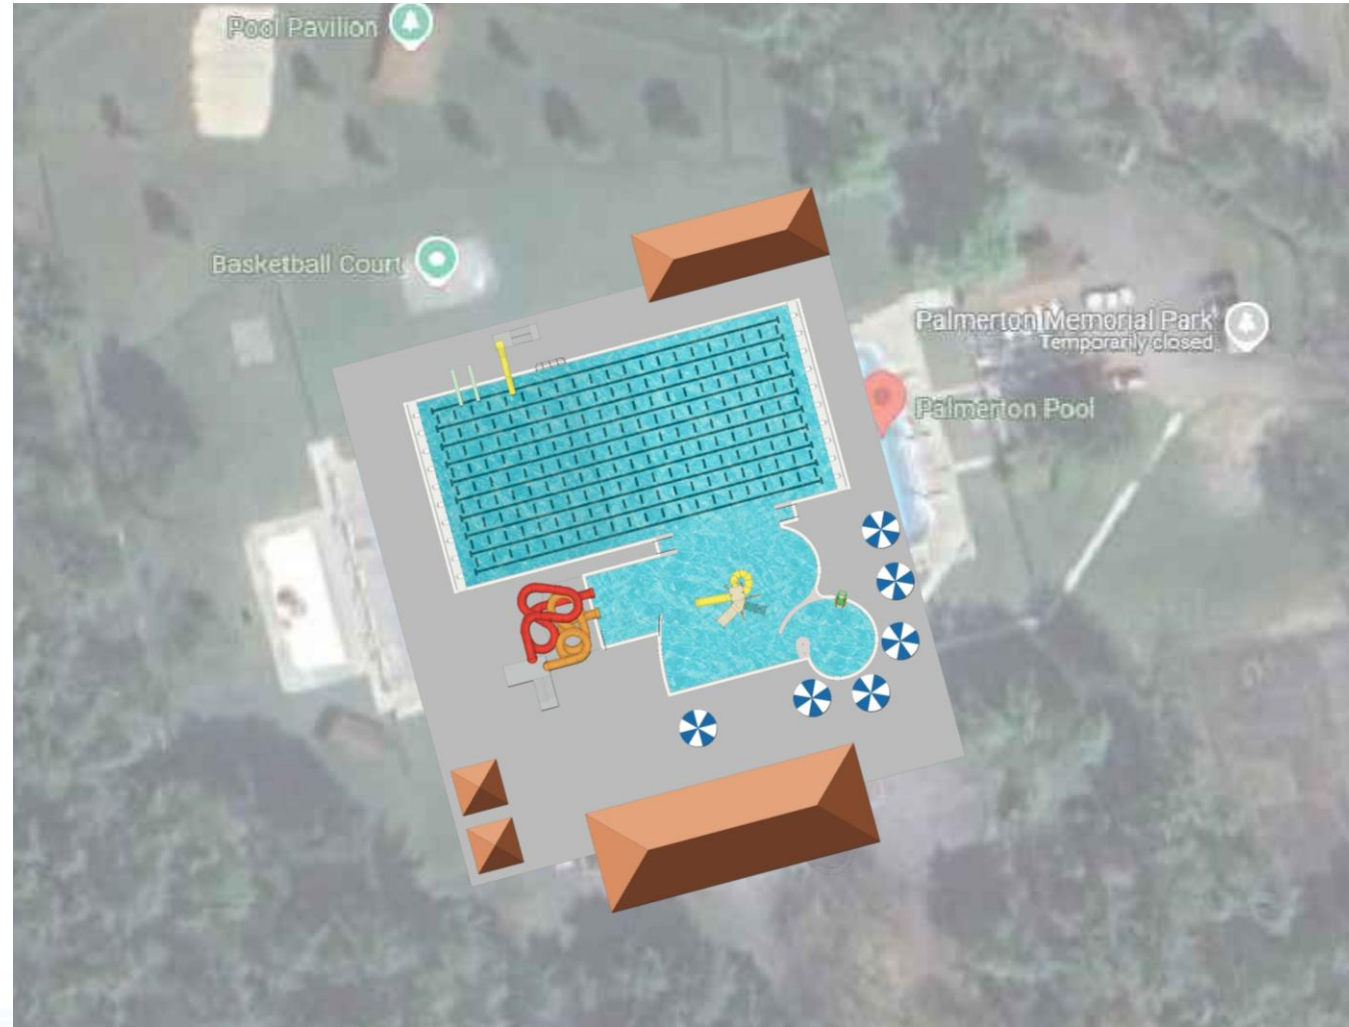
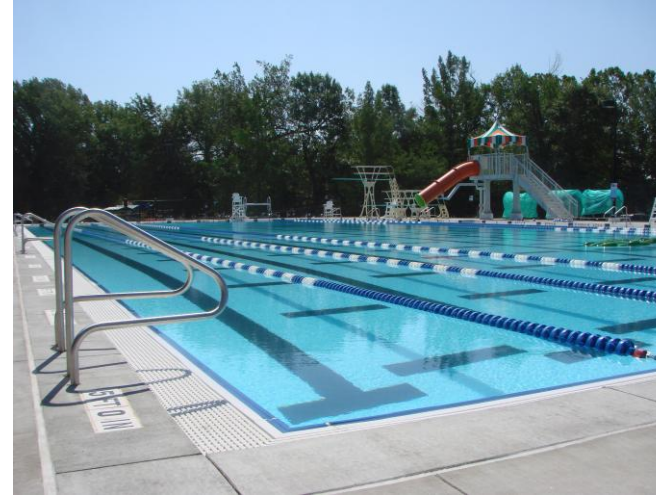
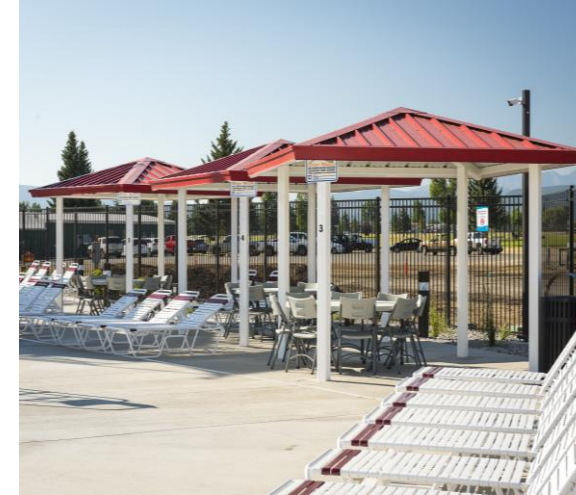
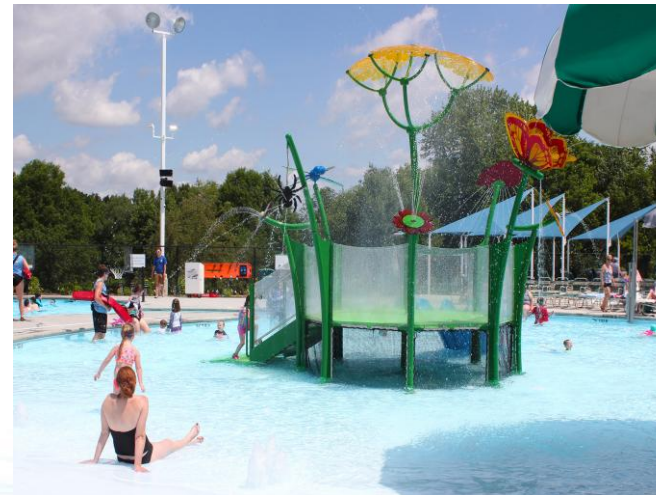
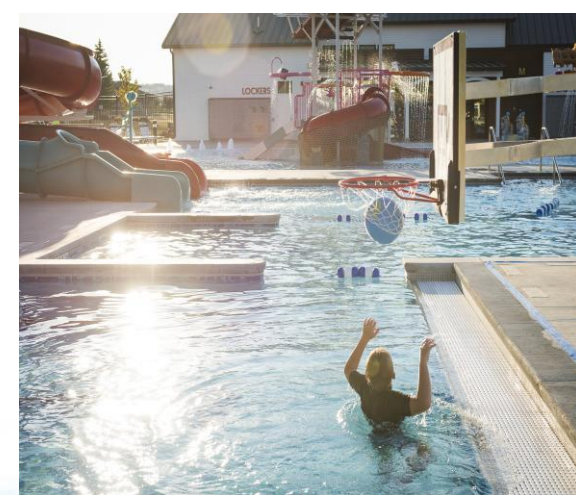
New Swimming Pool (2)

- 19,344 sq. ft. Leisure Pool
 - 8-lane, 50M lap pool
 - Zero beach entry with children's play structure
 - Tot pool
 - Two waterslides into plunge area
 - 1/3 meter diving boards
 - Drop slide into competition pool

- 19,344 sq. ft. Leisure Pool
 - 8-lane, 50M lap pool
 - Zero beach entry with children's play structure
 - Tot pool
 - Two waterslides into plunge area
 - 1/3 meter diving boards
 - Drop slide into competition pool

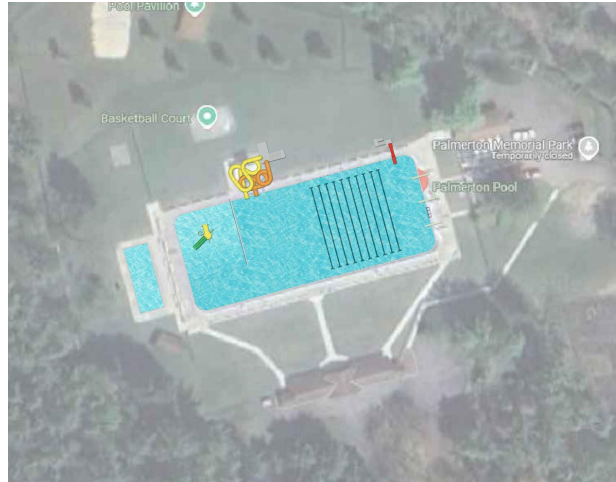
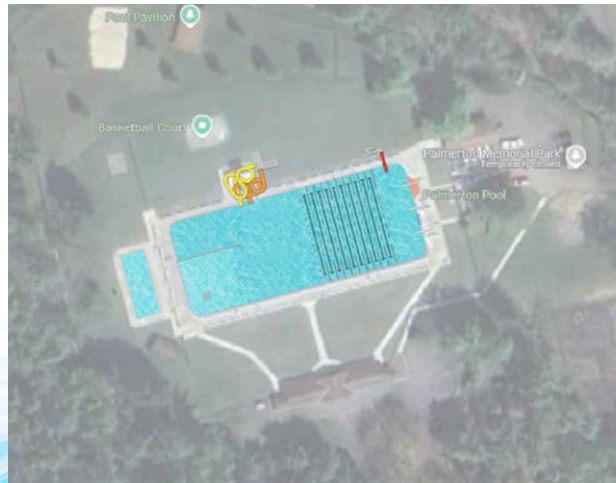
Renovation

Project Cost: \$7.5M to \$10M

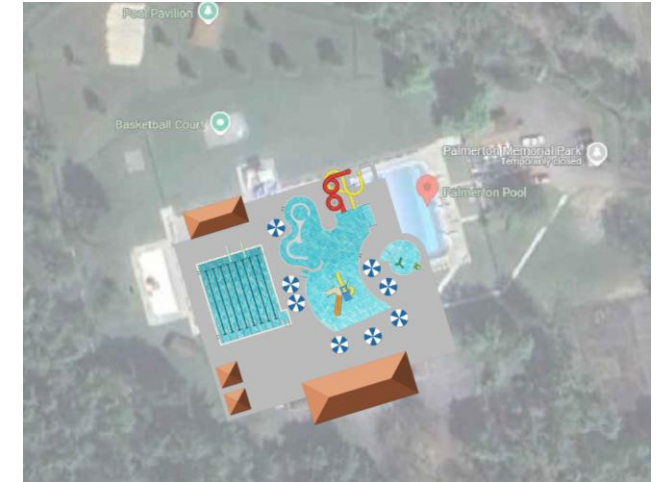
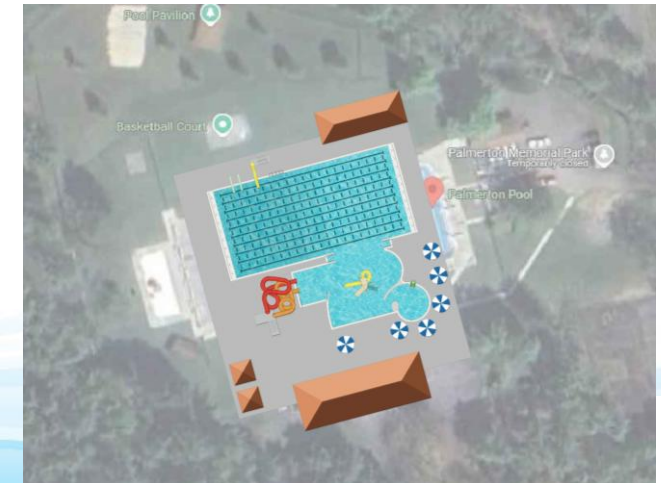
Replacement

Project Cost: \$13M to \$20M
