## CASE HISTORY

### Enviroklean Stain CarWell CP90/Rust Cop

**Customer**  
C&C Honolulu—Liberty Bell

**Location**  
Honolulu, Hawaii, USA

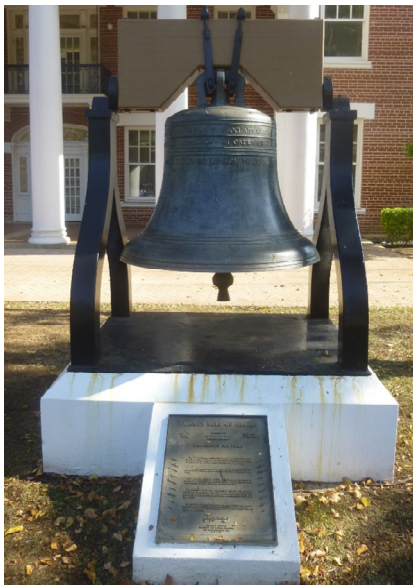
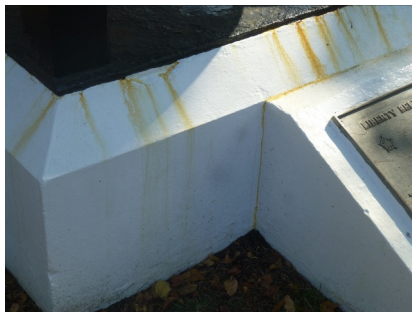
**Before**

C&C Honolulu has historic Liberty Bell of Aloha mounted on white concrete pedestal. The pedestal was repainted December 2014 and the metal plate has been bleeding unsightly rust stains down the sides of the pedestal. Left as is—the staining would get larger and darker and shorten the life of the paint. Not to mention an eyesore as this historic bell is located right next to City and County of Honolulu Hale main building.

1. Apply Enviroklean Stain Remover by rag or brush.
2. Rinse with fresh water.
3. Apply CarWell CP90/Rust Cop to all exposed metal surfaces to control further bleeding.

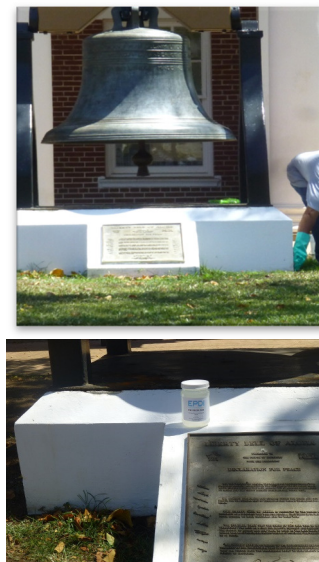
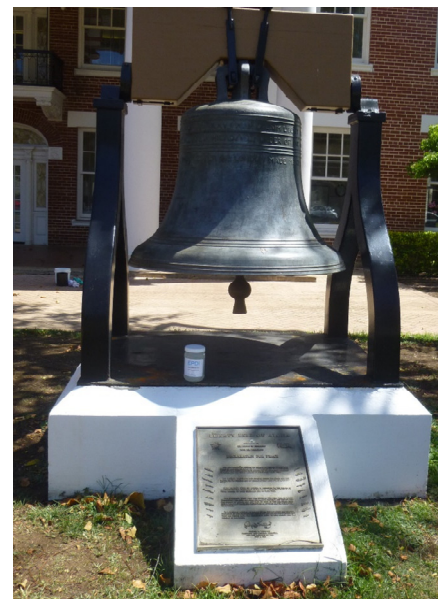
**After**

Simple—No repainting involved! Use of environmentally friendly, water based Enviroklean Stain Remover easily removed the rust staining on the painted surface. CarWell Rust Cop rust inhibitor will provide temporary corrosion protection to metal plate. Follow up maintenance as required due to corrosion on underside of metal plate until refurbished will keep bleeding rust.
