REPORT OF BOND STRENGTH TESTING OF REINFORCING STEEL BARS

VpCI CorrVerter® CORTEC

AET PROJECT NO: 05-03736 **DATE:** JUNE 26. 2008

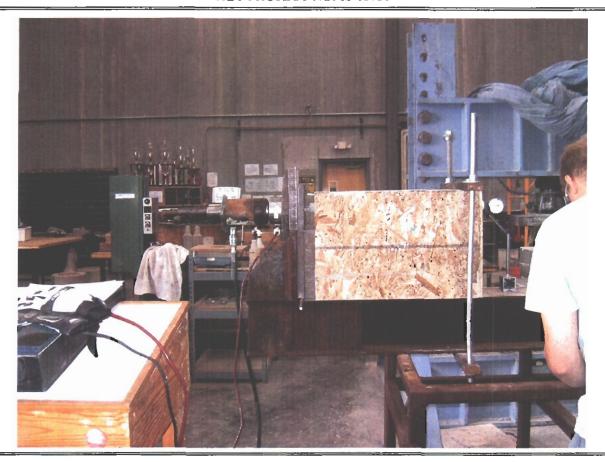
Photo 1: Test apparatus and specimen during testing

Bond strength testing was performed in accordance with ASTM:A944-05, "Standard Test Method for Comparing Bond Strength of Steel Reinforcing Bars to Concrete Using Beam End Specimens." The test specimens were constructed per ASTM:A944, "Standard Specifications for Epoxy Coated Prefabricated Steel Reinforcing Bars" Section 5, "Test Specimen." The test specimens were stored in the laboratory during the curing where the temperature typically ranges from 60 to 80°F.

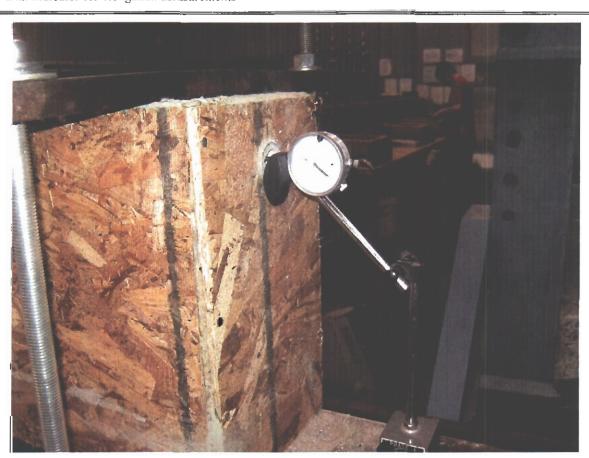
Photo 2: Dial indicator for elongation measurements

- 1. The concrete test cylinders stored in proximity of the test specimen had compressive strengths of 5380 and 5430 psi at the time of testing.
- 2. The failure mode of all six specimens, three with and three without coated bar was cracking of the concrete test specimens. Failure of all specimens was at a load of 24,000 lbs. Following is a summary of our elongation readings at the loaded specimen end.

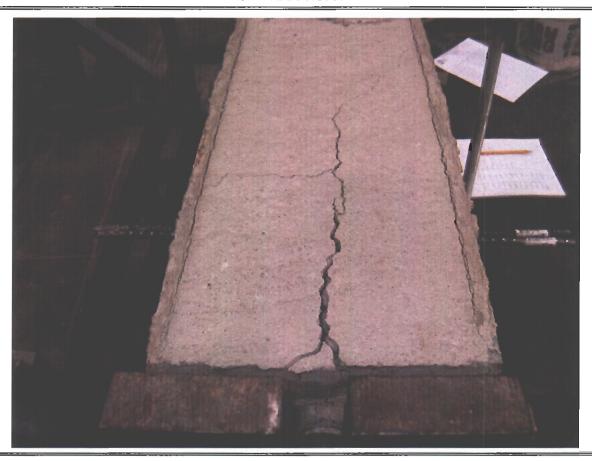
Photo 3: Typical failure of specimens

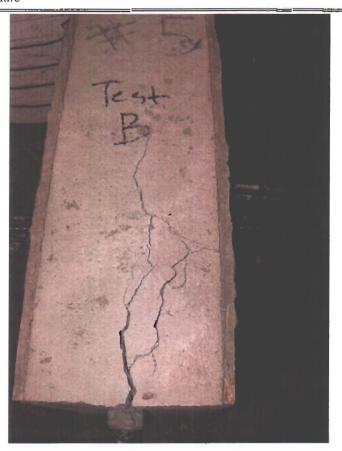
Photo 4: Test sample B after failure

Applied Load, lbs.	Free End Displacement				
	<u>Test A</u>	<u>Test B</u>	Test C	Test Average	
0	.013	.003	.008	.009	
2,000	.013	.015	.019	.016	
4,000	.021	.023	.031	.025	
6,000	.032	.037	.044	.038	
8,000	.041	.051	.053	.048	
10,000	.049	.059	.062	.057	
12,000	.055	.066	.077	.066	
14,000	.061	.078	.084	.074	
16,000	.076	.089	.089	.085	
18,000	.079	.103	.095	.092	
20,000	.086	.114	.104	.101	
22,000	.105	.129	.117	.117	
24,000	Concrete Failed	Concrete Failed	Concrete Failed	Concrete Failed

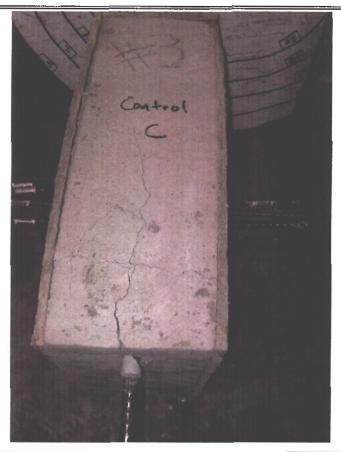
Photo 5: Control sample C after failure

Applied Load, lbs.	Free End Displacement				
	Control A	Control B	Control C	<u>Control</u> Average	
0	.009	.014	.002	.008	
2,000	.013	.024	.014	.017	
4,000	.021	.029	.023	.024	
6,000	.029	.037	.039	.035	
8,000	.036	.049	.045	.043	
10,000	.049	.062	.057	.056	
12,000	.062	.085	.073	0.73	
14,000	.079	.103	.091	0.91	
16,000	.092	.131	.106	.110	
18,000	.104	.146	.114	.121	
20,000	.123	.162	.129	.138	
22,000	.148	.185	.144	.159	
24,000	Concrete Failed	Concrete Failed	Concrete Failed	Concrete Failed
