REPORT OF BOND STRENGTH TESTING OF REINFORCING STEEL BARS

VpCI CorrVerter®

AET PROJECT NO: 05-03736

DATE: JUNE 26, 2008

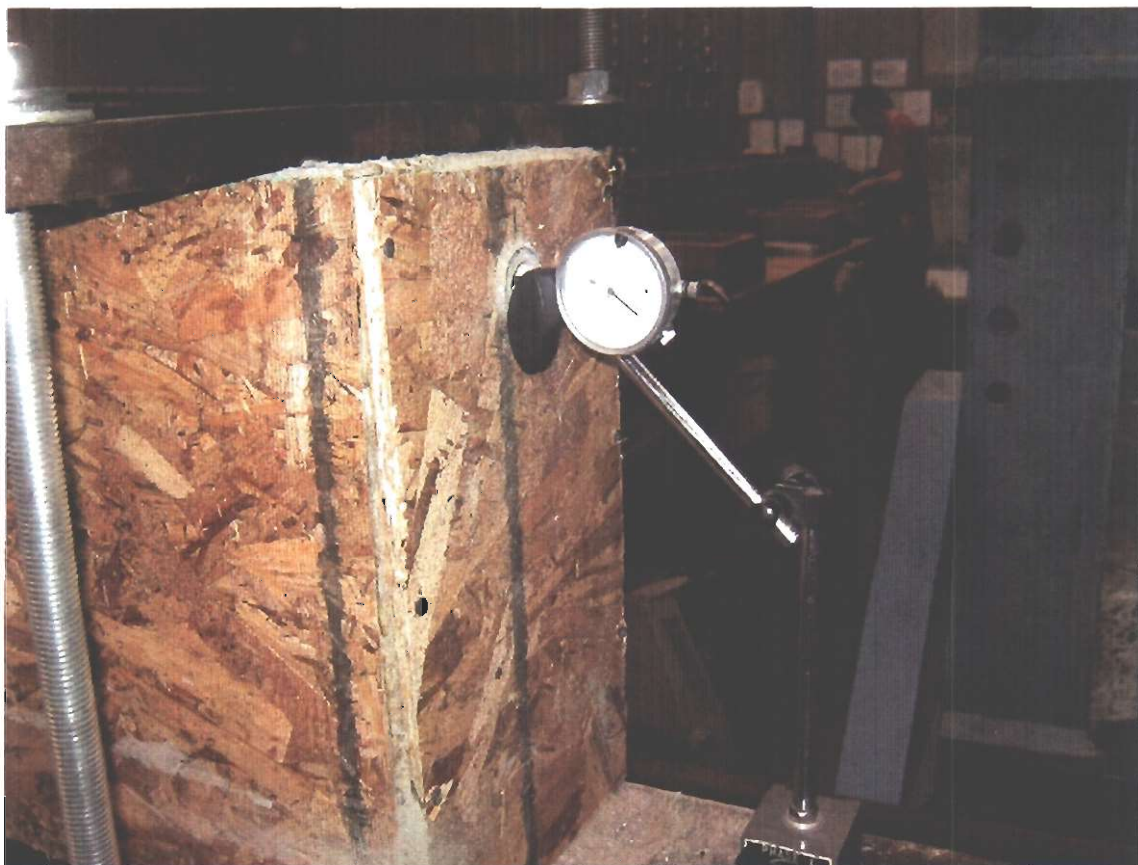
Photo 2: Dial indicator for elongation measurements

1. The concrete test cylinders stored in proximity of the test specimen had compressive strengths of 5380 and 5430 psi at the time of testing.
2. The failure mode of all six specimens, three with and three without coated bar was cracking of the concrete test specimens. Failure of all specimens was at a load of 24,000 lbs. Following is a summary of our elongation readings at the loaded specimen end.
 - A. Uncoated reinforcing steel

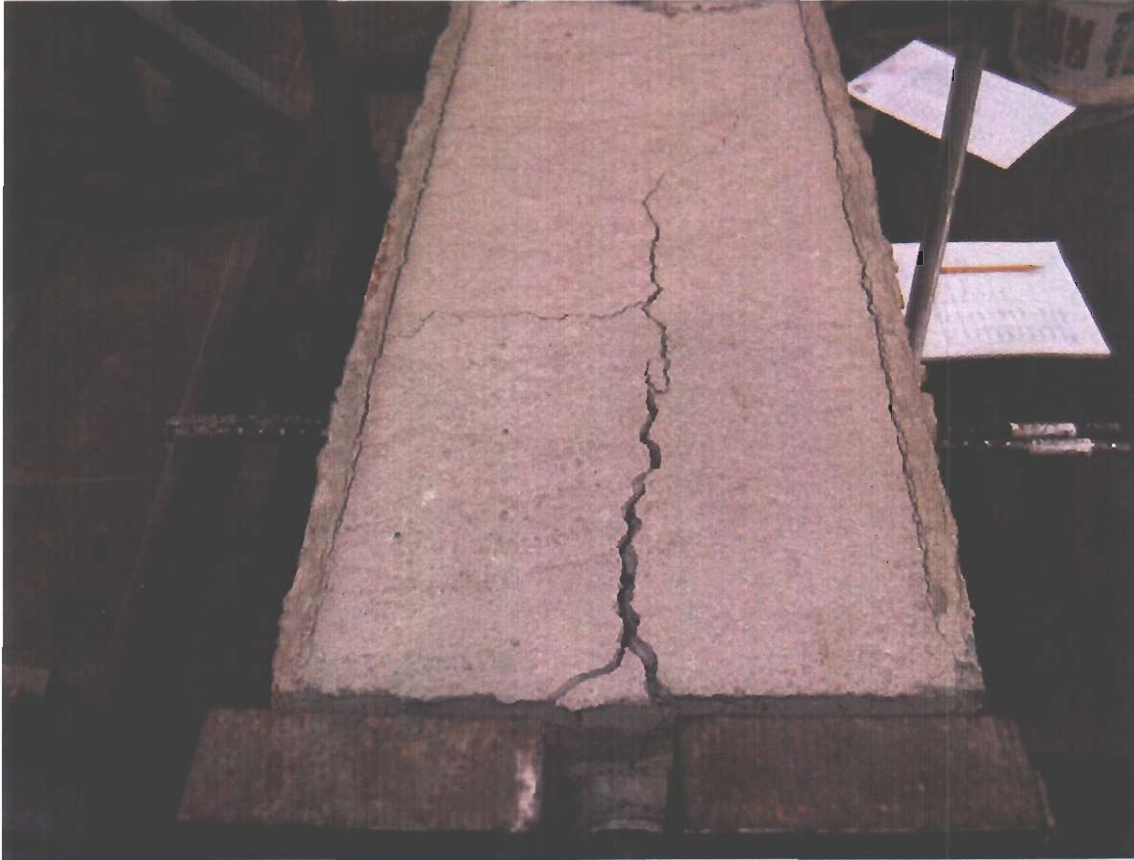
Photo 3: Typical failure of specimens

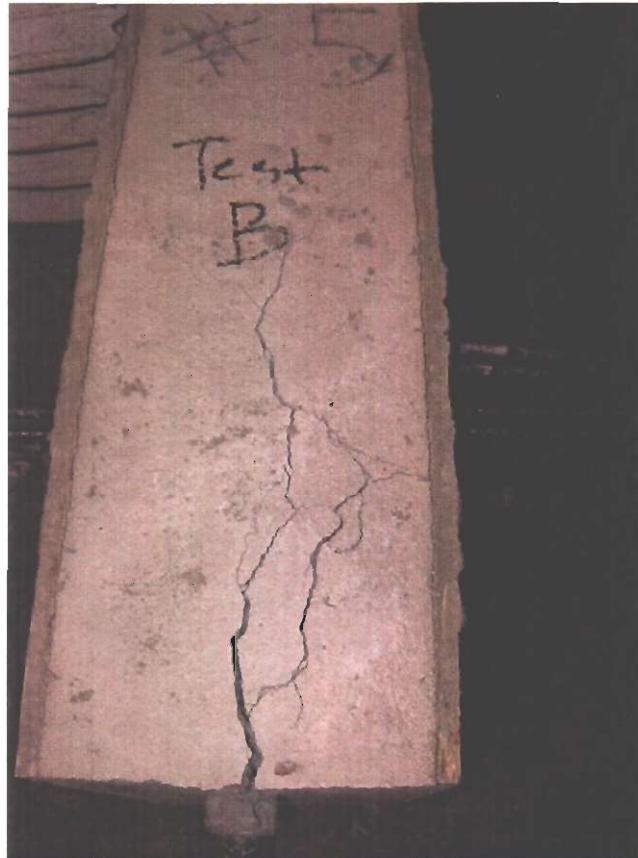
Photo 4: Test sample B after failure
