## CASE HISTORY

### Enviroklean Stain Remover CarWell CP90

**Customer**  
**Mauna Kea Resort**  
Clyde Takayama  
Director of Engineering

**Location**  
**Kohala Coast, Hawaii, USA**

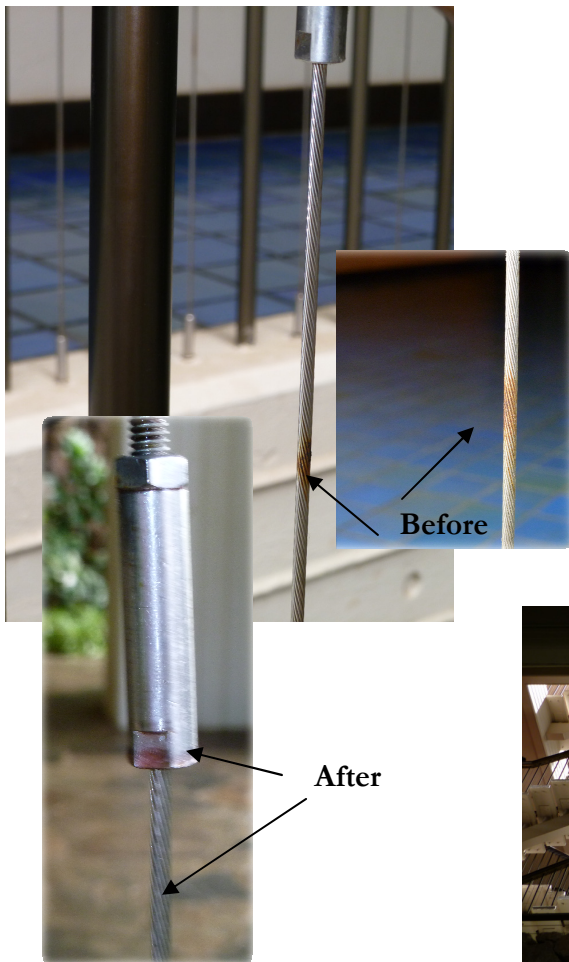
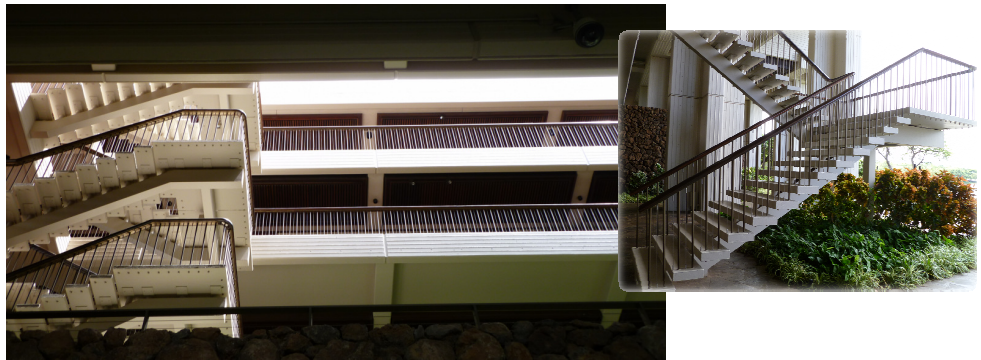
These Stainless Steel Cable pickets were rusting and unsightly. Left unprotected—pitting and corrosion would eat into the cables and would reduce the life and effectiveness of these pickets.

1. Apply Enviroklean Stain Remover by brush or sponge
2. Rinse with fresh water.
3. Apply CarWell CP90 to all exposed metal surfaces.

Use of Enviroklean Stain Remover easily removed the rust staining on the Stainless Steel Cable Pickets and applying CarWell CP90/Rust Cop rust inhibitor will provide further corrosion protection. Follow up maintenance required on yearly basis.
