**Customer**  
McCully Bicycle & Sporting Goods

**Location**  
Oahu, Hawaii, USA

## CASE HISTORY

### Enviroklean Stain Remover CarWell CP90

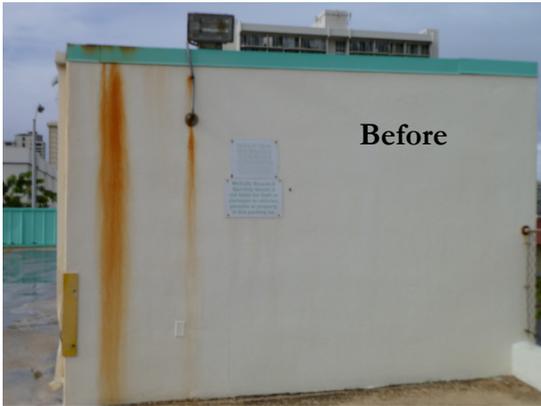
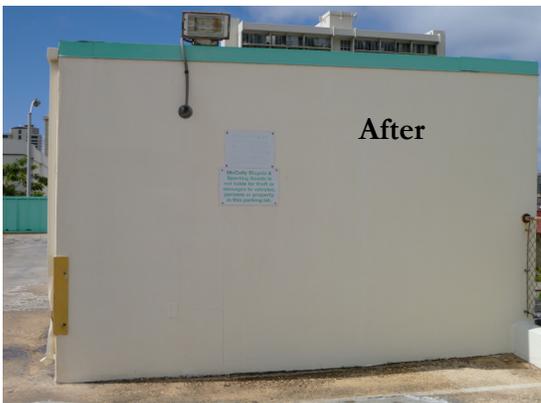
McCully Bicycle & Sporting Goods had roof top parking deck exterior wall with ugly rust stain. The metal trim was causing the bleeding as well as the security light was holding water causing another stain down the wall. Left as is and unprotected—the stain would cause and even bigger rust stain on the wall as well as on the ground and would reduce the life of the paint finish.

1. Apply Enviroklean Stain Remover by brush.
2. Rinse with fresh water. For old stains, such as this wall, leave wet Enviroklean on surface longer and repeat if needed.
3. Apply CarWell CP90/RUST COP to all exposed metal surfaces annually or as needed.
4. When you see staining reappear—a quick brush with Enviroklean will immediately remove stain.

Use of Enviroklean Stain Remover easily removed the rust staining on the concrete exterior wall without harming painted surface. Enviroklean is an environmentally friendly formulation, which means clean up is plain water.

Applying CarWell CP90/Rust Cop rust inhibitor will provide further corrosion protection. Follow up maintenance required on yearly basis.
