MIGRATORY CORROSION INHIBITOR (MCI®) PRODUCTS FOR CONCRETE

CASE HISTORY

Carbonation and Spalling of Concrete

Pacific Tower

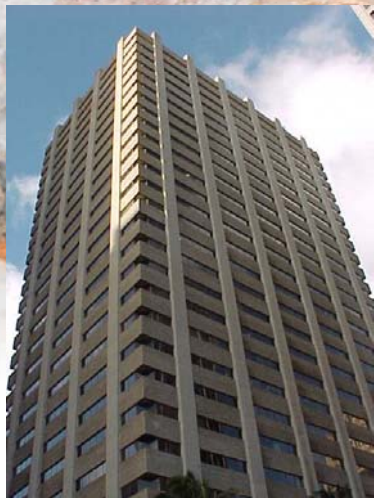
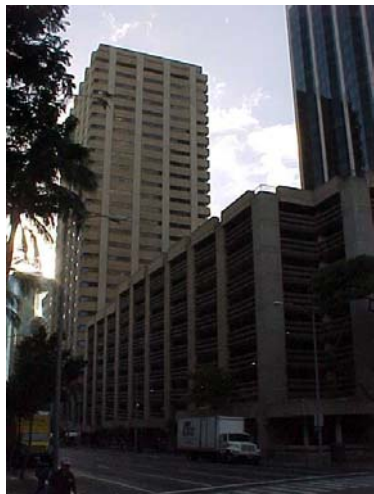
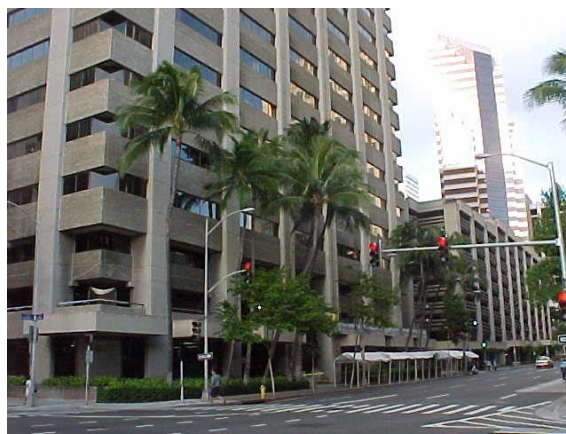
Carbonation and spalling of the concrete. MCI®-2020 containing a fugitive dye was sprayed on the entire structure including the parking garage. The structure has a bush hammered finish. This irregular finish acts to hold moisture, salt and volcanic emissions in the facade, leading to corrosion of embedded reinforcement. Since the project is located on a Pacific Island, a high degree of moisture laden trade winds strike the structure. In addition, over the last 10-12 years, Hawaii has experienced a high degree of volcanic activity which contributes to acid rain.

MCI®-2020 with a fugitive dye was applied to the structure at 150ft²/gal (3.68 m²/L)
