# **Soil Survey in the Bayview Neighbourhood Adjacent to Essar Steel Algoma Incorporated, Sault Ste. Marie, Ontario (2013)**

Report No. S5020-2013  
October 2014

**Ontario Ministry of the Environment and Climate Change**  
Environmental Monitoring and Reporting Branch

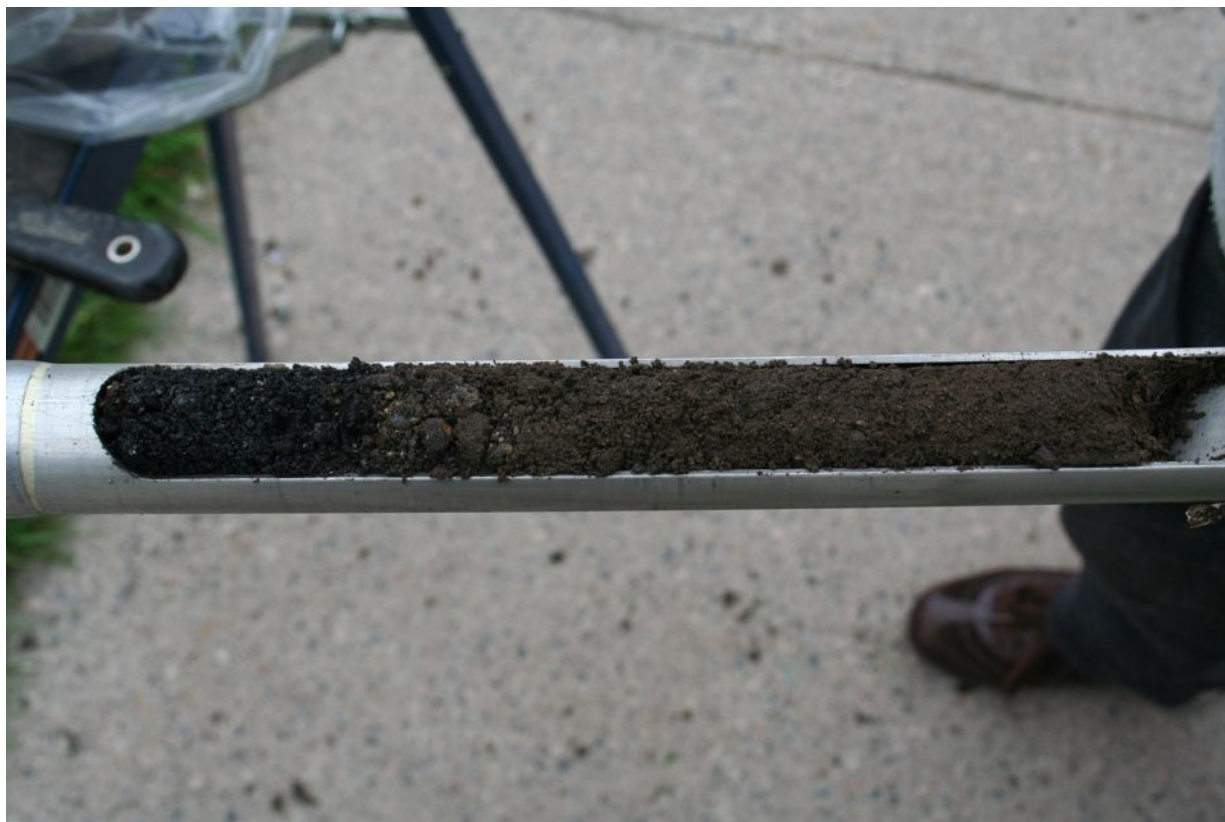
When collecting the samples at Site 207, it was clear that there was granular material in the soil cores, not consistent with native soils, at the deeper layers (Photo 1). Since this site had the highest PAH concentrations detected in the survey and there was granular material found in the sample, the soil samples from this site were also submitted for stereoscopic microscope analysis. The detailed analysis of the material in all layers is given in Table B1, Appendix B. The granular material was identified as metallurgical slag. This layer of material was considered fill material and not deposited by aerial deposition. Since the PAH concentrations in the layers containing metallurgical slag were much less than in the layers without metallurgical slag, this slag material is not likely the major source of PAHs at this site.

**Photo 1:** Soil core collected at Site 207. The surface layer of loam soil is shown on the right side, with a layer of nodules and black gritty material, sampled at depth, on the left side. (Photo by S.21, 19 September, 2014 )

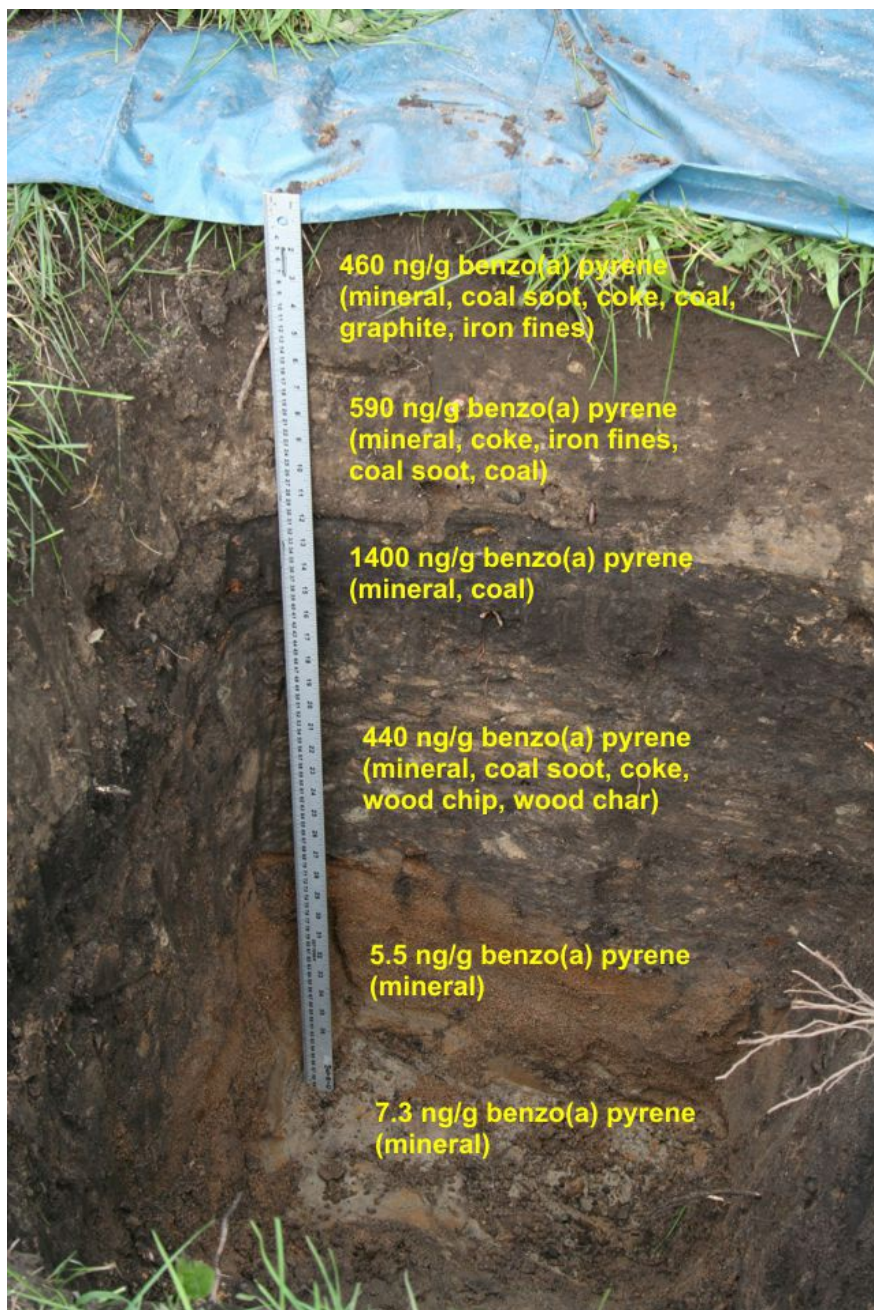
**Photo 3:** Soil Pit B. Benzo(a)pyrene concentrations and components that comprised more than 10% of the material in each layer/horizon are superimposed on the photograph to correspond to the layer/horizon sampled. (Photo by M. Dixon, 18 September 2013)

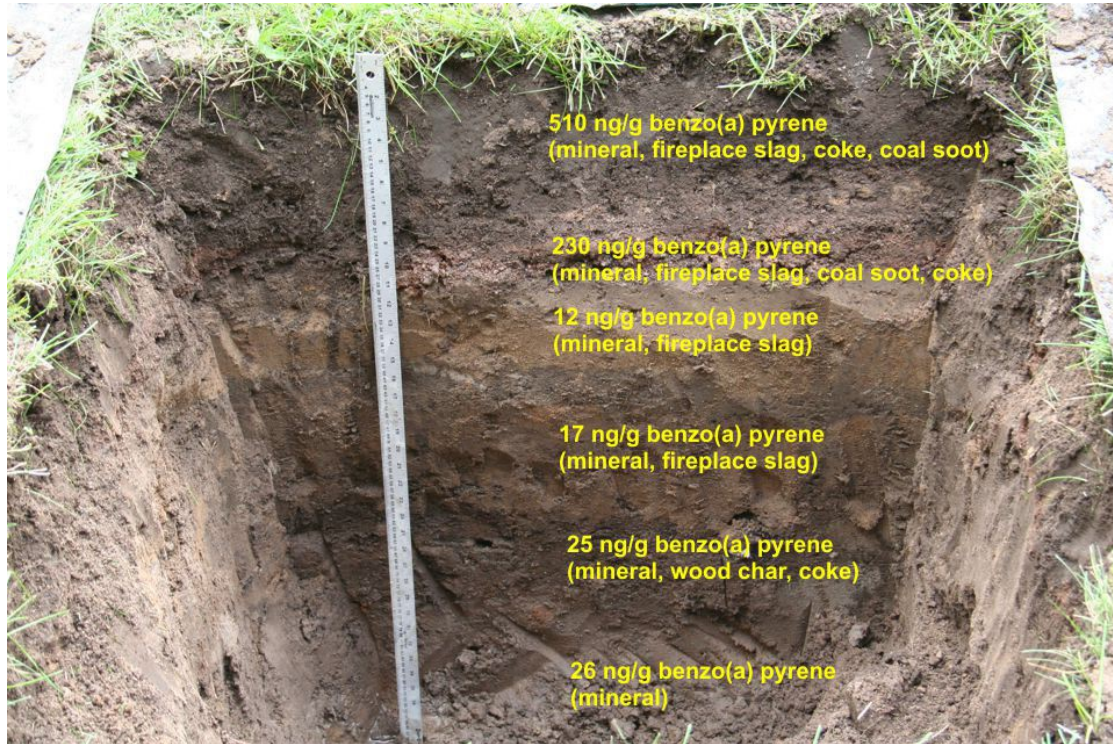
**Photo 5:** Soil Pit D. Benzo(a)pyrene concentrations and components that comprised more than 10% of the material in each layer/horizon are superimposed on the photograph to correspond to the layer/horizon sampled. (Photo by M. Dixon, 18 September 2013)

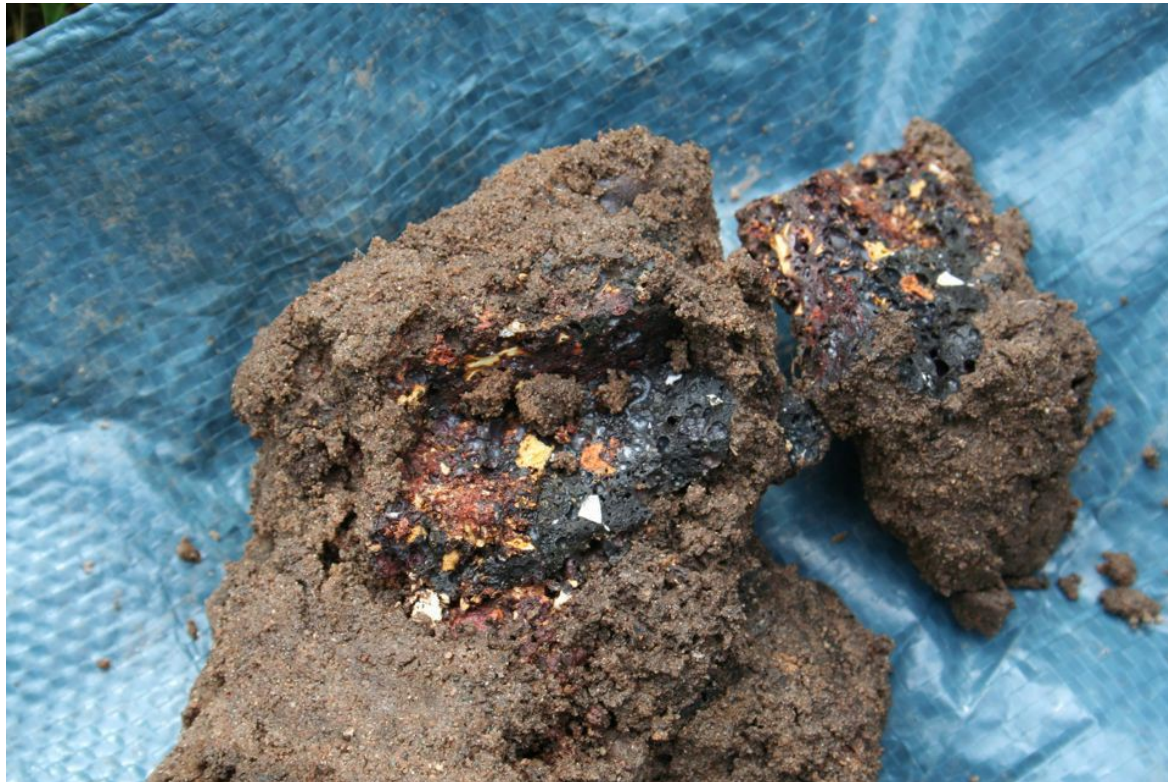
**Photo 6:** Slag-like material taken from the wall of Pit D at a 20 to 26 cm depth. (Photo by M. Dixon, 18 September 2013)
