OneWay live centre bearing replacement

Why replace the bearings

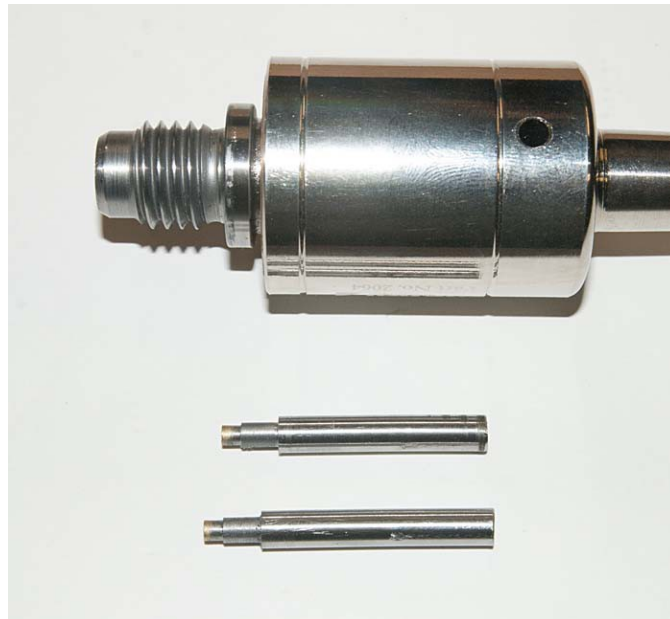
I did not have a pair of snap ring pliers. The inexpensive ones are designed for grinder wheels and the pins are too big and the arms too wide. I made a pair of pins to be a snug fit in the holes in the brass cover.

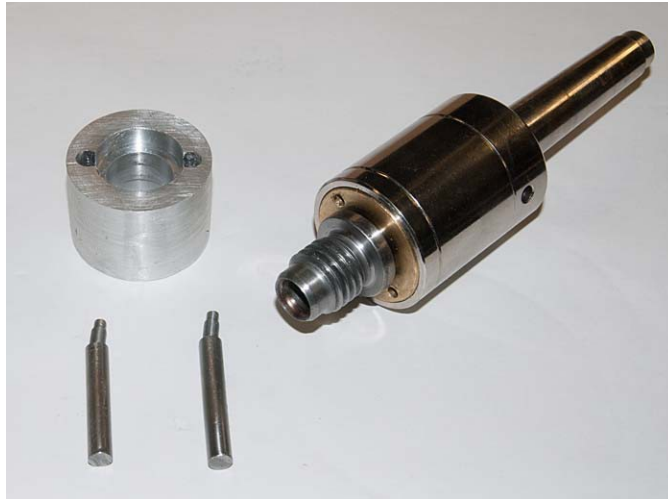
I mounted the taper in the tailstock, then used a very large wrench to grasp the pins while using a spanner wrench in the hole on the body. I eventually got the cover loose by hitting the spanner wrench with a mallet while my friend held the large wrench.

The bent pins in this picture gives an indication on the amount of force which I had to apply to get the cover loose.

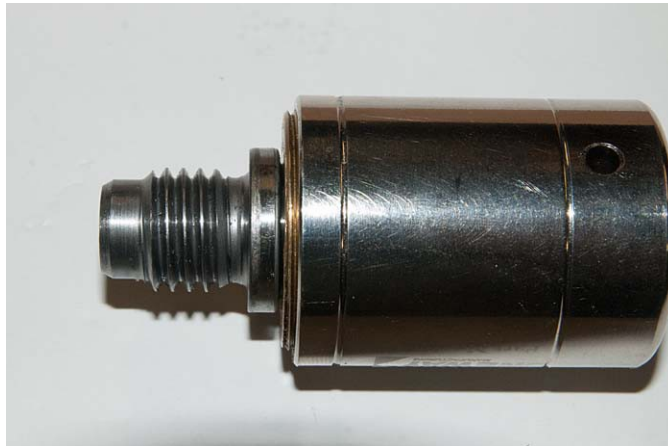
The next surprise is that the brass cover did not completely unscrew. It unscrewed until it reached the back of the flange.

The few threads stated that at this point *"the bearing assembly would come out without any strong language"*. Another said it should *"just pop out"*.

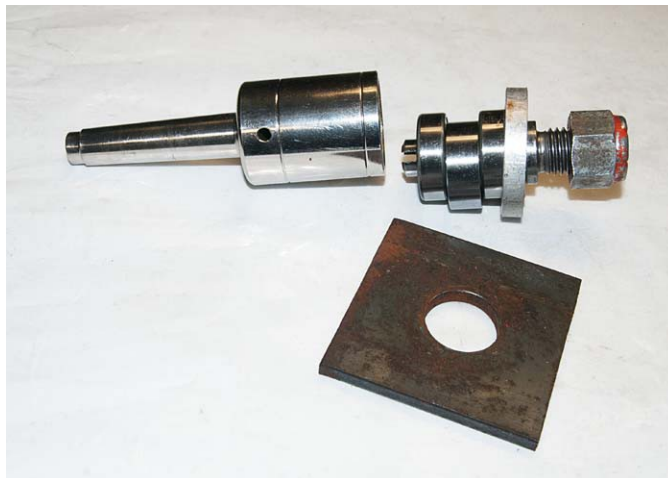
I needed to make another bushing, this one to fit over the flange and engage the shoulders of the housing. I then used a steel plate and a 3/4in x 10 tpi nut.

I used a 1/8in long punch in the knockout hole to prevent the bearing assembly from rotating while slowly applying pressure with a wrench on the nut.

I was able to slowly get the bearing assembly to move. A bit of a groan from inside indicated the bearings were a very tight fit.

Eventually I was able to remove the assembly.

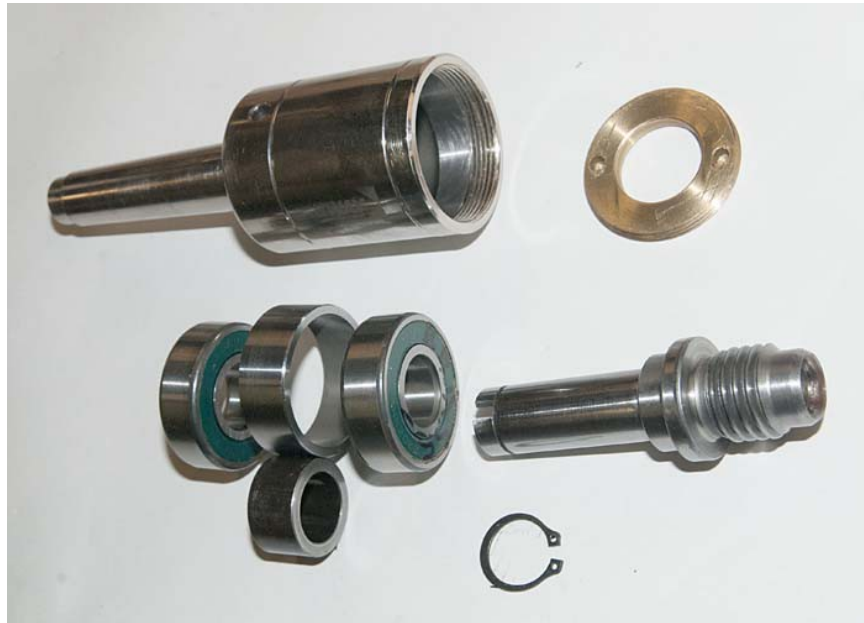
This is the live centre now completely taken apart.

Two bearings of deep groove design. I was hoping at least one would be a thrust bearing, but both are Nachi 6202 NKE deep groove bearings. Good for radial load, but not as good for thrust loads.

Two spacers between the bearings. One to engage on the inner races and the other to engage on the outer races.

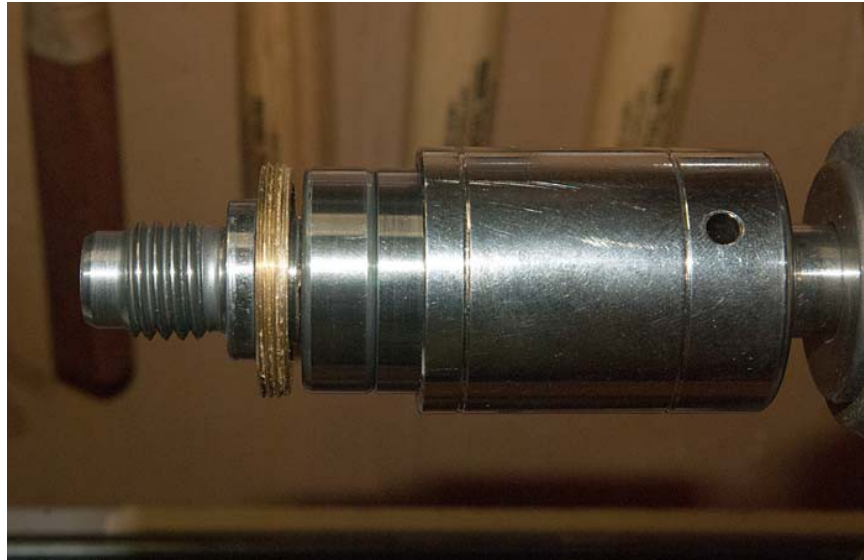
The bearings would not go in far. I am using hand pressure, not trying to force this in place, just see how far I can get this easily.

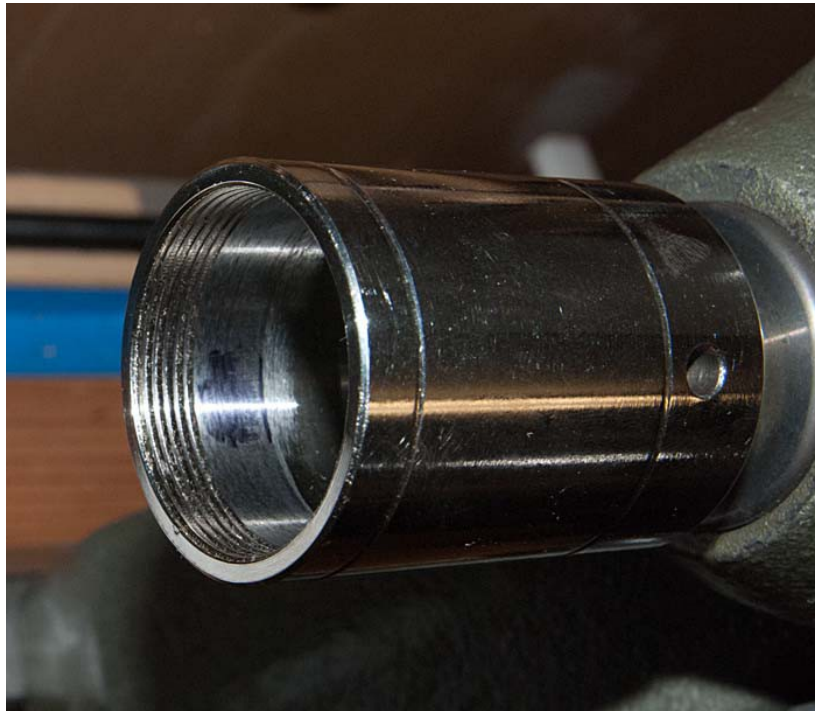
The assembly after the test fit. I can see where the ink was removed, mostly at the end of the first machined area.

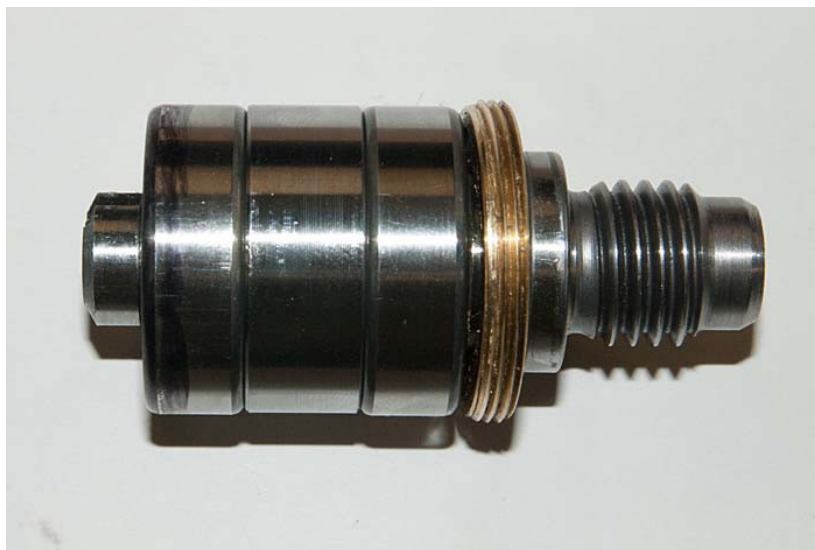
The assembly after the test fit. The left edge of the bearing has no ink which means it was rubbing on the housing.

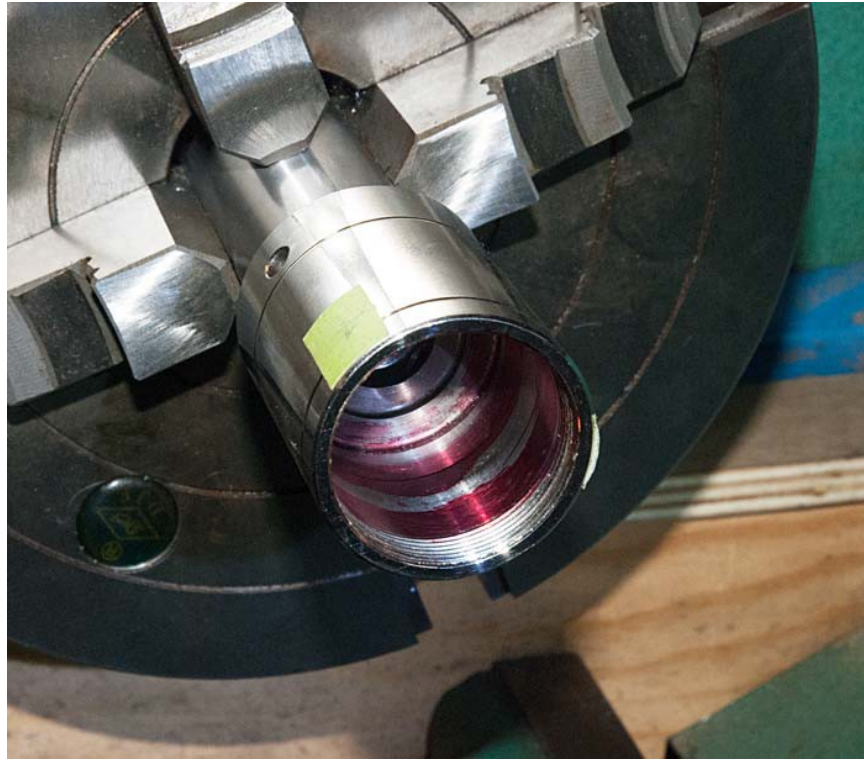
I insert the housing in the MT2 extension and take measurements of the two machined areas. As expected some runout. Also the rear area was smaller diameter than the front, so the rear area is likely the root cause of my bearings binding so bad.

I mark the two machined areas with layout dye, then make a first pass with a boring bar, trying to remove the smallest amount of metal.

This is the picture after the first pass. No dye removed from the front machined area and some dye removed from the rear. This confirms the rear machined area is too small diameter.

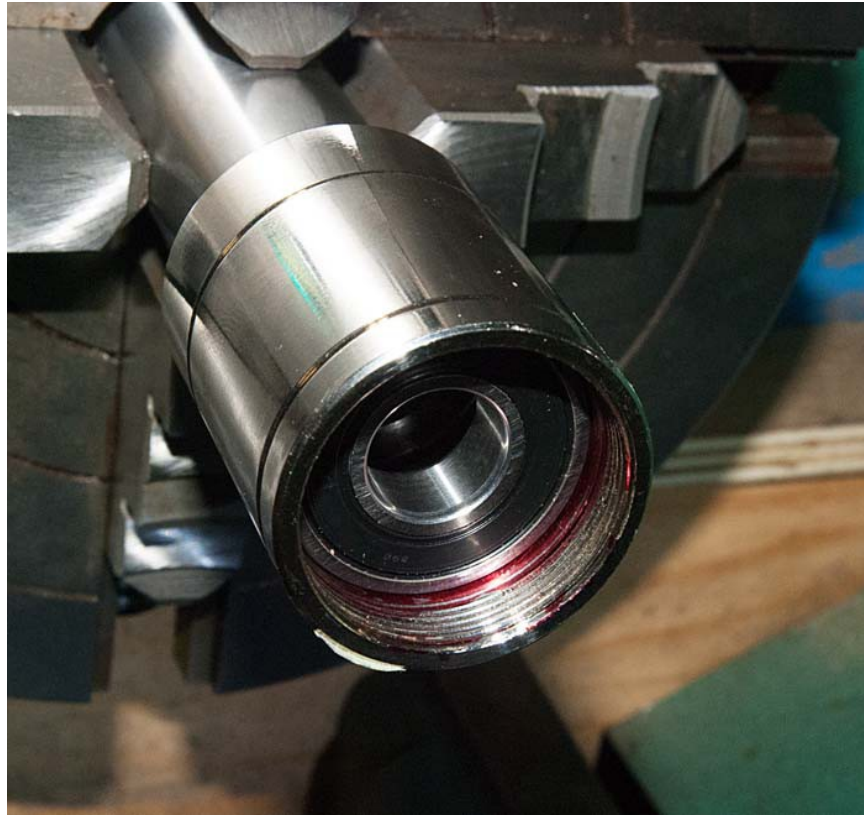
A test fit of a bearing. Snug fit on the first area, but does not go through.

I need to remove more metal – very carefully. I make a couple of passes and need to test the bearing fit.

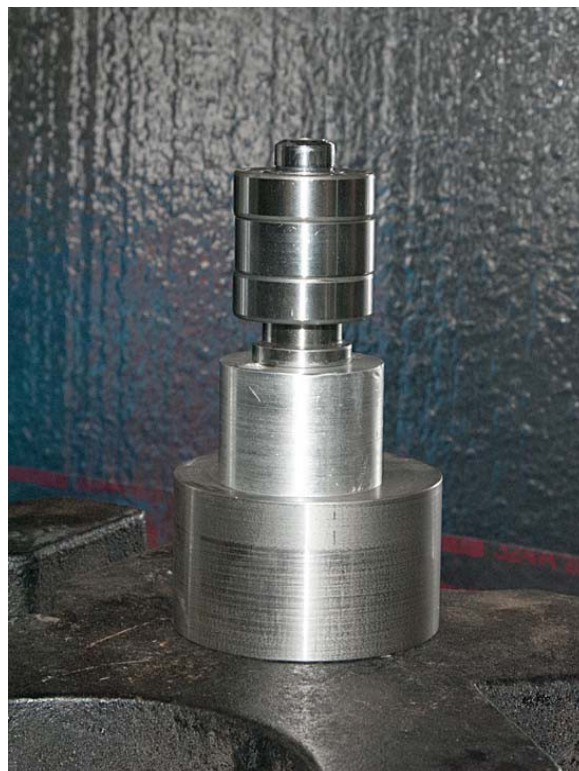
I go to my friend to press the bearings onto the shaft.

Eagle eyed readers will see that we have pressed on the bearings WITHOUT the brass cover. Drat, drat and double drat!!!!

We removed the bearings and included the brass cover. PAY ATTENTION to the orientation of the brass cover.

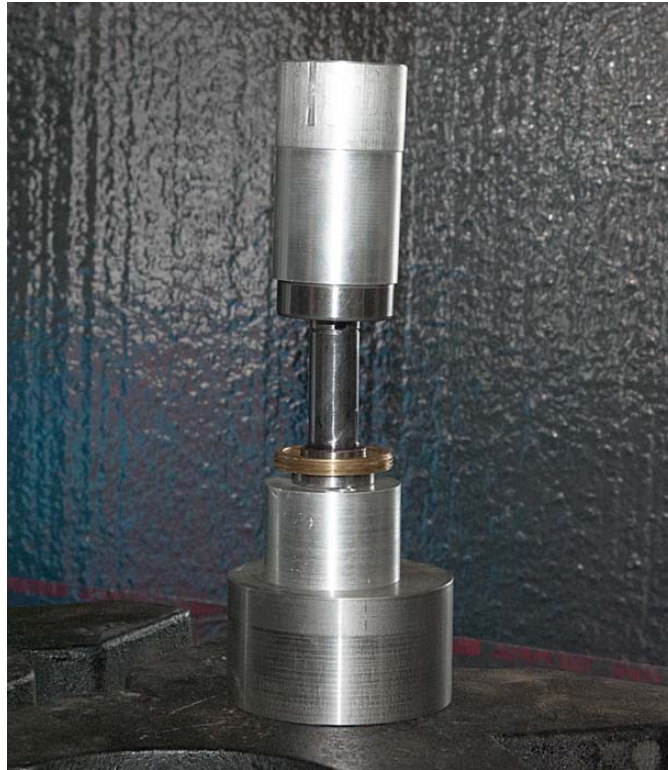
This time everything is in correct place and orientation.

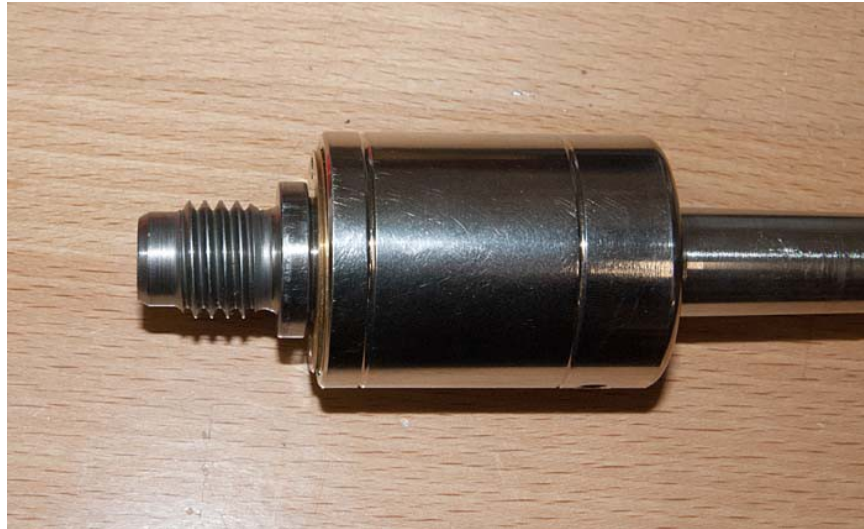
Next step is to insert the bearing assembly into the housing. Another round of iterations. The bearing assembly can only go so as far as the brass cover contacting the threads in the housing.

The brass cover then needs to be screwed into the housing until it contacts the bearing.

The bearing assembly then needs to be knocked deeper into the housing until the brass cover contacts the bottom of the flange on the shaft.

Finally the assembly is ready for final screwing into the housing.

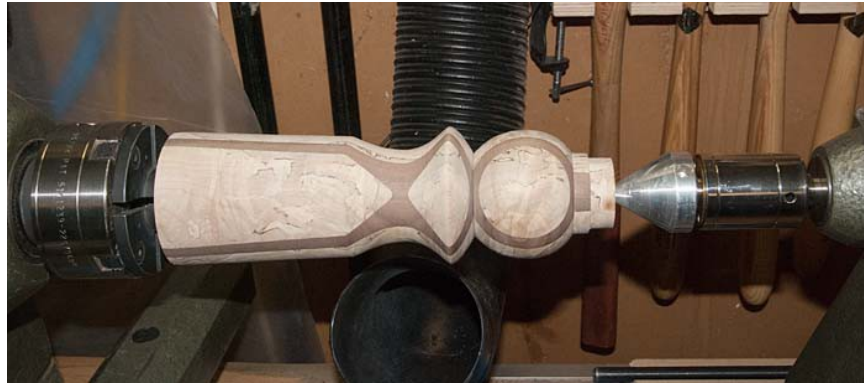
I mount an in-progress project between centres.

I turn on the lathe, run up to a high speed. No vibration, no noise, it is silent.

A project with a happy ending.
