# Mitigating the 2022 Queensland "White Spill" Event: strategies to prevent similar incidents

A report prepared for the Queensland Department of Environment and Science (DES) by Tangaroa Blue Foundation and Ten Little Pieces

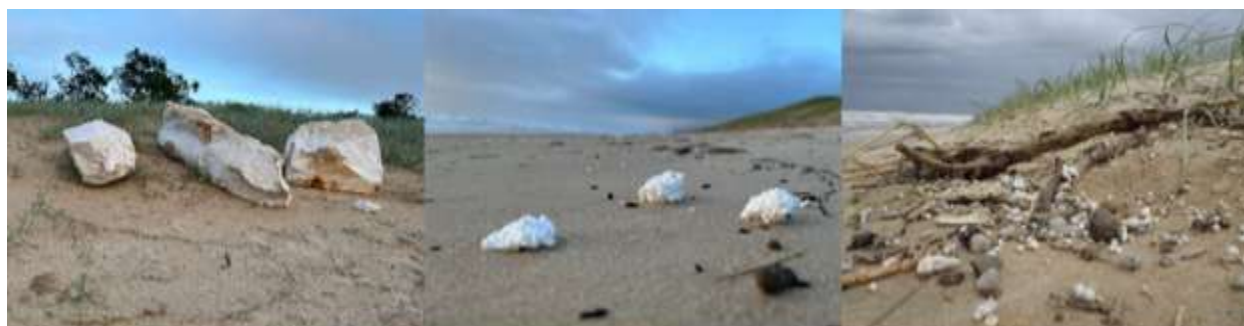
**Figure 2.** Examples of various sizes of polystyrene debris found along Queensland's coasts following the 2022 floods. Visible polystyrene debris ranged in size from less than 5 mm to the entire pontoon which could be 14 m x 4 m x 1 m and weigh 15 tonnes. Photo credit: Sharyn Kerrigan

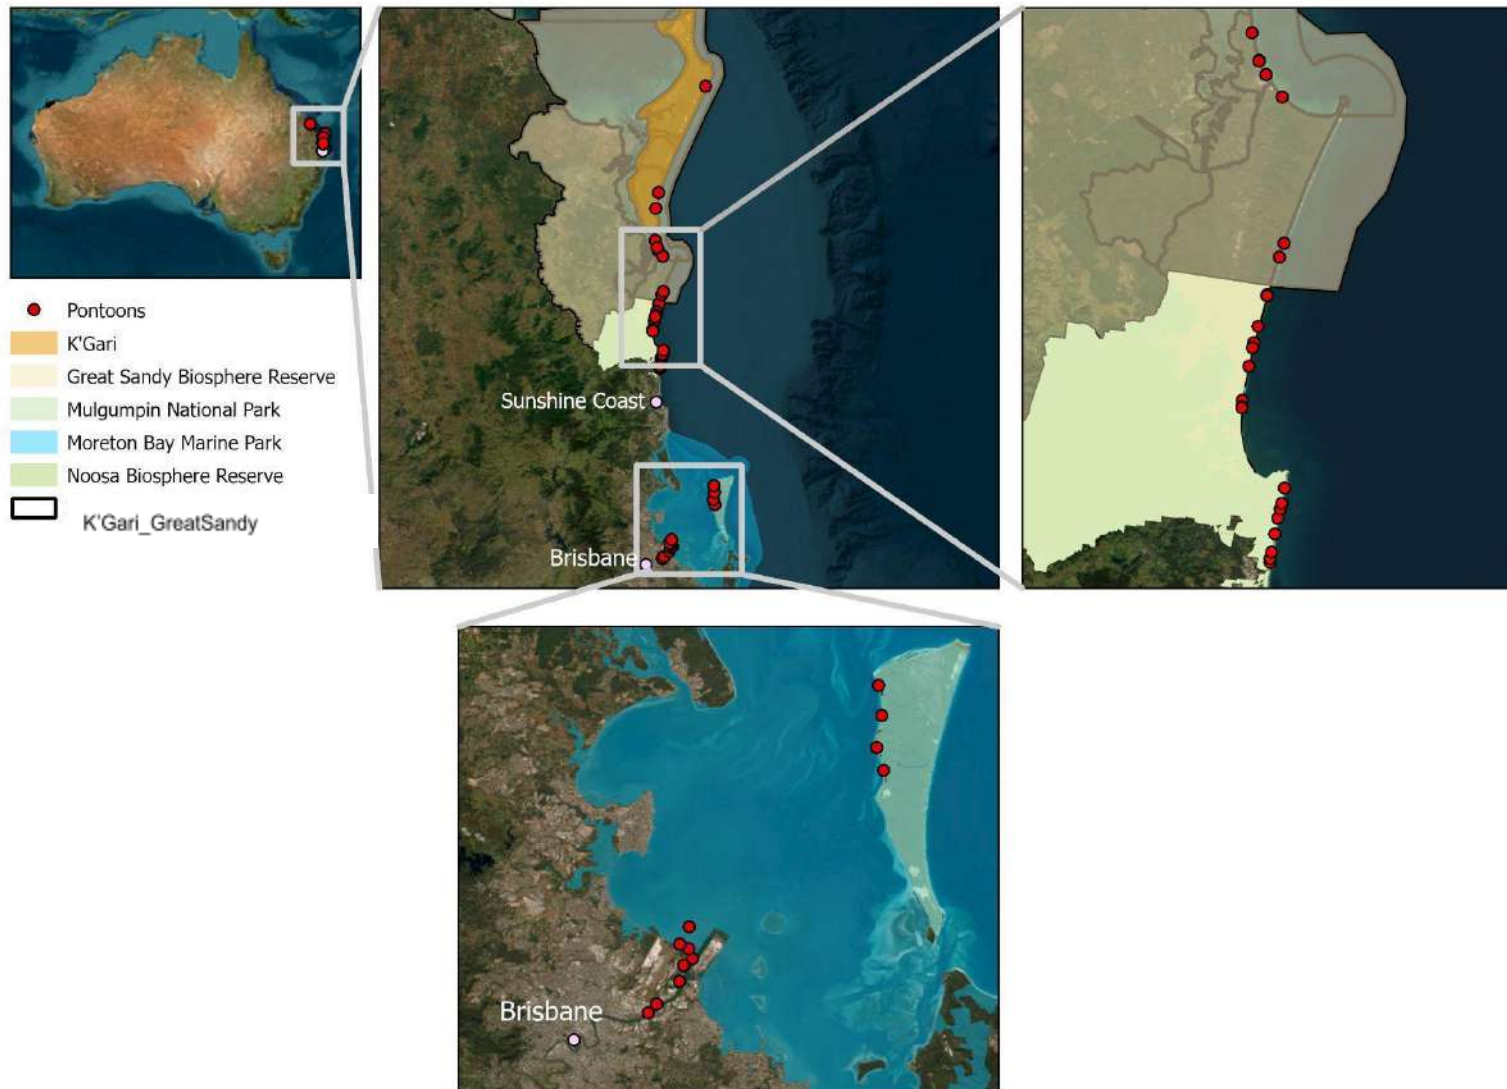
**Figure 3.** Map contributed to by local stakeholders on the pontoon locations in Southeast Queensland

In Queensland, an environmental disaster dubbed the "White Spill" occurred following the 2022 floods. The "White Spill" consisted of extreme marine debris dispersal and the beaching of some 37 known pontoons, i.e., a floating platform used for various recreational and commercial activities, and the widespread dispersal of polystyrene beads covering the beaches along the Queensland coast (Figure 2). Local community citizen scientists and organisations identified the source of polystyrene pollution originating from unsecured pontoons from rivers, i.e., the Brisbane and Logan Rivers, floating north of their moorings and breaking up along 250 kilometres of coastlines, from Mulgumpin (Moreton Island) north-east of Brisbane, across Noosa Eastern Beaches and Northern Shore and K'gari (Fraser Island; Figure 3; Appendix 1).

Environmental organisations mobilised across more than 250 km of Queensland's coast from Mulgumpin (Moreton Island) and Brisbane, north to Noosa and K'gari (Fraser Island) as pontoons were documented on multiple beaches (Fig 3). The state of Queensland is home to five United Nations (UN) Educational, Scientific and Cultural Organization (UNESCO) World Heritage sites, including the Great Barrier Reef, the world's largest coral reef system (Department of Environment and Science, 2023b). The distance between the most southern part of the Great Barrier Reef (Capricorn Bunker Group) and K'gari where we found multiple pontoons is only 65.1 nautical miles (122 km). During summer, the East Australian Current (EAC) moves southward from near K'gari to the eastern shores of Tasmania (Wright, 2012). The EAC is usually stronger in summer, when it reaches further south, often bringing with it northern tropical species such as tuna (Wright, 2012). Considering pontoon debris spread across more than 250 km of coastline and an untold number of pontoons were not recovered, it is unlikely polystyrene debris ended up in the Great Barrier Reef; however, this may not be the case in future flooding events.

Designated a UNESCO World Heritage site in 1992 (UNESCO, 2023b) K'gari was impacted by 2 pontoons beached near Eurong and 2 significant portions of pontoon to the north of Wyuna and Burad Camping Zone (Fig 3). K'gari is the largest sand island in the world and home to rainforest growing on sand and half of the world's freshwater dune lakes highlighting its uniqueness and global environmental significance (UNESCO, 2023b).

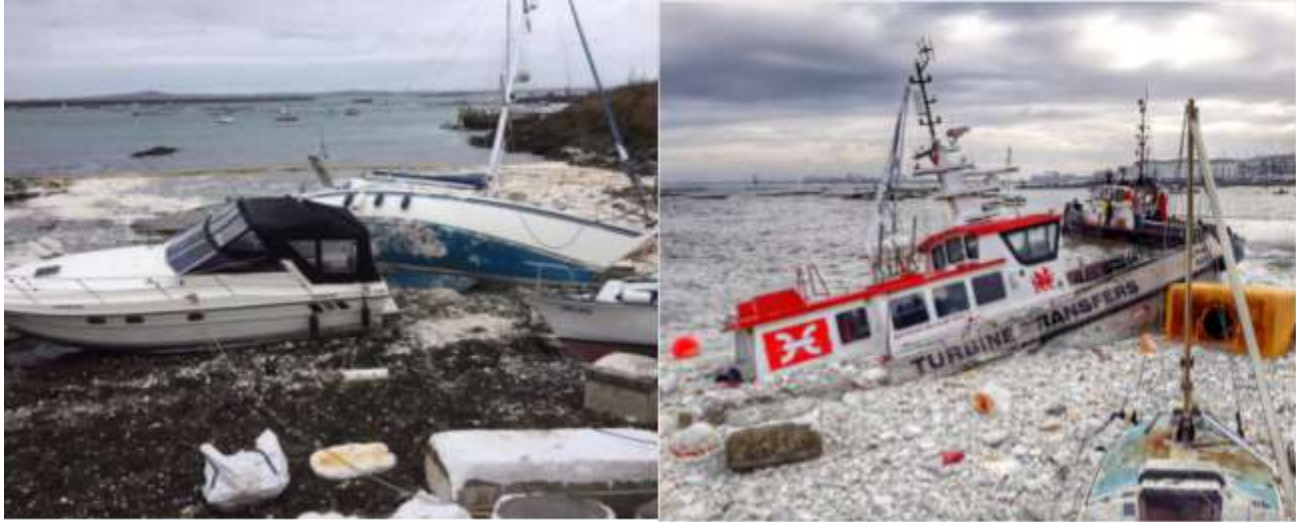
**Figure 5.** Example images of polystyrene pollution from Storm Emma in the Holyhead Marina. Image on the left from (Garrod, 2019) and image on the right from Flora & Fauna International (2020).

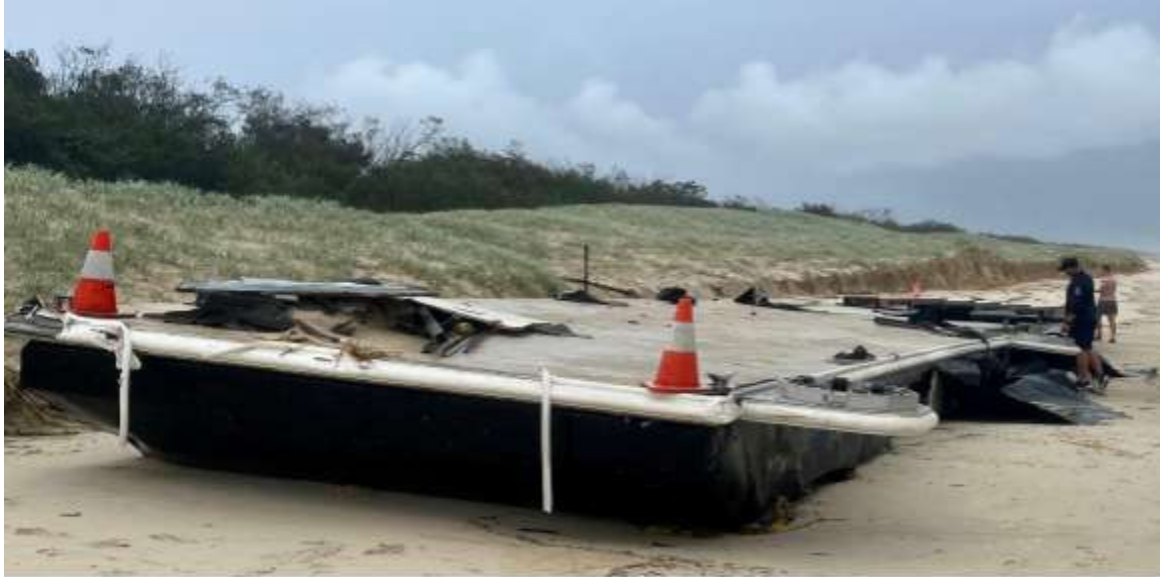
**Figure 6.** One of the beached polystyrene pontoons on North Peregian Beach, Noosa, Queensland 4th March 2023. Image credit: Sharyn Kerrigan

Polystyrene pontoons can range in size and type of construction design and material usage. Industry experts in Queensland supplied basic manufacturing specifications of typical piled pontoons. Their specifications had a typical pontoon measuring 14 m x 4 m x 1 m, weighing up to 16 tonnes, including 39 m<sup>3</sup> of polystyrene weighing 600 kg. pontoons are commonly encapsulated in a polyethylene liner with the remaining weight of 15,400 kg incorporating steel, aluminium and concrete (Fig 6; John Hogan, CEO Superior Jetties, personal communication). Polystyrene pontoons are not always encapsulated in another material, such as hard plastic or concrete, (Allen et al., 2021; Miller, 2021) resulting in susceptibility to flood debris impact and consequent disintegration. However, even those pontoons that are encapsulated are susceptible to damage during a flood resulting in a loss of polystyrene into the environment (Fig 6).

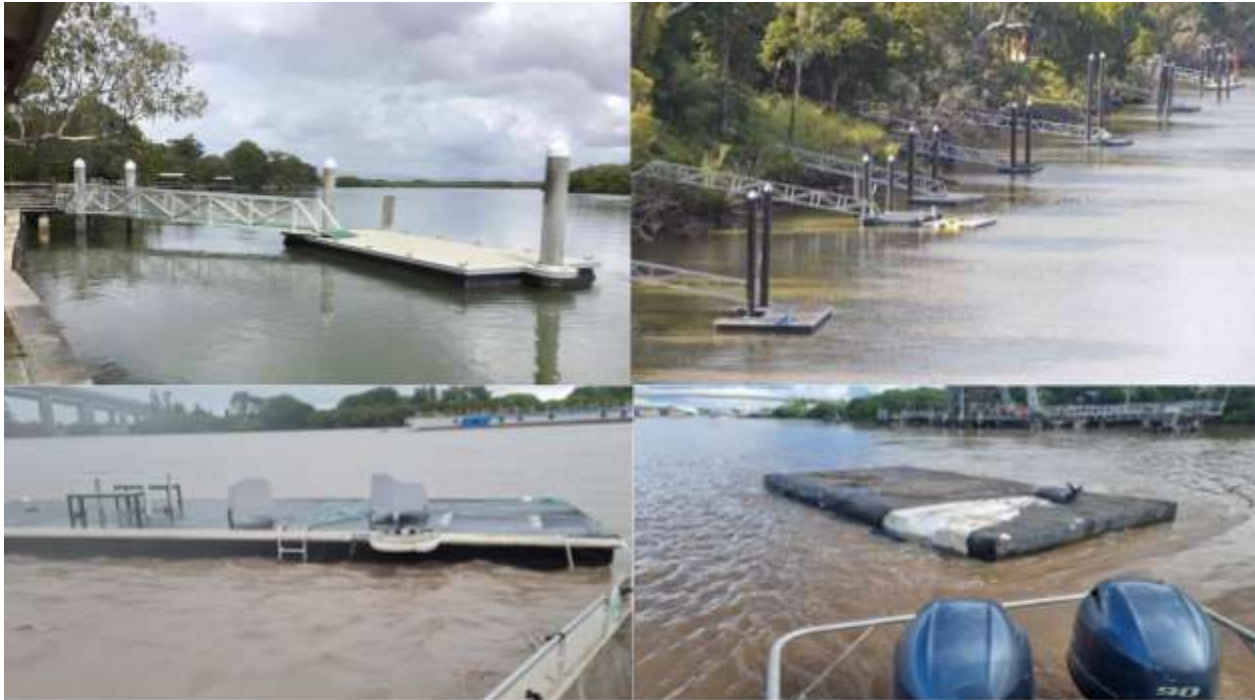
**Figure 8.** Images of pontoons in the Brisbane River before the 2022 floods (top) and during the flood (bottom), Image credit: Ocean Crusaders.

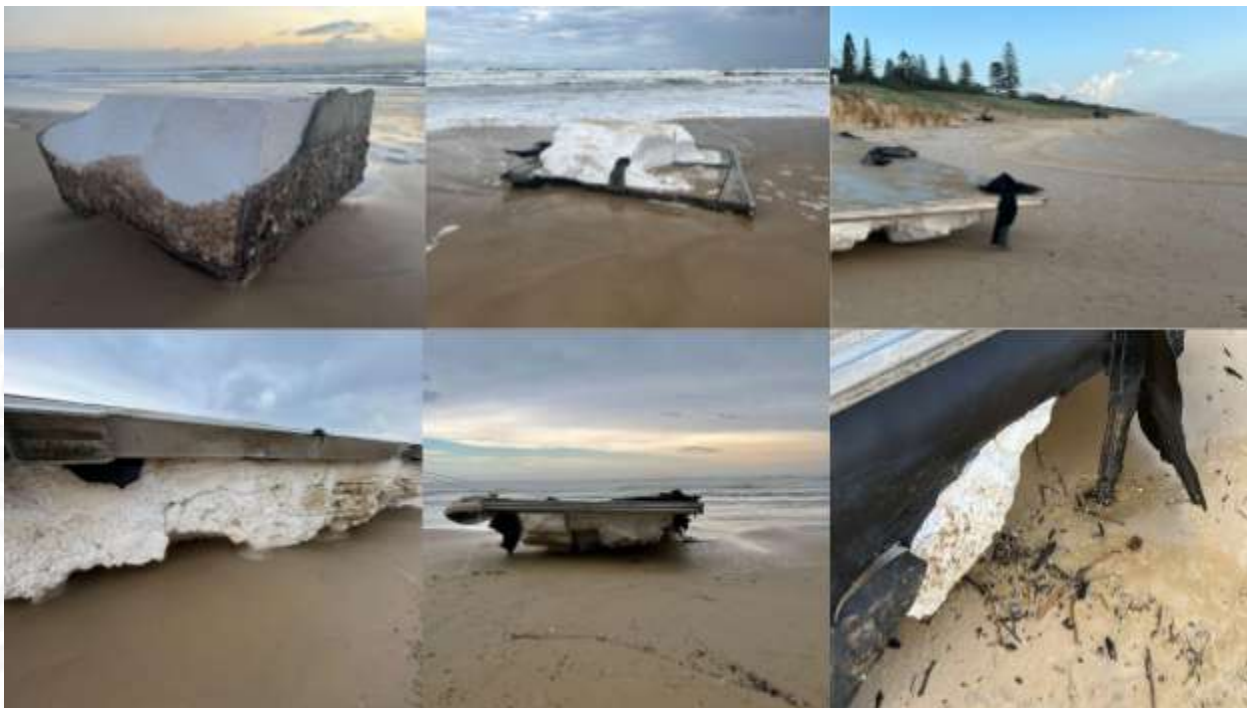
**Figure 9.** Examples of breached or absent encasement of polystyrene pontoons that were beached following the 2022 floods. Image credit: Sharyn Kerrigan

The pontoons beached in various degrees of disintegration and damage. All presented with breached or entirely shredded encapsulation membranes if, indeed, there had been any present before the flood event. Some pile loops and tethering brackets appeared to be intact but others were completely destroyed. Without exception, they were all dispersing polystyrene into the environment (Fig 11).

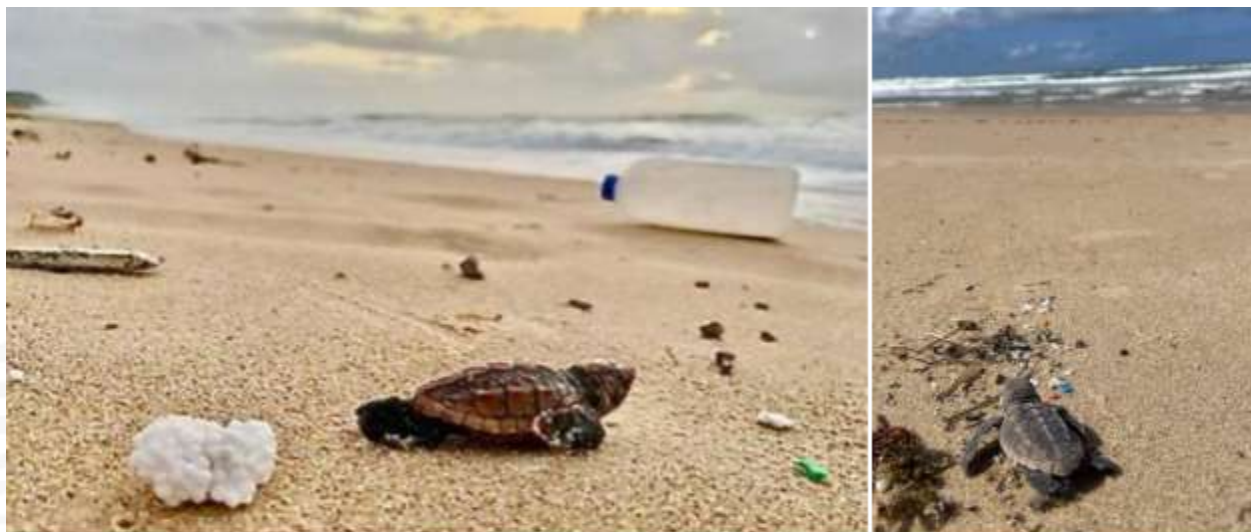
**Figure 10.** Endangered loggerhead turtle hatchling on Sunshine Beach with polystyrene (left) and with microplastic (right) March 2022. Image credit: Caroline Whitehead

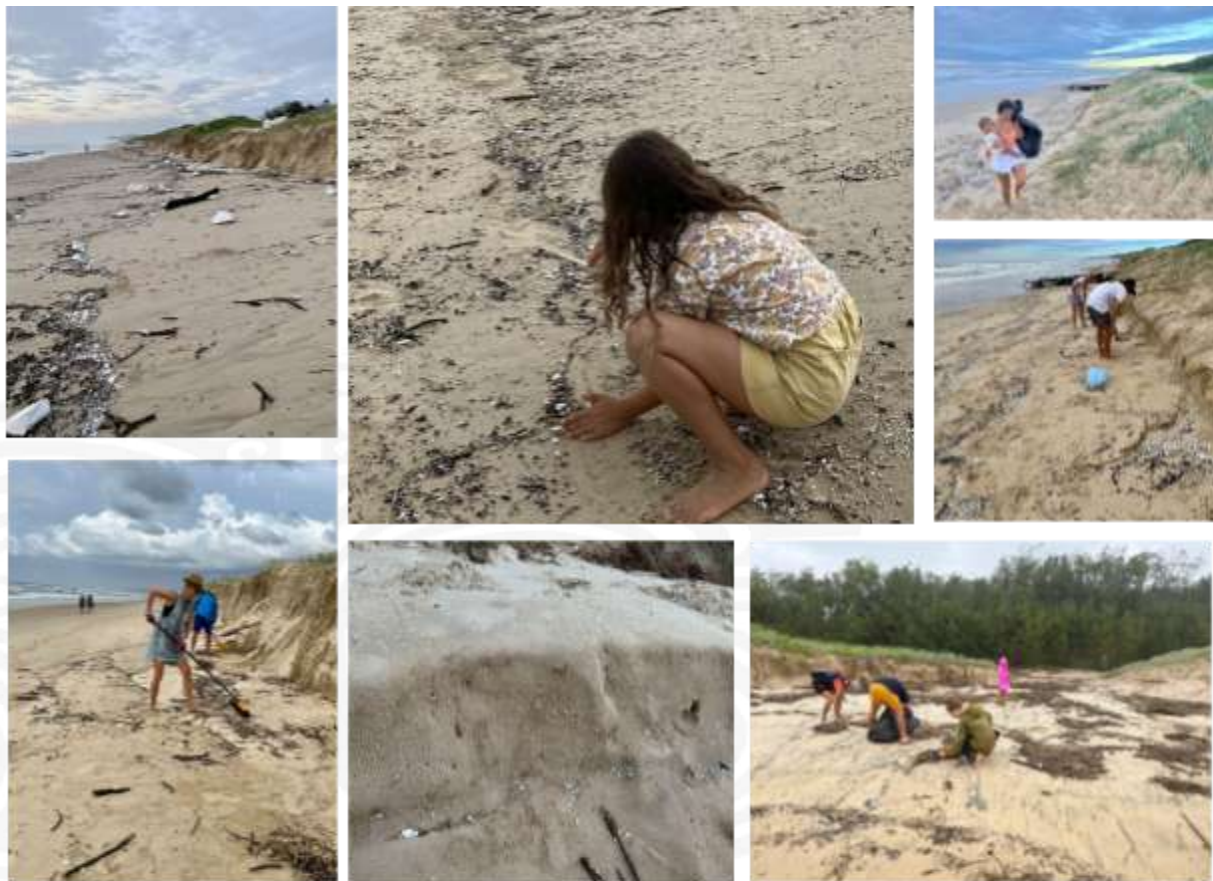
**Figure 12.** Examples of the polystyrene pieces collected on beaches by volunteers. Image credit: Sharyn Kerrigan

All impacted sites showed heavy polystyrene debris loads. The pontoon impact sites were smothered in large polybergs, smaller chunks and individual polystyrene particles with wave action consistently bringing wave upon wave of polystyrene flotsam (Fig 12; Appendix 2). Scientific studies have demonstrated the extreme fragility of polystyrene exposed to UV and abrasion in laboratory studies (Song et al., 2017) and this was anecdotally demonstrated in the “White Spill” event. The breached encasement covers of the pontoons combined with abrasion against the shore and exposure to both heavy wave action and high winds, accelerated the rapid and extreme fragmentation, disintegration, and dispersal of polystyrene from the pontoons. Tide lines, beaches and dune systems across the 250 km impacted range displayed streams of polystyrene. Large transects of the coastline had an appearance that resembled snow and the disaster was coined the “White Spill” by environmentalist Sharyn Kerrigan of Brahminy Beach, Noosa.

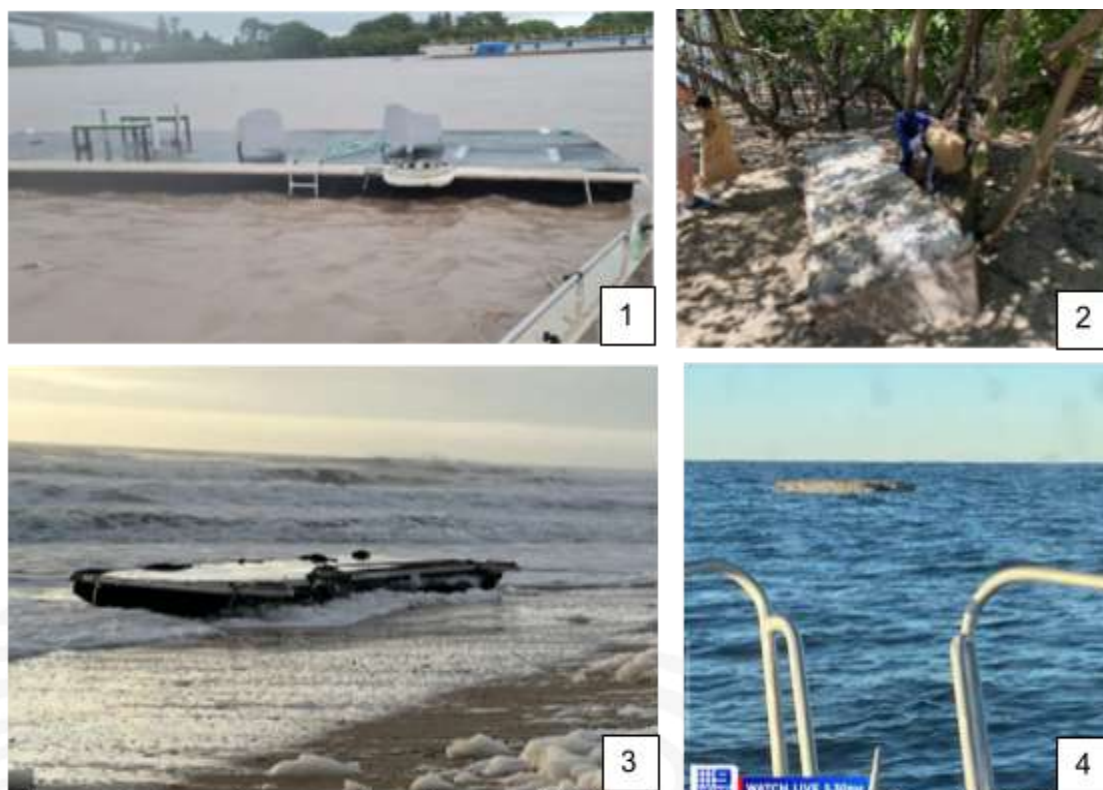
**Figure 13.** Example scenarios where guidelines for who is responsible should be developed including (1) pontoon floating down the Brisbane River during the 2022 floods (Image credit Ocean Crusaders); (2) pontoon on land at Kangaroo Point in April 2023 (Image credit: Tangaroa Blue Foundation); (3) a pontoon on Peregian Beach after the 2022 floods (Image credit: Sharyn Kerrigan); and (4) a pontoon in open water reported in waters off Currumbin in May 2023 (Image Credit Doug Burts Tackle World Gold Coast).

involved in order to utilise helicopters to remove the pontoons. We recommend developing clear guidelines on who is responsible in each possible scenario such as:

1. a pontoon floating down the river (Fig 13),
2. a pontoon stranded on land (Fig 13)
3. a pontoon on a coastal beach being moved by the waves and surf (Fig 13) and
4. pontoon in open water (Fig 13),

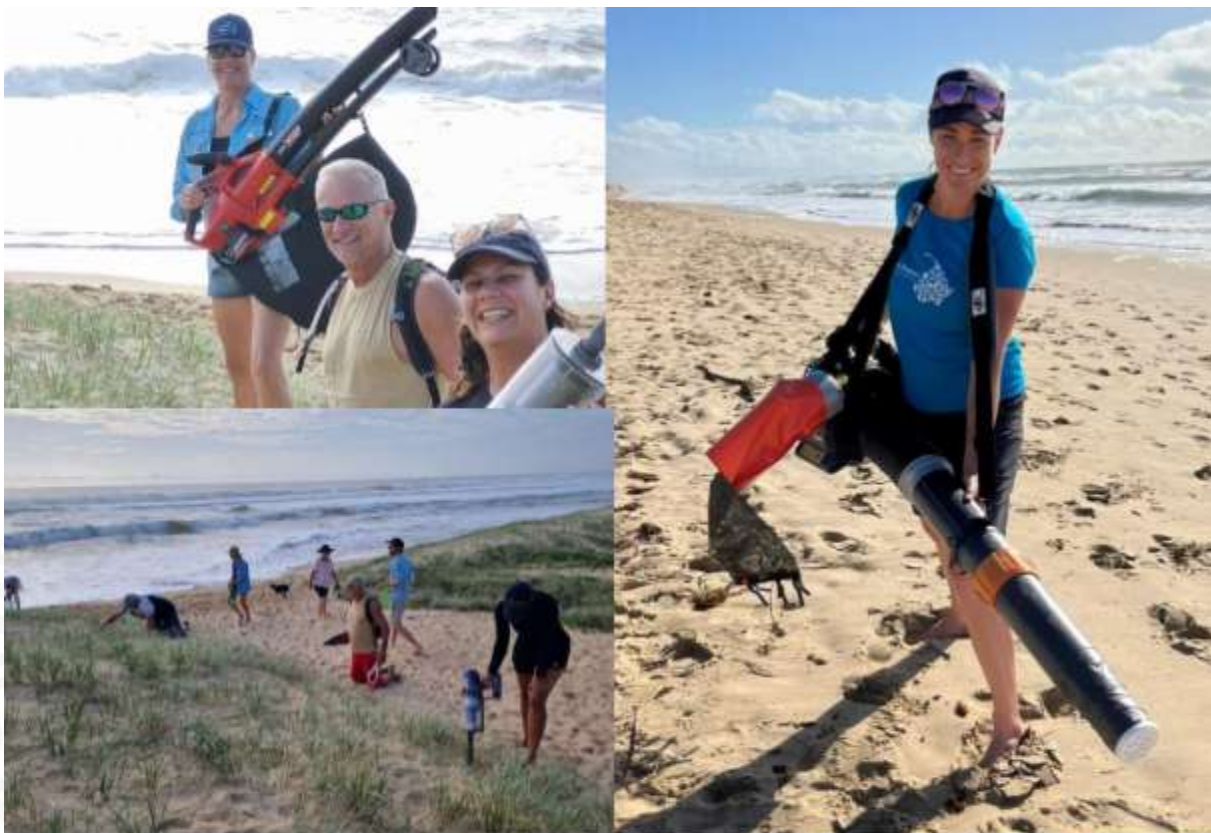
**Figure 14.** Hand-held and over the shoulder vacuums used to collect polystyrene debris from beaches. (Image credit: Karen Anderson & Reef Check Australia)

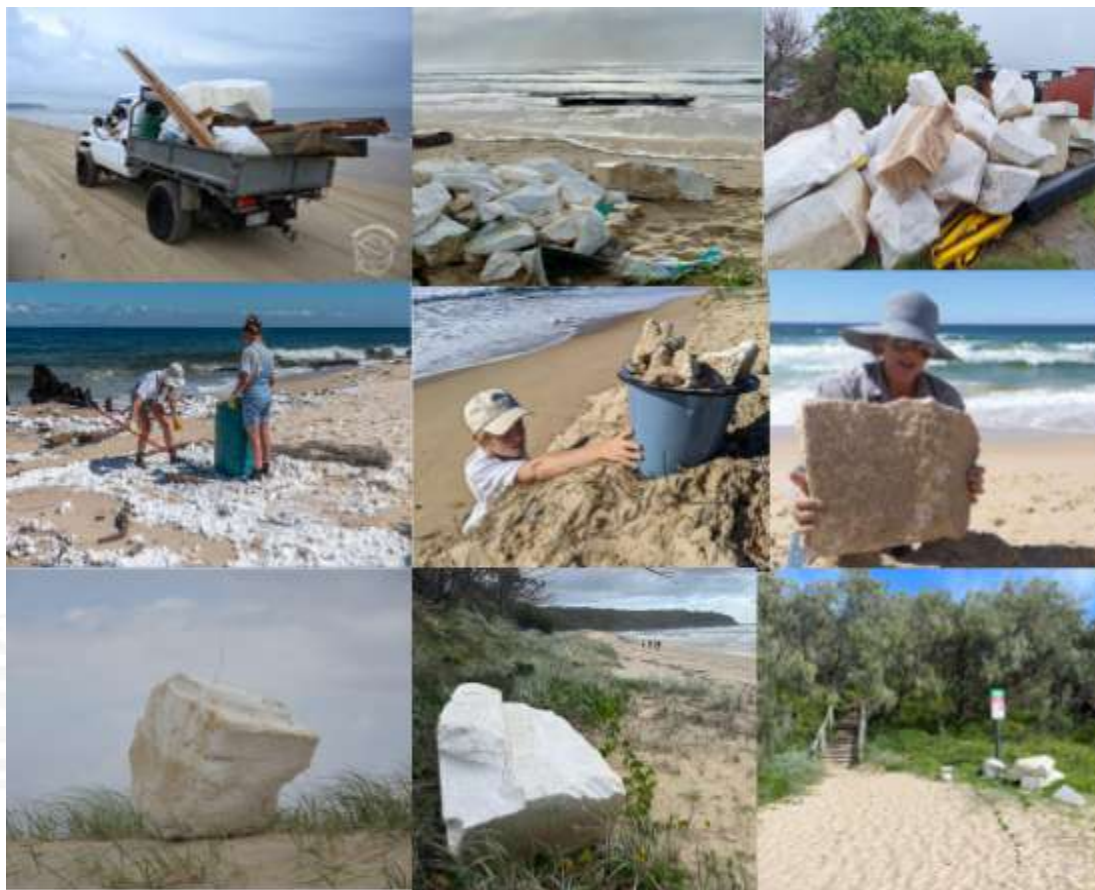
**Figure 15.** Examples of large polystyrene chunks that were removed as a priority to limit dispersal. (1) Mulgumpin (Image credit: Sea Shepherd Marine Debris Australia); (2); Peregian Beach (Image credit: Sharyn Kerrigan); (3) Brisbane River (Image credit: Ocean Crusaders); (4) K'Gari (Image credit: Ocean Crusaders and K'Gari Fraser Island Adventures); (4) Castaways Beach (Image credit: Reef Check Australia); (6) Castaways Beach (Image credit: Ten Little Pieces); (7) Sunshine Beach (Image credit: Sharyn Kerrigan); (8) Peregian Beach (Image credit: Sharyn Kerrigan); and (9) Sunrise Beach (Image credit: Sharyn Kerrigan).

1. Marine debris triage. The fragility and dispersal characteristics of polystyrene under exposed conditions requires a triage system in which the largest distributed chunks of polystyrene or pontoons are a priority (Fig 15). We believe this will limit the creation of polystyrene “snow” which is much more difficult to clean-up from the environment.
2. Vacuums
  - a. Hand-held, battery-powered domestic or garden vacuums were used to collect small pieces of polystyrene from the sand and environment including some supplied by Clean Water Group (Fig 14).

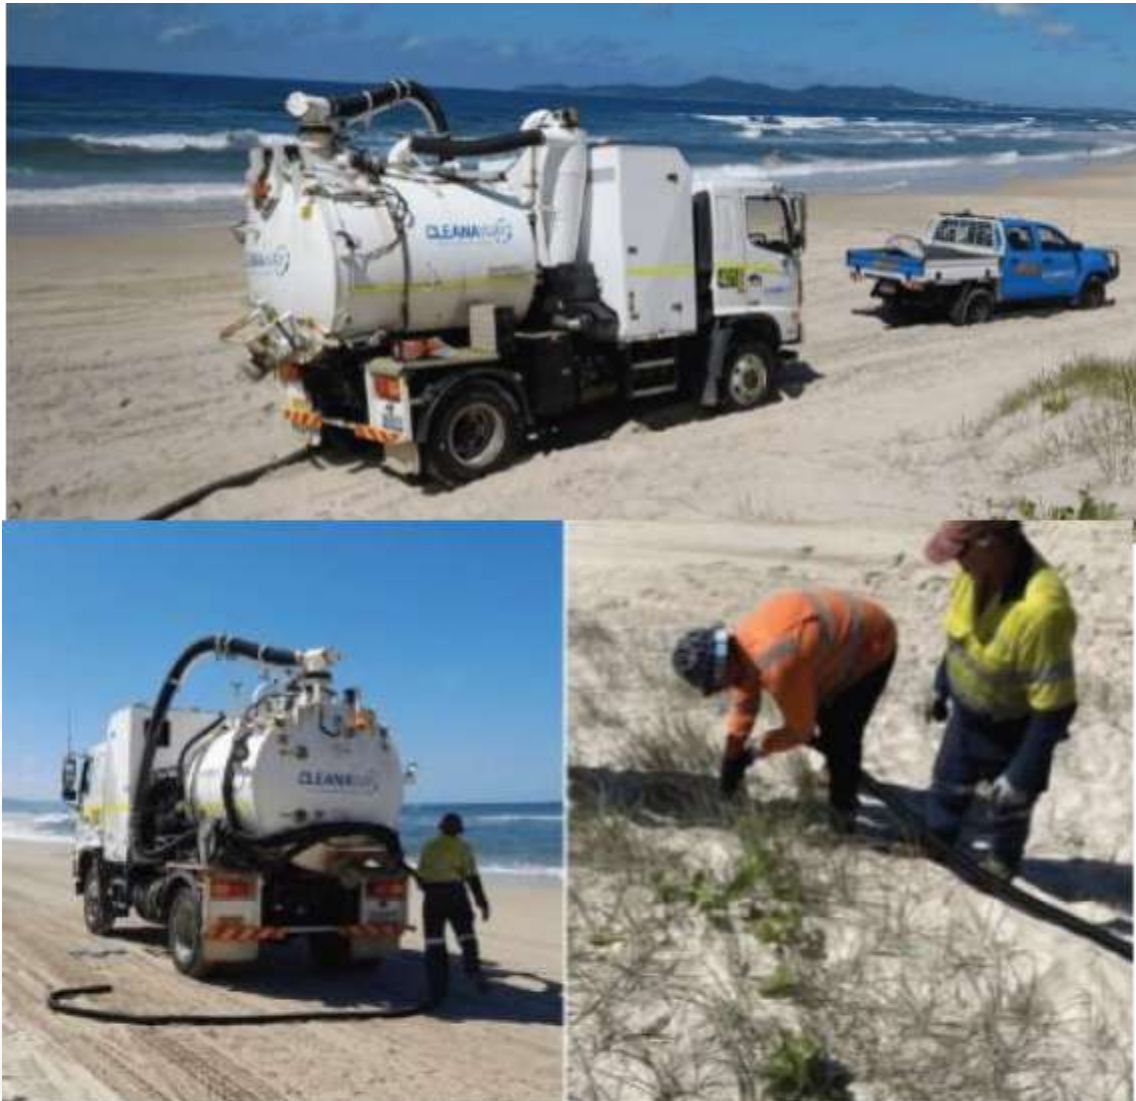
**Figure 16.** CleanAway Queensland all terrain truck removing polystyrene from the beach (Image credit: Sharyn Kerrigan).

- b. An industrial vacuum was also operated by Ocean Crusaders. Ocean Crusaders modified a Greystone Horse Paddock Vacuum which was mounted on a surf lifesaving buggy.
- c. Cleanaway's Queensland IWS was contracted by Noosa Council to remove the polystyrene from Noosa Northern Beaches and the Noosa Eastern Beaches (mid May 2022). They operated an all-terrain vacuum truck that used a vibration separator to trial removing the polystyrene from the beaches (Appendix 5 and Fig 16).

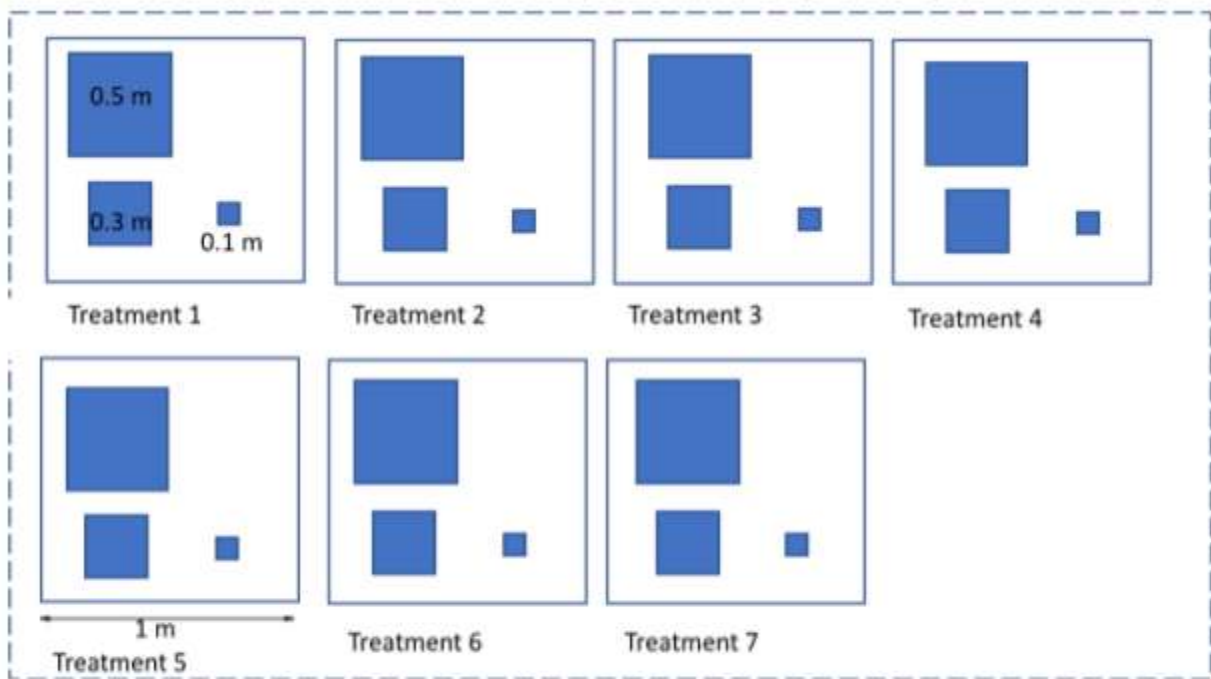
**Figure 17.** Schematic of the containment method experimental set-up with seven treatment options and three size variations for each treatment option.

1. Control: no dissolution or containment treatment;
2. Containment: light stretch clear shrink wrap 17 um thickness;
3. Containment: heavy shrink wrap 25 um thickness;
4. Containment: biodegradable hand stretch wrap 20 um thickness;
5. Containment: shade cloth (90% UV heavy duty cloth) silver;
6. Containment: shade cloth (70% UV light duty cloth) black;
7. Containment: heavy duty tarp
8. Dissolution treatment: d-limonene
9. Dissolution treatment: acetone

Each containment method was attached to the corresponding polystyrene pieces and the length, width, height, and weight were recorded. The experiment was set up as in Figure 17 in a Tangaroa Blue Foundation employee’s garden with stakes at the corner of each treatment and hessian cloths around each treatment as a primary barrier (Fig 18). All three sized pieces with the same treatment were contained within the same barrier. All pieces were staked to the ground using ratchet straps and tent pegs to ensure pieces were not carried away in any extreme weather. A secondary perimeter around all treatments was set up (Fig 18).

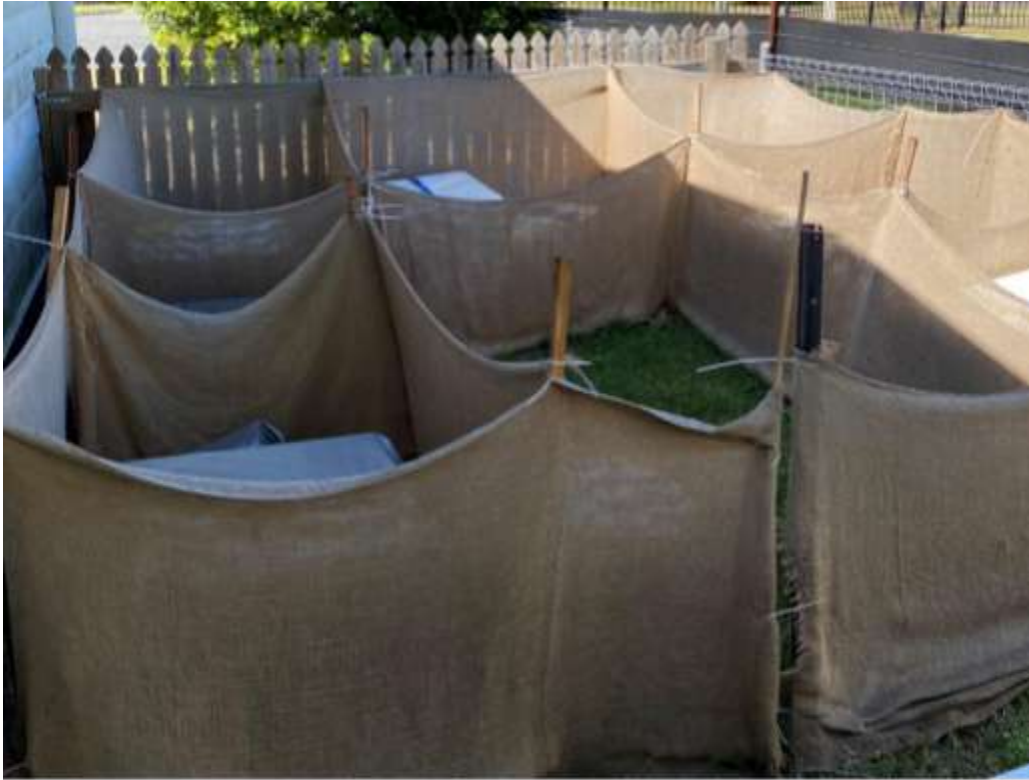
**Figure 18.** The containment method experimental set-up.

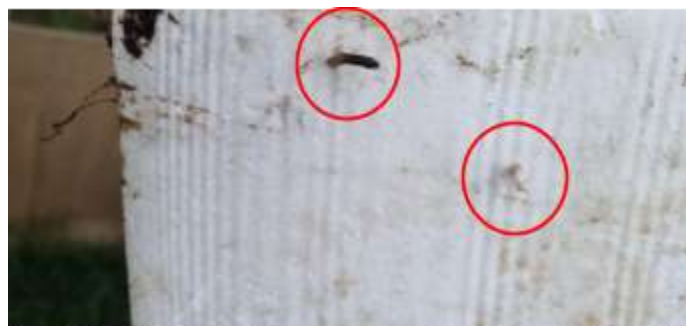
**Figure 20** Control treatment with items growing out of the polystyrene (indicated in the red circles).

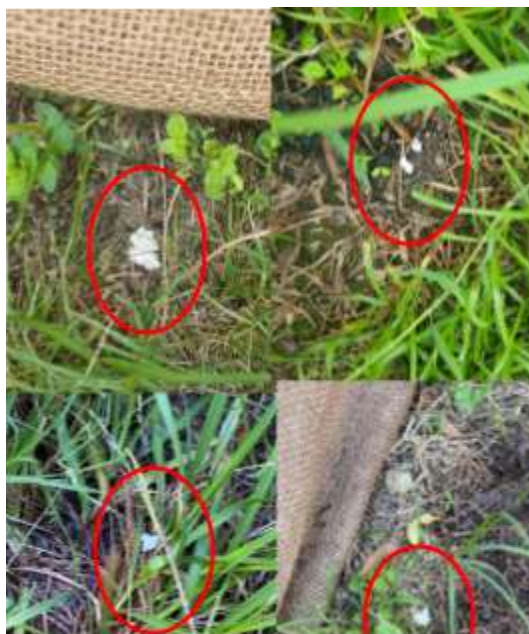
**Figure 21.** Polystyrene leakage in the primary barrier from the control treatment (top) and the biodegradable hand stretch wrap (bottom).

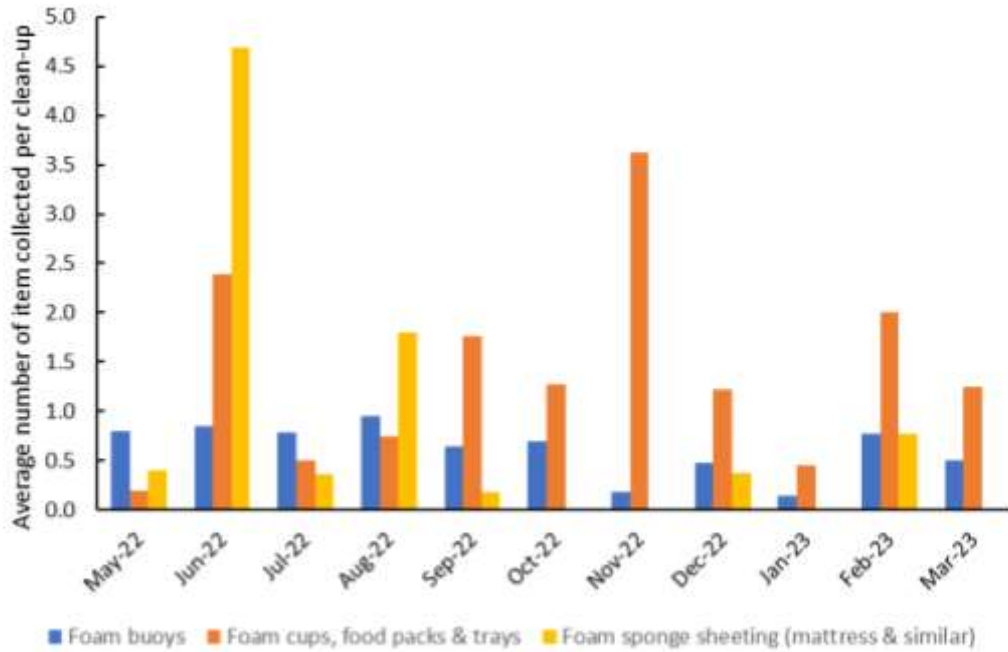
**Figure 24.** The average number of foam items, by type, collected per clean-up event in Southeast Queensland from May 2022 to March 2023

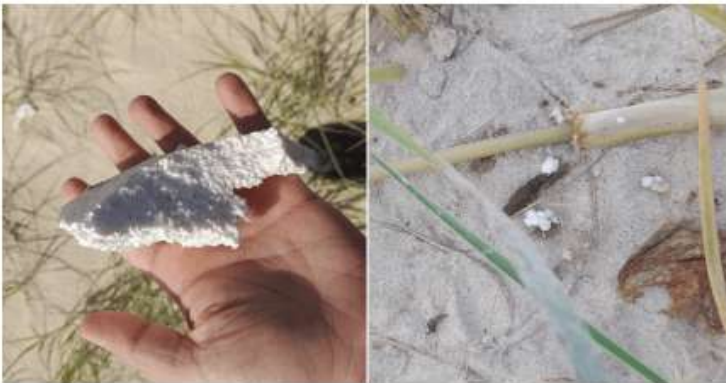
*Pictured: Polystyrene particles washed up on the Noosa Beach shoreline.*

Despite the challenges, the Queensland IWS team conducted the polystyrene clean-up trial in early April 2022 – only four months into Pir's career with Cleanaway. Using his newly modified general waste vacuum unit, the team went to work sucking up layers of sand containing polystyrene, which would then be screened at a nearby quarry. Once the polystyrene particles were screened, the clean sand was returned to the beach.

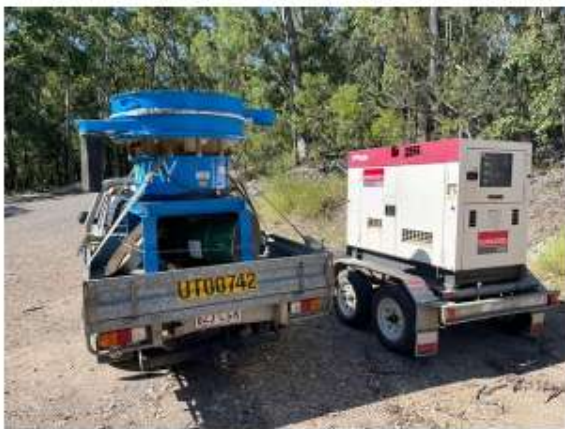
*Pictured: The mobile screen that was set up at a nearby quarry to screen polluted sand collected from Noosa Beach.*

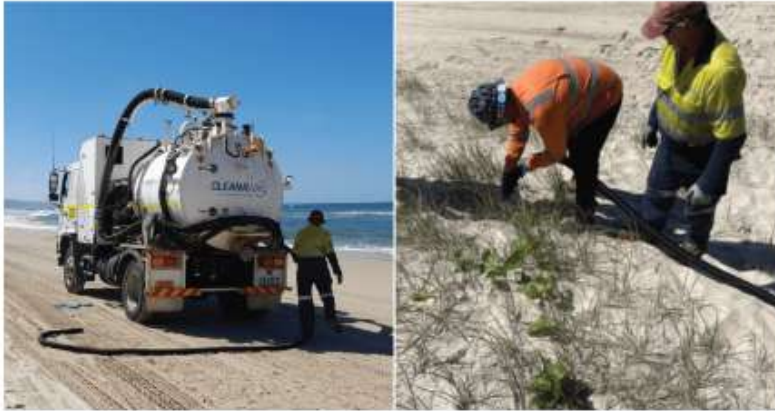
*Pictured: The Queensland IWS team sucking up polystyrene waste from the affected areas of Noosa Beach using extension hoses.*

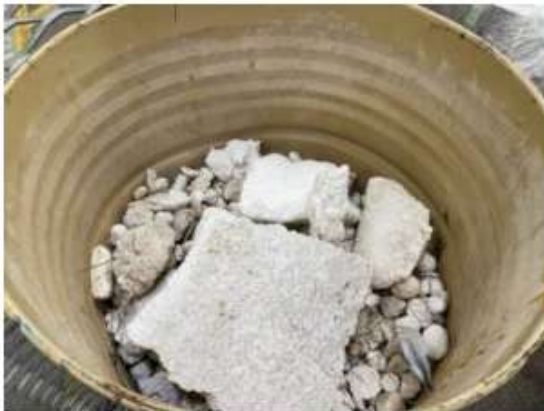
*Pictured: Some of the polystyrene debris collected during the clean-up trial.*

The team's vacuum innovation cleaned up a total of 160L of polystyrene along 5.5km of beachfront in just five days. Any remaining polystyrene particles were collected by hand by Noosa Council crews who were brought in to follow behind Cleanaway vacuum operators.

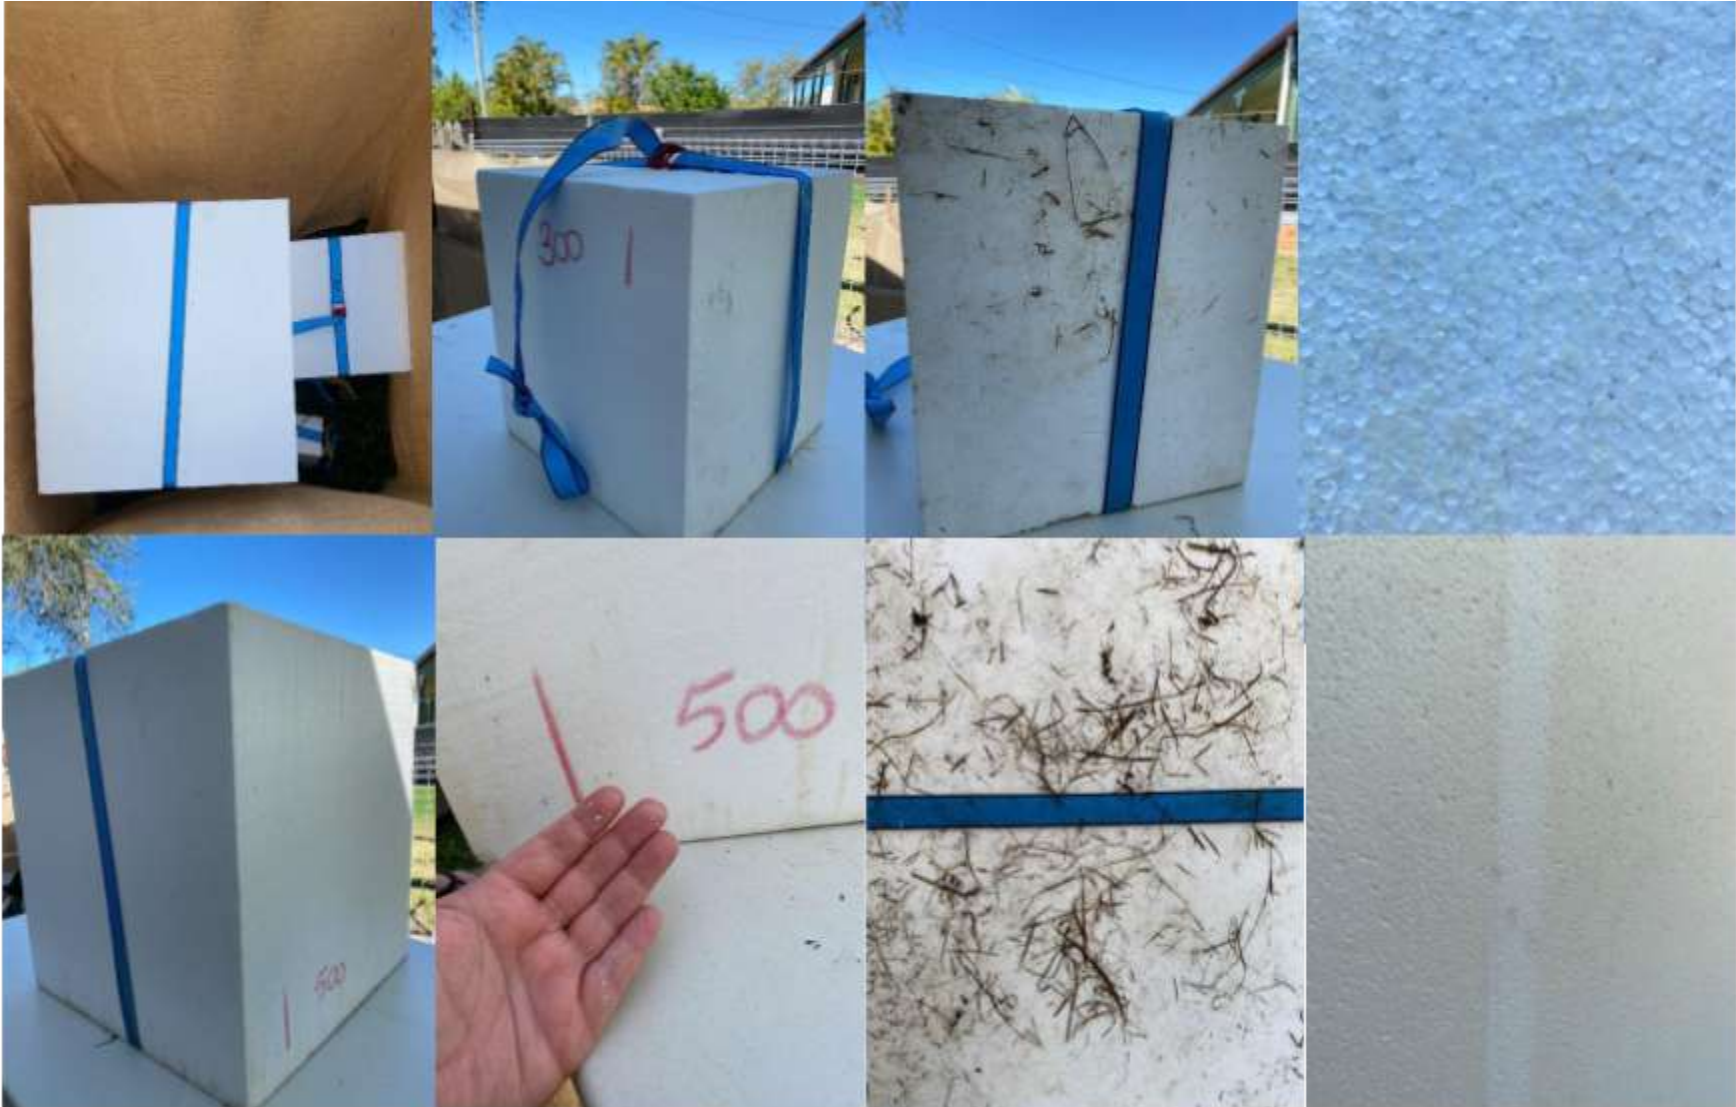
Supp Fig 1. Control treatment at the beginning of the experiment (A); the 0.3 m<sup>3</sup> piece at the end (B-D) and the 0.5 m<sup>3</sup> piece at the end (E-H).

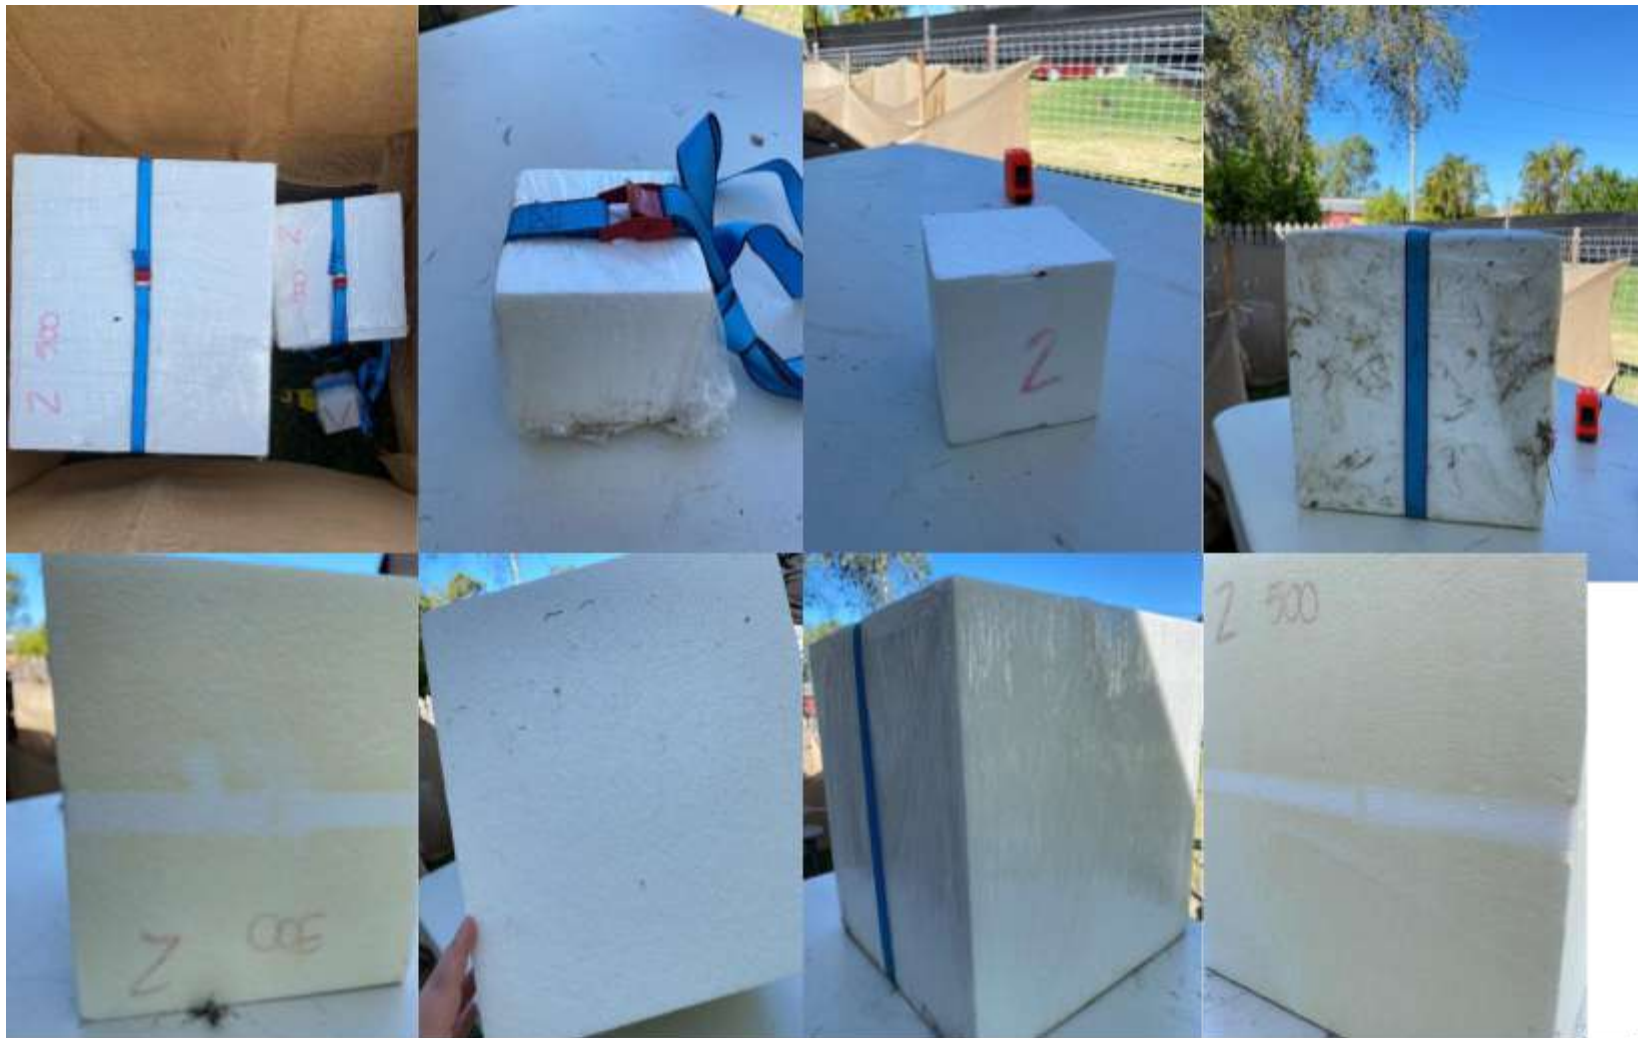
Supp Fig 2. Treatment 2: light stretch clear shrink wrap (17  $\mu\text{m}$  thickness) at the beginning of experiment (A); the 0.1  $\text{m}^3$  piece at the end (B-C); the 0.3  $\text{m}^3$  piece at the end (D-F); and the 0.5  $\text{m}^3$  piece at the end (G-H).
