# Mitigating the 2022 Queensland "White Spill" Event: strategies to prevent similar incidents

A report prepared for the Queensland Department of Environment and Science (DES) by Tangaroa Blue Foundation and Ten Little Pieces

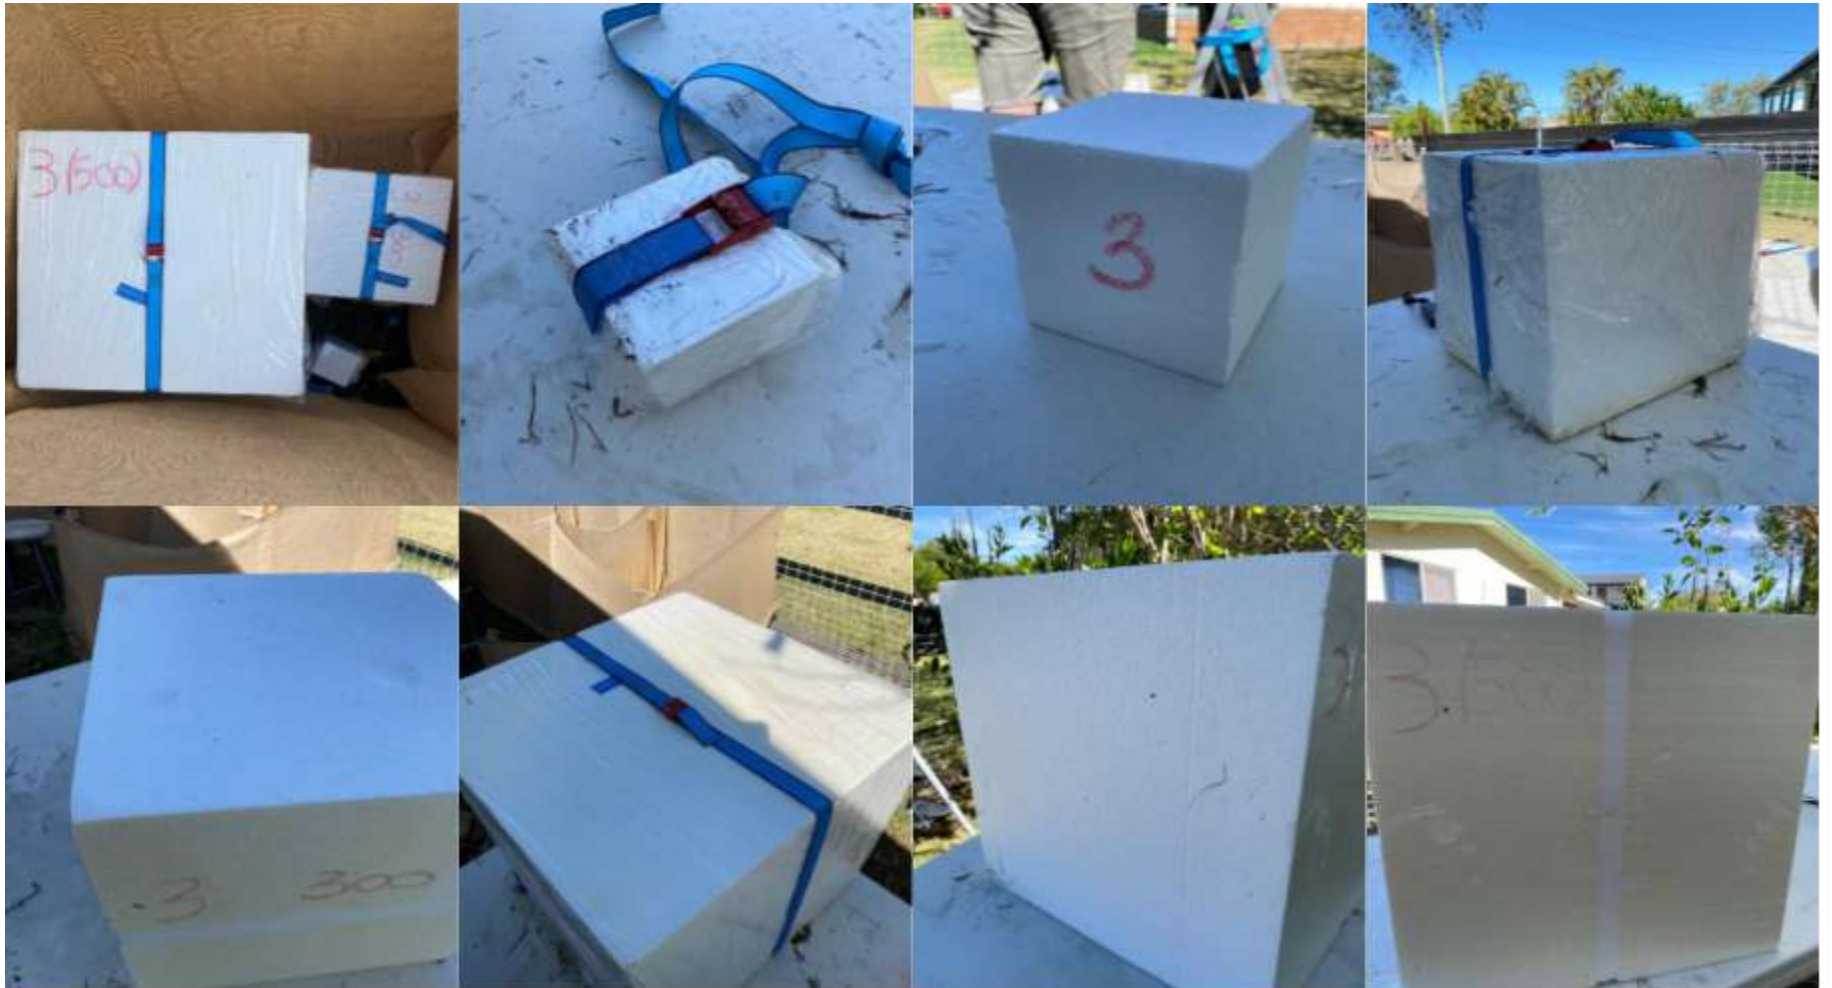
Supp Fig 3. Treatment 3: heavy shrink wrap (25  $\mu\text{m}$  thickness) at the beginning of experiment (A); the 0.1  $\text{m}^3$  piece at the end (B-C); the 0.3  $\text{m}^3$  piece at the end (D-E); and the 0.5  $\text{m}^3$  piece at the end (F-H).

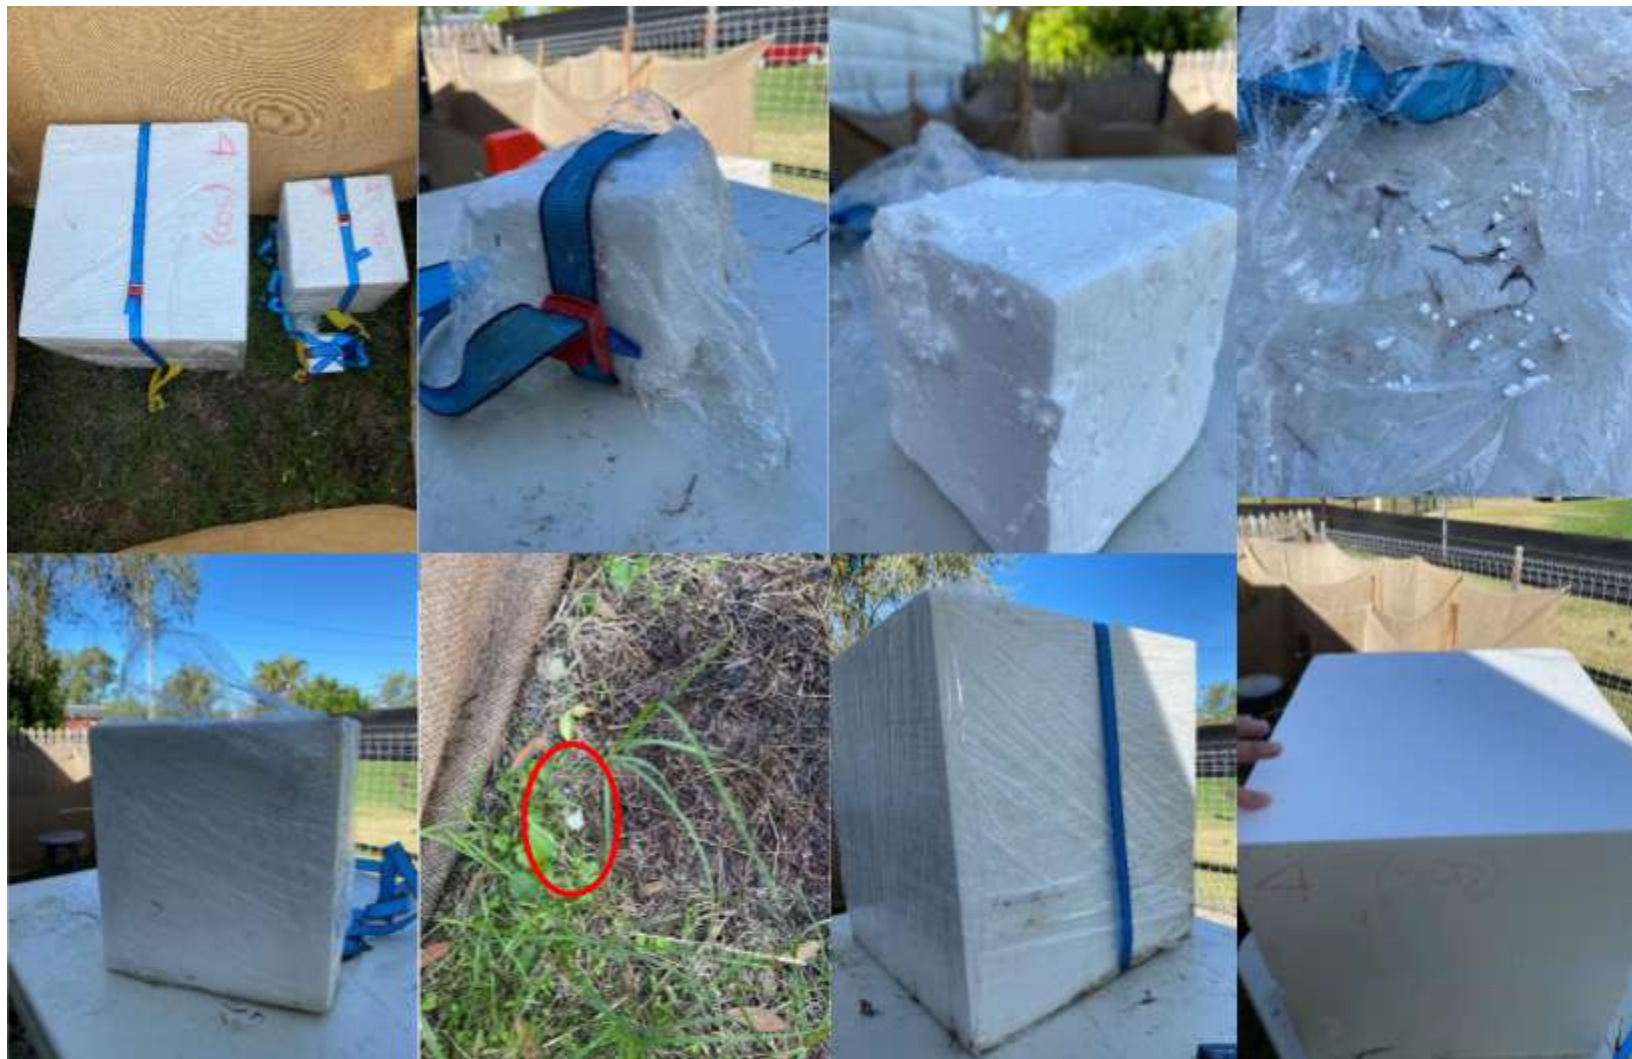
Supp Fig 4. Treatment 4: biodegradable hand stretch wrap (25  $\mu\text{m}$  thickness) at the beginning of experiment (A); the 0.1  $\text{m}^3$  piece at the end (B-D); the 0.3  $\text{m}^3$  piece at the end (E); polystyrene caught within the primary barrier (F); and the 0.5  $\text{m}^3$  piece at the end (G-H).

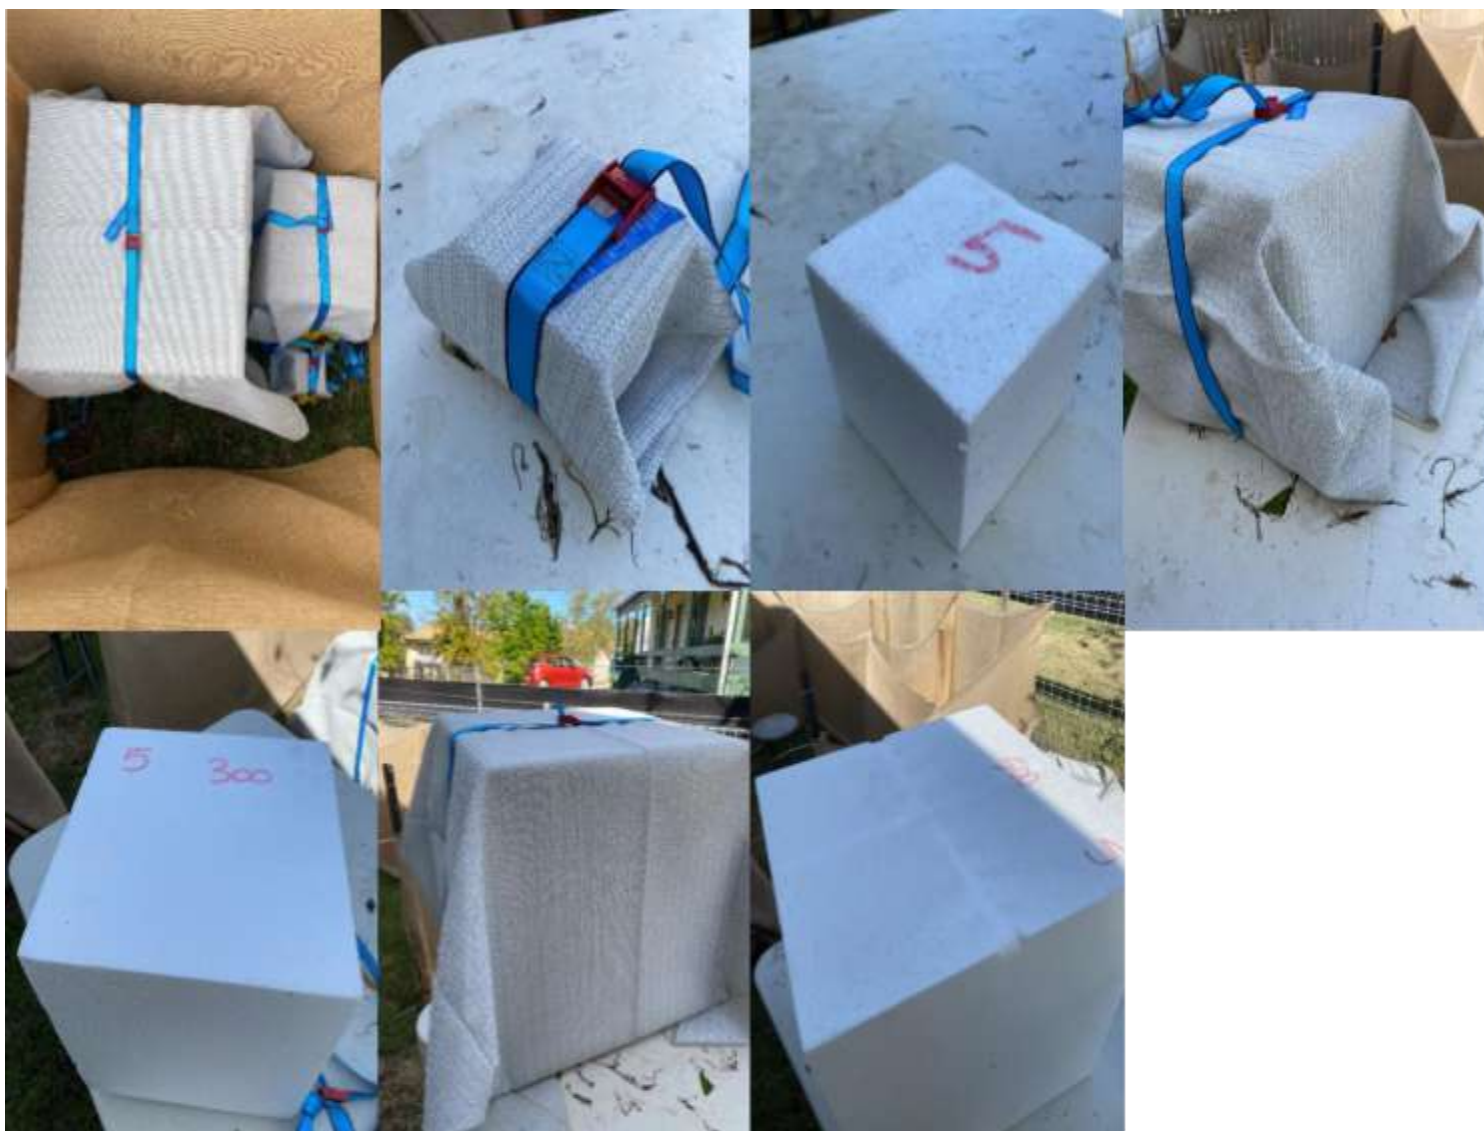
Supp Fig 5. Treatment 5: shade cloth silver (90% UV heavy duty cloth) at the beginning of experiment (A); the 0.1 m<sup>3</sup> piece at the end (B-C); the 0.3 m<sup>3</sup> piece at the end (D-E); and the 0.5 m<sup>3</sup> piece at the end (F-G).

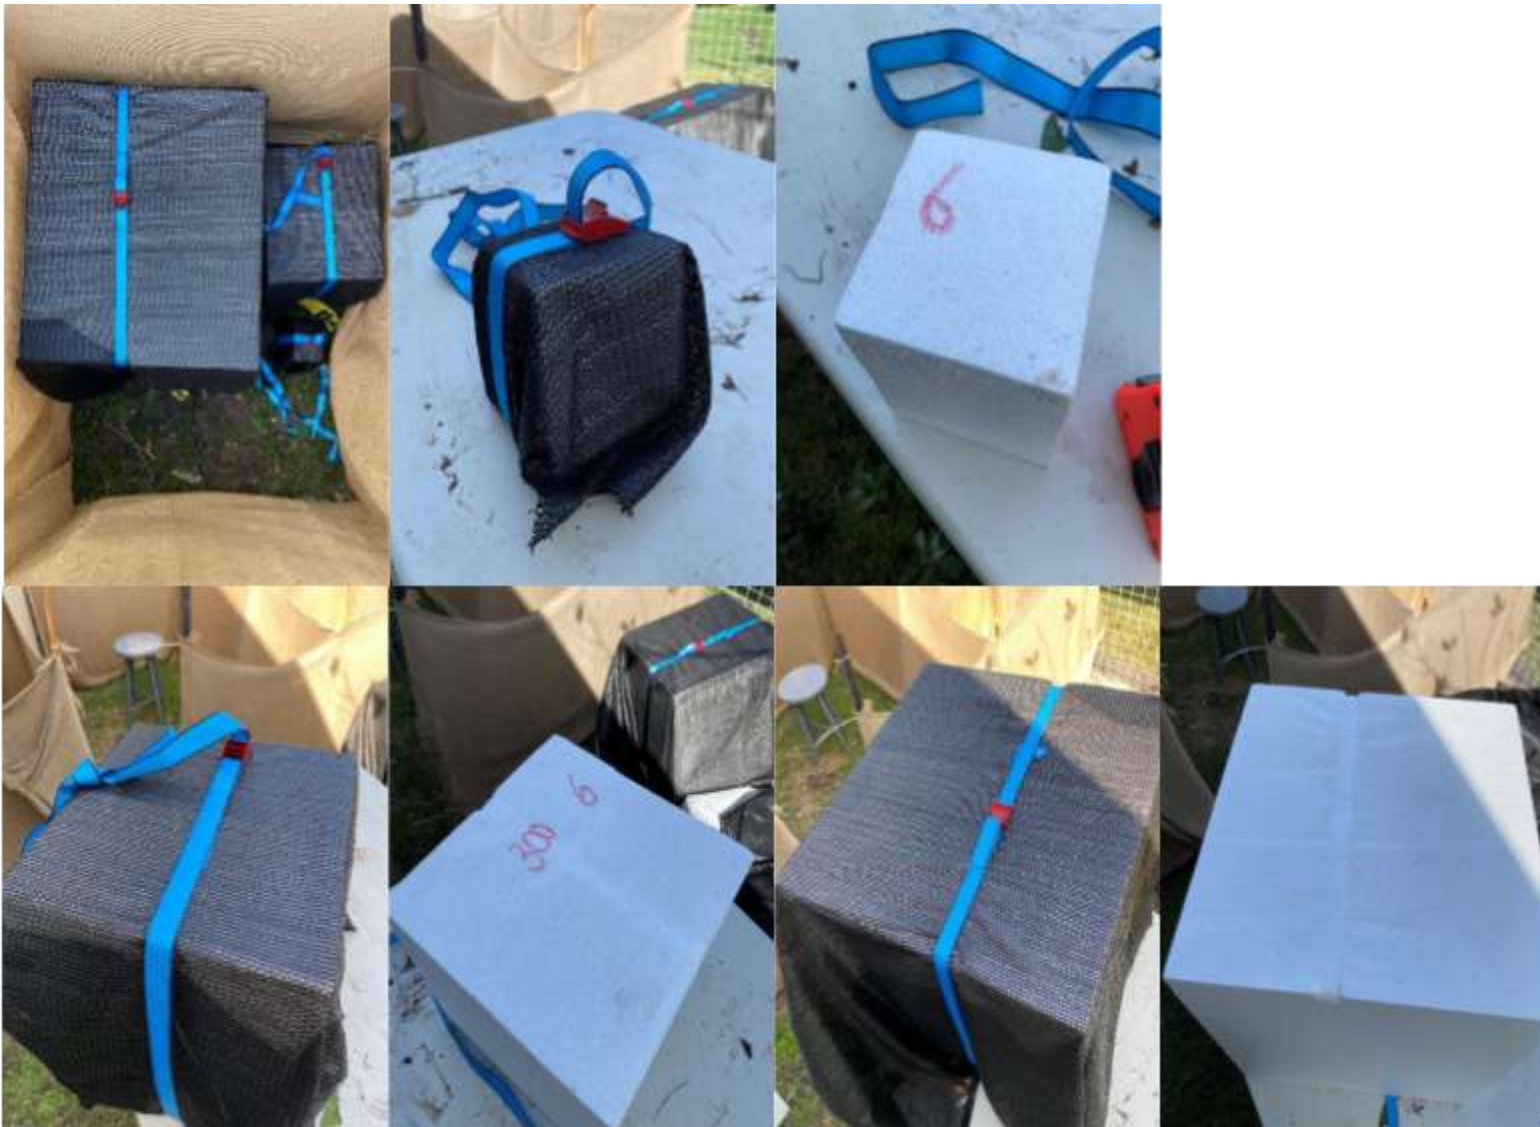
Supp Fig 6. Treatment 6: shade cloth black (70% UV light duty cloth) at the beginning of experiment (A); the 0.1 m<sup>3</sup> piece at the end (B-C); the 0.3 m<sup>3</sup> piece at the end (D-E); and the 0.5 m<sup>3</sup> piece at the end (F-G).

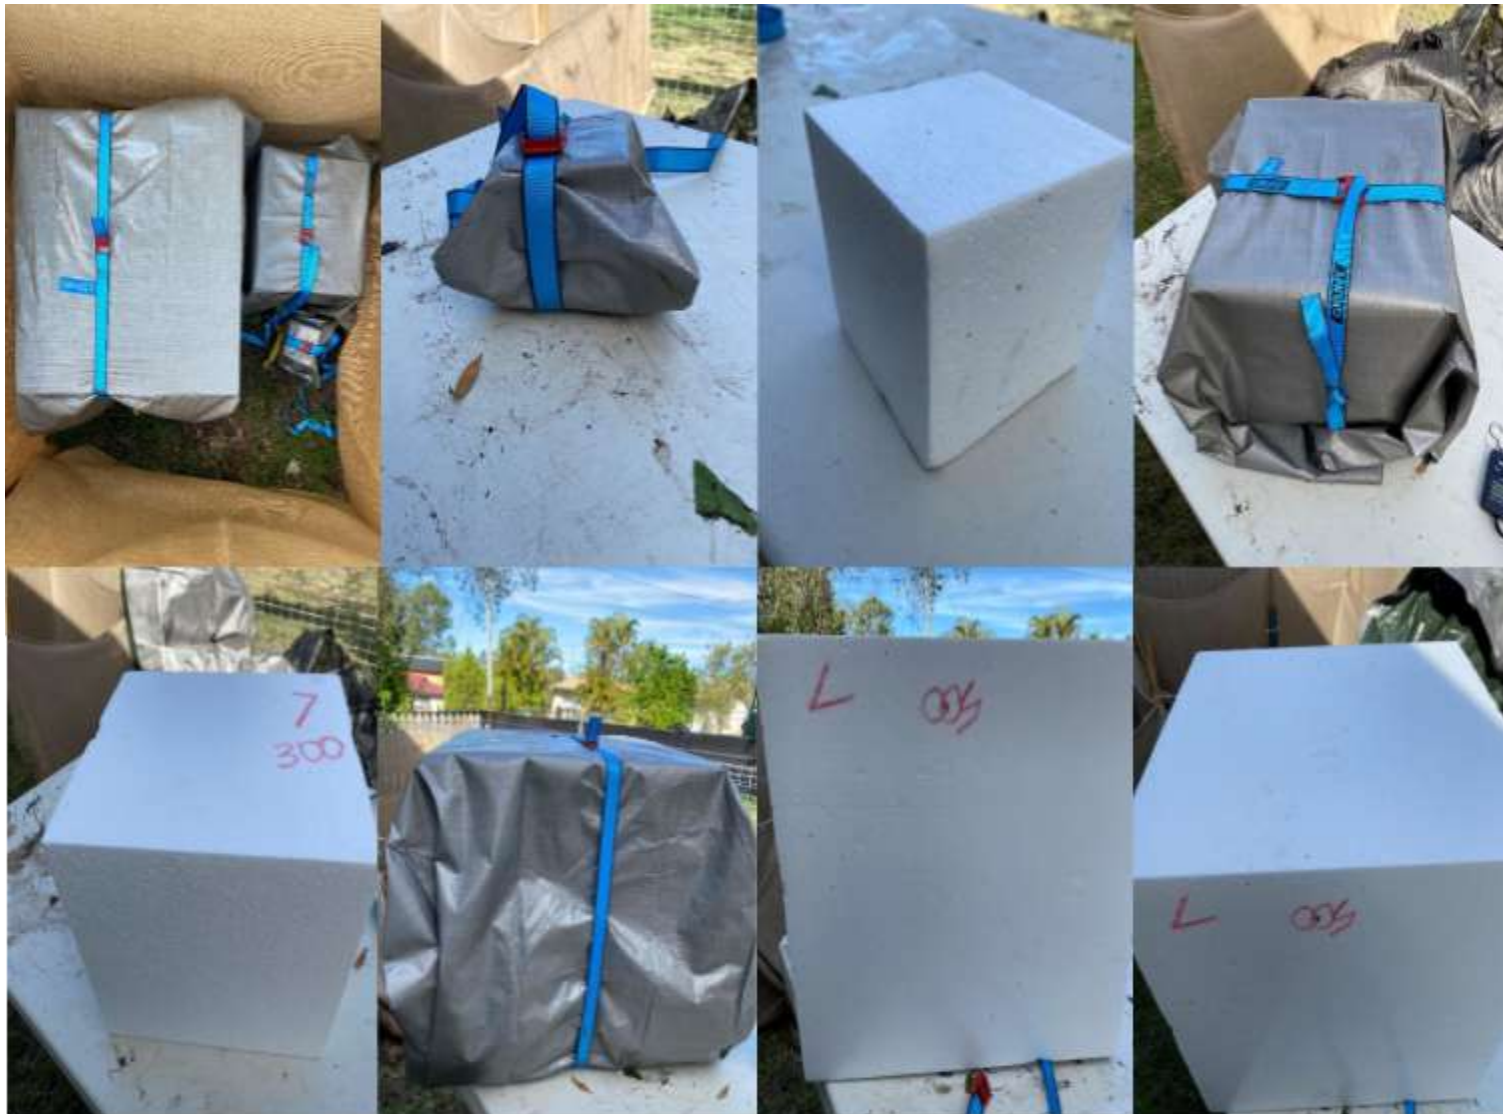
Supp Fig 7. Treatment 7: heavy duty tarp at the beginning of experiment (A); the 0.1 m<sup>3</sup> piece at the end (B-C); the 0.3 m<sup>3</sup> piece at the end (D-E); and the 0.5 m<sup>3</sup> piece at the end (F-H).

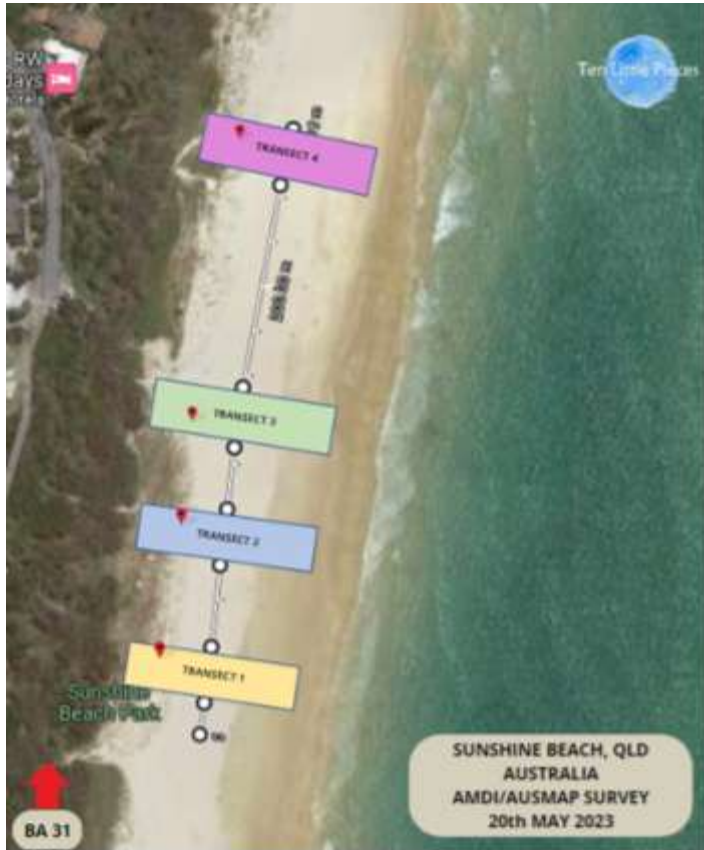
Map 1: Sunshine Beach, Qld. AMDI/AUSMAP Survey 20<sup>th</sup> May 2023.

<b>Transect Range Start Point: BA 31</b> <b>GPS Coordinates: -26.404698 153.113492</b> <b>Survey Distance: 300m heading North</b>				
	Random number	GPS Coordinates	AUSMAP quadrat high tide line random number	Photos taken
Transect 1	14 - 39m	-26.404424 153.113514	21m	Yes
Transect 2	75 - 100m	-26.403977 153.113530	91m	Yes
Transect 3	128 - 153m	-26.403434 153.113605	138m	Yes
Transect 4	246 - 271m	-26.402372 153.113831	259m	Yes

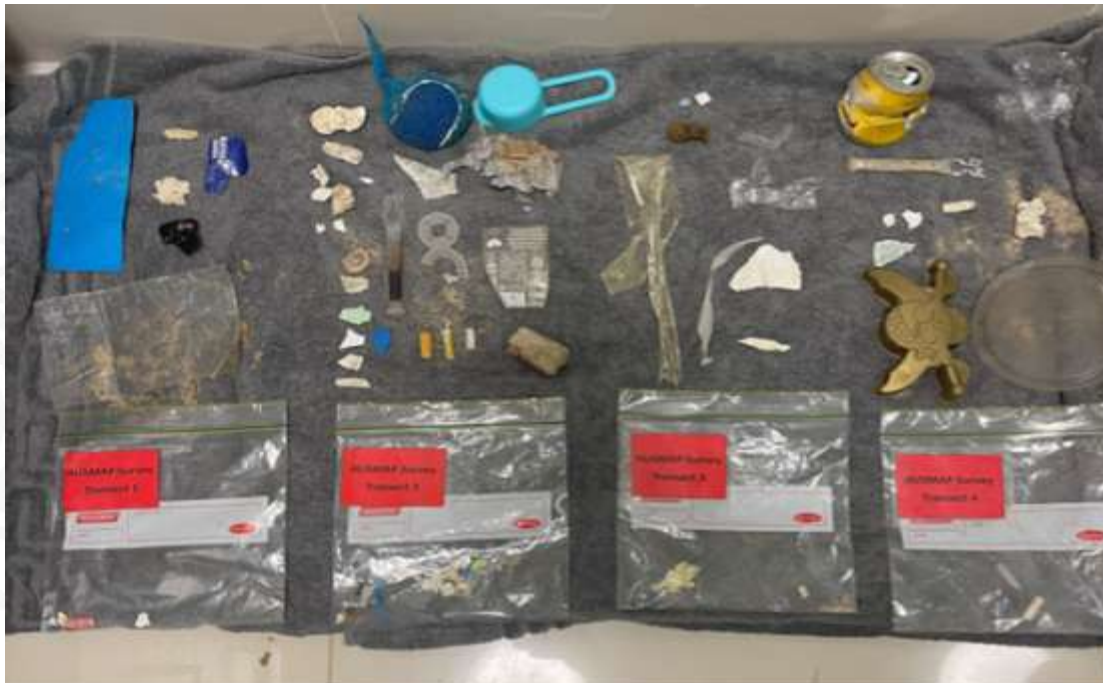
Figure 1: Debris sort AMDI/AUSMAP Survey Sunshine Beach, Qld. May 20<sup>th</sup> 2023.

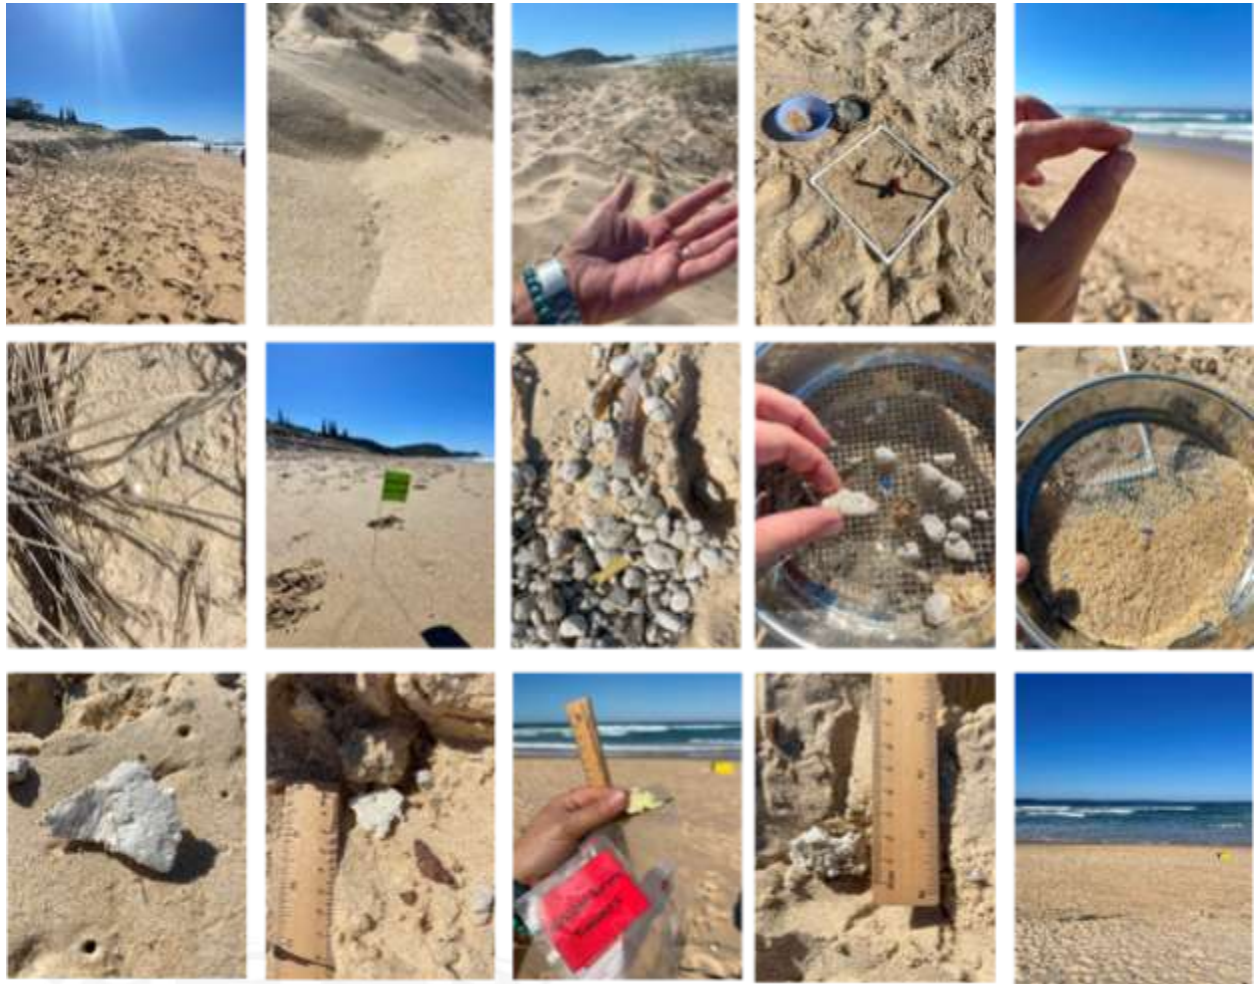
Images from Sunshine Beach, Qld Survey  
20<sup>th</sup> May 2023

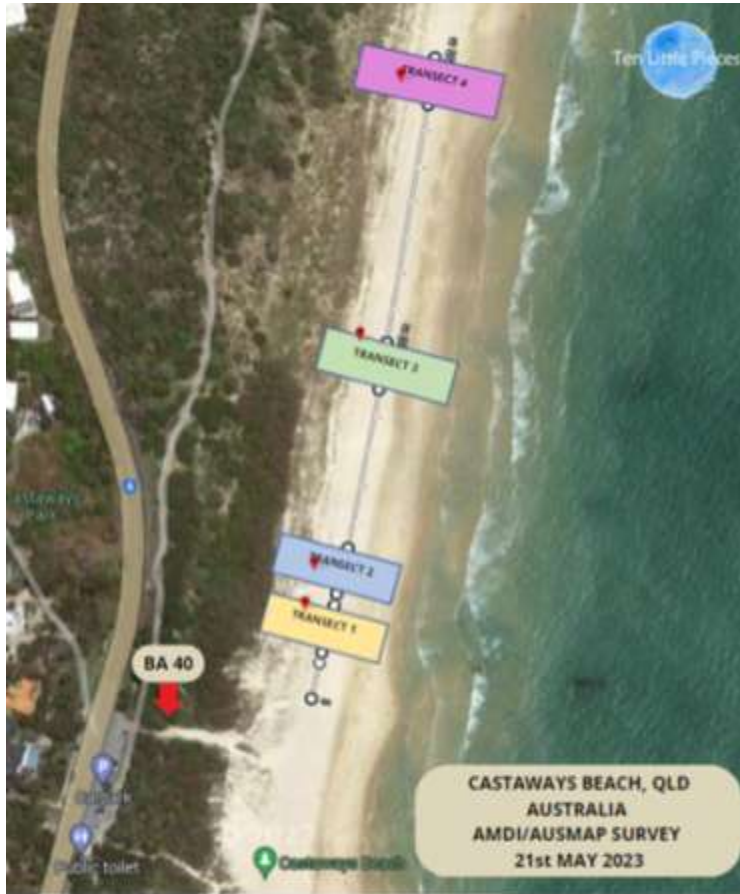
Map 2: Castaways Beach, Qld. AMDI/AUSMAP Survey 21<sup>st</sup> May 2023

<b>Transect Range Start Point: BA 40</b> <b>GPS Coordinates: -26.434672, 153.106856</b> <b>Survey Distance: 400m heading North</b>				
	Random number	GPS Coordinates	AUSMAP quadrat high tide line random number	Photos taken
Transect 1	26-51m	-26.43447, 153.10700	14m	Yes
Transect 2	58-83m	-26.43418, 153.10707	64m	Yes
Transect 3	175-200m	-26.43295 153.10733	197m	Yes
Transect 4	336-361m	-26.43149 153.10763	348m	Yes

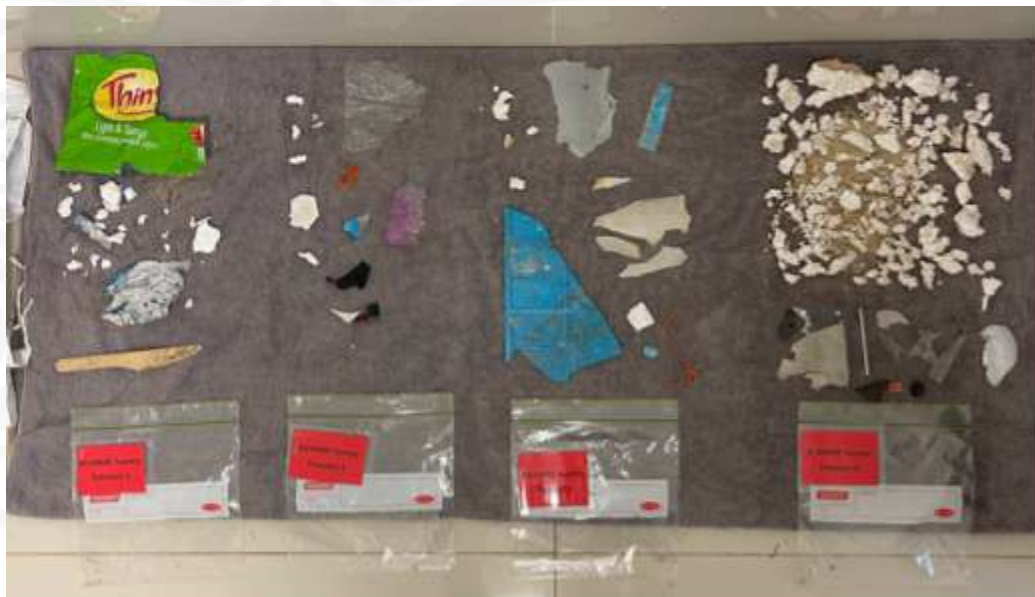
Figure 2: Debris sort AMDI/AUSMAP survey Castaways Beach, Qld. May 21<sup>st</sup> 2023.

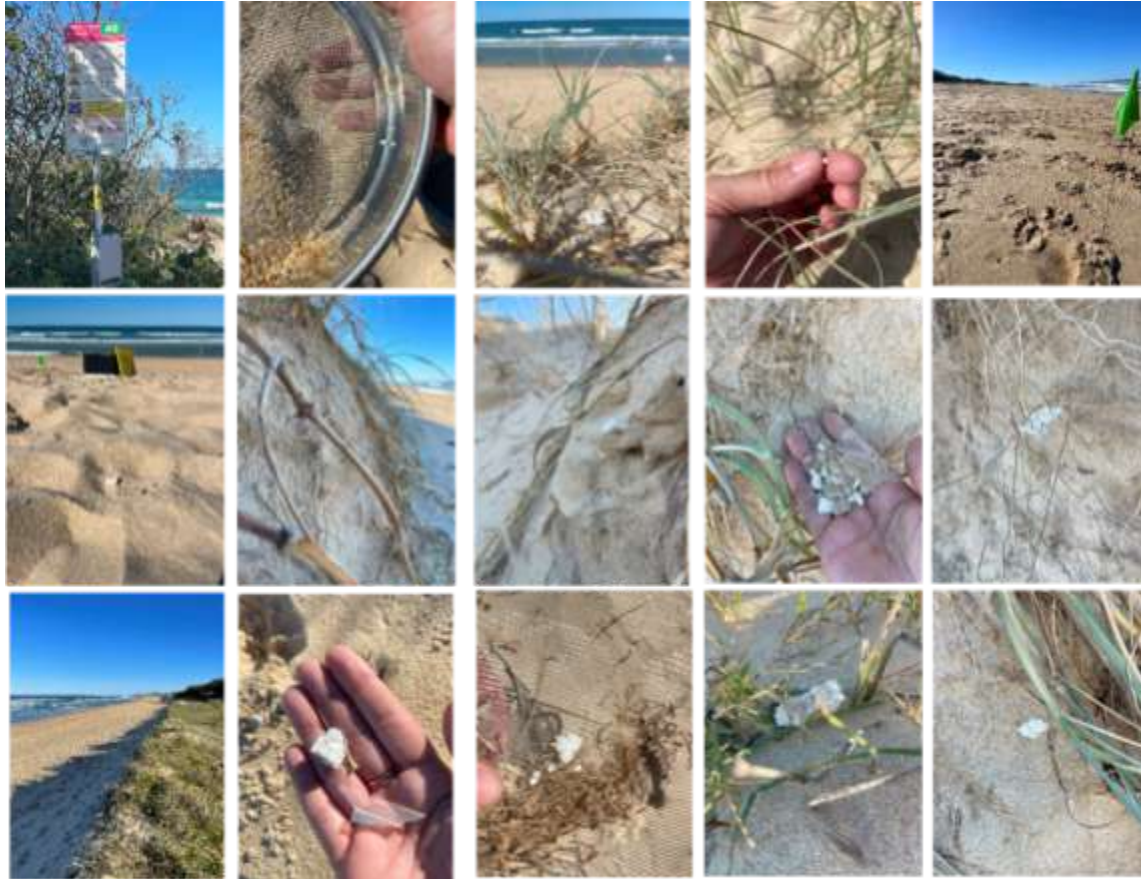
**Images from Castaways Beach, Qld Survey  
21<sup>st</sup> May 2023**

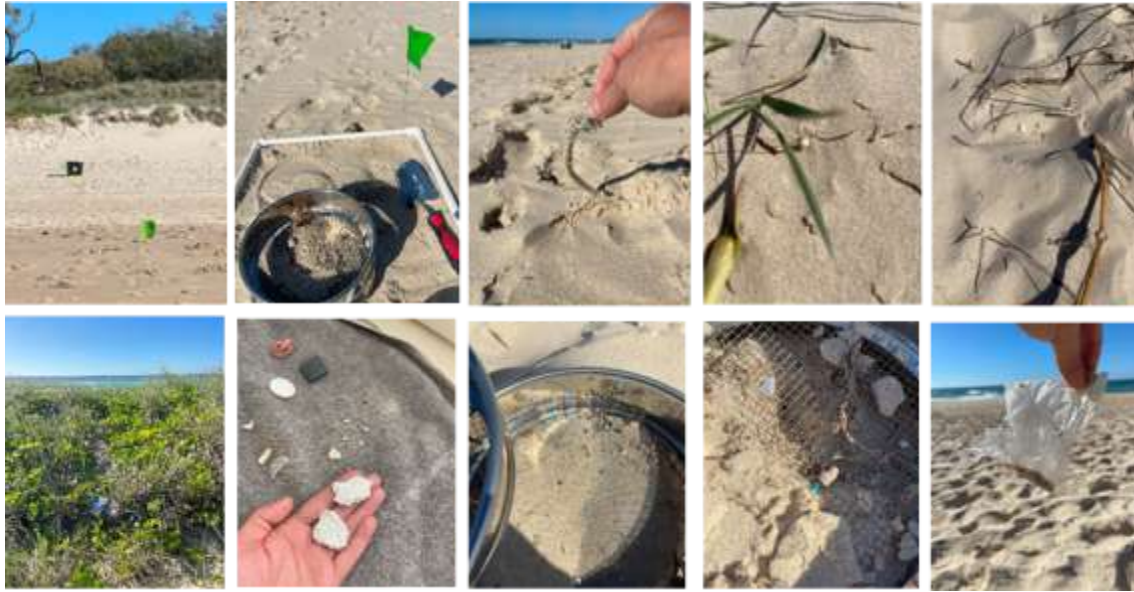
**Images from Peregrine Beach, QLD Survey  
27<sup>th</sup> May 2023**
