CJ Pro Inspections

Property Inspection Report

1234 Yellow Brick Rd, North Star, USA 012345

PROPERTY INSPECTION REPORT

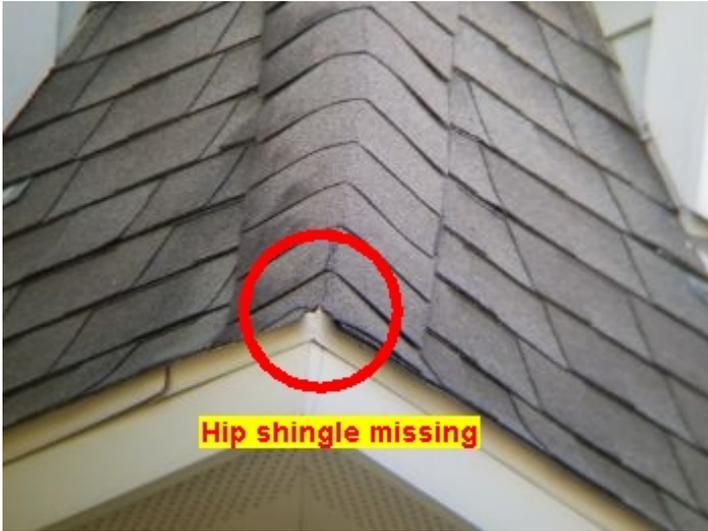
Back Right corner Hip

• **Some shingles appear loose, missing, curling and/or lifting at one or more areas**

Hip shingle missing

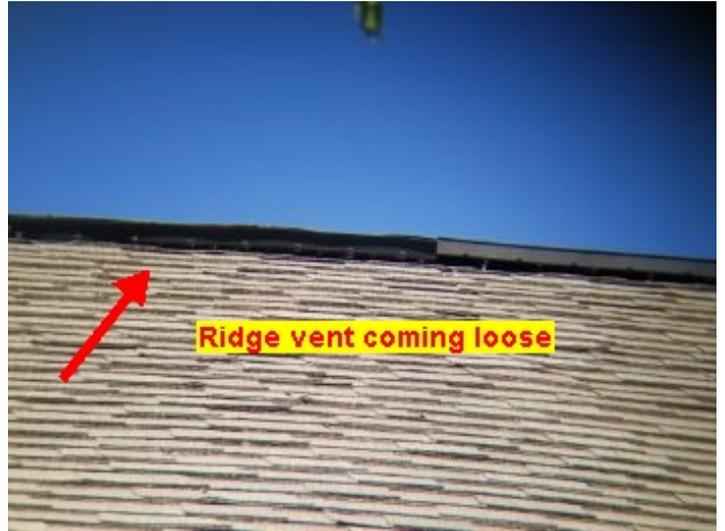
Front of house

• **Ridge vents were noted at the time of the inspection and coming loose**

Ridge vent coming loose

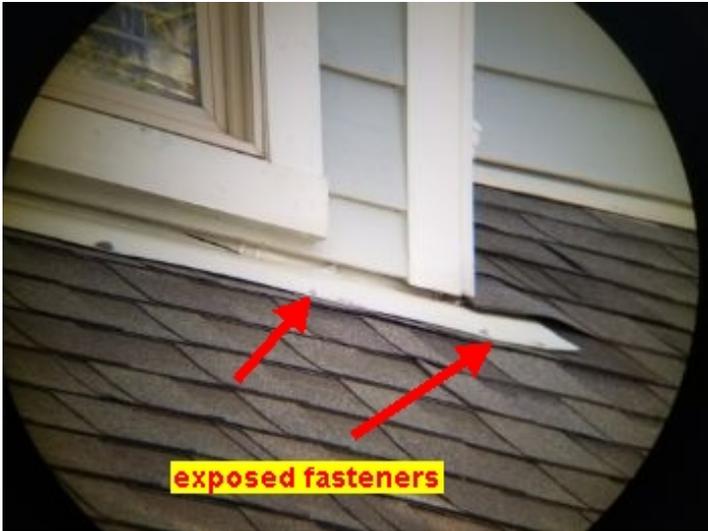
Front and right side of house

• **Exposed roof fasteners: The manufacturer requires these fasteners to be sealed with an approved roof sealant for the prevention of moisture penetration into the structure.**

exposed fasteners

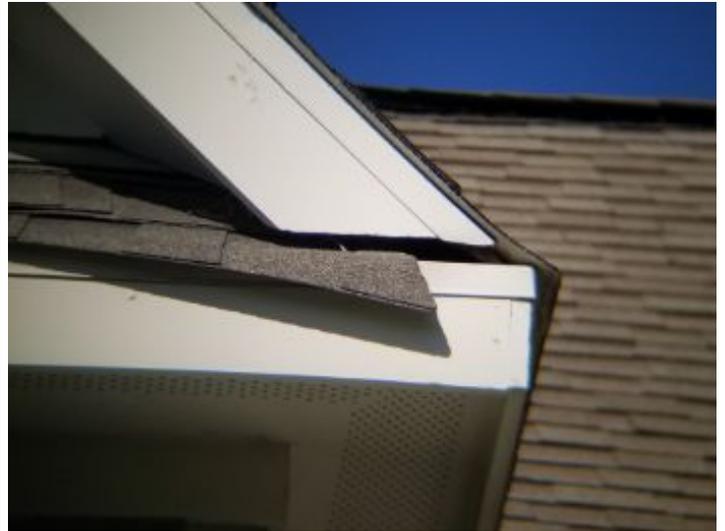
Front side

• **Evidence of spots, markings and/or indentations were visible on the roof surface. It is recommended that a qualified roofing contractor be consulted for further evaluation**

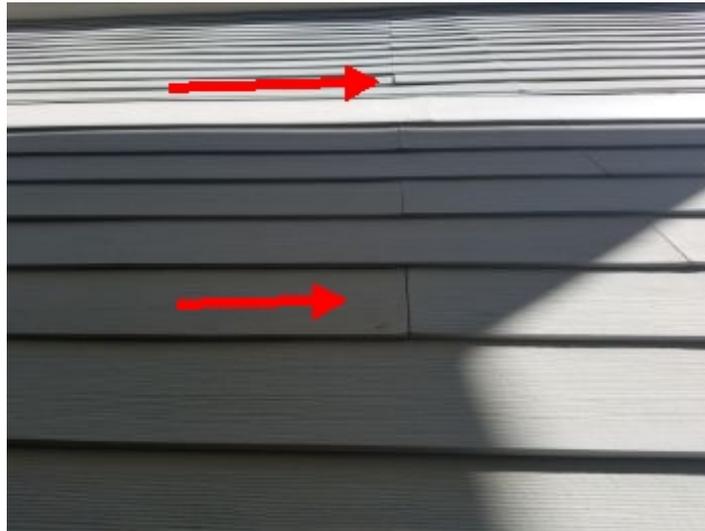
Left side

- **All exterior wall penetrations need to be properly sealed at the wall coverings. Cracks, gaps, and separations allow water to “wick” along the penetrations back into the interior structural portion of the wall. Minor sealant repairs should be performed around all lights, electric boxes, pipes, window jambs, vent caps, and any other unsealed wall penetration.**

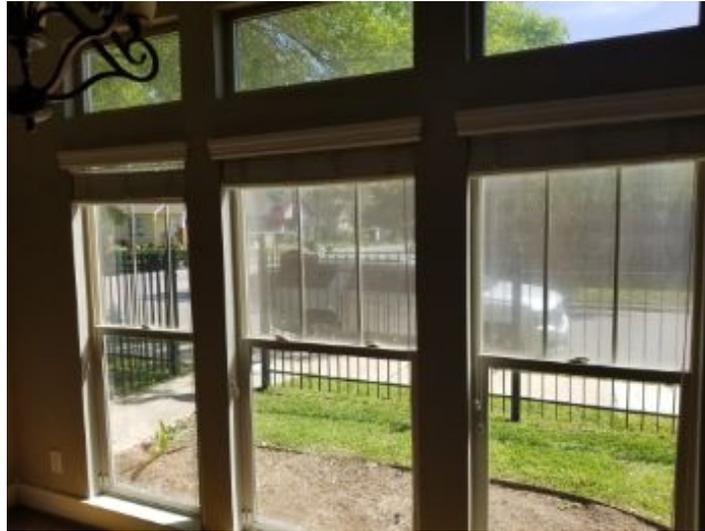
Kitchen, Dinning, Living, Front Guest Bedroom

- **One or more of the thermal pane windows were observed to have lost their seals. This has resulted in condensation or a fog like film to develop between the panes of glass. The thermal pane windows are no longer functional as designed when the seal is lost and replacement may be necessary.**
- **One or more of the window screens were observed to be missing**

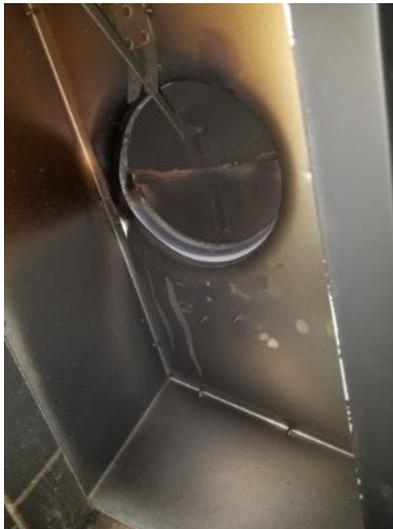
- **The damper is missing a safety clamp which keeps the damper partially open during operation to keep the carbon monoxide gases from entering the living area during gas log operation.**

no damper clamp

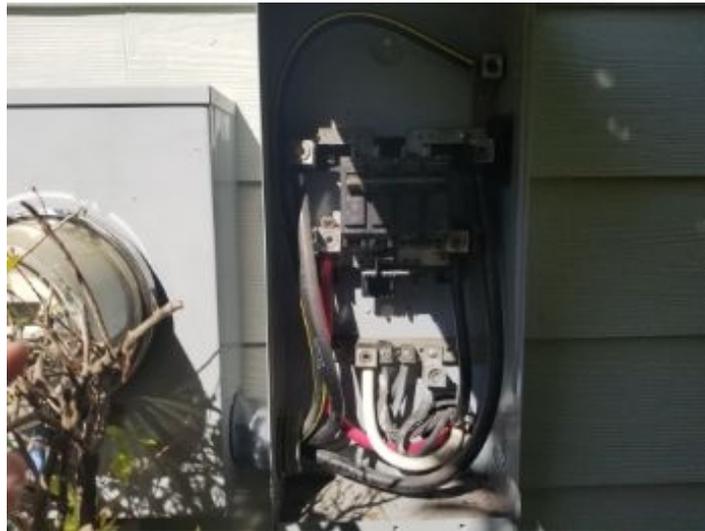
Main Panel front side

- **The aluminum wiring in the service panel and sub-panel was not treated with anti-oxidant sealant**

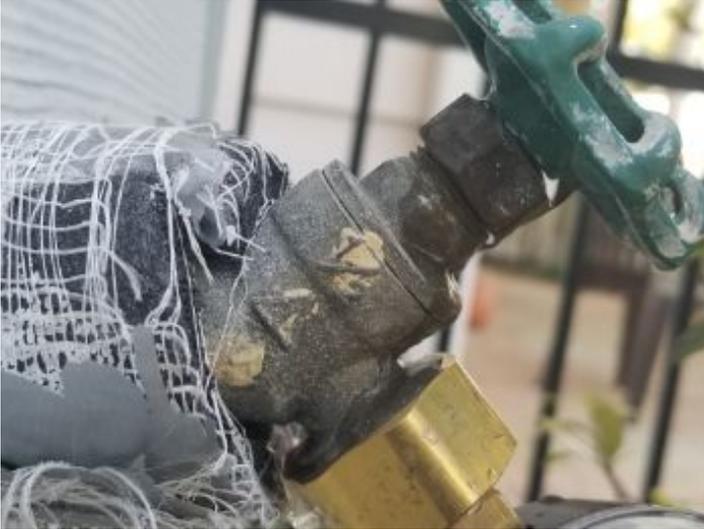
- **The exterior hose bib {faucet} was observed to have either a broken and/or missing valve handle**
- **The Master bathroom commode leaks on to the floor when flushed**
- **Missing grout was noted in the Guest tub and Master shower area and should be corrected to avoid water penetration into the wall cavity**
- **Guest bathroom had no hot water in tub**

Right side leaking
