## TECHNICAL MEMORANDUM

**Subject:** East Hampton Airport Noise Mitigation Program  
Preliminary Results of the Noise Measurement Program;  
Phase I – June 25<sup>th</sup> to July 8<sup>th</sup> 2003

Preliminary Results of the Noise Measurement Program: Phase I

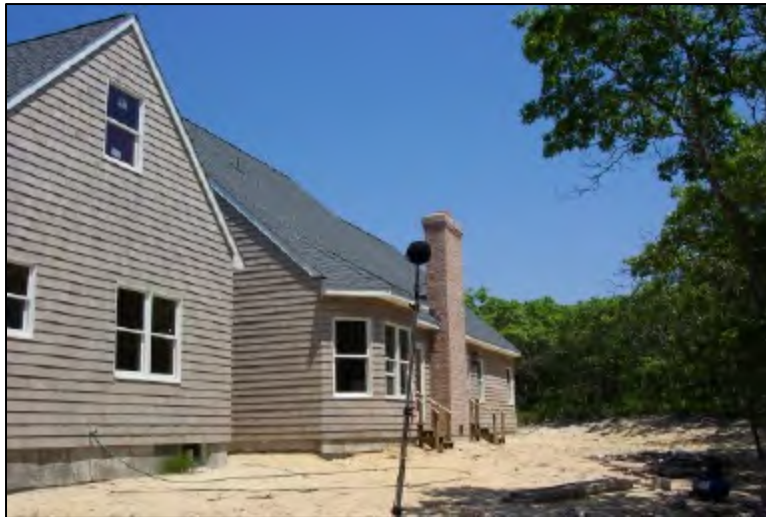
**Figure 1. Microphone Location for Site 1**

Site 1 was located in the backyard of a single-family home located at 11 Highview Drive in Wainscott. This site was north of the airport, approximately 3200 feet from the end of Runway 16/34 and 1000 feet west of the extended runway centerline. Figure 1 shows the location of the microphone in the backyard of this residence.

Site 1 was selected to document helicopter traffic patterns and operations. The site is located roughly 500 feet north of a power line that is used as a reference for helicopter pilots on approach to Runway 16.

In general, helicopter operations generated the highest noise levels at Site 1. The measured SEL for noise events generated by observed helicopter operations ranged from 66 to 92 dBA, while the measured  $L_{max}$  for observed helicopter noise events ranged from 60 to 83 dBA.

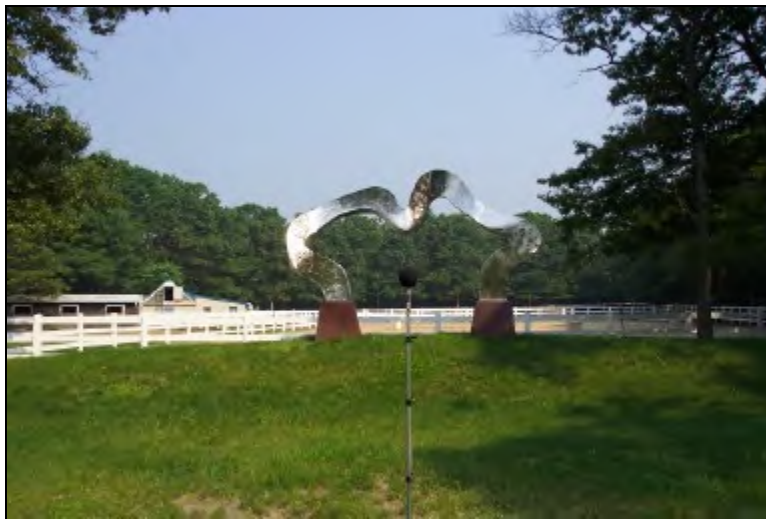
**Figure 2. Microphone Location for Site 2A**

Sites 2 and 2A were located in the yards of single-family homes located at 103 and 93 Merchants Path, respectively. These sites were situated west of the airport, approximately 5200 feet from the end of Runway 10/28 and 1700 feet south of the extended runway centerline. Figure 2 shows the location of the microphone in the front yard of the residence at 93 Merchants Path.

Sites 2 and 2A were selected to obtain noise levels and document aircraft operations from Runway 10/28. Attended noise measurements were conducted on June 26<sup>th</sup> from 10:45 to 12:58, on June 26<sup>th</sup> from 16:40 to 17:04, on June 27<sup>th</sup> from 09:24 to 12:32, on July 1<sup>st</sup> from 09:45 to 12:34, on July 7<sup>th</sup> from 17:15 to 18:31, and on July 8<sup>th</sup> from 09:15 to 13:00.

In general, jet aircraft operations generated the highest noise levels at Site 2. The measured SEL generated by observed jet aircraft operations ranged from 71 to 91 dBA, while the measured  $L_{max}$  for observed jet aircraft noise events ranged from 62 to 84 dBA.

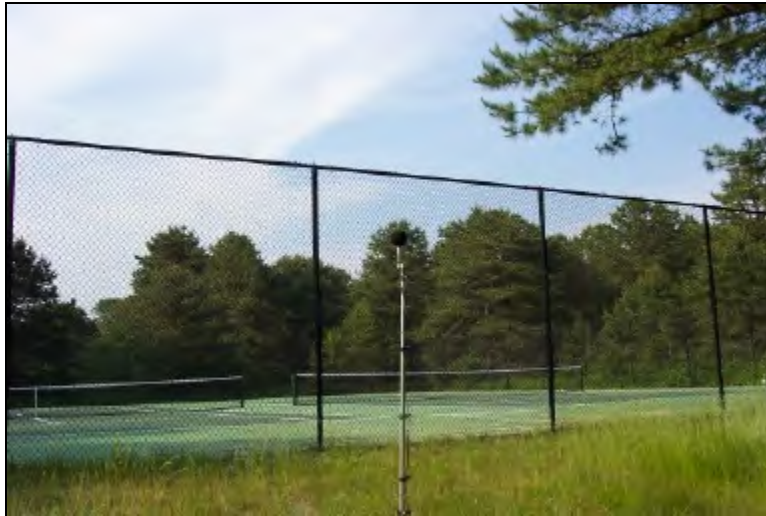
**Figure 5. Microphone Location for Site 5**

Site 5 was located near the tennis courts at Georgica Estates in East Hampton. This site was east of the airport, approximately 4700 feet from the end of Runway 10/28 and 500 feet south of the extended runway centerline. Figure 5 shows the location of the microphone in relation to the tennis courts.

Site 5 was selected to obtain noise levels and document aircraft operations to and from Runway 10/28. Attended noise measurements were conducted on June 26<sup>th</sup> from 15:06 to 17:34, on June 27<sup>th</sup> from 15:20 to 17:01, on July 1<sup>st</sup> from 15:40 to 19:08, and on July 8<sup>th</sup> from 11:30 to 12:37. The noise event threshold for this site was originally set at 50 dBA then, on June 26<sup>th</sup> at 17:34, the noise event threshold was changed to 55 dBA, and the monitor was moved to the location as shown in Figure 5.

In general, jet aircraft operations generated the highest noise levels at Site 5. The measured SEL for observed jet aircraft operations ranged from 68 to 96 dBA, while the measured  $L_{max}$  for observed jet aircraft ranged from 57 to 89 dBA.

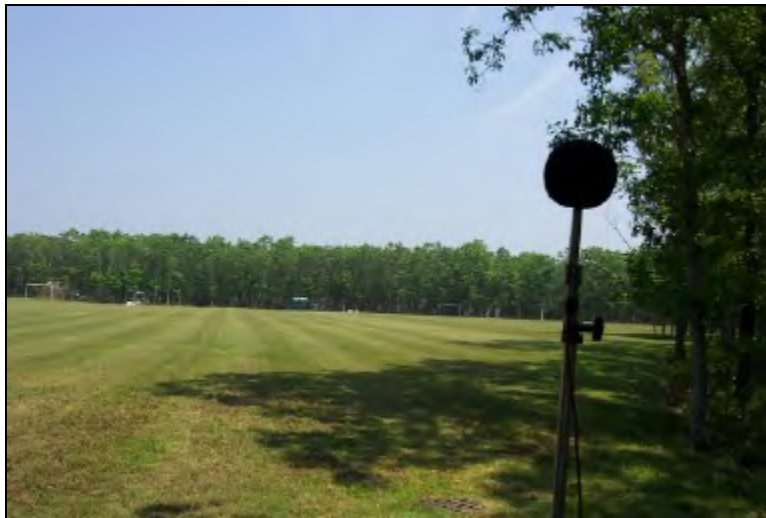
**Figure 6. Microphone Location for Site 6**

Site 6 was located near the athletic fields at the Ross School in Wainscott. This site was north of the airport, approximately 2000 feet from the end of Runway 04/22 and 600 feet east of the extended runway centerline. Figure 6 shows the location of the microphone in relation to the athletic fields.

Site 6 was selected to obtain noise levels and document aircraft operations to and from Runways 04/22 and 16/34. Attended noise measurements were conducted on June 26<sup>th</sup> from 14:50 to 15:49, on June 27<sup>th</sup> from 14:00 to 14:52, and on July 1<sup>st</sup> from 10:00 to 12:34.

In general, jet aircraft operations generated the highest noise levels at Site 6. The measured SEL for observed jet aircraft operations ranged from 71 to 81 dBA, while the measured  $L_{max}$  for observed jet aircraft ranged from 57 to 69 dBA.

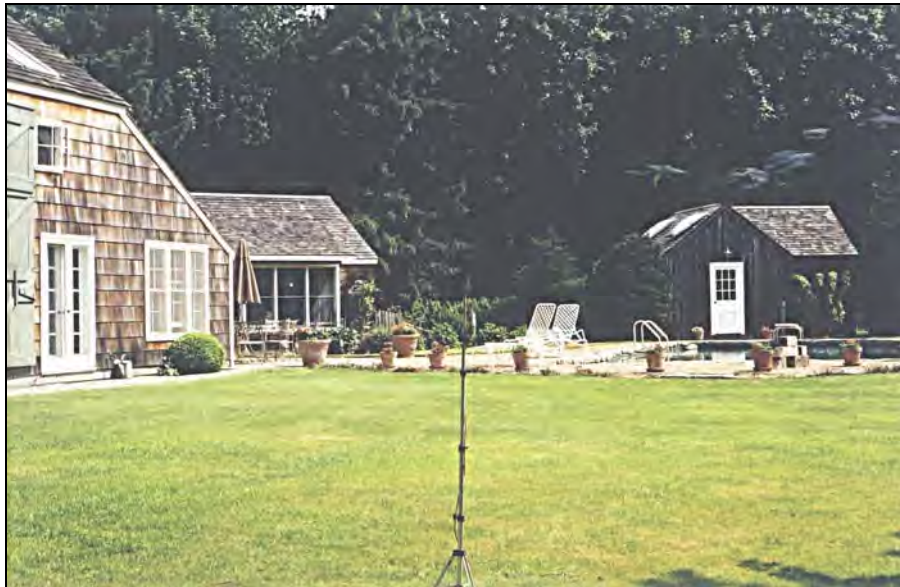
**Figure 7. Microphone Location for Site 7**

Site 7 was located in the backyard of a single-family home at 136 Main Street in East Hampton Village. This site was east of the airport, approximately 15000 feet from the end of Runway 10/28 and 500 feet south of the extended runway centerline. Figure 7 shows the location of the microphone in relation to the house.

Site 7 was selected to obtain noise levels and document aircraft operations for Runway 10/28. Attended noise measurements were conducted on July 2<sup>nd</sup> from 09:59 to 12:00, and on July 8<sup>th</sup> from 09:50 to 10:52.

During this measurement period, non-aircraft sources that contributed to the noise environment at this site included landscaping equipment and local street traffic. Appendix A provides graphs of the hourly noise levels for all sites, including the following noise metrics:  $L_{max}$ ,  $L_{eq}$ ,  $L_1$ ,  $L_{10}$ ,  $L_{50}$ , and  $L_{90}$ .
