## TECHNICAL MEMORANDUM

**Subject:** East Hampton Airport Noise Mitigation Program  
Preliminary Results of the Noise Measurement Program;  
Phase II – August 21<sup>st</sup> to September 2<sup>nd</sup> 2003

**Reference:** HMMH Job No. 299500

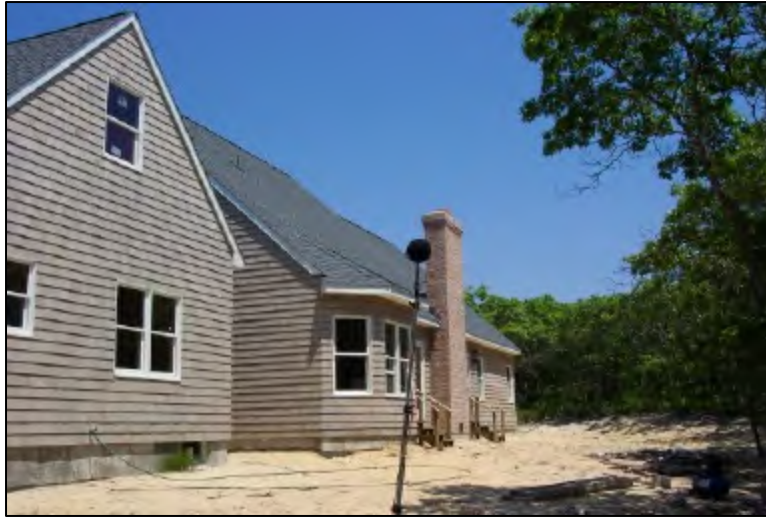
**Figure 1. Microphone Location for Site 1**

Site 1 was located in the backyard of a single-family home located at 11 Highview Drive in Wainscott. This site was north of the airport, approximately 3200 feet from the end of Runway 16/34 and 1000 feet west of the extended runway centerline. Figure 1 shows the location of the microphone in the backyard of this residence.

Site 1 was selected to document helicopter traffic patterns and operations. The site is located roughly 500 feet north of a power line that is used as a reference for helicopter pilots on approach to Runway 16.

The measured Total DNL ranged from 55 to 58 dBA over an 8-day period. The DNL due to measured noise events (both aircraft and non-aircraft) ranged from 50 to 57 dBA. The tables in Appendix B provide summaries of the measured DNL for all of the sites.

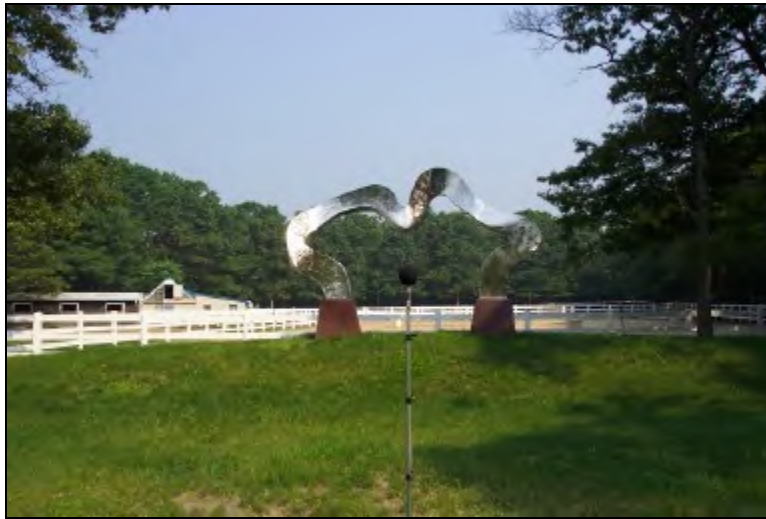
**Figure 2. Microphone Location for Site 2A**

Site 2A was located in the yard of a single-family home located at 93 Merchants Path. This site was situated west of the airport, approximately 5200 feet from the end of Runway 10/28 and 1700 feet south of the extended runway centerline. Figure 2 shows the location of the microphone in the front yard of the residence at 93 Merchants Path.

Site 2A was selected to obtain noise levels and document aircraft operations from Runway 10/28. Attended noise measurements were conducted on August 22<sup>nd</sup> from 11:40 to 14:00, and on August 25<sup>th</sup> from 14:47 to 17:31. Appendix A provides graphs of the hourly noise levels for all sites, including the following noise metrics:  $L_{max}$ ,  $L_{eq}$ ,  $L_1$ ,  $L_{10}$ ,  $L_{50}$ , and  $L_{90}$ .

The measured Total DNL ranged from 59 to 66 dBA over a 7-day period. The DNL due to measured noise events (both aircraft and non-aircraft) ranged from 53 to 62 dBA. The tables in Appendix B provide summaries of the measured DNL for all of the sites.

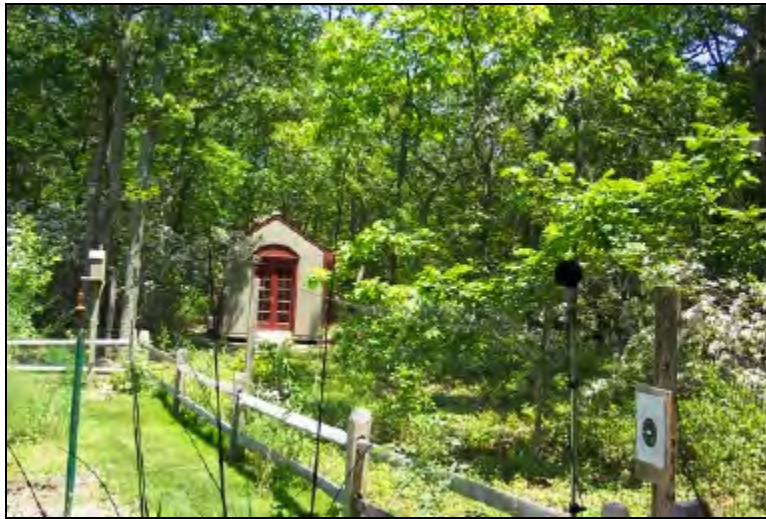
**Figure 3. Microphone Location for Site 3**

Site 3 was located in the backyard of a single-family home located at 244 Widow Gravitts in Bridgehampton. This site was northwest of the airport, approximately 7700 feet from the end of Runway 10/28 and 3200 feet north of the extended runway centerline. Figure 3 shows the location of the microphone in the backyard of this residence.

Site 3 also was selected to document helicopter traffic patterns and operations. The site is located roughly 500 feet south of a power line that is used as a reference for helicopter pilots on approach to Runway 16.

The measured Total DNL ranged from 56 to 62 dBA over the 13-day period. The DNL due to measured noise events (both aircraft and non-aircraft) ranged from 49 to 60 dBA. The tables in Appendix B provide summaries of the measured DNL for all of the sites.

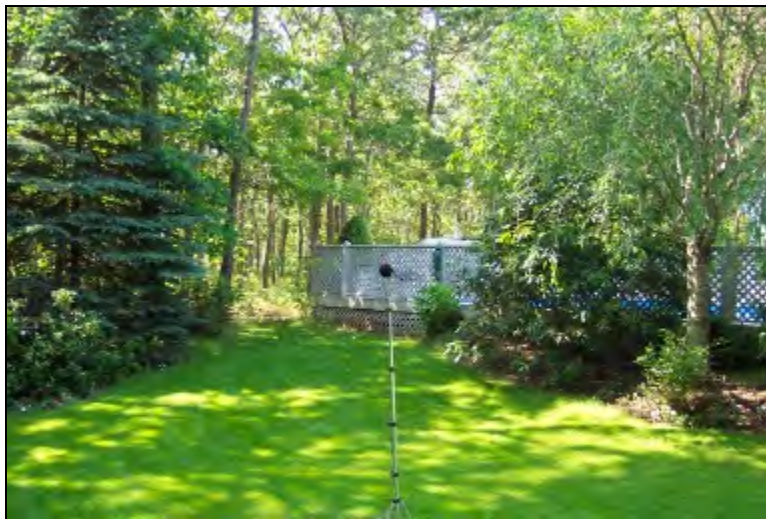
**Figure 4. Microphone Location for Site 4**

Site 4 was located in the backyard of a single-family home located at 75 West Gate in Wainscott. This site was south of the airport, approximately 1500 feet from the end of Runway 04/22 and 700 feet east of the extended runway centerline. Figure 4 shows the location of the microphone in the backyard of this residence.

Site 4 was selected to obtain noise levels and document aircraft operations to and from Runways 04/22 and 10/28. Attended noise measurements were conducted on August 22<sup>nd</sup> from 11:55 to 14:05, on August 26<sup>th</sup> from 09:40 to 12:40, and on August 27<sup>th</sup> from 09:53 to 13:23. Appendix A provides graphs of the hourly noise levels for all sites, including the following noise metrics:  $L_{max}$ ,  $L_{eq}$ ,  $L_1$ ,  $L_{10}$ ,  $L_{50}$ , and  $L_{90}$ .

The measured Total DNL ranged from 58 to 66 dBA over the 7-day period. The DNL due to measured noise events (both aircraft and non-aircraft) ranged from 47 to 61 dBA. The tables in Appendix B provide summaries of the measured DNL for all of the sites.

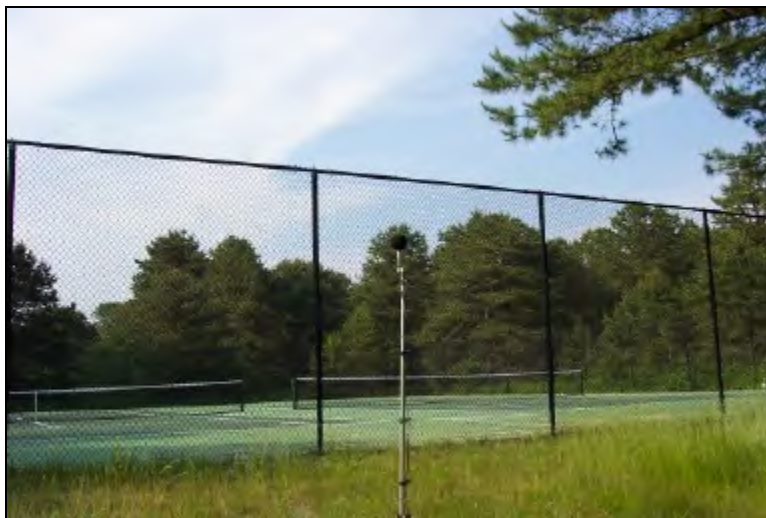
**Figure 5. Microphone Location for Site 5**

Site 5 was located near the tennis courts at Georgica Estates in East Hampton. This site was east of the airport, approximately 4700 feet from the end of Runway 10/28 and 500 feet south of the extended runway centerline. Figure 5 shows the location of the microphone in relation to the tennis courts.

Site 5 was selected to obtain noise levels and document aircraft operations to and from Runway 10/28. Attended noise measurements were conducted on August 22<sup>nd</sup> from 15:24 to 18:33, on August 26<sup>th</sup> from 15:43 to 17:01, on August 28<sup>th</sup> from 10:15 to 13:24, on August 30<sup>th</sup> from 09:47 to 11:54, on August 31<sup>st</sup> from 10:48 to 11:02, on September 1<sup>st</sup> from 11:15 to 14:05, and on September 2<sup>nd</sup> from 08:45 to 11:15. Appendix A provides graphs of the hourly noise levels for all sites, including the following noise metrics:  $L_{max}$ ,  $L_{eq}$ ,  $L_1$ ,  $L_{10}$ ,  $L_{50}$ , and  $L_{90}$ .

The measured Total DNL ranged from 59 to 64 dBA over the 12-day period. The DNL due to measured noise events (both aircraft and non-aircraft) ranged from 52 to 58 dBA. The tables in Appendix B provide summaries of the measured DNL for all of the sites.

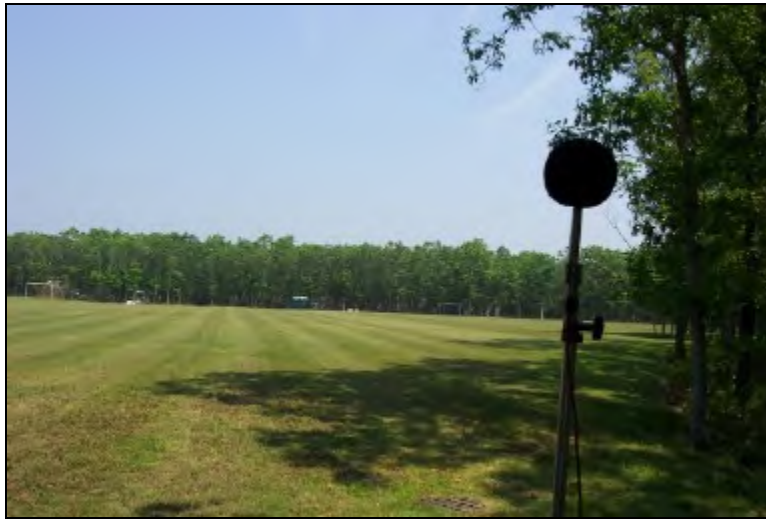
**Figure 6. Microphone Location for Site 6**

Site 6 was located near the athletic fields at the Ross School in Wainscott. This site was north of the airport, approximately 2000 feet from the end of Runway 04/22 and 600 feet east of the extended runway centerline. Figure 6 shows the location of the microphone in relation to the athletic fields for the Phase 1 measurements.

Site 6 was selected to obtain noise levels and document aircraft operations to and from Runways 04/22 and 16/34. Attended noise measurements were conducted on August 25<sup>th</sup> from 10:12 to 11:31, on August 26<sup>th</sup> from 09:24 to 12:27, and on August 27<sup>th</sup> from 10:13 to 11:37. Appendix A provides graphs of the hourly noise levels for all sites, including the following noise metrics:  $L_{max}$ ,  $L_{eq}$ ,  $L_1$ ,  $L_{10}$ ,  $L_{50}$ , and  $L_{90}$ .

The measured Total DNL ranged from 56 to 59 dBA over the 3-day period. The DNL due to measured noise events (both aircraft and non-aircraft) ranged from 48 to 52 dBA. The tables in Appendix B provide summaries of the measured DNL for all of the sites.

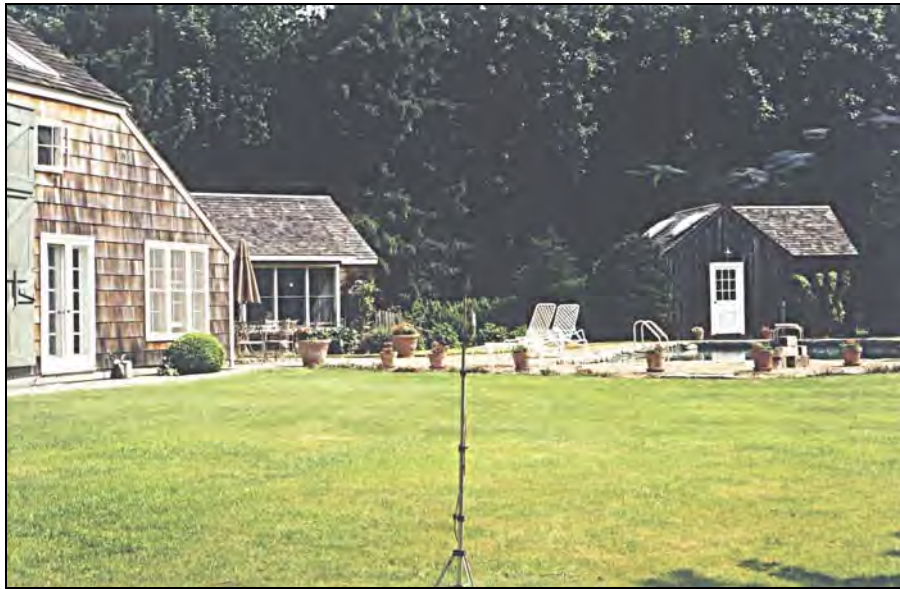
**Figure 7. Microphone Location for Site 7**

Site 7 was located in the backyard of a single-family home at 136 Main Street in East Hampton Village. This site was east of the airport, approximately 15000 feet from the end of Runway 10/28 and 500 feet south of the extended runway centerline. Figure 7 shows the location of the microphone in relation to the house.

Site 7 was selected to obtain noise levels and document aircraft operations for Runway 10/28. Attended noise measurements were conducted on August 27<sup>th</sup> from 16:22 to 18:53, on August 28<sup>th</sup> from 15:30 to 19:09, on August 29<sup>th</sup> from 16:15 to 18:12, on August 30<sup>th</sup> from 14:30 to 16:13, on August 31<sup>st</sup> from 16:30 to 17:55, and on September 1<sup>st</sup> from 17:40 to 19:00. Appendix A provides graphs of the hourly noise levels for all sites, including the following noise metrics:  $L_{max}$ ,  $L_{eq}$ ,  $L_1$ ,  $L_{10}$ ,  $L_{50}$ , and  $L_{90}$ .

The measured Total DNL ranged from 53 to 58 dBA over the 7-day period. The DNL due to measured noise events (both aircraft and non-aircraft) ranged from 40 to 51 dBA. The tables in Appendix B provide summaries of the measured DNL for all of the sites.
