FDS INSPECTION SERVICES LLC

FDS INSPECTION SERVICES

2202 Van Buren St 1-2  
The City, FL 0000

OCTOBER 1, 2022

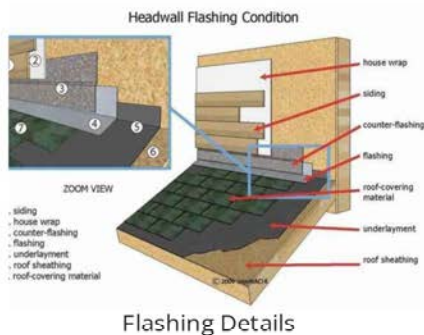
### Flashing: Wall Intersections

I looked for flashing where the roof covering meets a wall or siding material. There should be step and counter flashing installed in these locations. This is not an exhaustive inspection of all flashing areas.

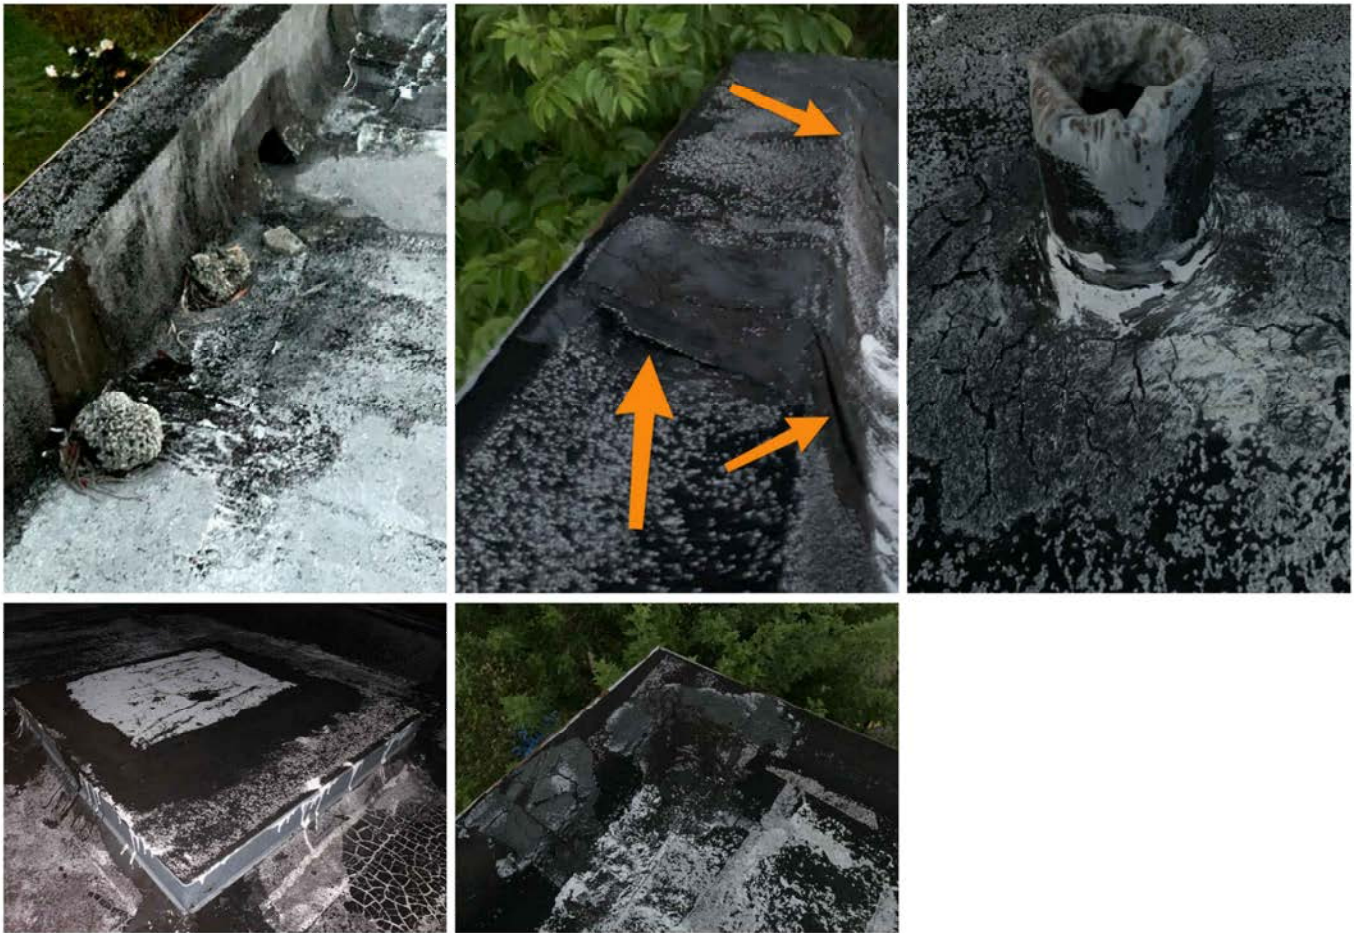
#### CRACKED AND DAMAGED ROOF COVERING

Major Defect

I observed areas of cracked/splitting and damaged roof-covering materials. This is a major defect. Prone to water leaking into the house. I recommend that a qualified roofing contractor to further evaluate and make repairs to the roof system,.

Contact a qualified roofing professional.

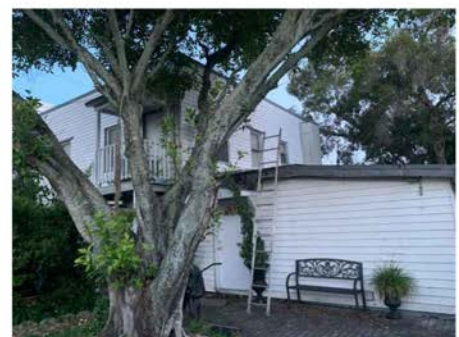
1.1.2 Roof Covering

**TREE TOO CLOSE**

I observed indications that a tree and or tree branch where overhanging the roof and maybe in contact with it.

Contact a qualified tree service company.

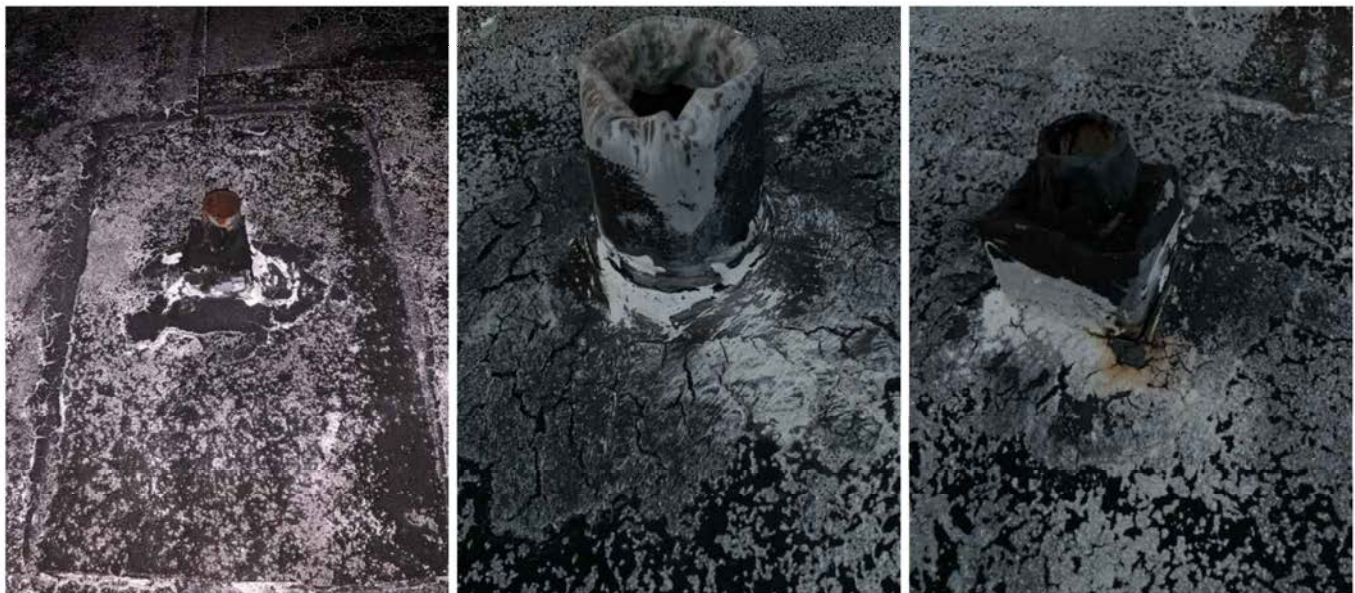
Major Defect

#### **VENT PIPE FLASHING MATERIAL WAS CRACKED**

The rubber membrane flashing material around the vent pipe was cracked and damaged. This is prone to water penetration. Defect. Correction and further evaluation is recommended.

Contact a qualified roofing professional.

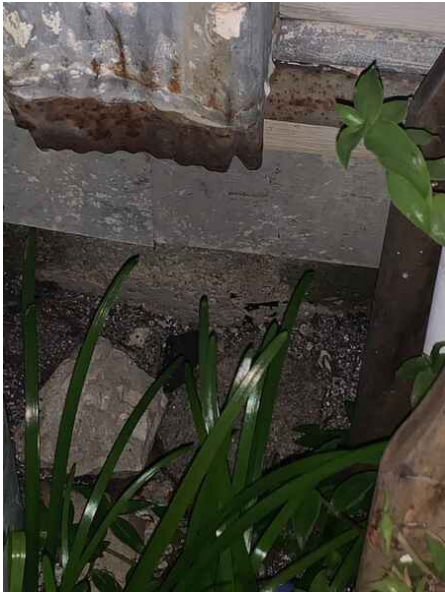
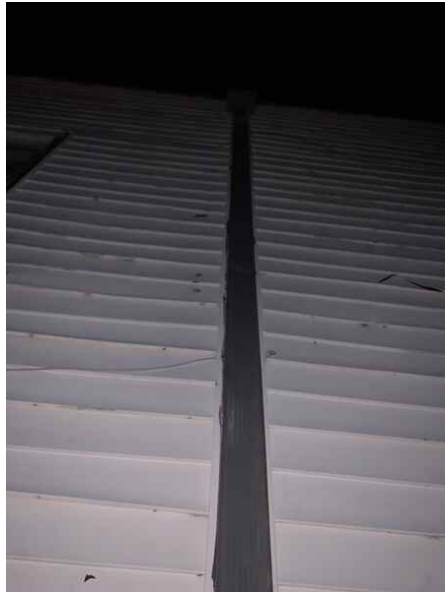
### 1.4.1 Gutters & Downspouts

Minor Defect

One or more downspouts drain too close to the home's foundation. This can result in excessive moisture in the soil at the foundation, which can lead to foundation/structural movement. Recommend a qualified contractor adjust downspout extensions to drain at least 6 feet from the foundation. A handy homeowner should be able to do this project.

Recommended DIY Project

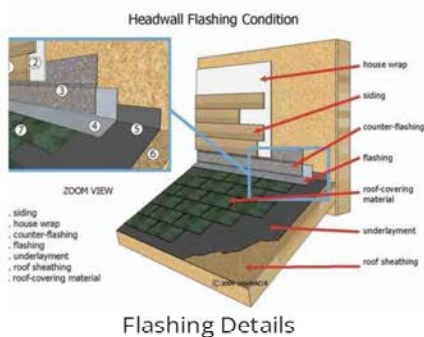
#### Flashing: Wall Intersections

I looked for flashing where the roof covering meets a wall or siding material. There should be step and counter flashing installed in these locations. This is not an exhaustive inspection of all flashing areas.

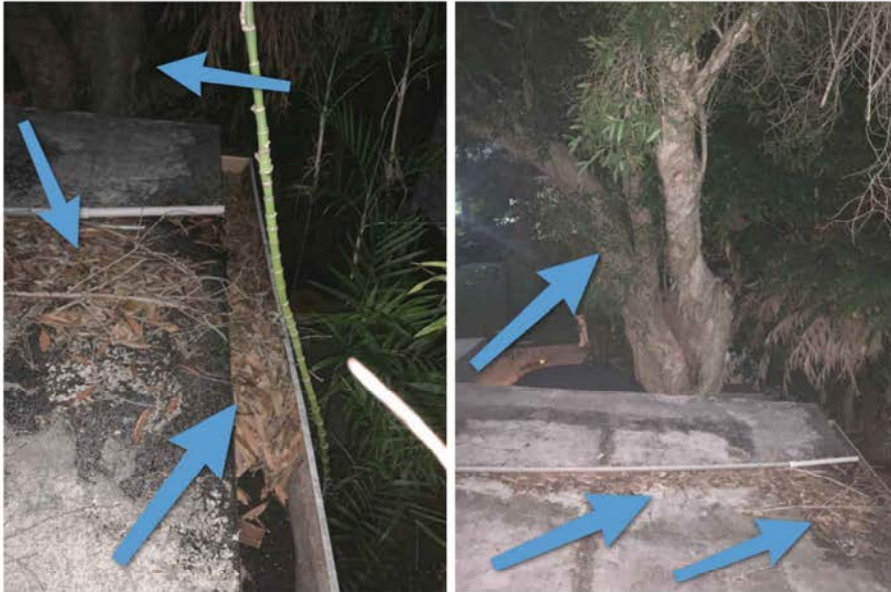
I observed indications that a tree and or tree branch where overhanging the roof and maybe in contact with it.

Contact a qualified tree service company.

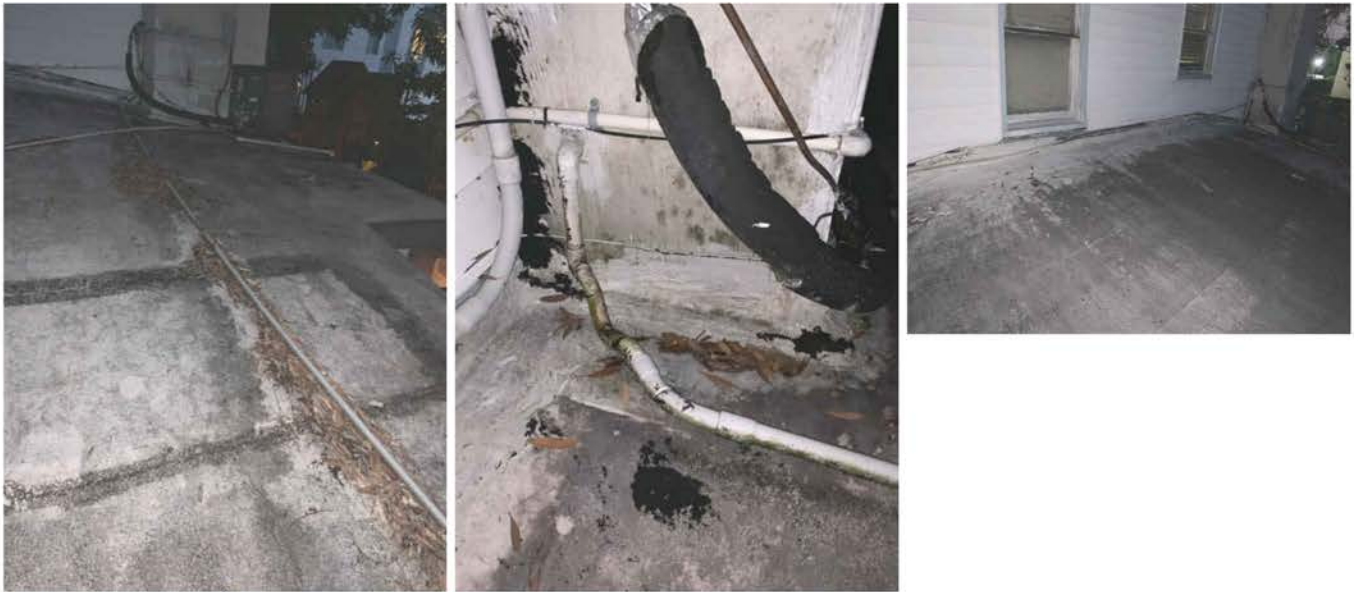
## 2.1.3 Roof Covering

I observed during my inspection that the system appeared to be old and at the end of its service life. It may not be reliable. Ask the homeowner or occupant about its recent performance. Regular maintenance and monitoring of its condition is recommended. Budgeting for repairs and future replacement is recommended. [InterNACHI's Standard Estimate Life Expectancy Chart for Homes](#)

Recommend monitoring.

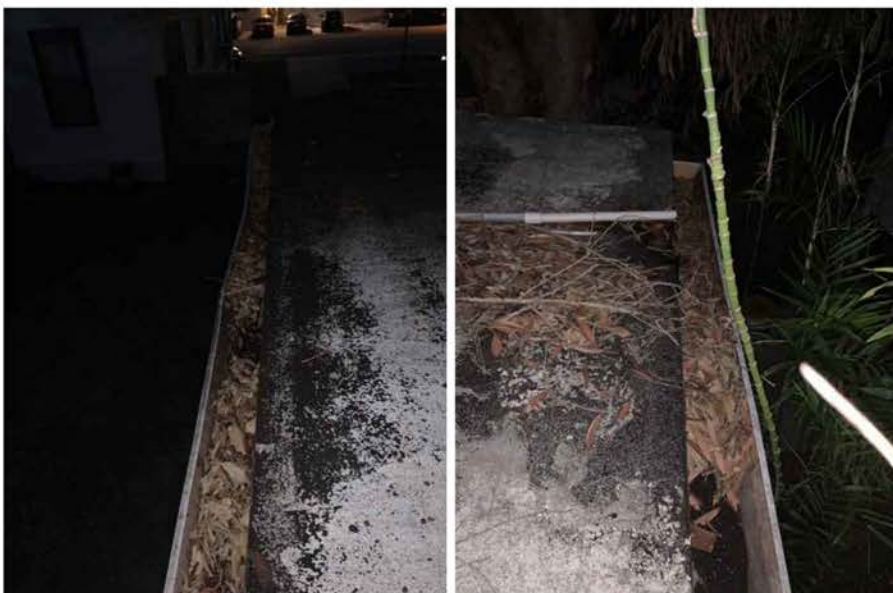
Minor Defect

I observed debris in the gutter. Cleaning and maintenance is recommended.

Contact a qualified gutter contractor

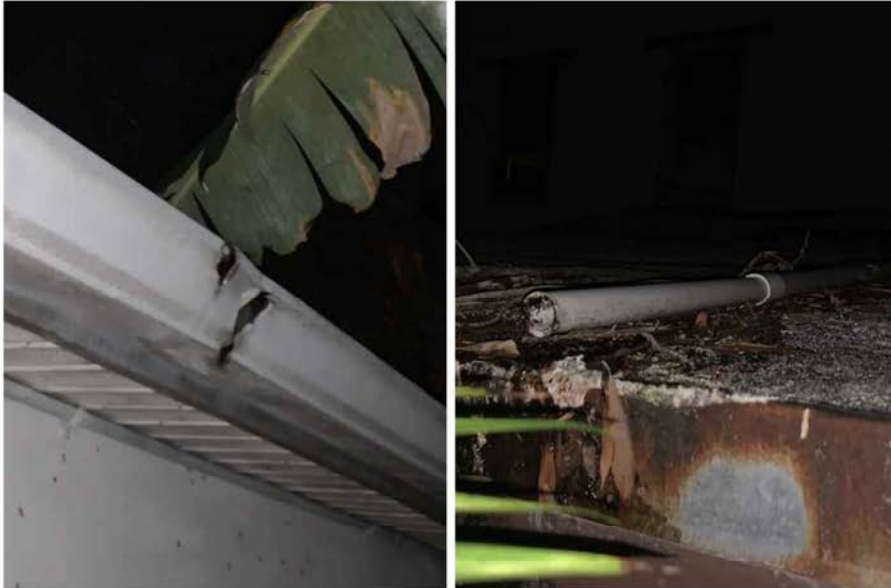
## 2.4.2 Gutters &amp; Downspouts

Major Defect**GUTTER DAMAGED**

I observed damage to the gutter. This is a defect that should be corrected by a professional contractor.

Contact a qualified gutter contractor

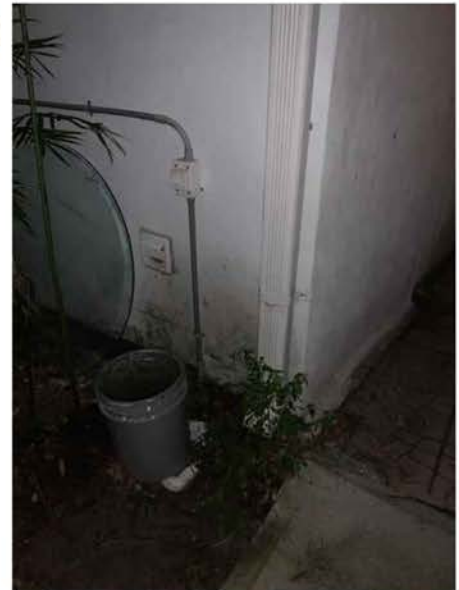
#### 2.4.4 Gutters & Downspouts

### **DOWNSPOUTS DRAIN NEAR HOUSE**

Minor Defect

One or more downspouts drain too close to the home's foundation. This can result in excessive moisture in the soil at the foundation, which can lead to foundation/structural movement. Recommend a qualified contractor adjust downspout extensions to drain at least 6 feet from the foundation. A handy homeowner should be able to do this project.

Recommended DIY Project

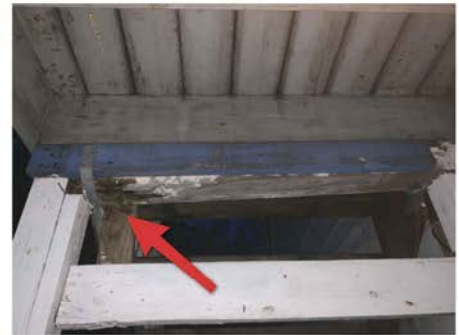
I observed indications of deteriorated conditions at the deck componentson the day of inspection.

Recommendation  
Contact a qualified carpenter.

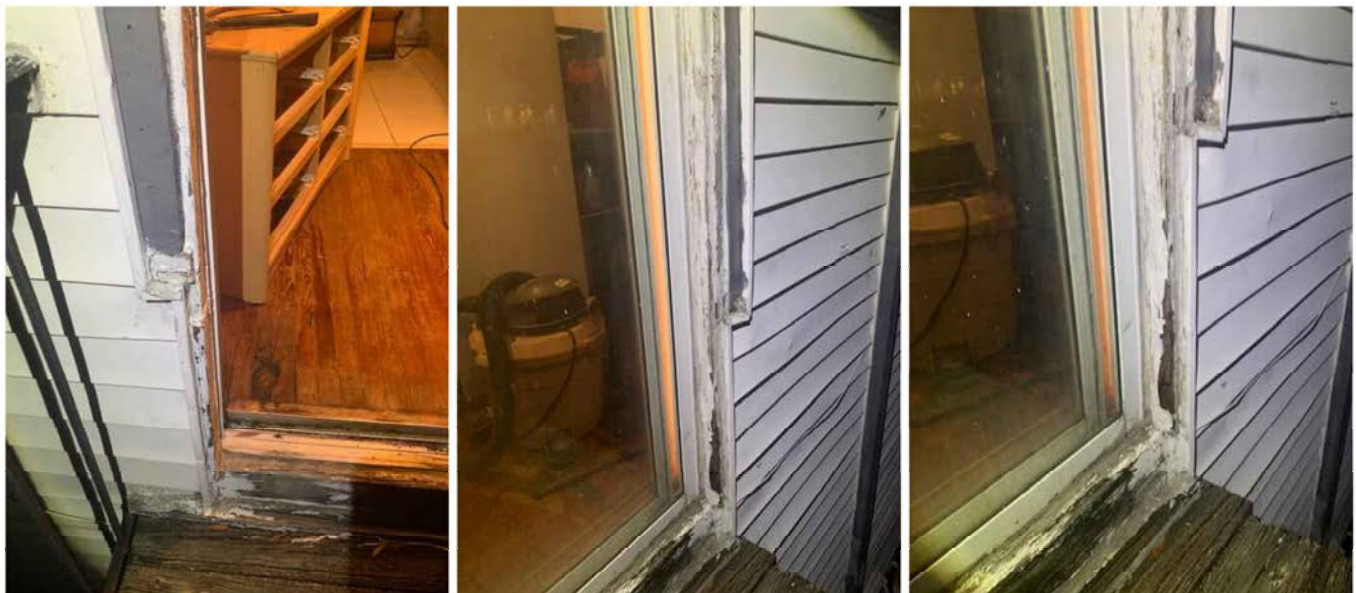
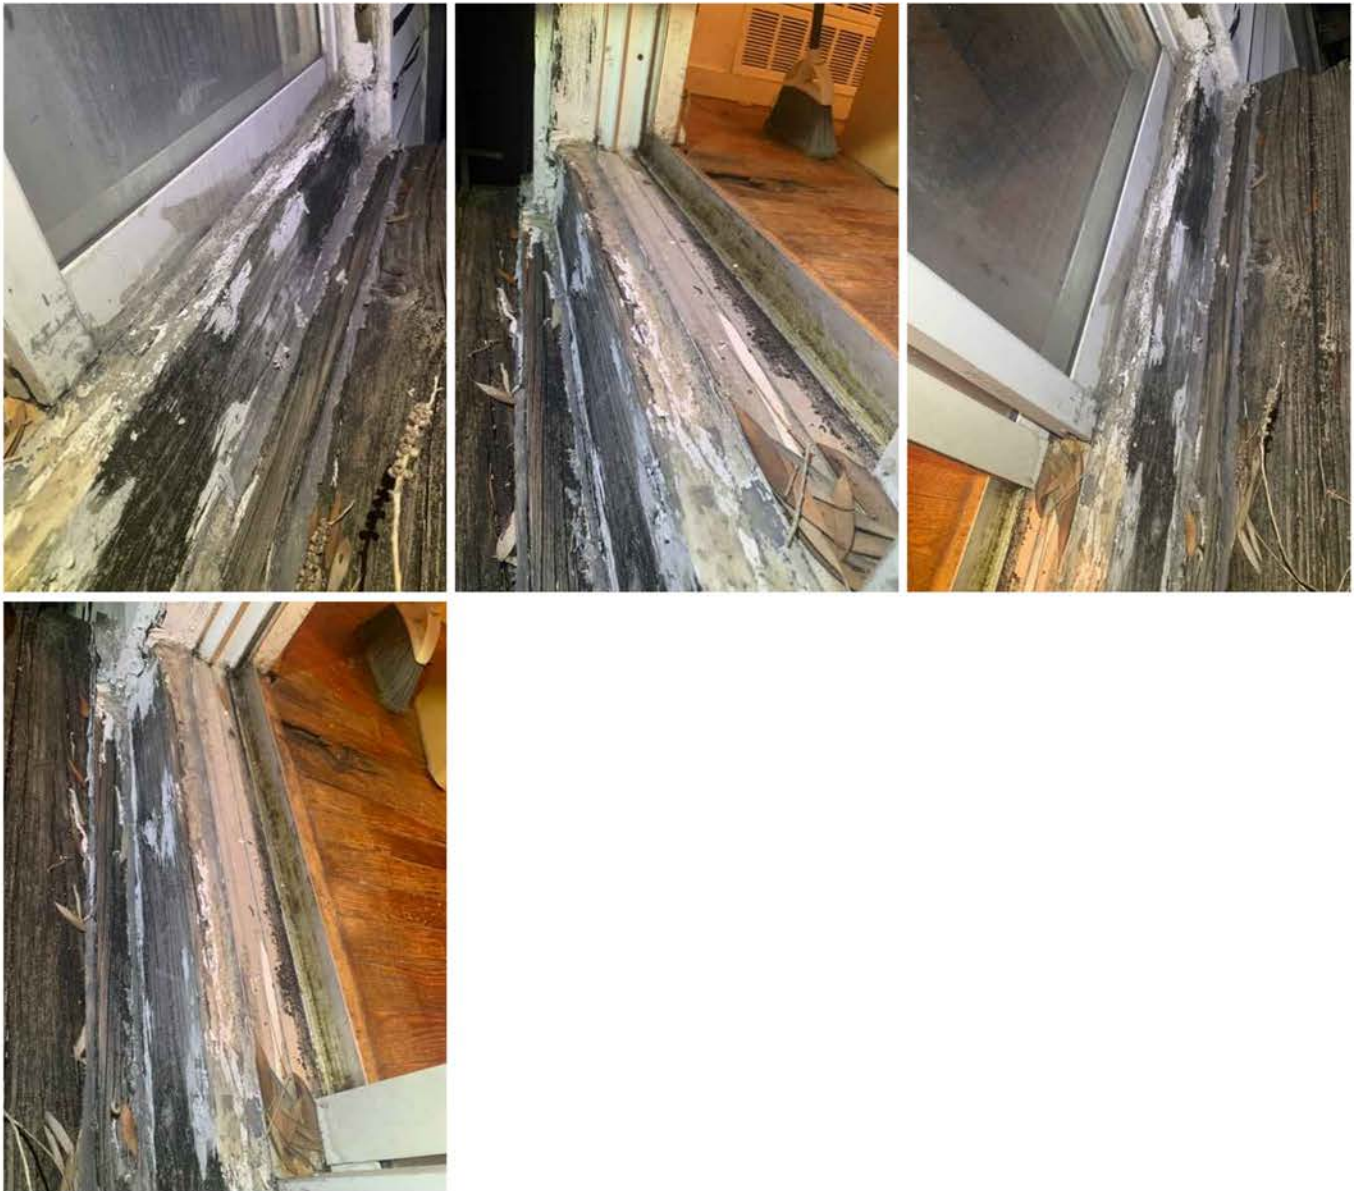
4.8.2 Porches, Patios, Decks, Balconies & Carports

I observed indications of a flashing defect. This flashing problem may allow water to enter into the wall cavity or building components.

Recommendation  
Contact a qualified deck contractor.

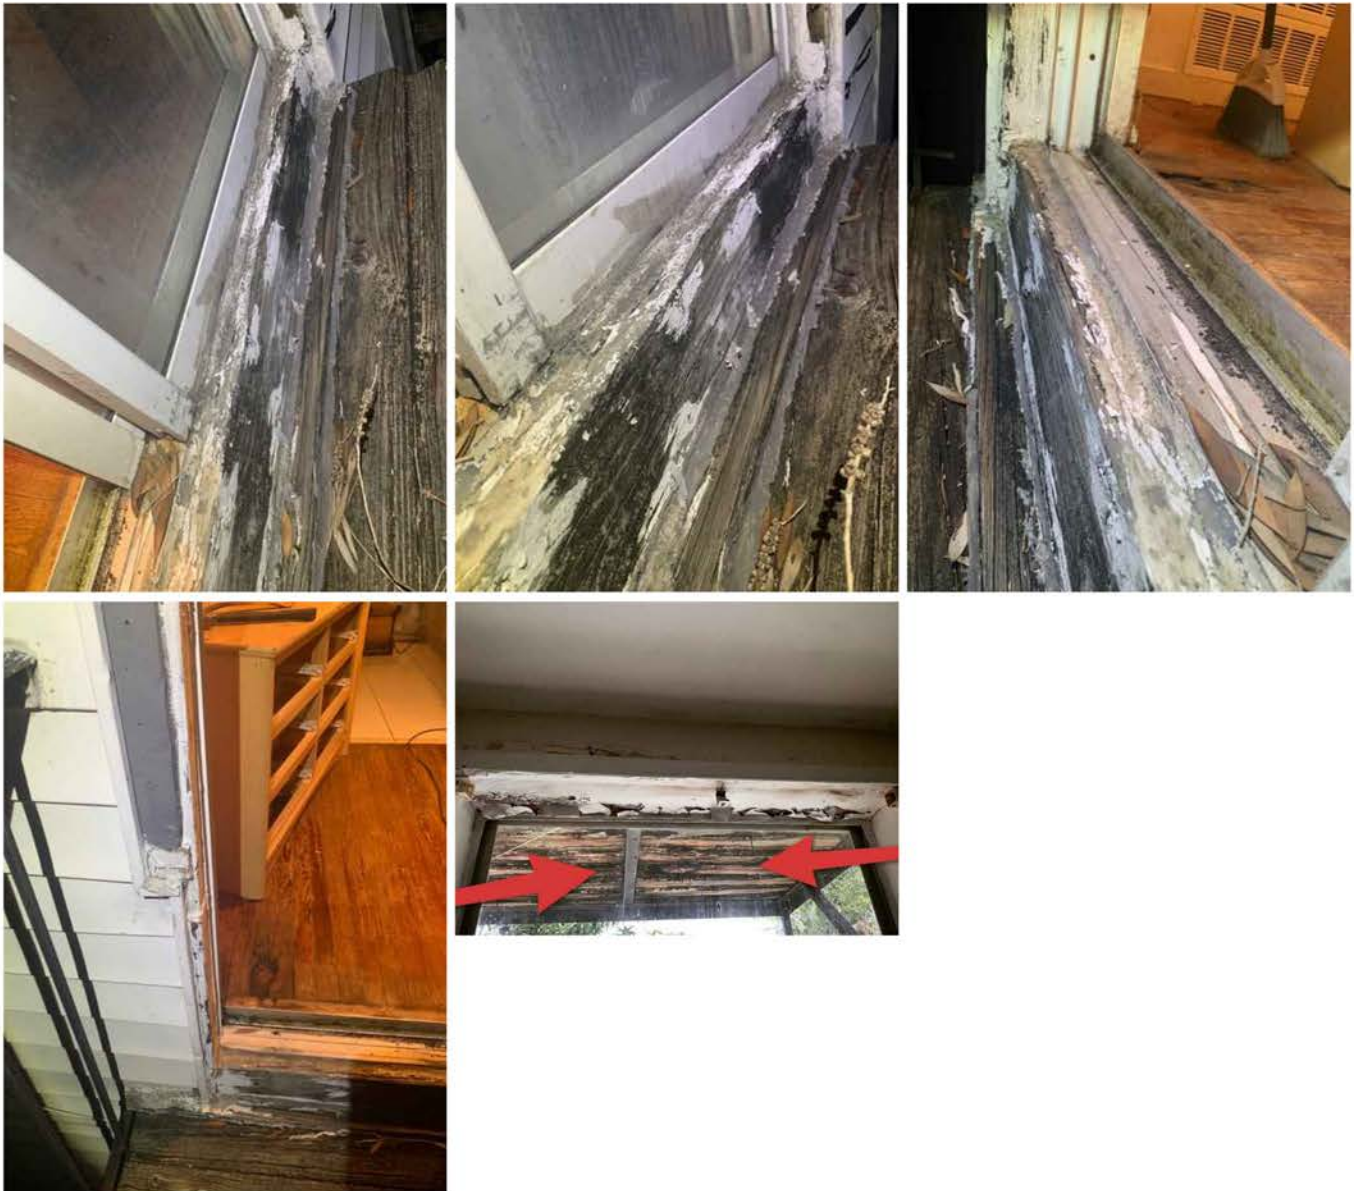
#### 4.8.3 Porches, Patios, Decks, Balconies & Carports

### **DECK - WOOD ROT**

Contact a qualified deck contractor.

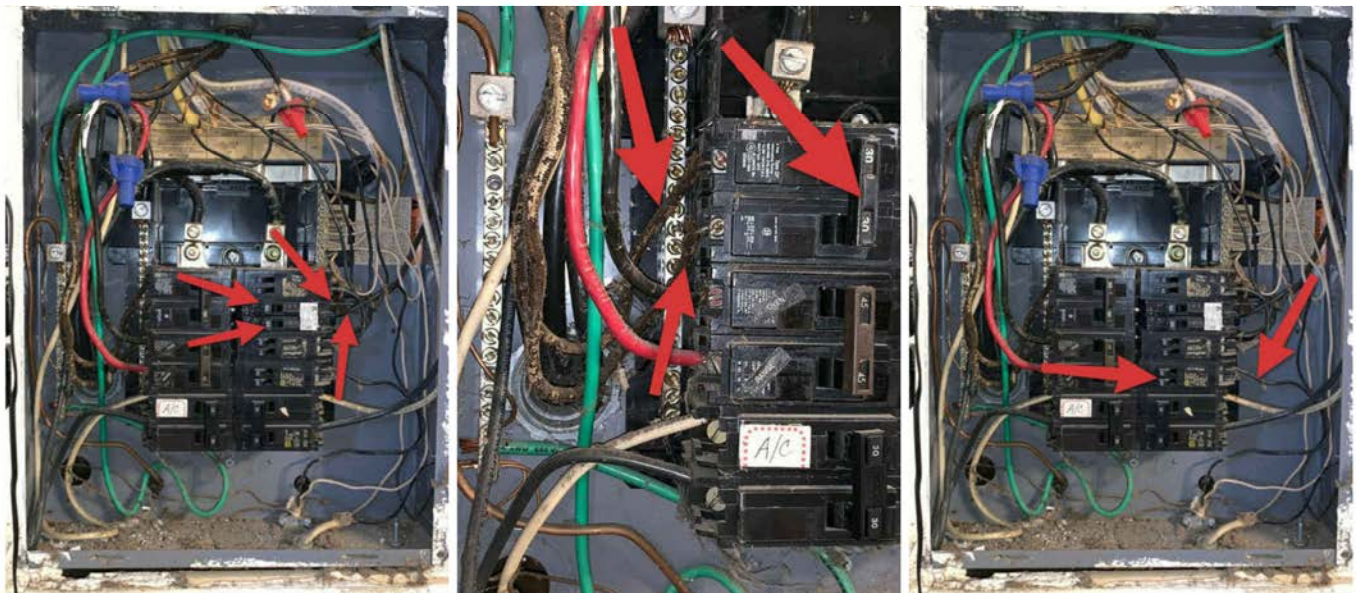
30 amp breaker utilizing 14 AWG wiring on two circuit breakers, significantly undersized conductor which is a potential safety hazard.

30 amp breaker utilizing 14 AWG wiring on two circuit breakers, significantly undersized conductor which is a potential safety hazard. Two conductors are exposed and not fully seated in the double pole breaker.

Contact a qualified electrical contractor.

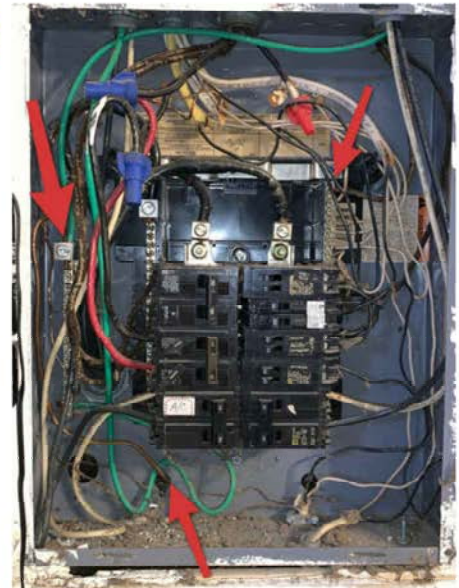
## 9.5.3 Panelboards &amp; Breakers

**SUBPANEL GROUNDS NEUTRALS NOT SEPARATED**

Earth ground is also touching the box.

Contact a qualified electrical contractor.

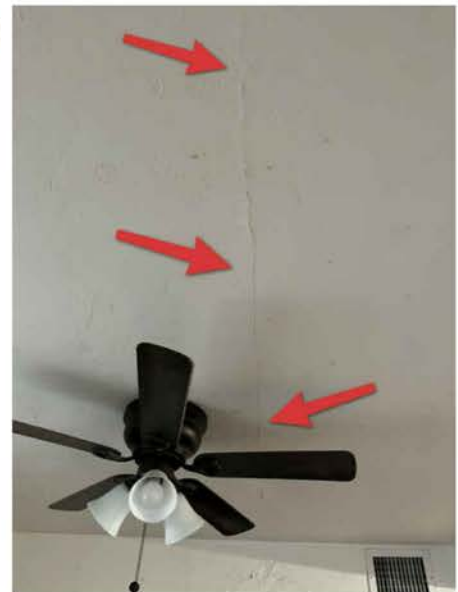
12.4.2 Floors, Walls, Ceilings

**MINOR CORNER CRACKS**

Contact a qualified professional.

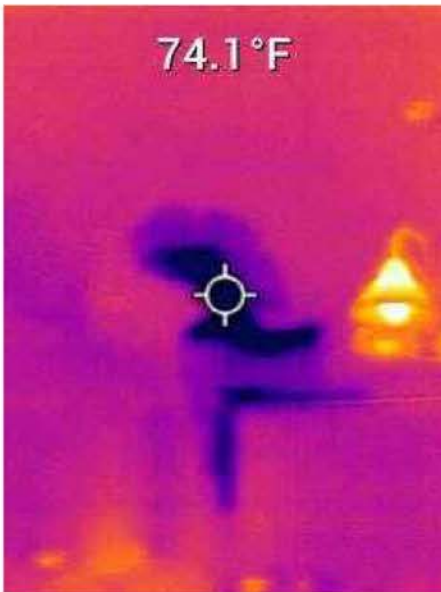
12.4.3 Floors, Walls, Ceilings

**MOISTURE DAMAGE**

Contact a qualified professional.

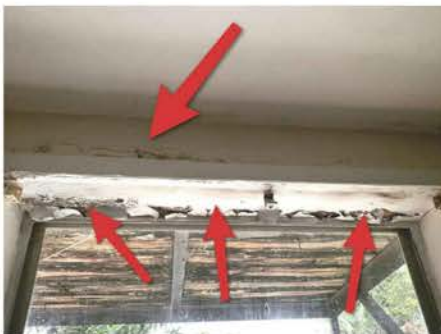
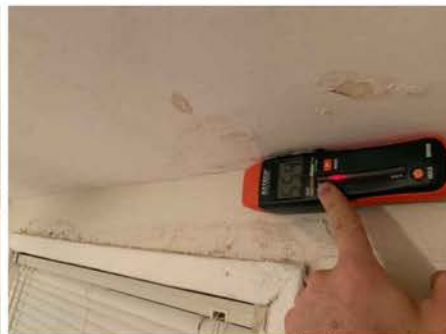
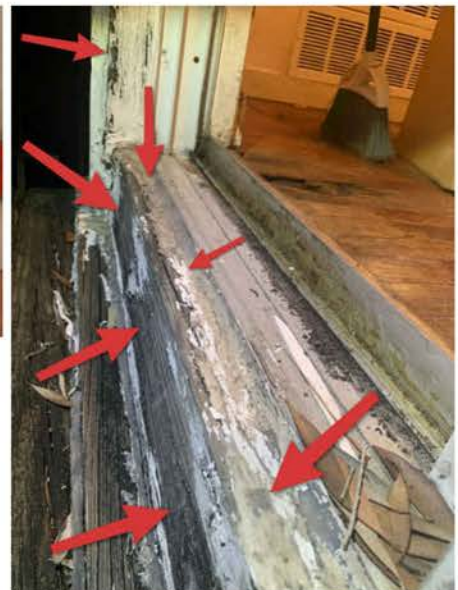
12.4.4 Floors, Walls, Ceilings

Major Defect

Moisture was over 55%, which is conducive to mold growth.

Contact a qualified mold inspection professional.

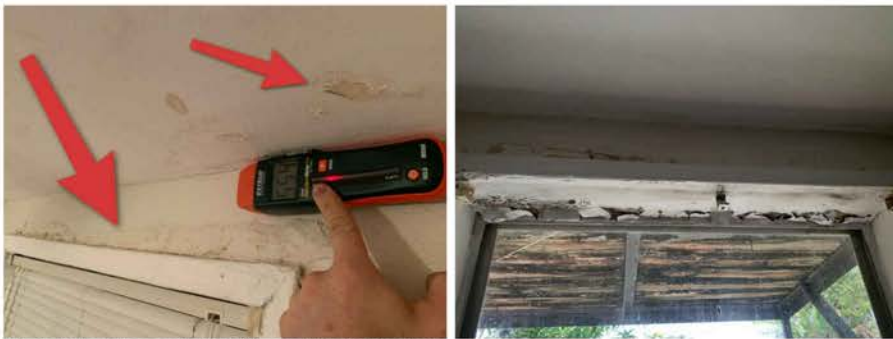
12.4.5 Floors, Walls, Ceilings

**RECENT ROOF LEAK DAMAGE**

Major Defect

Moisture was over 55% around window

Contact a qualified professional.

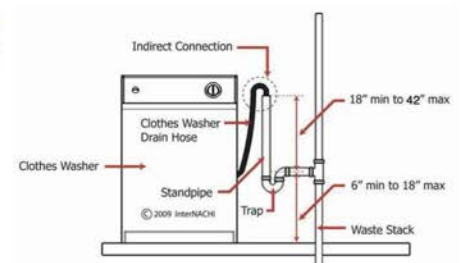
Standpipe Configuration

Contact a qualified plumbing contractor.
