# Fairfield Pond Aquatic Plant Inventory

October 19, 2018

**ARROWWOOD ENVIRONMENTAL**

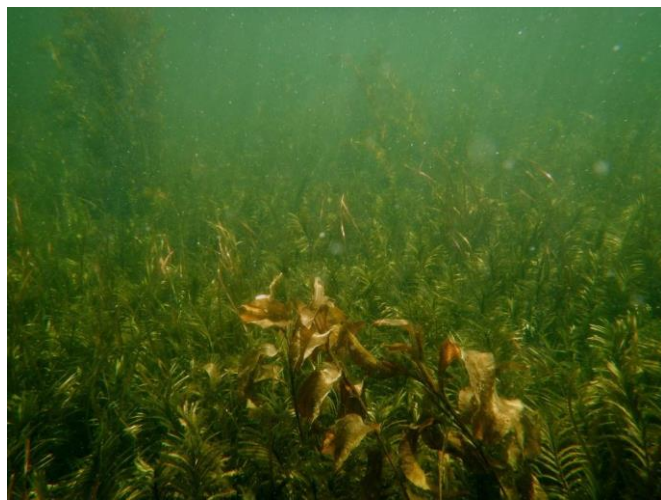
Though dominated by those three species, this community assemblage is quite diverse and often includes other aquatic plants such as water-weed (*Elodea canadensis*), eel-grass (*Vallisneria americana*), water-naiad (*Najas flexilis*), common snailseed pondweed (*P. spirillus*) and Berchtold's pondweed (*P. berchtoldii*). Small areas of dense water-naiad can be found in some

**Figure 3. The Robbin's Pondweed Assemblage**

areas of this type. EWM is also found in most examples of this community throughout the Pond.

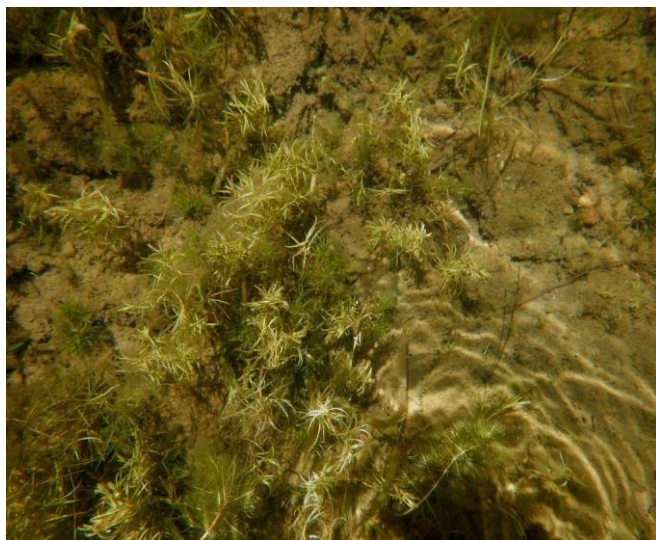
***Figure 3. The sparsely vegetated Arrowhead-Mud Rush Assemblage***

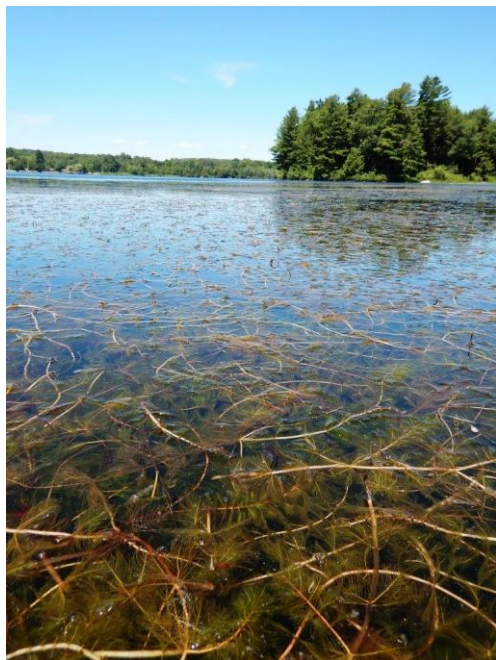
***Figure 9. Eurasian water milfoil infestation C in Fairfield Pond***

The EWM infestation in the outlet cove is also quite Dense, reaching 100% in places. EWM at this location has occupied an otherwise nice example of a native and diverse Robbin's Pondweed Assemblage. Further spread of this infestation to the east is likely, where it will continue to choke out this native community.

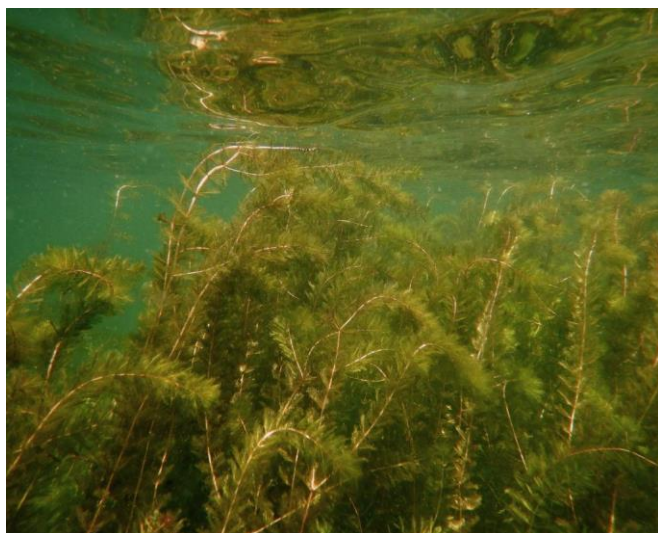
*Figure 10. Eurasian water milfoil in Fairfield Pond*
