Laguna Niguel Lake California, USA

Application dates: 29th April – 2nd May 2013

Summary

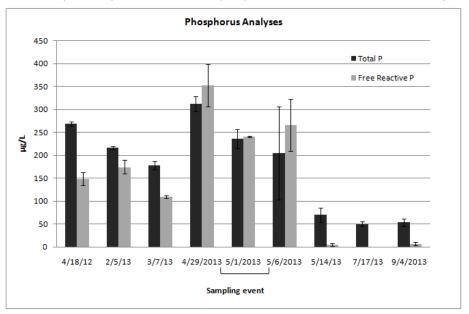
Figure 5. The Total and free reactive phosphorus concentrations. Values are averages from three sampling locations. Error bars represent one standard deviation. Underlined event represents sampling during the Phoslock application period (Figure taken from Bishop et al., 2014).

No significant changes were measured in pH, turbidity, conductivity and alkalinity throughout the study. However, Phoslock rapidly (< 2 weeks) and significantly (p < 0.0005) decreased the total (> 80%) and free reactive phosphorus (> 95%) in the water column (Figure 5). It was also documented to bind the potentially releasable sediment phosphorus fractions to form stable fractions post-treatment.
