## INSPECTION REPORT BY STEVE'S HOME INSPECTIONS

2410 SE 22nd Pl Florida 34471  
Ocala FL 34471

Steven Trans  
FEBRUARY 18, 2021

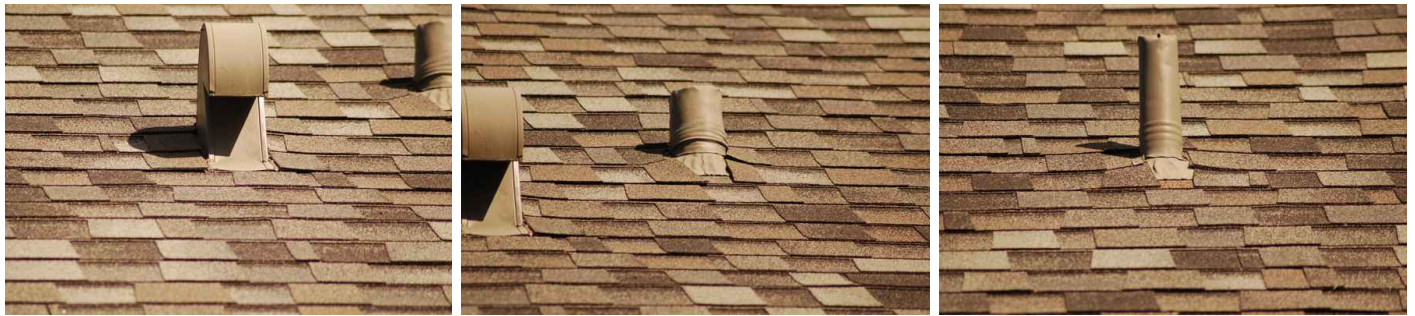
### Plumbing Vent Pipes: Plumbing Vent Pipes Inspected

I looked at DWV (drain, waste and vent) pipes that pass through the roof covering. There should be watertight flashing (often black rubber material) installed around the vent pipes. These plumbing vent pipes should extend far enough above the roof surface.

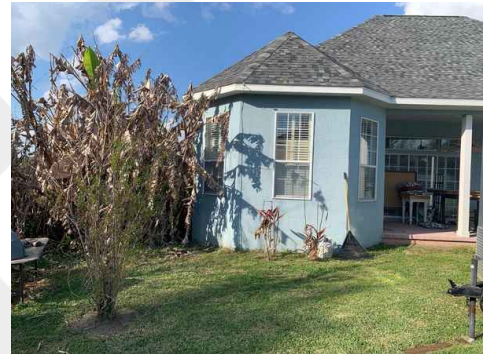
I observed indications that a tree and or tree branch were overhanging the roof and maybe in contact with it.

Contact a handyman or DIY project

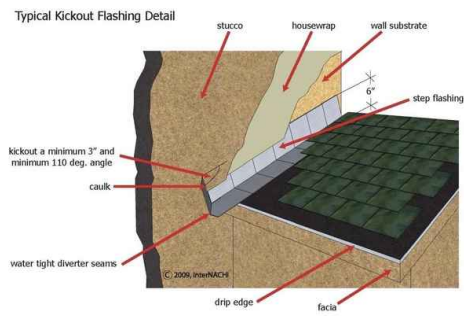
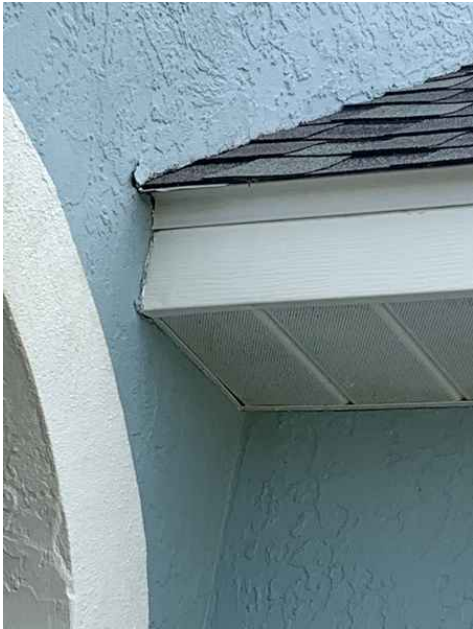
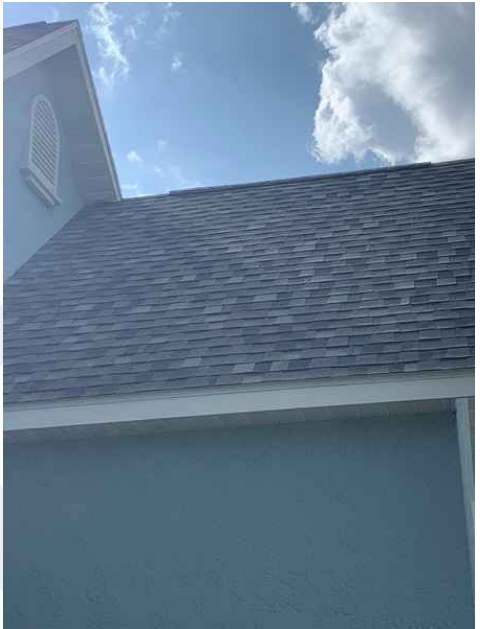
I observed a defect at the flashing area called a "kickout." It's missing. Not installed. A kickout flashing "kicks" the roof water away from the house structure and diverts it into a gutter. This missing flashing could lead to hidden moisture intrusion and water damage. At the time of inspection no water stains were observed inside the attic. A roofing professional is needed to further evaluate and make necessary corrections.

Missing Kickout

Contact a qualified roofing professional.

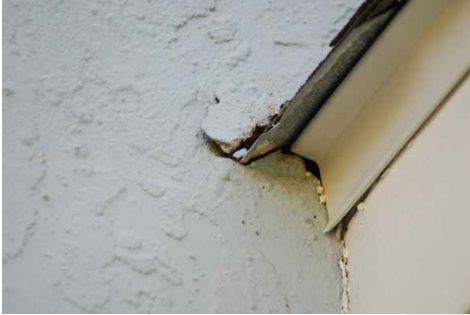
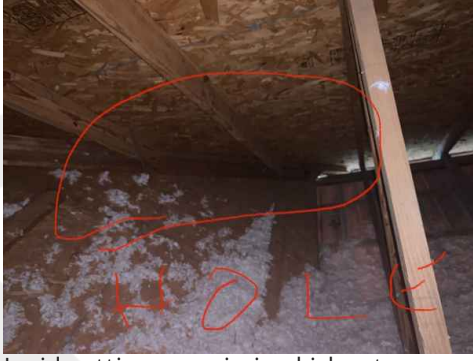
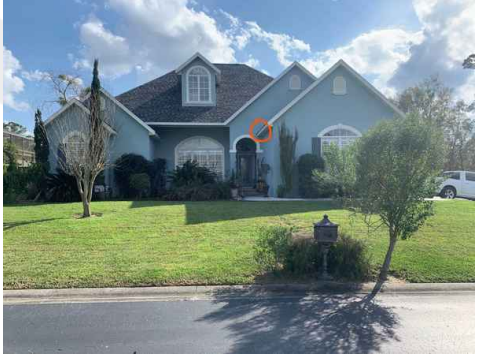
Inside attic near missing kickout

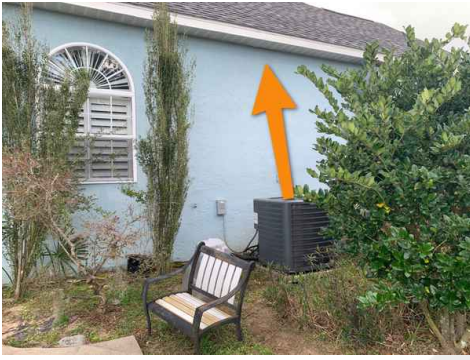
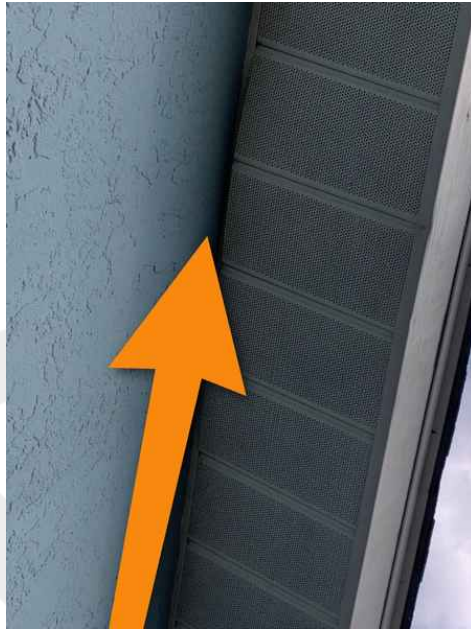
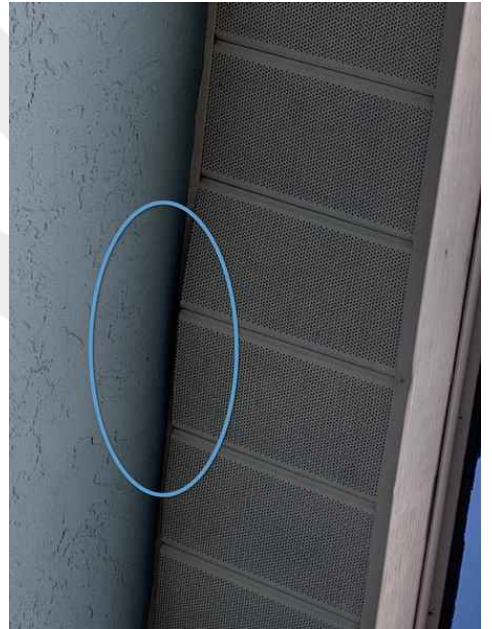
I observed loose panels in the soffit.

Loose panels

Correction and further evaluation is recommended.

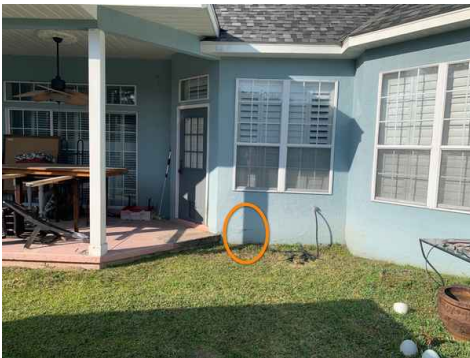
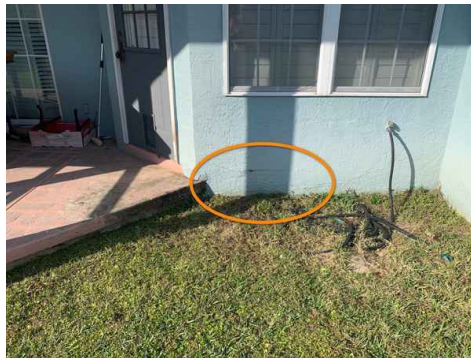
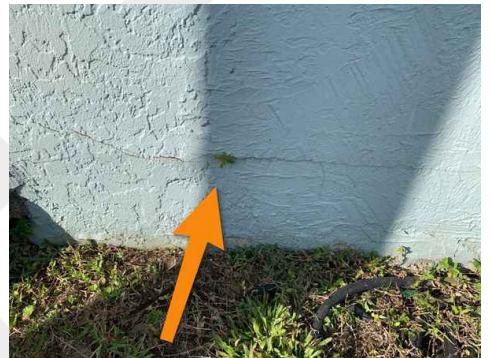
I observed indications of a crack in the wall covering. Vegetation in the crack may indicate there has been water intrusion. Water intrusion can lead to rotting of the substrate.

Crack with vegetation

Correction and further evaluation is recommended.

Contact a stucco repair contractor

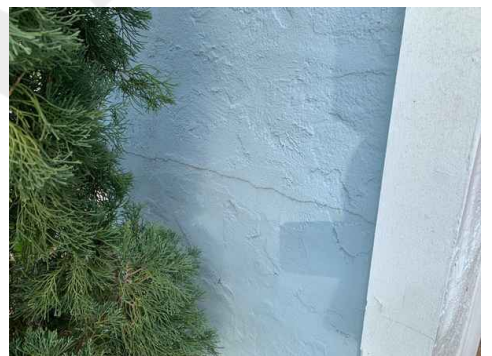
Crack in the stucco where the foundation wall meets the frame. Recommend repair by stucco contractor while he is onsite for the major repair mentioned above.

Contact a stucco repair contractor

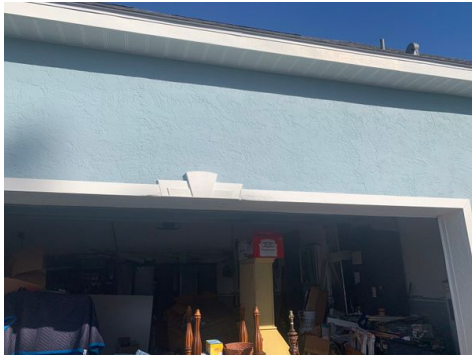
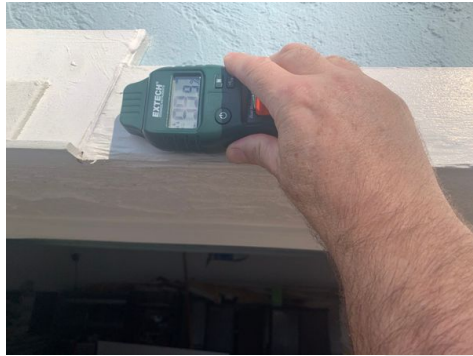
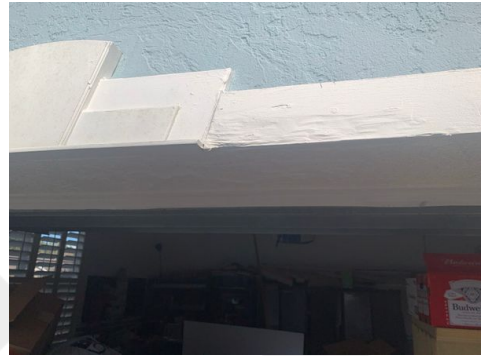
I observed areas of rotting wood trim. Rotting trim can affect the structure behind the trim. Rotting trim may lead to insect infestation. Recommend a carpentry contractor to repair and further evaluate.

Contact a qualified carpenter.

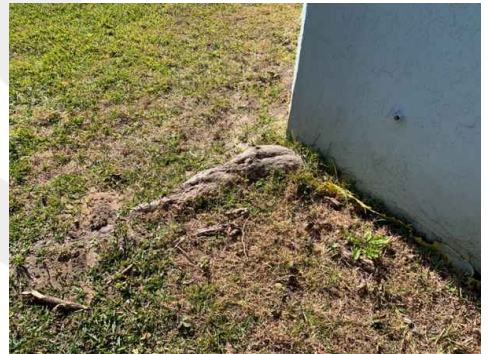
I observed roots growing up against the foundation. Roots can damage foundation walls and allow for water damage.

Roots growing into foundation Southeast corner

Contact a qualified tree service company.

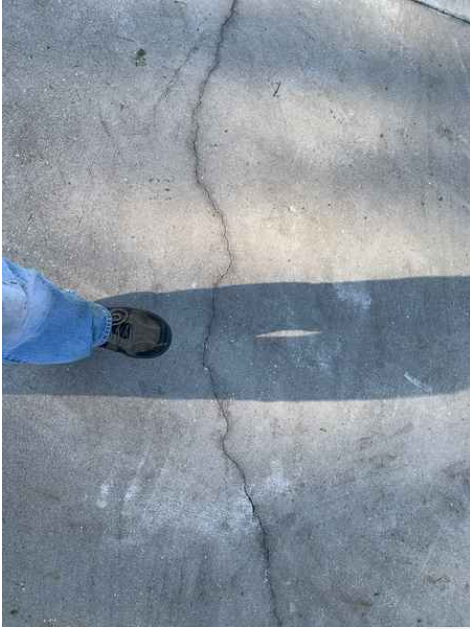
I observed indications of minor cracking at the driveway. There was no displacement at the time of inspection.

Concrete is prone to cracking, Small cracks in concrete do not usually pose a problem.

Recommend monitoring.

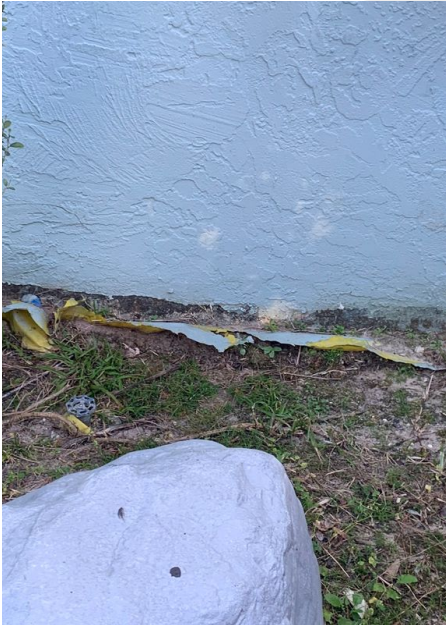
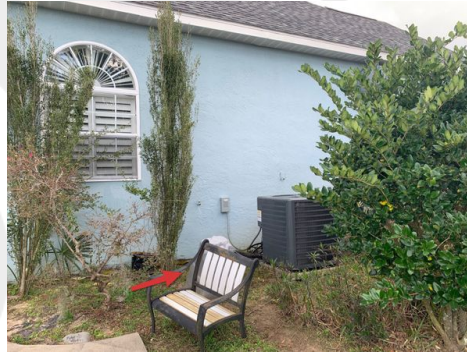
#### Main Water Shut-Off Valve: Location of Main Shut-Off Valve

Garage, Outside of House

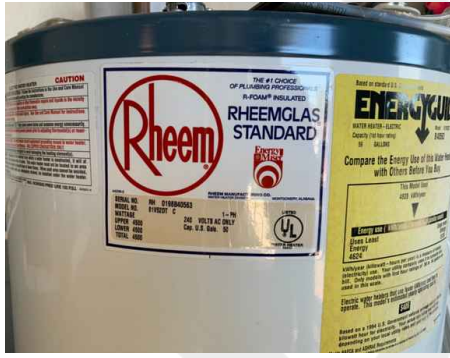
Garage

I inspected the hot water source and equipment according to the [Home Inspection Standards of Practice](#).

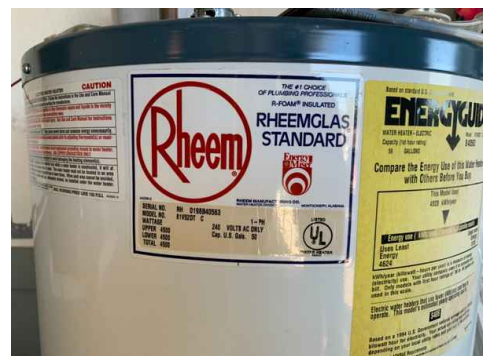
I observed during my inspection that the system appeared to be old and at the end of its service life. It may not be reliable. Ask the homeowner or occupant about its recent performance. Regular maintenance and monitoring of its condition is recommended. Budgeting for repairs and future replacement is recommended. [InterNACHI's Standard Estimate Life Expectancy Chart for Homes](#)

Manufactured in Jan 1998

Recommend monitoring.

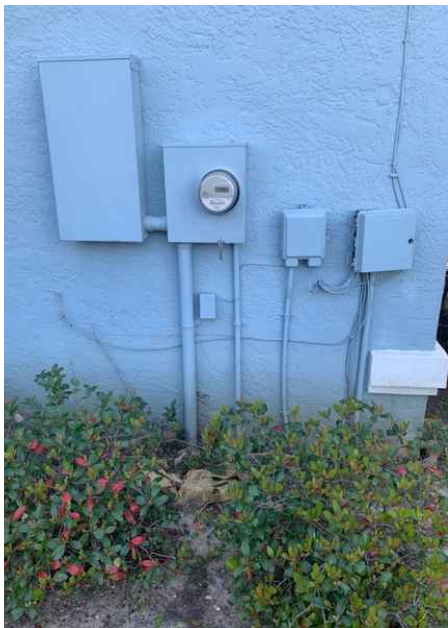
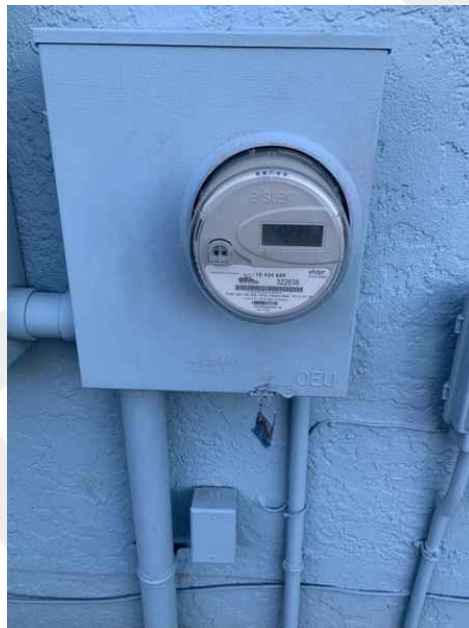
### Electric Meter & Base: Inspected the Electric Meter & Base

I inspected the electrical electric meter and base.

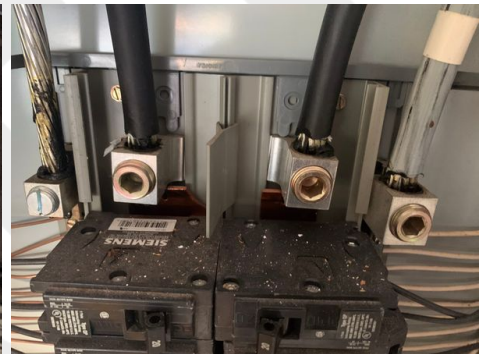
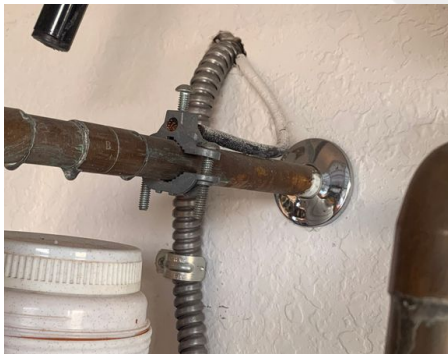
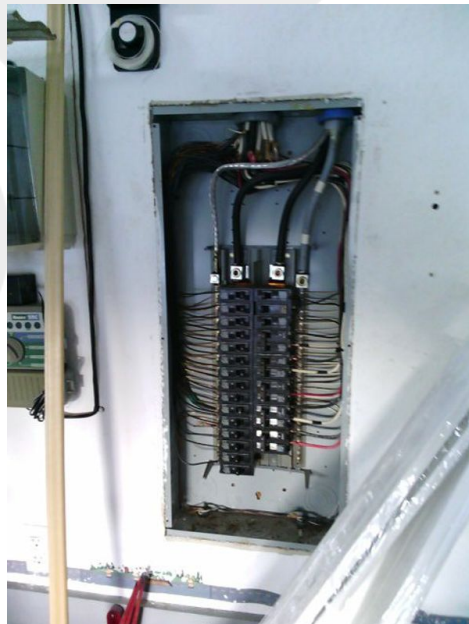
Garage

I inspected the electrical panelboards and over-current protection devices (circuit breakers and fuses).

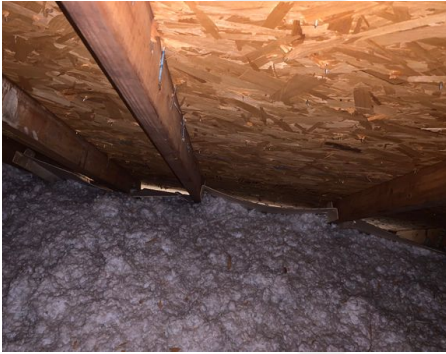
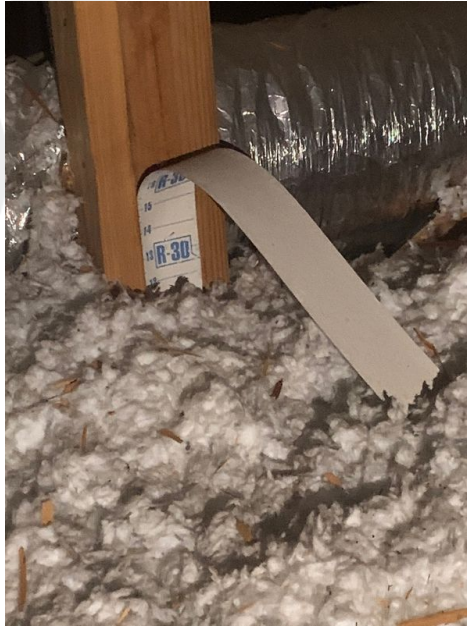
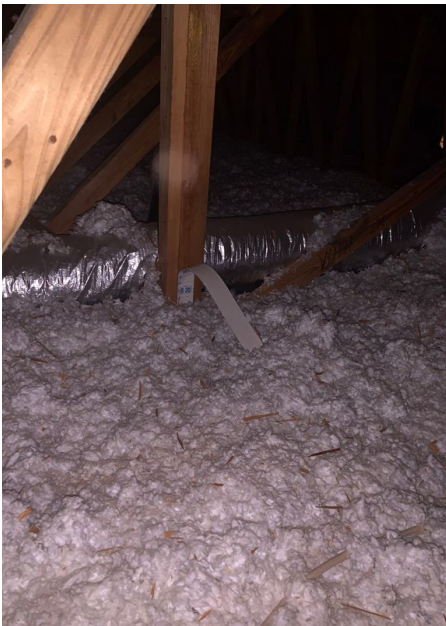
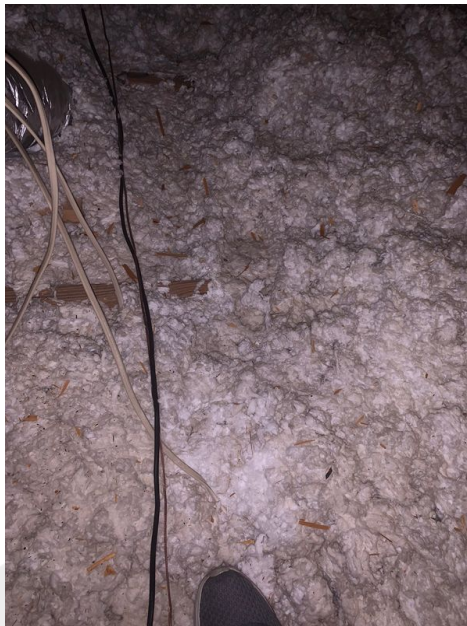
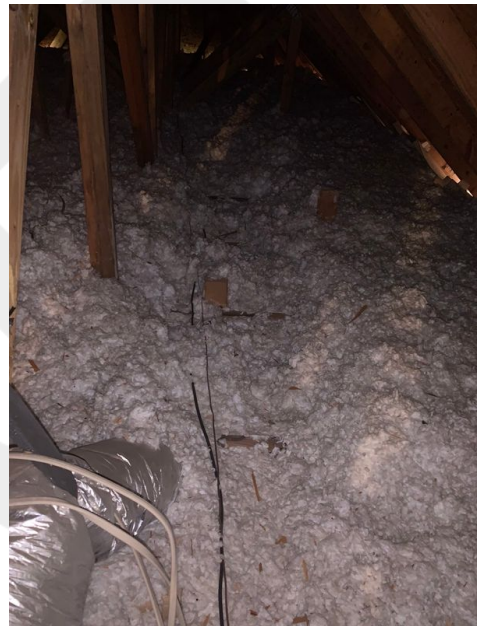
### Insulation in Attic: Approximate Average Depth of Insulation

9-12 inches

Determining how much insulation should be installed in a house depends upon where a home is located. The amount of insulation that should be installed at a particular area of a house is dependent upon which climate zone the house is located and the local building codes.

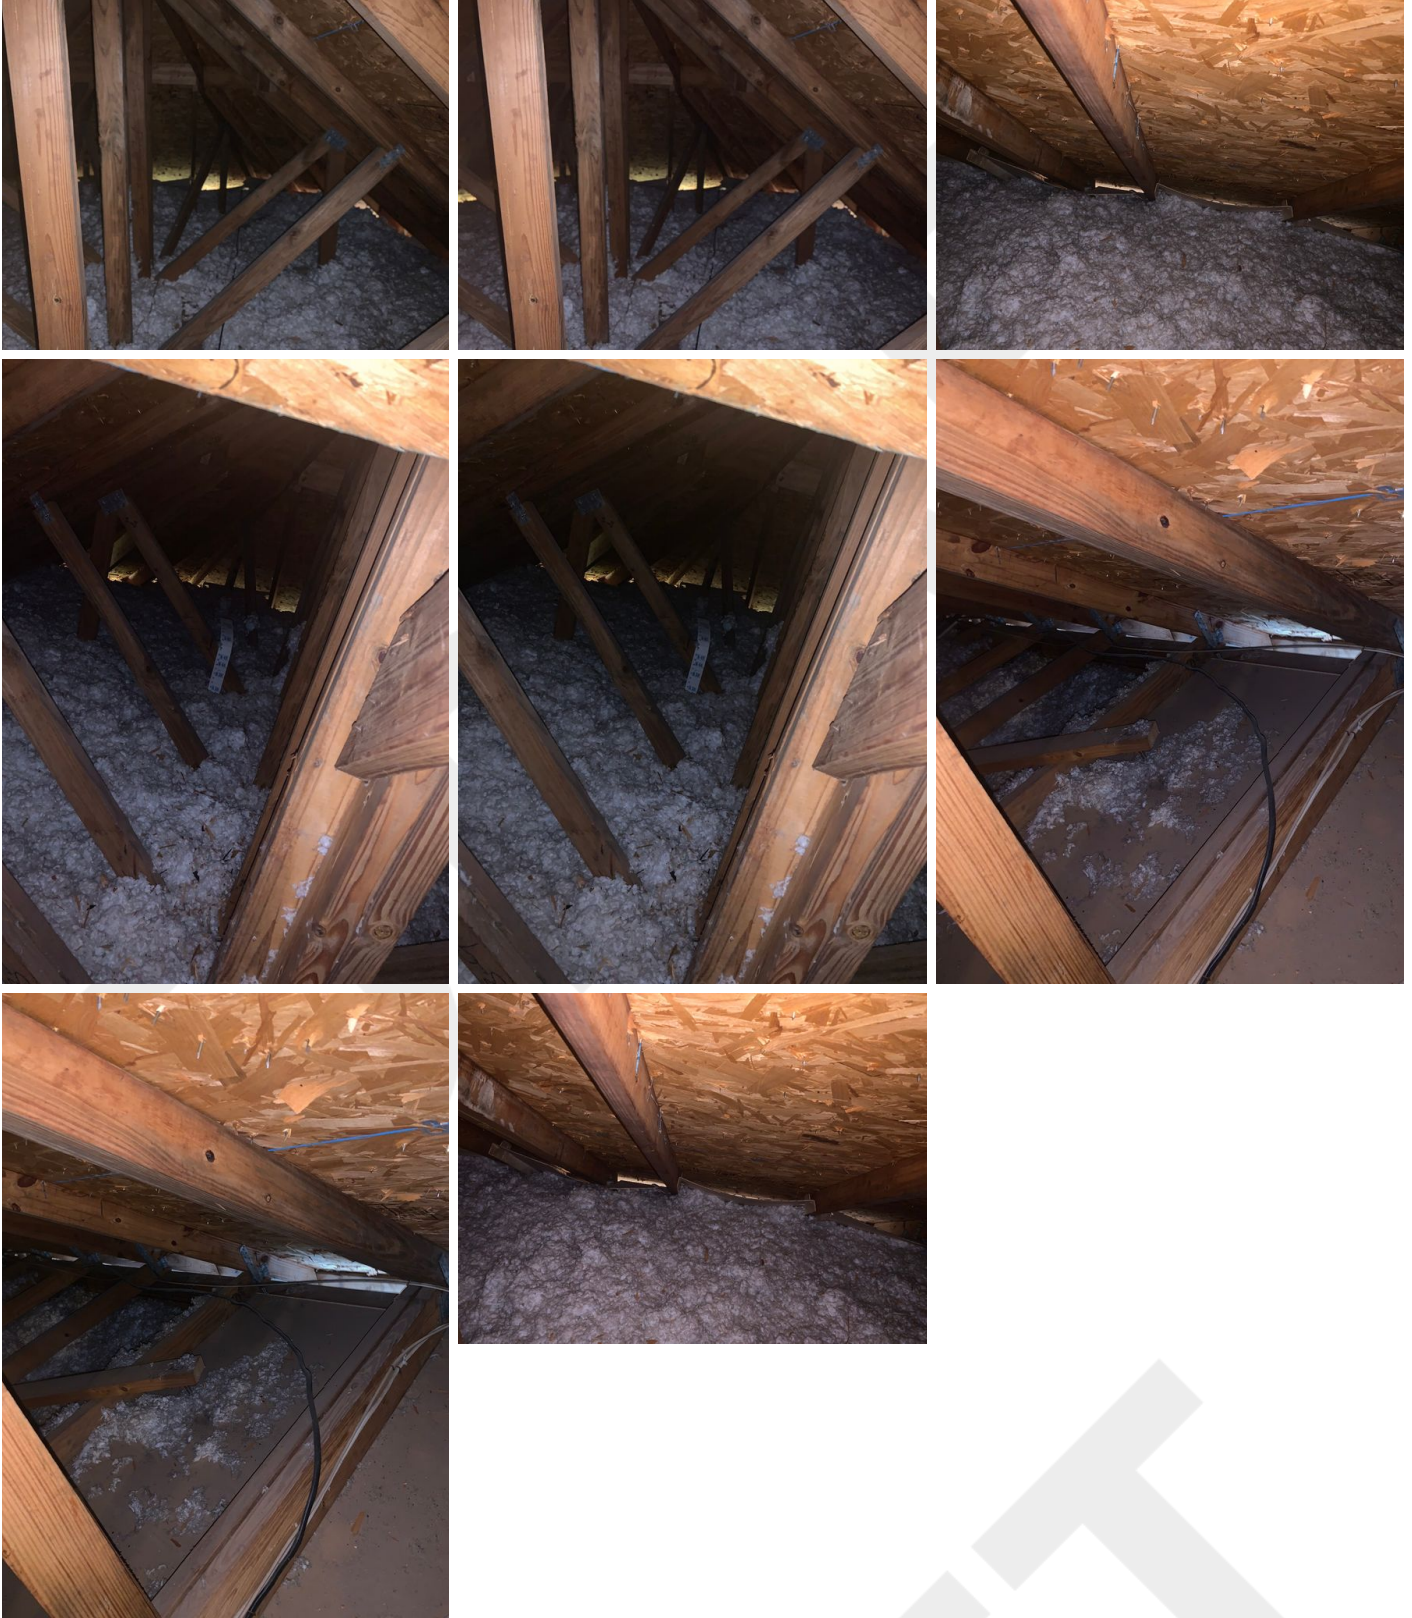
### Ventilation in Attic: Ventilation Inspected

During the home inspection, I inspected for ventilation in unfinished spaces, including attics, crawlspaces and foundation areas. And I inspected for mechanical exhaust systems.

I report as in need of correction the general absence of ventilation in unfinished spaces.

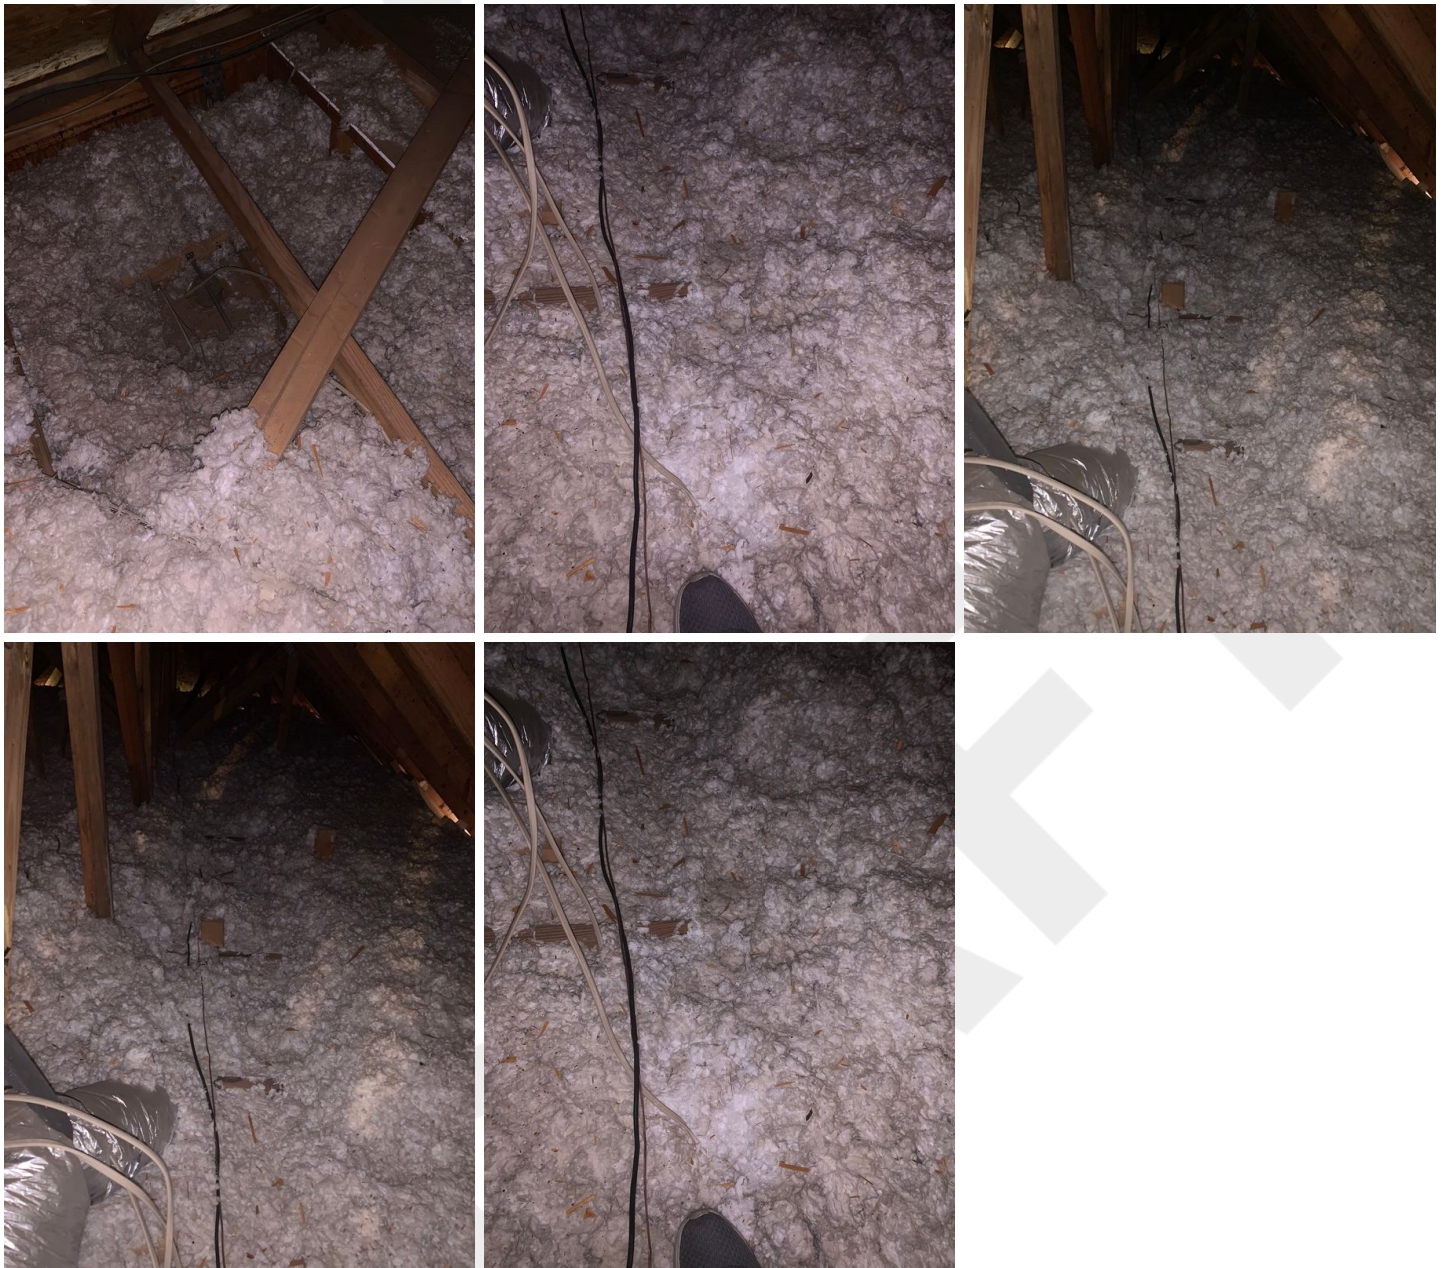
I observed indications that the insulation in the attic was stepped upon. The insulation in those areas are compressed. The insulation is not as thick and not performing as expected. Adding insulation in these areas is recommend.

Contact a qualified insulation contractor.

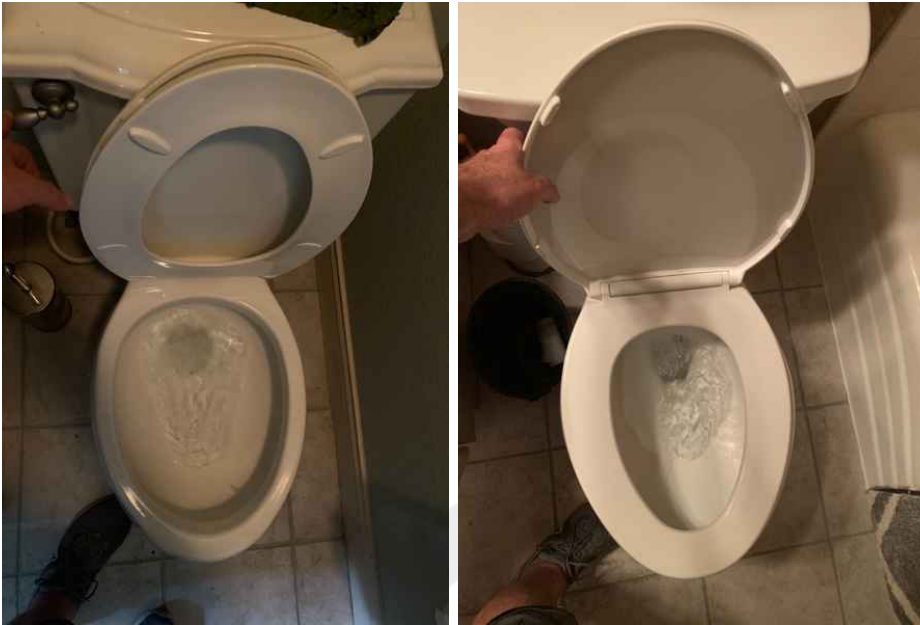
#### Bathroom Toilets: Toilets Inspected

I flushed all of the toilets.

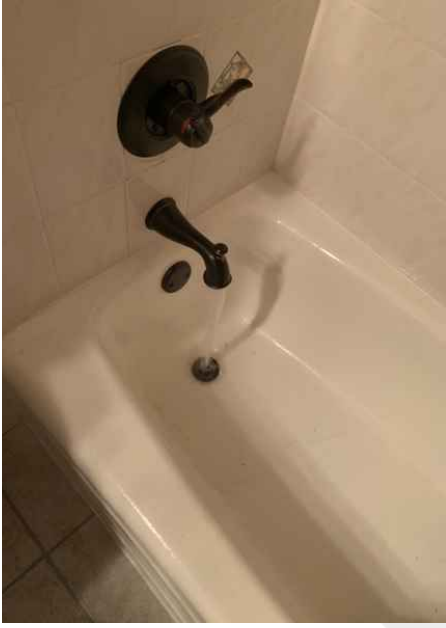
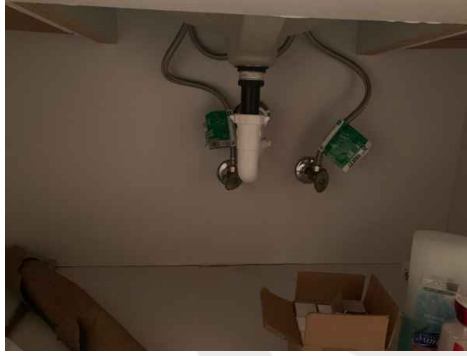
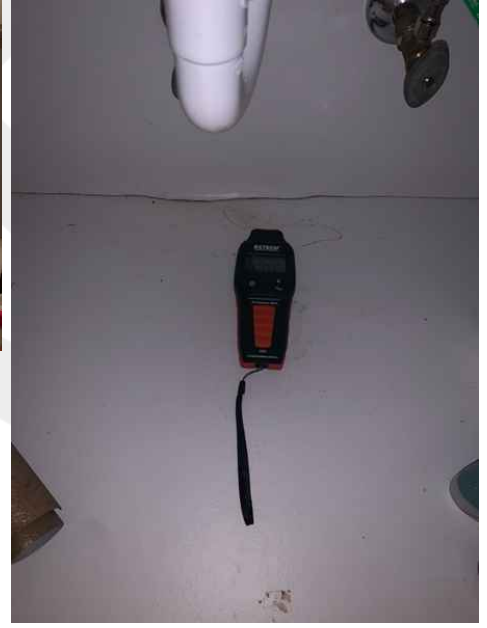
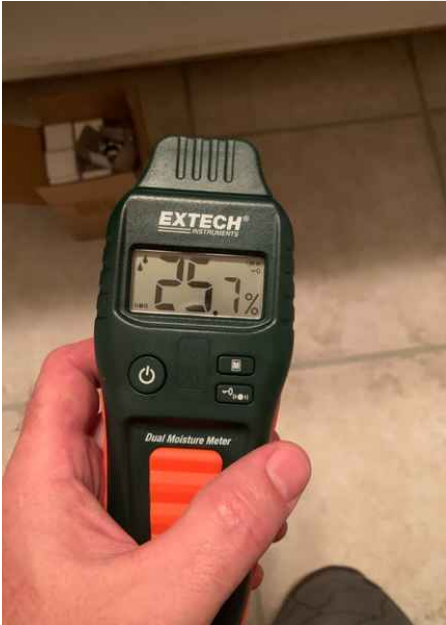
### Sinks, Tubs & Showers: Ran Water at Sinks, Tubs & Showers

I ran water at all bathroom sinks, bathtubs, and showers. I inspected for deficiencies in the water supply by viewing the functional flow in two fixtures operated simultaneously.

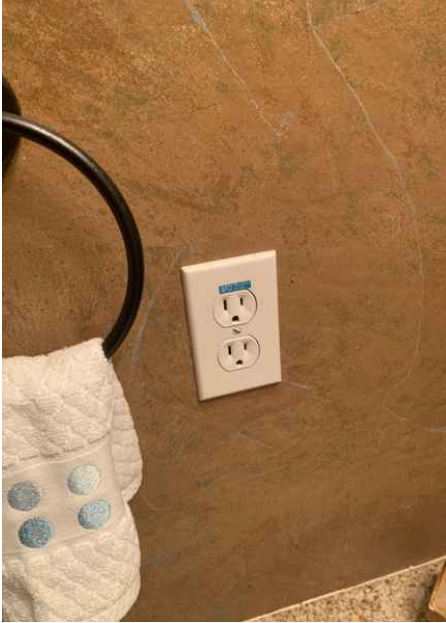
I inspected the GFCI-protection at the receptacle near the bathroom sink by pushing the test button at the GFCI device or using a GFCI testing instrument.

All receptacles in the bathroom must be GFCI protected.

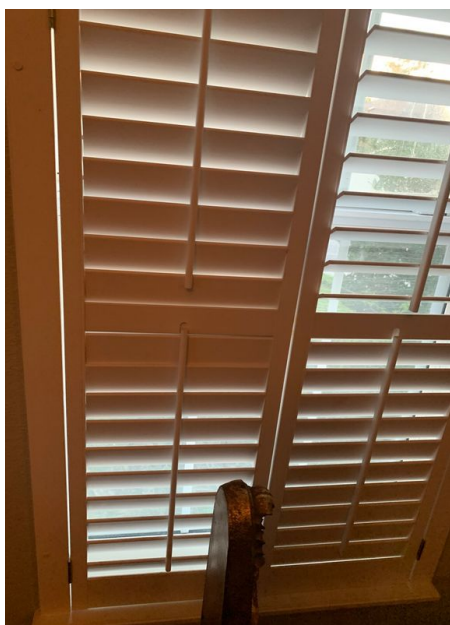
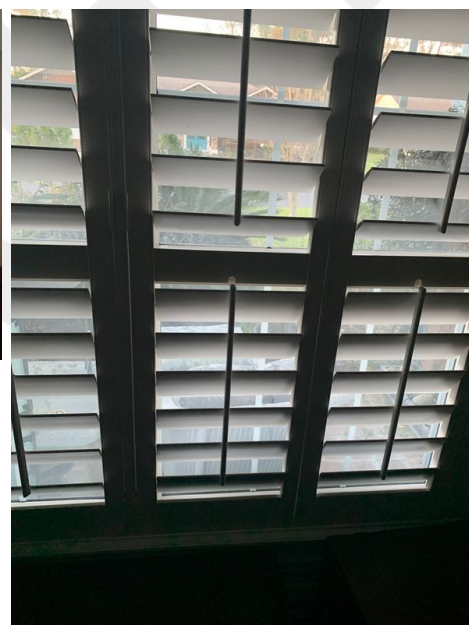
### Windows: Windows Inspected

I inspected a representative number of windows according to the [Home Inspection Standards of Practice](#) by opening and closing them. I did not operate window locks and operation features, which is beyond the scope of a home inspection.

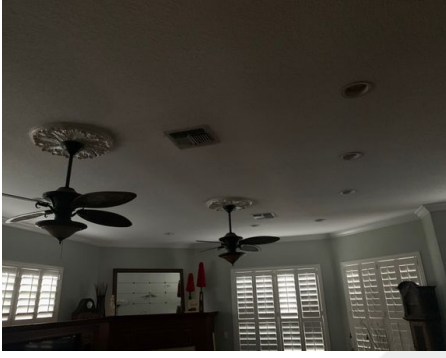
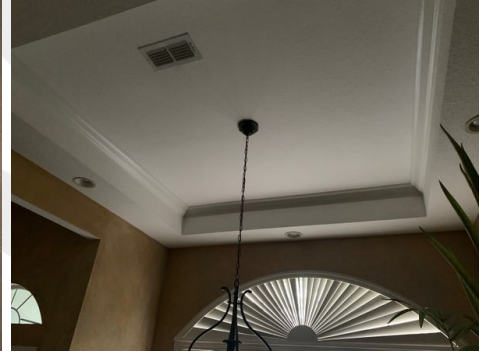
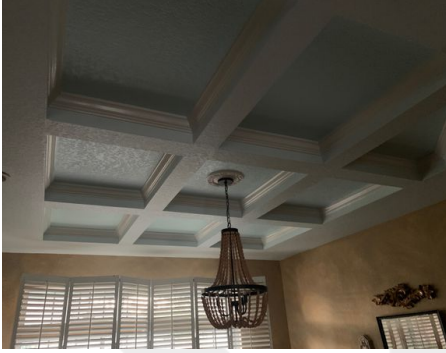
### Floors, Walls, Ceilings: Floors, Walls, Ceilings Inspected

I inspected the readily visible surfaces of floors, walls and ceilings. I looked for material defects according to the [Home Inspection Standards of Practice](#).

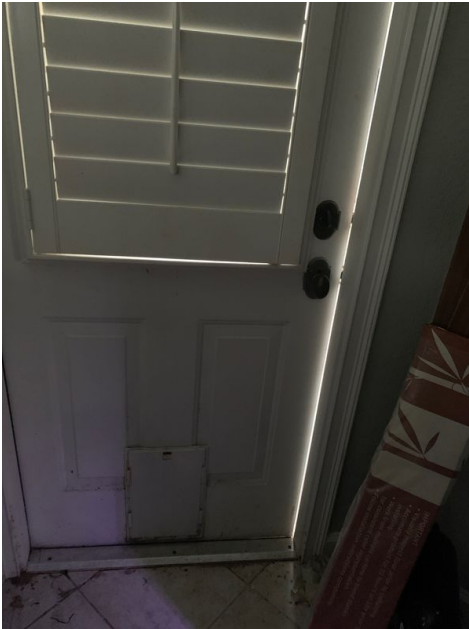
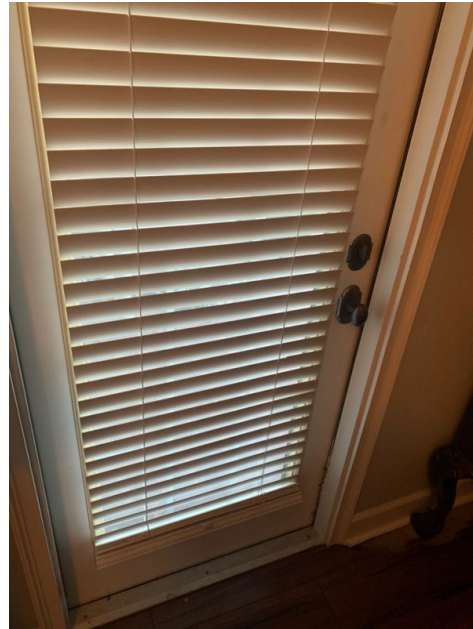
I observed missing weather stripping at the exterior door.

Contact a qualified door repair/installation contractor.

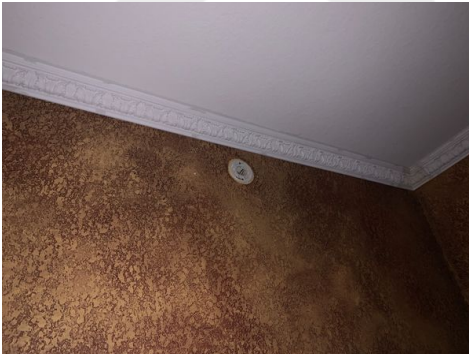
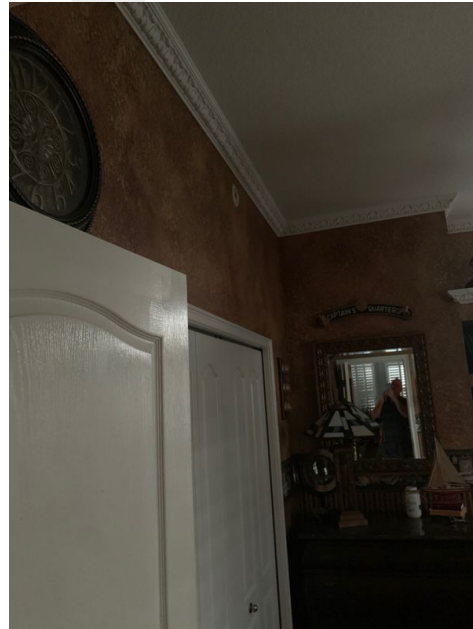
I observed indications of a missing smoke detector. Hazard.

Contact a qualified professional.

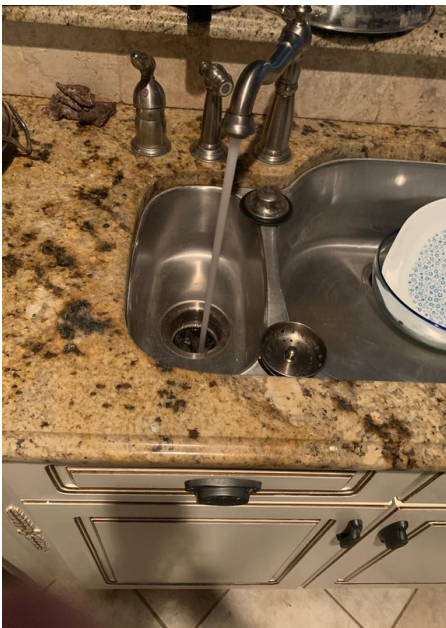
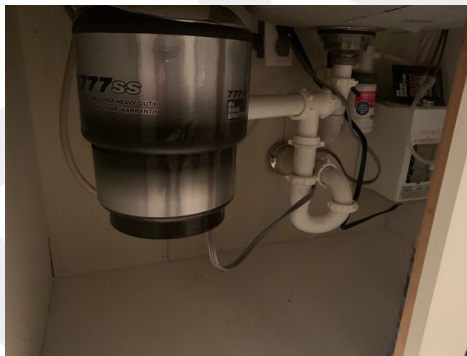
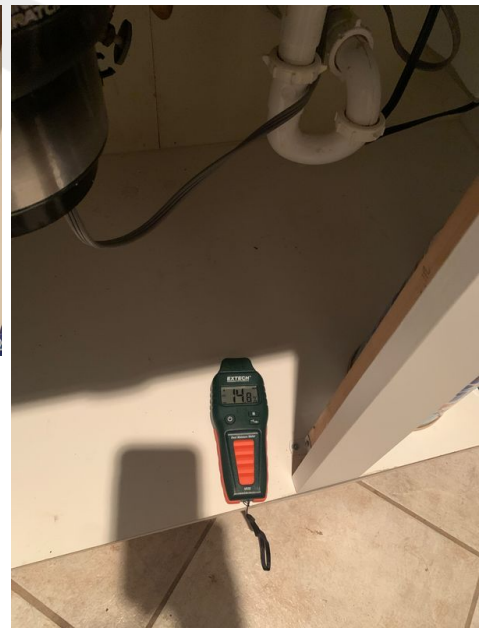
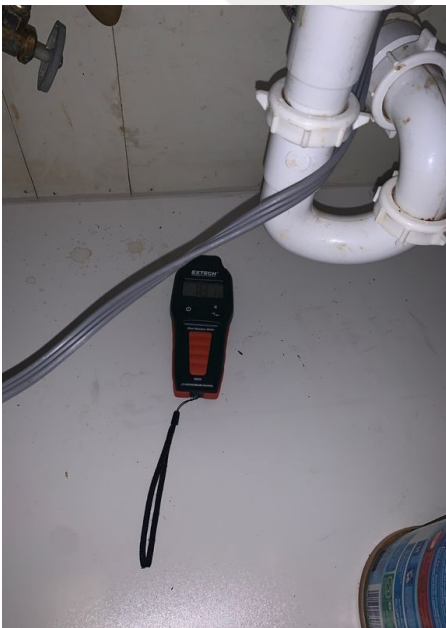
### Kitchen Sink: Ran Water at Kitchen Sink

I ran water at the kitchen sink.

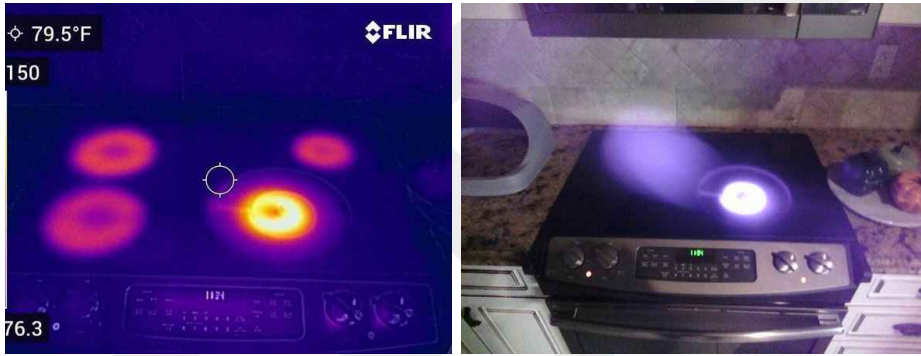
### Range/Oven/Cooktop: Turned On Stove & Oven

I turned on the kitchen's stove and oven.

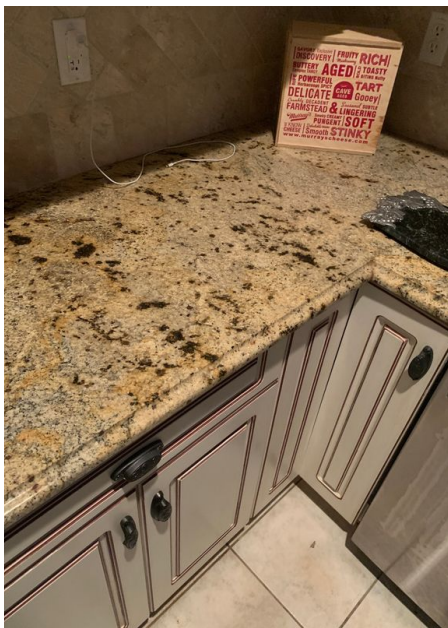
### Countertops & Cabinets: Inspected Cabinets & Countertops

I inspected a representative number of cabinets and countertop surfaces.
