# DFA Damage Assessment 2023 Freshet Flooding

Village of Cache Creek

July 2023

Project No. 310-441

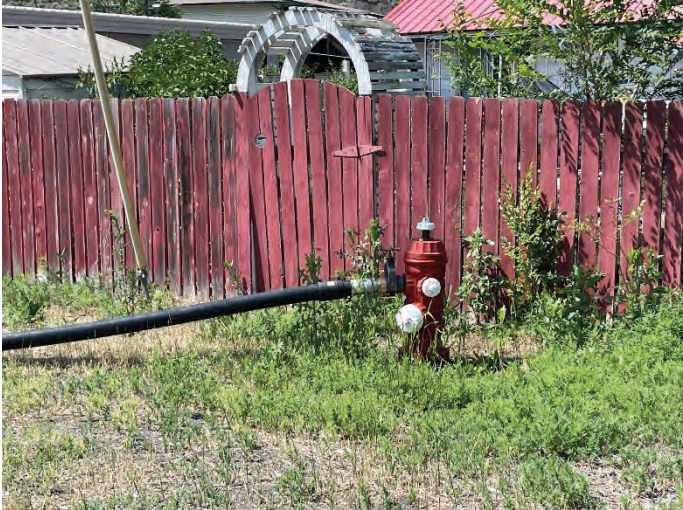
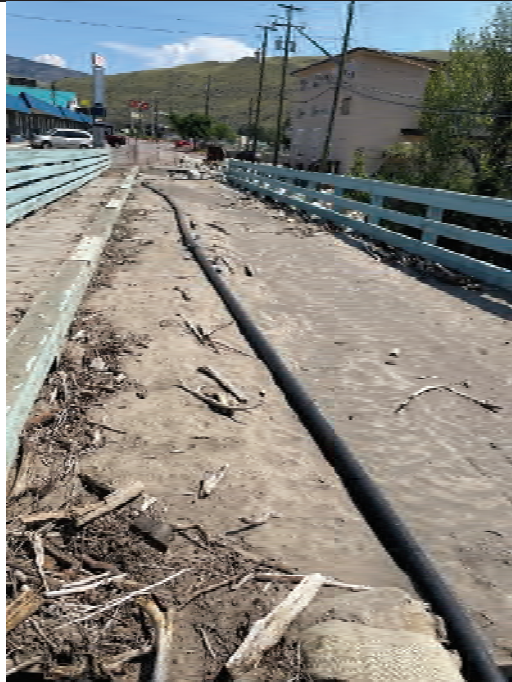
<p>1. Critical Watermain Crossing – a section of watermain crossing under the Bonaparte River was compromised during the flooding event and was isolated to prevent contamination and loss of pressure in the system. Temporary HDPE pipe is in place to supply water until a permanent repair can be made. This current temporary solution does not provide adequate fire flow and is highly susceptible to freezing.</p>

RECOMMENDED RECOVERY ACTION	PRELIMINARY RECOVERY COST ESTIMATE	ENHANCEMENTS	ENHANCEMENT COST ESTIMATE	ESTIMATE ELIGIBLE COST	DESCRIPTION
1a. Directional Drill water crossing across Bonaparte River.	\$232,000.00	N/A	N/A	\$232,000.00	This Action is already approved under DFA regulation as Event #2324-01 Project 1 - Watermain. Details can be found in TRUE's 2023 Flood Event Emergency Works – Replacement of River Crossing report which can be found in Appendix B.
1b. Engineering and Project Management for Project 1a. (approved under response)	\$45,000.00	N/A	N/A	\$45,000.00	The cost estimate provided for recovery action 1a was provided in the context of flood response in which engineering and project management would be covered separately. Given that the project is now taking place under the umbrella of recovery this cost will now have to be accounted for here.

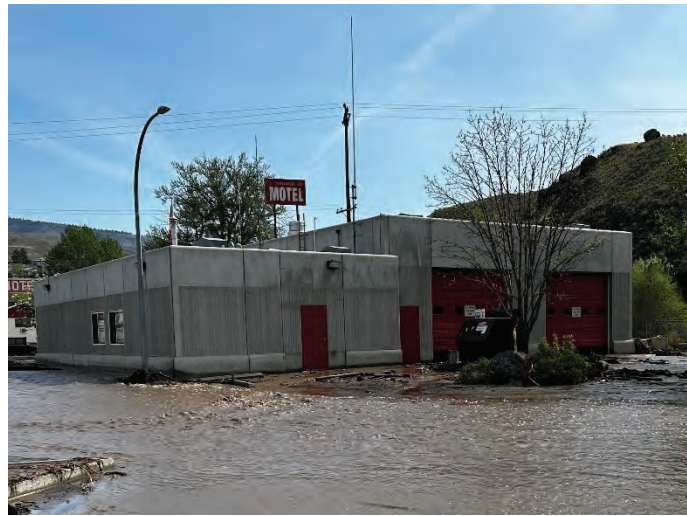
2. Firehall – Floodwaters from Cache Creek passed through the firehall causing extensive damage. This damage is expected to be covered by insurance.

2. Firehall Insurance Deductible.	\$50,000.00	N/A	N/A	\$50,000.00	Firehall building repairs are covered by insurance with a \$50,000 deductible to be paid.
3a. Todd Road Bridge Insurance Deductible.	TO BE DETERMINED	N/A	N/A	TO BE DETERMINED	Bridge repairs and asphalt bridge approaches fall under the umbrella of Village insurance.
3b. Repair Road on both sides of Todd Road bridge, Storm MH, and fire hydrant.	\$115,000.00	N/A	N/A	\$115,000.00	Aggregates to fill eroded areas below Todd bridge approaches as well as exposed fire hydrant and storm MH will to be replaced are not covered by insurance and will need to be funded by DFA.
4a. Remove bedload and existing Quartz Road culvert, re-install new crossing.	TO BE DETERMINED	N/A	N/A	TO BE DETERMINED	This is the cost estimate to restore the culvert to pre-flood condition. Remove bedload left from floodwaters and damaged culvert. Reconstruct culvert and road along Quartz Road.

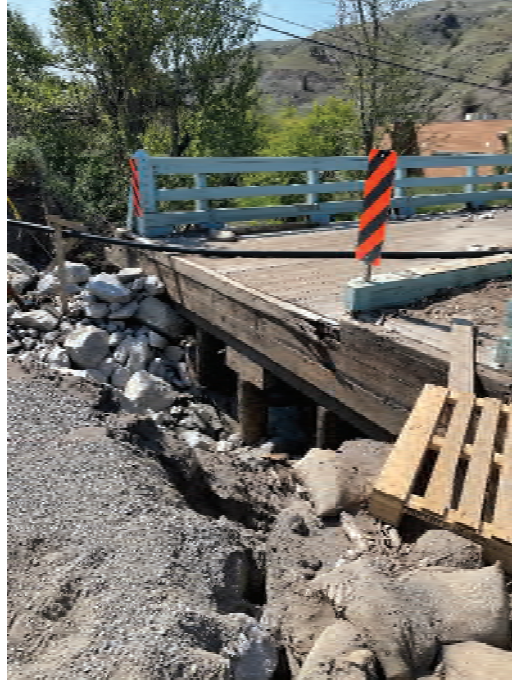
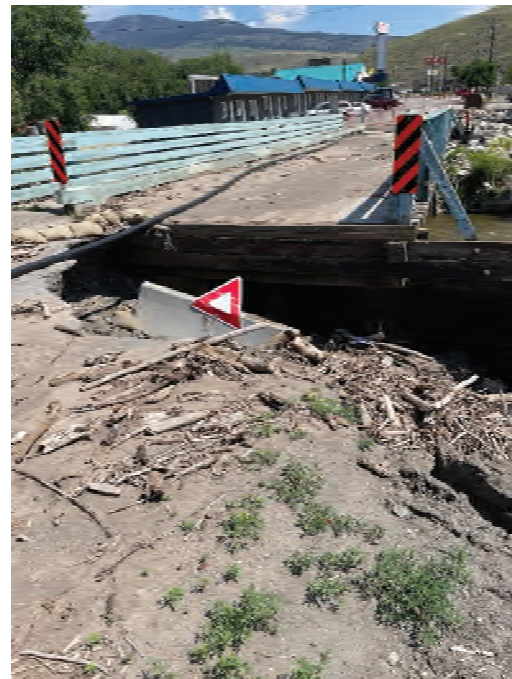
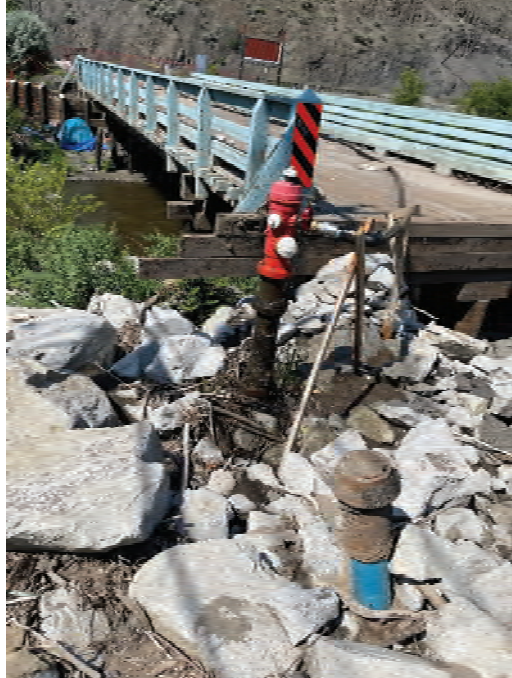
3. Todd Road Bridge – Access on each side of the wooden deck bridge was eroded from Cache Creek overland flows. This left a significant portion of fire hydrant standpipe exposed with limited thrust restraint as well as an exposed storm manhole.

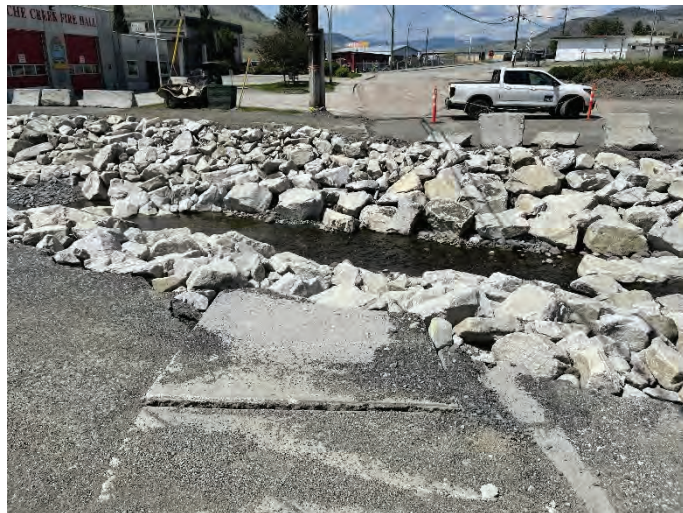
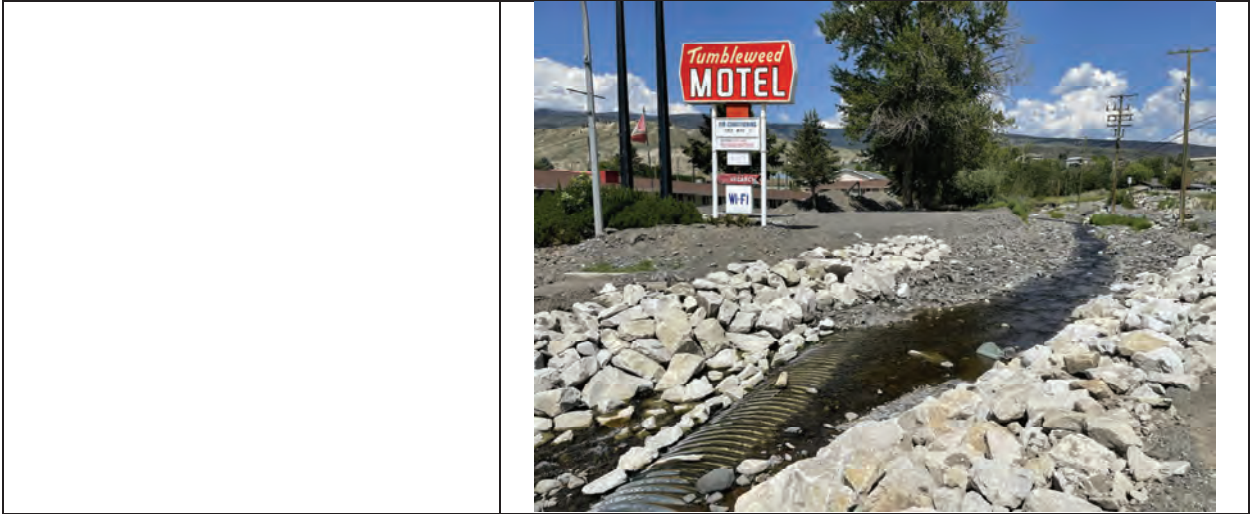
4. Quartz Road Culvert – rapid high-volume flow in Cache Creek carried significant bedload which eventually plugged and damaged the culvert causing overtopping which subsequently eroded the road structure leaving the current bottom of creek at top of culvert elevation.

The Quartz Road culvert enhancement may involve replacing the crossing with a bridge instead of a culvert. This is due to the repeated flooding at this culvert and to the extensive damage sustained by the 2023 flooding.

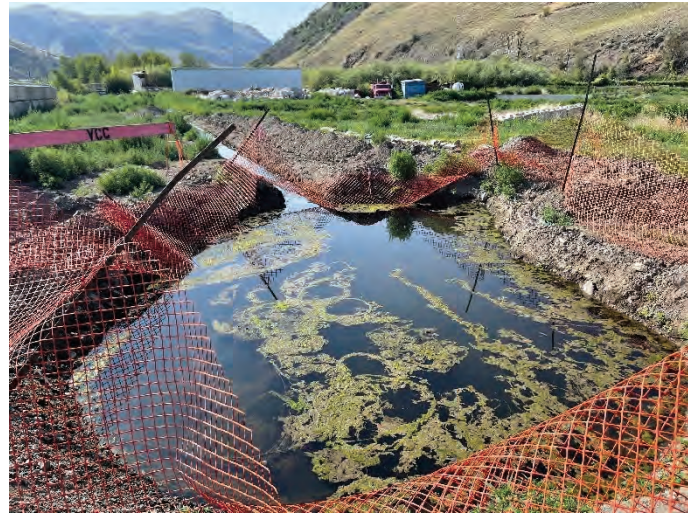
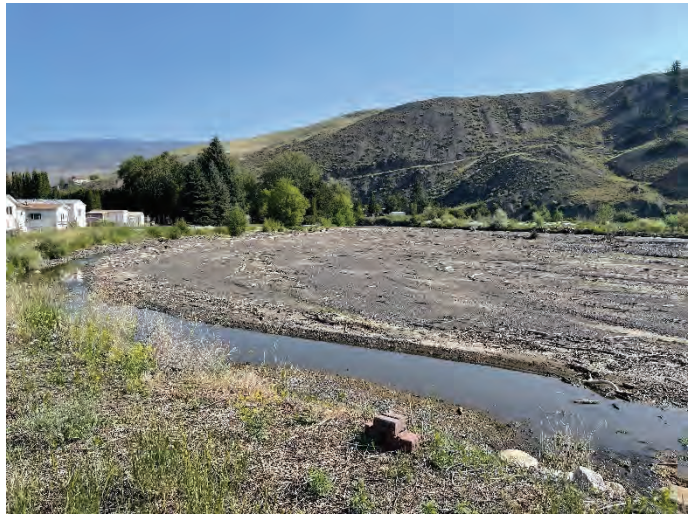
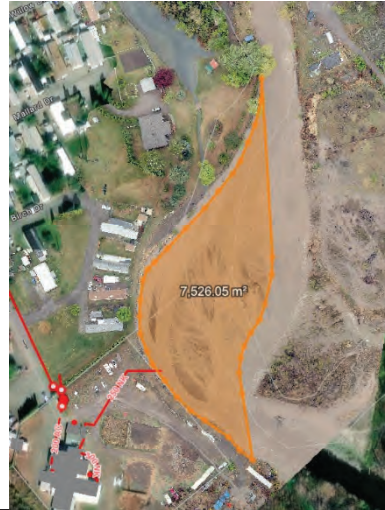
5. WWTP Outfall – Beginning in 2020 high volume flow in the Bonaparte River has deposited significant bedload at the location of the wastewater treatment plant outfall. The main river channel has migrated to the east, separating the outfall from the river. Prior to the 2023 flood the outfall was functional, however no longer flowing into a dilution zone in the river. During the 2023 flood the outfall failed completely and wastewater effluent began bubbling to the surface on site. A temporary channel was constructed and is currently being used to convey treated effluent to the Bonaparte River. The last photo shown is a snip showing an area polygon against an ortho photo taken during the flood event to highlight the scale of change in the Bonaparte River.

construct road with bridge.					floodwaters and damaged culvert. Construct bridge crossing at Quartz Road.
5a. reroute Bonaparte River to previous location and rebuild outfall	\$1,128,300.00	N/A	N/A	\$1,128,300.00	This is the cost estimate to restore the previous WWTP outfall to pre-flood condition. Due to River migration during the flood this project would involve removing a large amount of material within the river and would require extensive environmental consideration while re-routing the river. Once the previous river path is reestablished a new outfall would be restored in its previous location.
5b. Design and build new WWTP outfall c/w engineered wetland.	TO BE DETERMINED	TO BE DETERMINED	TO BE DETERMINED	TO BE DETERMINED	TO BE DETERMINED

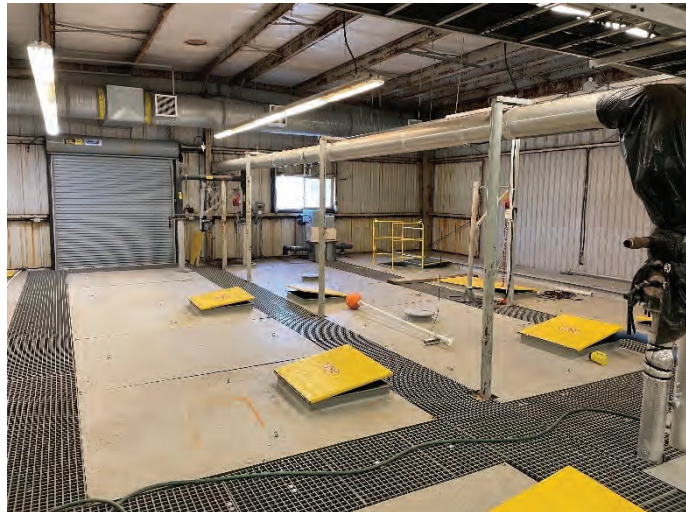
6. WWTP sediment cleanout – treatment tanks at the WWTP faced significant silt content during flood event flows before the WWTP was completely bypassed. This sediment has settled out reducing the capacity of the aeration tanks and limiting the effectiveness of the treatment plant.

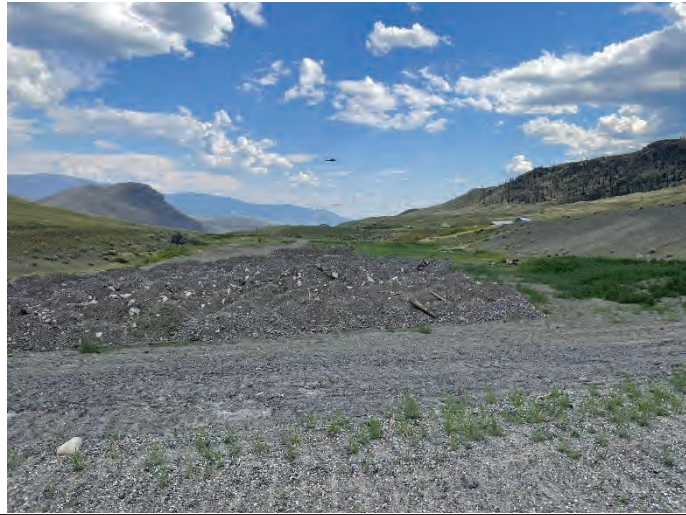
7. Debris Removal – approximately 350 truckloads of silt and gravel were removed from flooded areas in the Village and stockpiled near the local landfill.

7. Spread material over landfill	\$37,500.00	N/A	N/A	\$37,500.00	Material will be graded and spread out for use as landfill cover in place.
8. Remove and replace firehall apron concrete and base aggregate.	\$43,100.00	N/A	N/A	\$43,100.00	Replacement of firehall apron is essential in providing rapid fire response that matches pre-flood conditions.

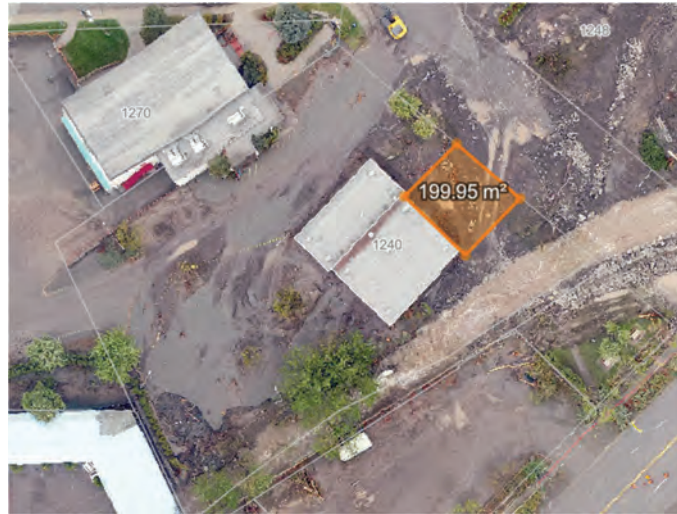
8. Firehall Apron- flood waters caused lifting and heaving of concrete slabs in the apron of the firehall.

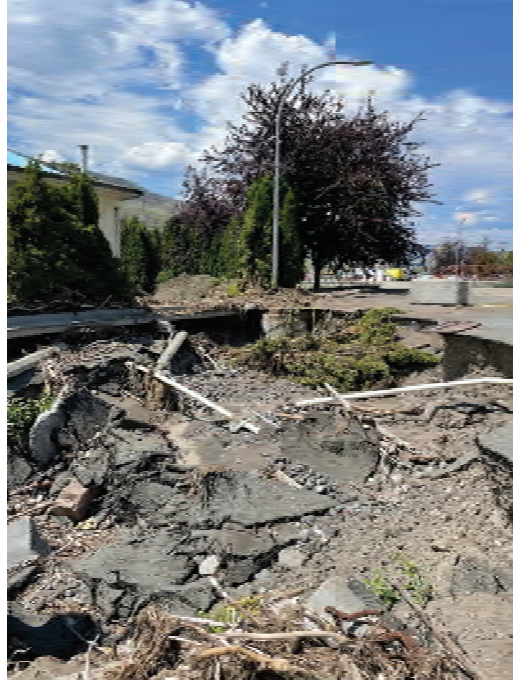
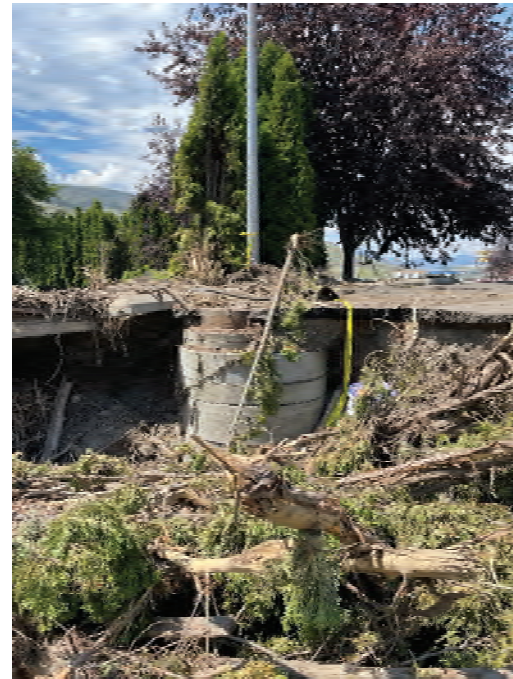
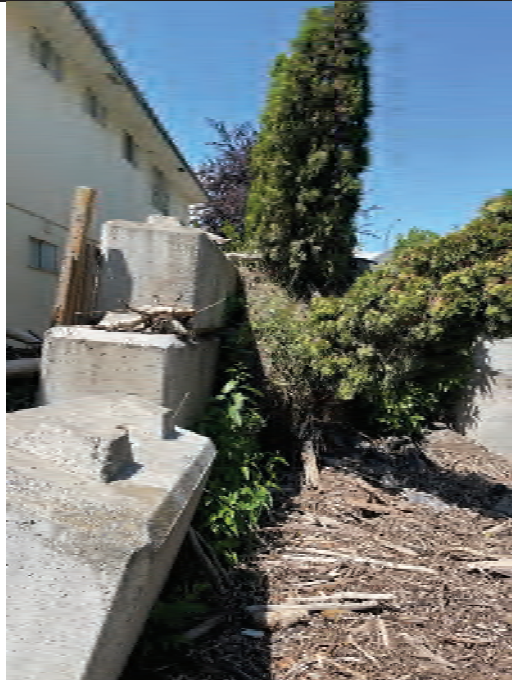
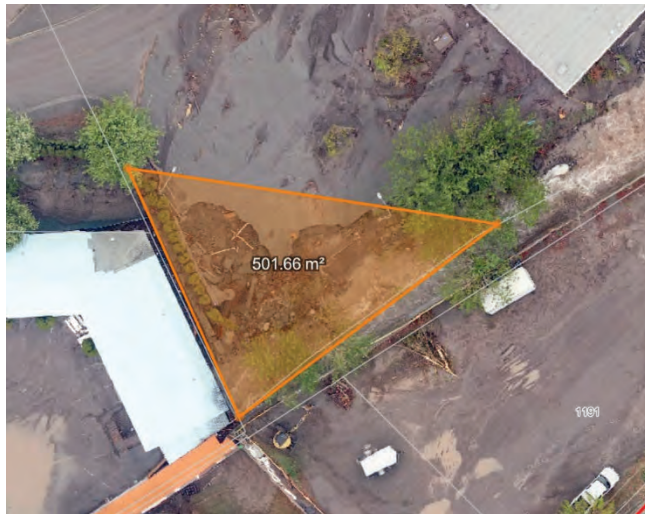
9. Community Hall Parking – Cache Creek floodwaters caused significant undermining and erosion of storm infrastructure, electrical conduit, parking load structural aggregates and surfacing. A lock-block retaining wall at the south-West corner was also undermined and damaged.

9. Remove and replace damaged infrastructure, place aggregates and asphalt at community hall parking lot.	\$328,900.00	N/A	N/A	\$328,900.00	This Project will require the removal of a damaged storm CB, CB lead, MH, Concrete curb, electrical conduit, and replacement of the same items. Removal and reassembly of a portion of the lock-block retaining wall will be required prior to backfilling and paving parking lot.

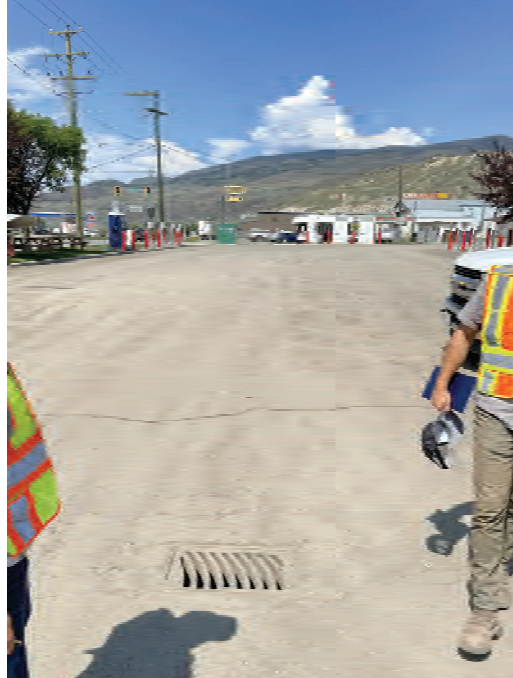
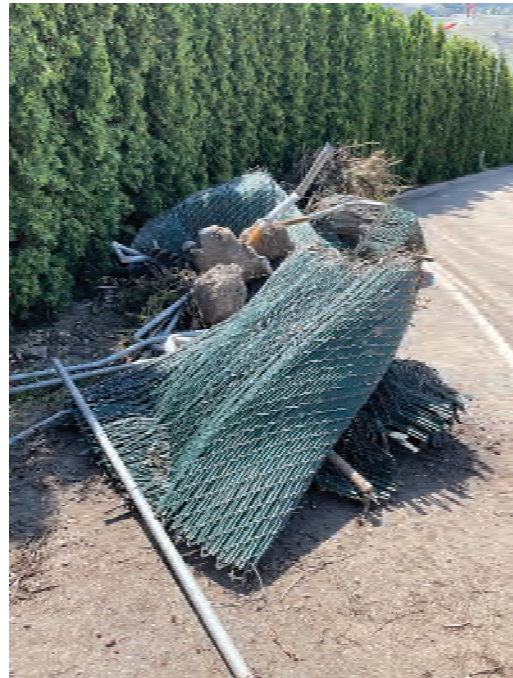
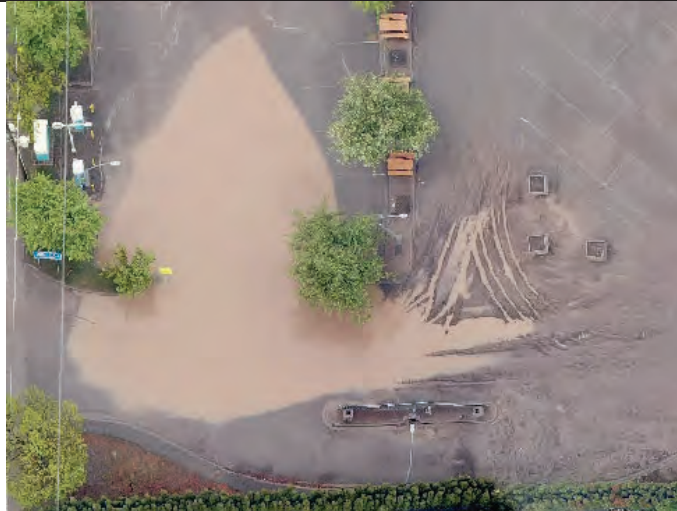
10. Community Hall Rock Pit – Sediment from Cache Creek floodwaters has filled the voids in the rock pit leaving no capacity for storm water. The last photo is taken from ortho imagery taken during the flood event. This rock-pit was attempted to be cleaned by vac-truck but remains unusable.

10. Remove and replace rock pit near community hall.	\$124,300.00	N/A	N/A	\$124,300.00	Entire rock pit will need to be excavated and reconstructed with new clean drain rock material, backfilled and re-paved. This will require a large excavation and for material to be imported from outside of the Village.

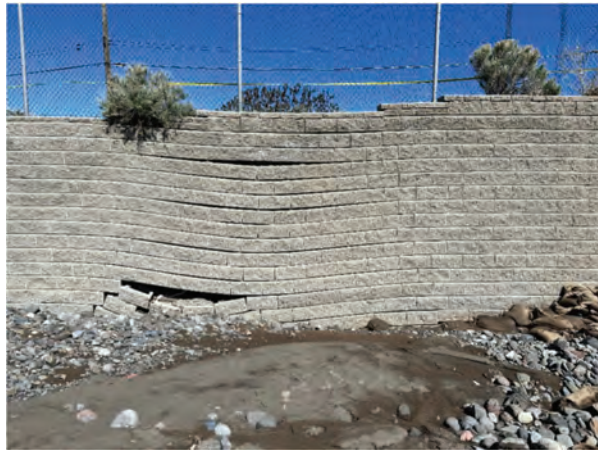
11. Stage Road Retaining Wall. Cache creek floodwaters undermined the Allan block retaining wall causing settling of a section of the wall and a tension crack to form behind of the wall as was noted in an assessment by Telford Geotechnical Ltd.

11. Repair damaged section of Stage Road retaining wall.	TO BE DETERMINED	TO BE DETERMINED	TO BE DETERMINED	TO BE DETERMINED	Temporary backfill along wall to stabilize it while engaging geotechnical engineer to detail methods of replacement. Assessment report can be found in Appendix C.

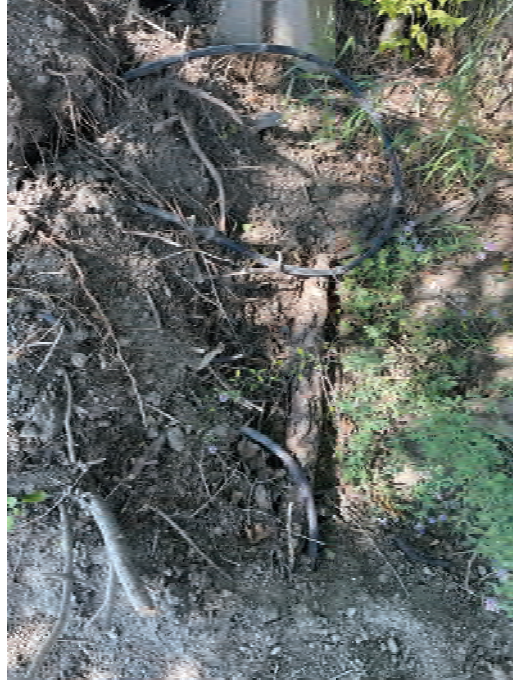
13. Irrigation Systems Failure – many locations throughout the Village of Cache Creek have damaged irrigation lines from Cache Creek flood waters and the debris carried within them. This has left significant portions of the irrigation system inoperable.

13. Replace damaged irrigation lines throughout Village.	\$29,000.00	N/A	N/A	\$29,000.00	Remove and place damaged sections of irrigation lines c/w required appurtenances to restore the irrigation network.

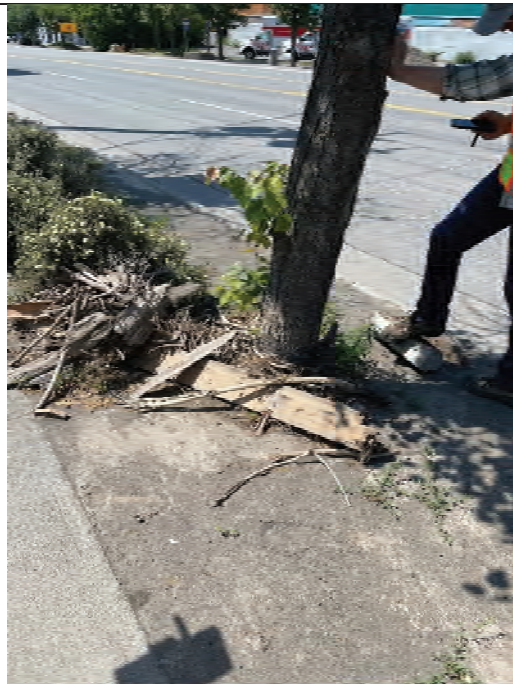
14. Sediment and Debris Removal – floodwaters left gravel, silt, and woody debris throughout the Village. The finer material is easily picked up by wind creating hazardous dust.

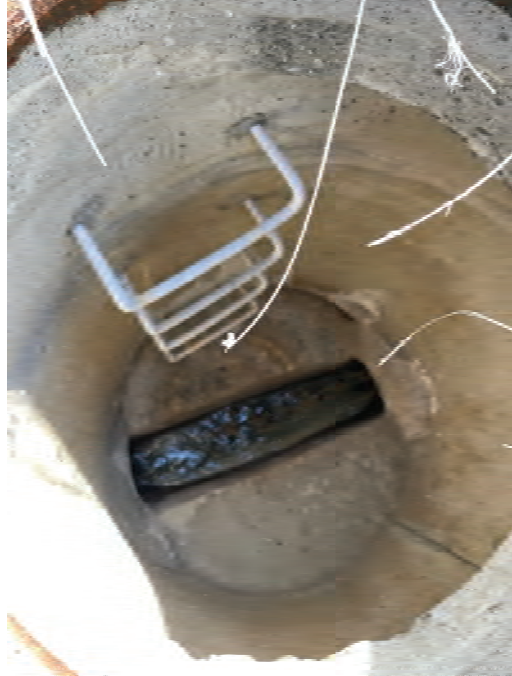
15. Sanitary Sewer Flushing and Inspection – Significant flows containing a significant amount of sand and gravel from floodwater passed through the sanitary sewer system which deposited sediment and may have caused damage within the system.

15. Flush and inspect sanitary system using CCTV.	\$101,100.00	N/A	\$101,100.00	\$101,100.00	CCTV of the Villages sanitary sewer was completed April 18/19, 2023, and can be used to reference and confirm what damage to sanitary sewer system was directly caused by floodwaters. This cost only represents the investigation and doesn't reflect repairs that may be added after the investigation.

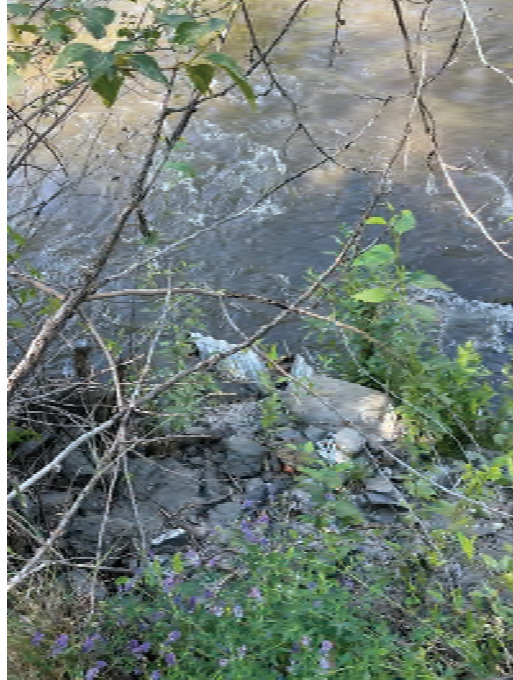
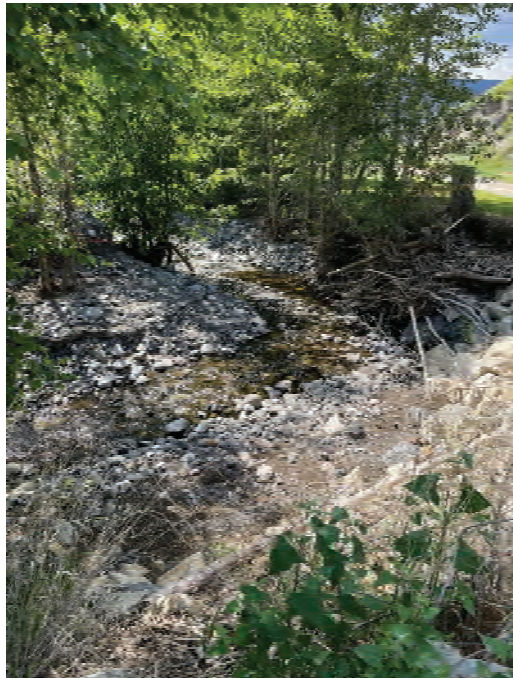
17. Storm Outfalls– the sediment transport during the flood event caused multiple storm outfalls to be buried.

17. Investigate buried storm outfalls with CCTV.	\$10,400.00	N/A	N/A	\$10,400.00	Use CCTV to determine extent of damage and repairs required. This cost only represents the investigation and doesn't reflect repairs that may be added after the investigation.

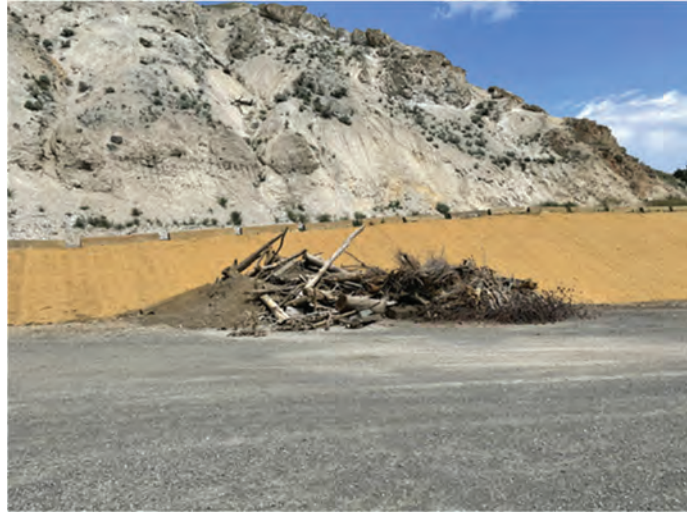
18. Chipping of Woody debris – large woody debris was deposited in the Village after floodwaters receded.

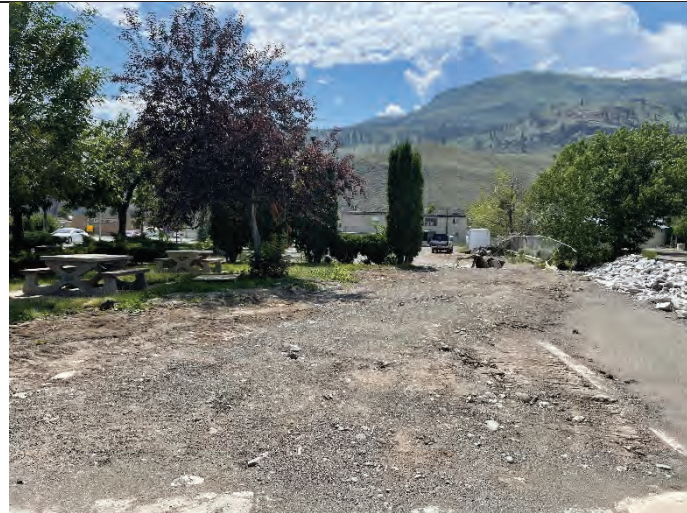
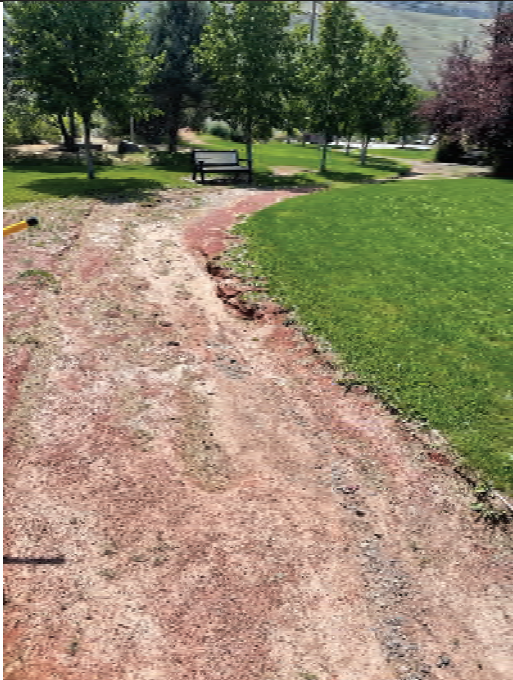
19. Park Rehabilitation – Floodwaters from Cache Creek eroded grass and soils at Firehall Park. Cariboo Sam's Park pathways experienced erosion and sediment deposits.

19. Remove flood debris, regrade path with new gravels and hydroseed grass in damaged parks.	\$22,300.00	N/A	N/A	\$22,300.00	Remove material along park pathway and replace aggregate to recreate a usable, accessible pathway. Hydroseed area where grass was removed during flood.

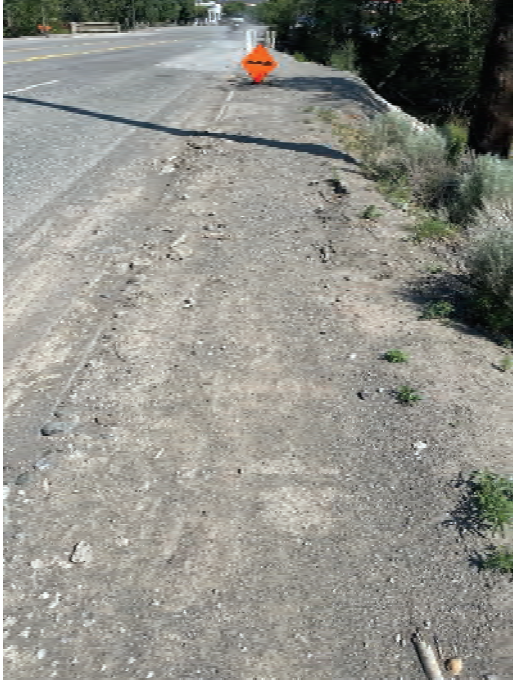
<p>20. Sidewalk Replacement – Extensive lengths of sidewalk owned by the Village was damaged or completely removed along the Trans-Canada-Highway and Highway 97 from Cache Creek floodwaters and emergency response.</p>

20. Replace damaged sidewalk sections.	\$90,400.00	N/A	N/A	\$90,400.00	Excavate fines deposited from floodwaters, replace aggregate as required, frame and pour new concrete sidewalk sections.

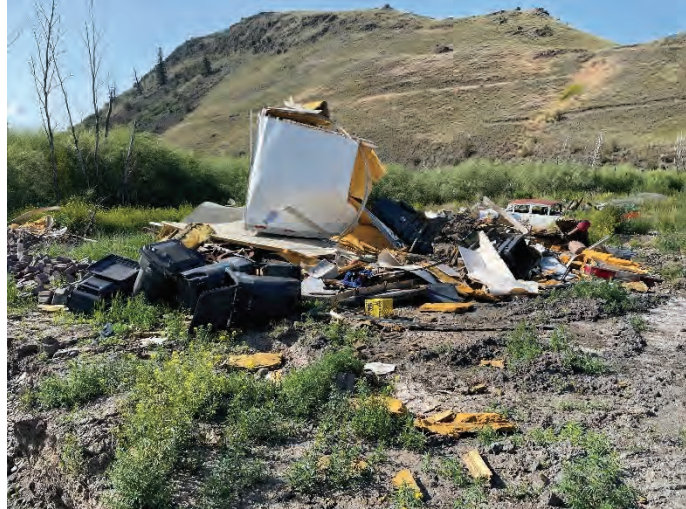
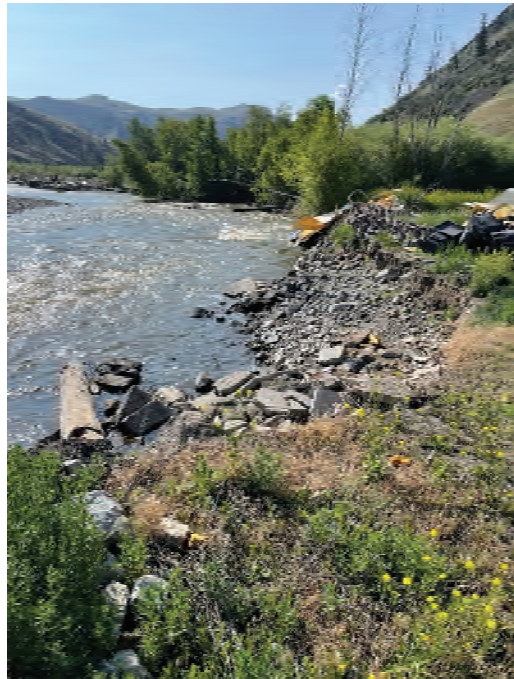
21. Storage Trailer – The Bonaparte River eroded the rivers edge where a Village storage trailer was located. This caused the trailer to tip into the river, fall apart, and scatter debris along the rivers edge.

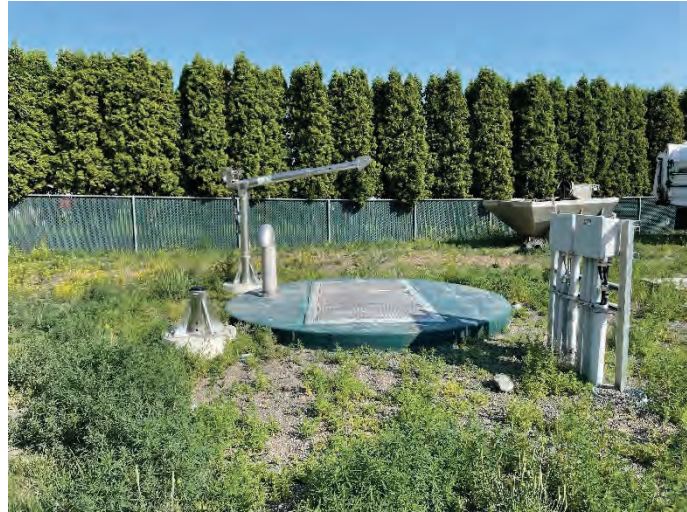
22. WWTP Lift station – high sediment concentrations in the wastewater are likely to have caused excessive wear on lift station pumping components with the impeller of particular concern.

22. Clean WWTP lift station using Hydro-Vac truck for inspection.	\$10,000.00	N/A	N/A	\$10,000.00	Use vac-truck to remove material in lift station and inspect pump impeller to determine if replacement is required to return to pre-flood condition. This cost only represents the investigation and doesn't reflect repairs that may be added after the investigation.

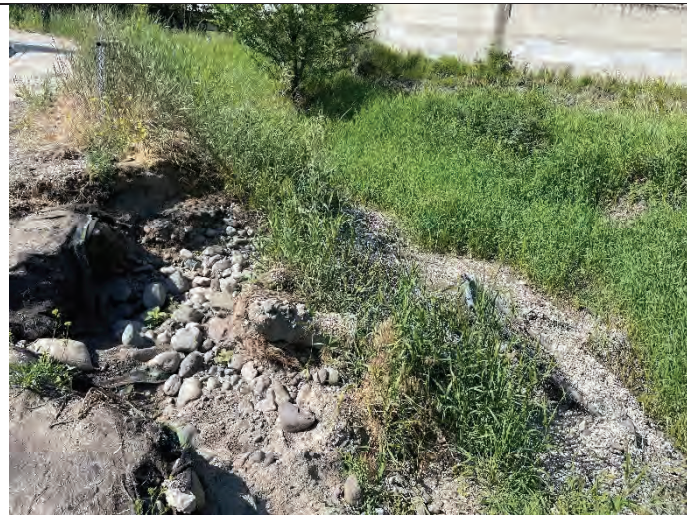
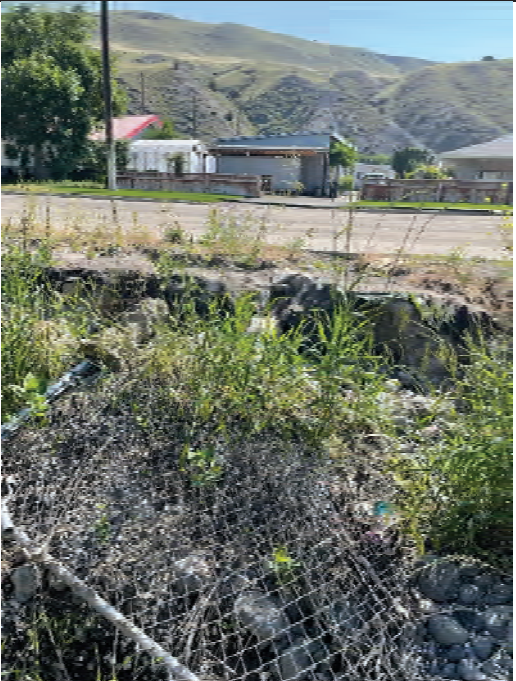
23. Collins Road stormwater outfall – overland flow from Cache Creek conveyed on Collins Road caused an outfall to be both filled with sediment and damaged by flows outside of the outfall which cause erosion in the area. A section of chain-link fence was also damaged by the floodwaters.

23. Clean out and repair outfall, backfill eroded material and repair fencing.	\$11,900.00	N/A	N/A	\$11,900.00	Use vac-truck to remove material from clogged outfall, replace any damaged sections once visual inspection is possible, replace and grade eroded section, seed disturbed earth and repair section of chain link fencing.

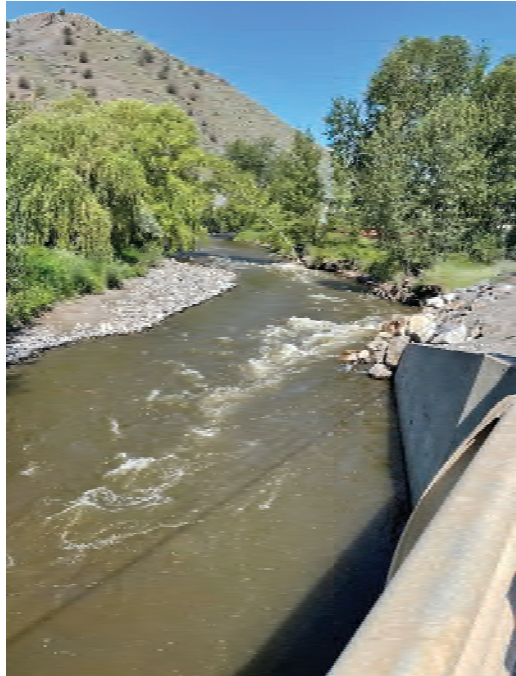
<p>24. Highway bridge damaged watermain – This project refers to the same water crossing damage observed in item 1. The watermain crossing the river was damaged during emergency response. It is likely that the riprap piled on the North bank of the river to protect the bridge abutment caused the damage. The watermain can not be left in its current state.</p>

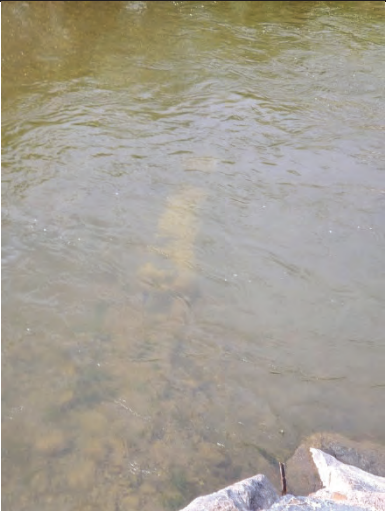
25. Bonaparte River Sanitary crossing – rapid moving floodwater exposed sanitary crossing leaving it with no cover below river bottom.

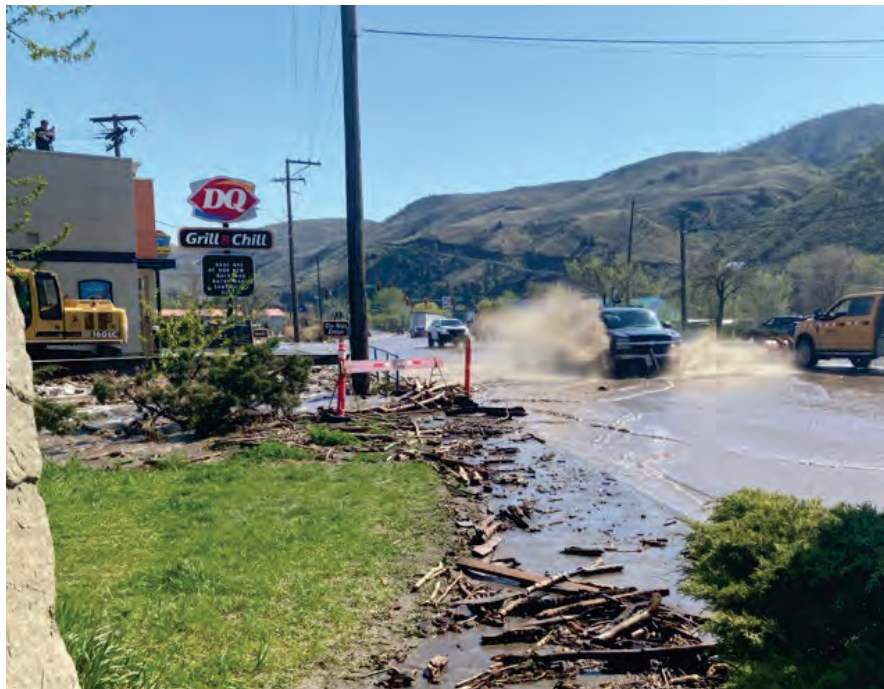
**FIGURE 1-1: CACHE CREEK FLOOD WATERS ON HIGHWAY 97 (MAY 03, 2023)**

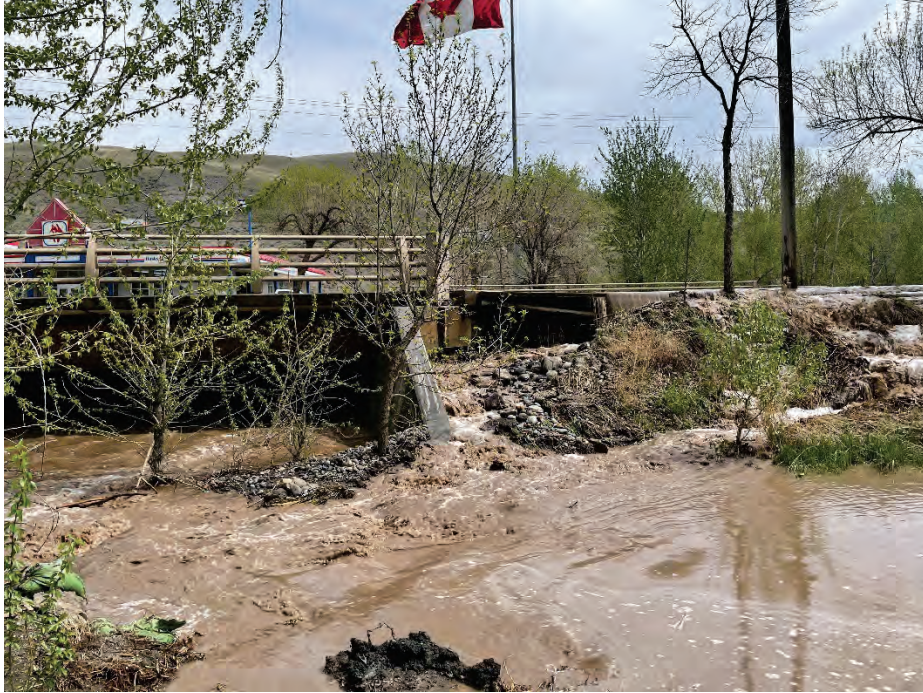
**FIGURE 1-2: EROSION BEHIND TCH BRIDGE ABUTMENT (MAY 03, 2023)**

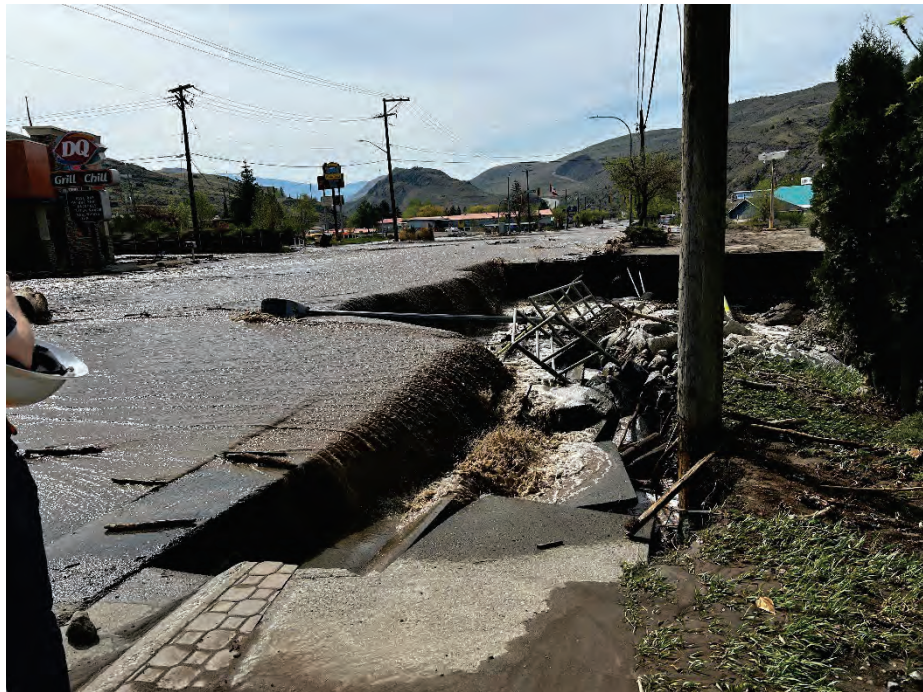
**FIGURE 1-3: HIGHWAY 97 EROSION FROM OVERLAND FLOW (MAY 04, 2023)**

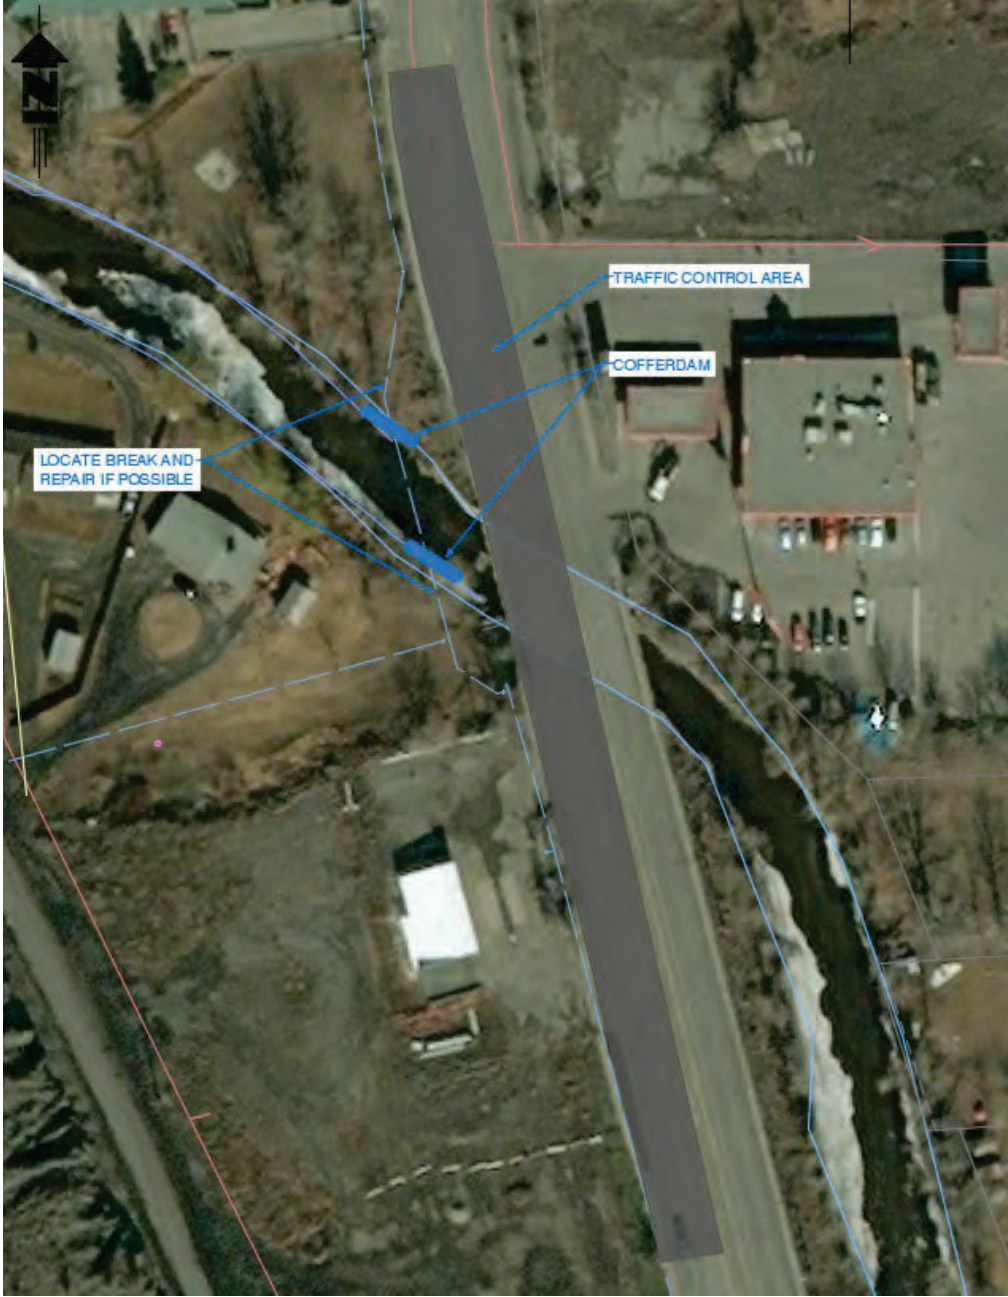
FIGURE 5-1: OPTION 1 HIGH LEVEL SKETCH

- This option involves waiting for flows in the Bonaparte River to recede to seasonal lows, building coffer dams and dewatering to keep a safe dry worksite to locate the damage section of water main and repair it if it is found to be accessible.

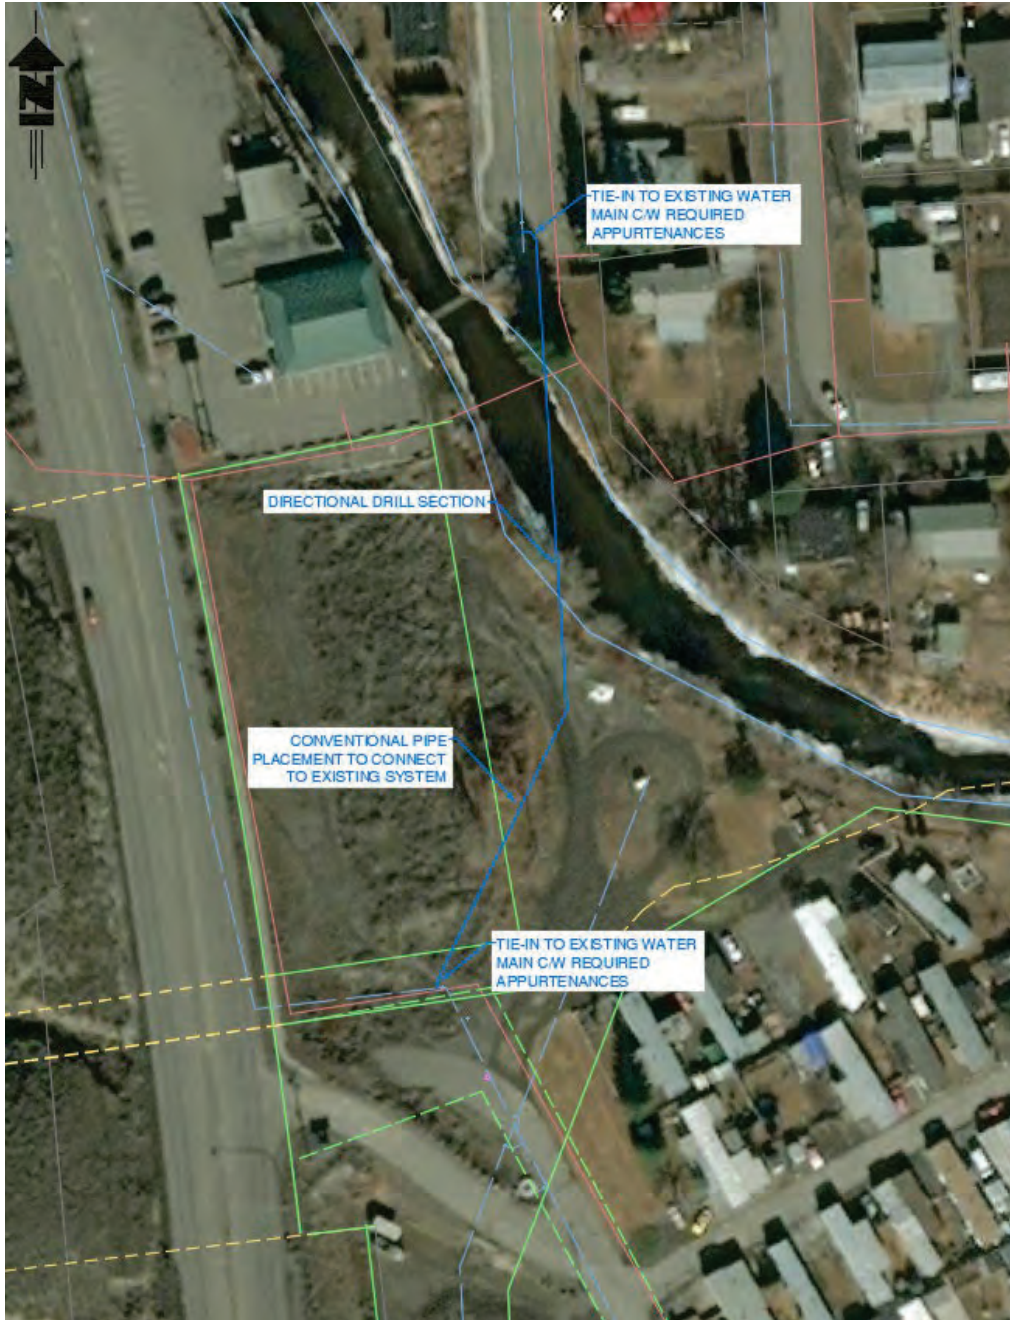
**FIGURE 5-2: OPTION 3 HIGH LEVEL SKETCH**

From this analysis, TRUE recommends proceeding in accordance with Option 3 as we believe it to be the most feasible option to quickly and restore adequate fire flow and clean drinking water supply to the affected residents in the area. This Option represents the lowest risk option recognizing that the break may be in a location that is not accessible and so there is no guarantee

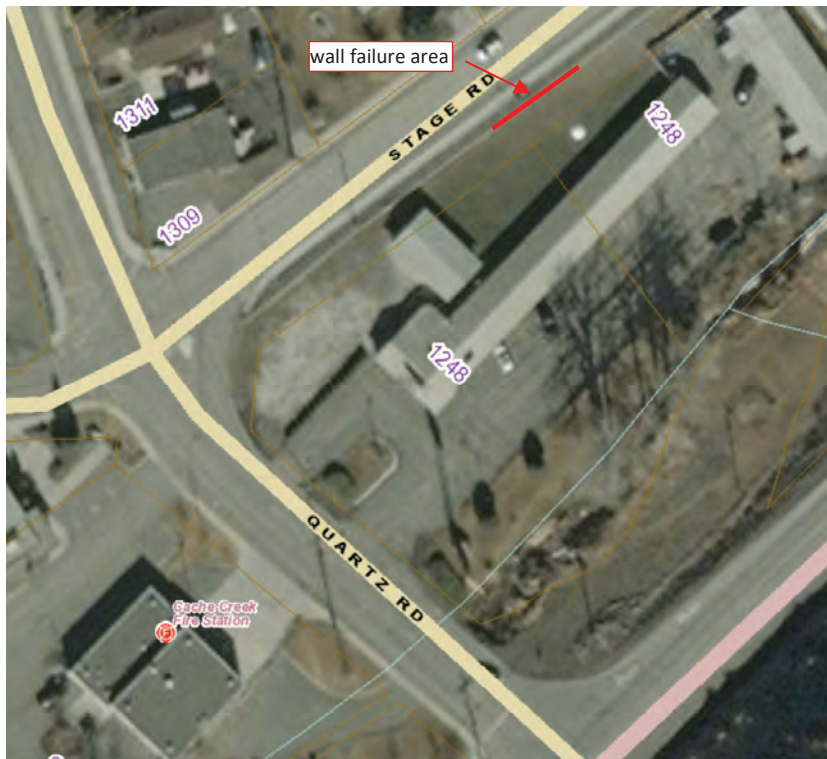
**Observations:** The recent flooding of Cache Creek has caused undermining of the base of the Allan block retaining wall that is currently supporting Stage Road. The approximate location of the wall failure area is shown in red on Figure 1 below.

Figure 1: Wall failure area

A crack approximately 6 m long and 50 to 75 mm wide has developed approximately 0.35 m behind the Allan block wall. The depth of the crack is approximately 0.8 m below the existing ground surface (Figures 1 & 2).

**Recommendations:** In the short term, it is recommended to backfill the wall to support it temporarily where it has been undermined with granular fills to a height of 2.0 m above the base of the wall.

It is recommended that a Geotechnical Engineer review the design drawings to assist with re-building of the wall. The re-building of the wall will have to step up laterally from the outer edges of the failure area to allow for a safe working slope.

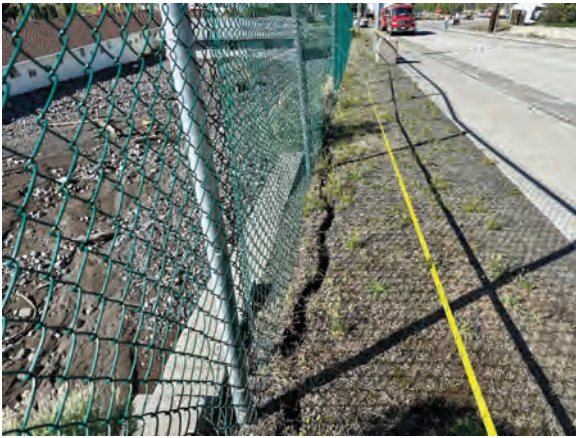
Figure 2: Crack above wall (looking southwest)

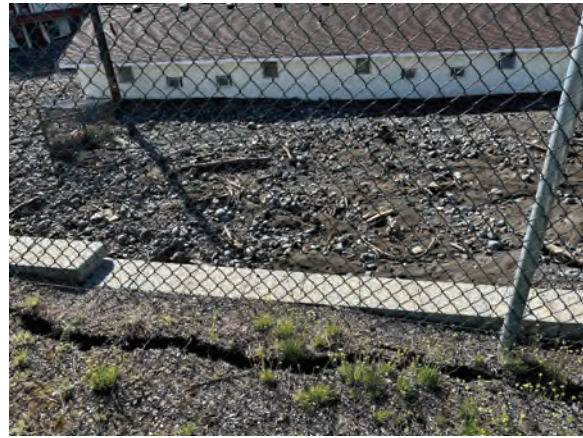
The wall has settled where it was undermined by the flood waters and the upper 3 blocks wall appears to have rotated slightly to a near vertical position (Figures 3 & 4).

Figure 3: Crack above wall (looking southeast)
