# DFA Damage Assessment 2023 Freshet Flooding

Village of Cache Creek

July 2023

Project No. 310-441

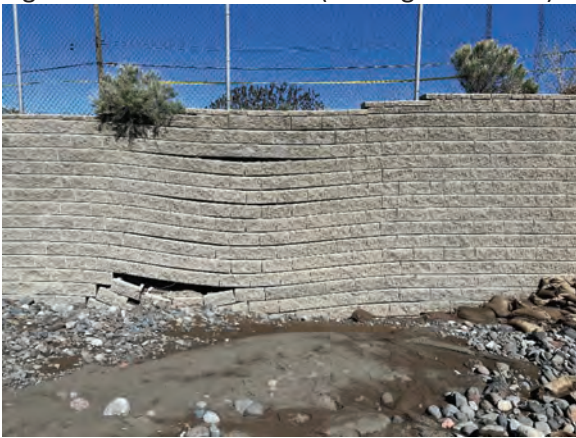
The wall has settled where it was undermined by the flood waters and the upper 3 blocks wall appears to have rotated slightly to a near vertical position (Figures 3 & 4).

Figure 4: Wall failure (looking northwest)

**Conclusions:** The recent flooding has undermined the base of the retaining wall along Stage Road and the erosion of the base soils has caused the wall to settle and rotate vertically. Typically walls of this type are reinforced with geogrid every 2<sup>nd</sup> or 3<sup>rd</sup> block (0.4 to 0.6 m in height) and the geogrid extends 70 to 100% of the wall height behind the wall.

**Recommendations:** In the short term, it is recommended to backfill the wall to support it temporarily where it has been undermined with granular fills to a height of 2.0 m above the base of the wall.

It is recommended that a Geotechnical Engineer review the design drawings to assist with re-building of the wall. The re-building of the wall will have to step up laterally from the outer edges of the failure area to allow for a safe working slope.

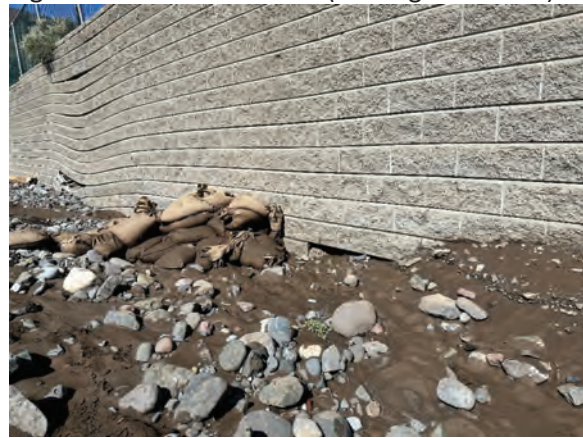
Figure 5: Wall failure (looking southwest)
