## Pinnacle Home Inspection

1234 Main St  
Libby, MT 59923

# Summary

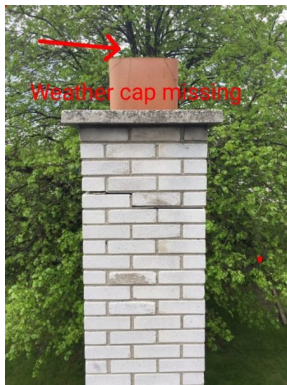
- The chimney is missing a weather-protective cap.

- Chimney is missing weather protective cap. It is recommended to add a cap to protect the chimney from the weather elements
