Nepal: Devastation of Churia

Professor D.D. Poudel, PhD
University of Louisiana at Lafayette, USA

Geological, Hydrological and Socio-economic Dimensions:

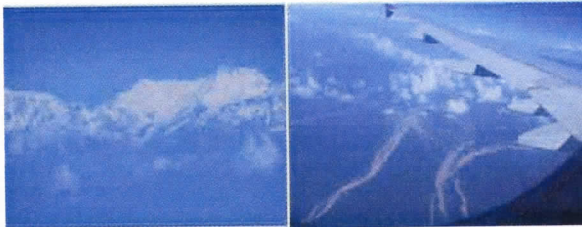
Flying over the landscape often presents a great opportunity for viewing landforms on earth's surface and comprehending the occurrence and the magnitude of geohazards and environmental degradation. In recent years, individuals flying in the skies of Nepal experience not only the majestic and inspiring Himalayas but are also shocked by the countless scars of landslides, especially in the Churia region, as well as bare mountains, massive river-cuttings, and blanket of polluting haze over developed cities such as Kathmandu. One can clearly notice the aftermath of severe landslides, debris-flow, and flooding, and the degradation of Churia region from the sky as the plane descends for landing at the Tribhuvan International Airport in Kathmandu.

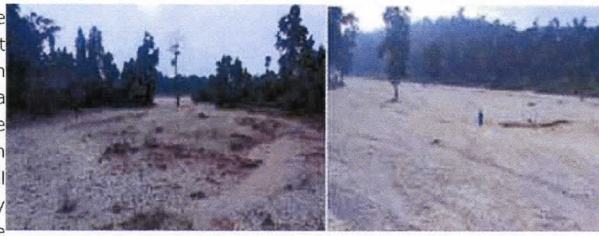
the not too distant future. With some exceptions, most Churia rivers that originate from the Chure hills contain water for only a limited duration in a year. These rivers contain an abundance of exposed rocks, pebbles, and gravel in their beds at distances up to several miles from their origin, where they literally appear as "Rock Beds". The pictures below show a Churia river and its tributary near Hetauda. Several similar tributaries were observed a short distance away.
