Graphite Heat Exchanger Repair – Case Study

InKorr Pty Ltd
Specialising in Heat Exchanger Service – Maintenance - Repairs

InKorr Graphite Heat Exchanger Repair Service Highlights

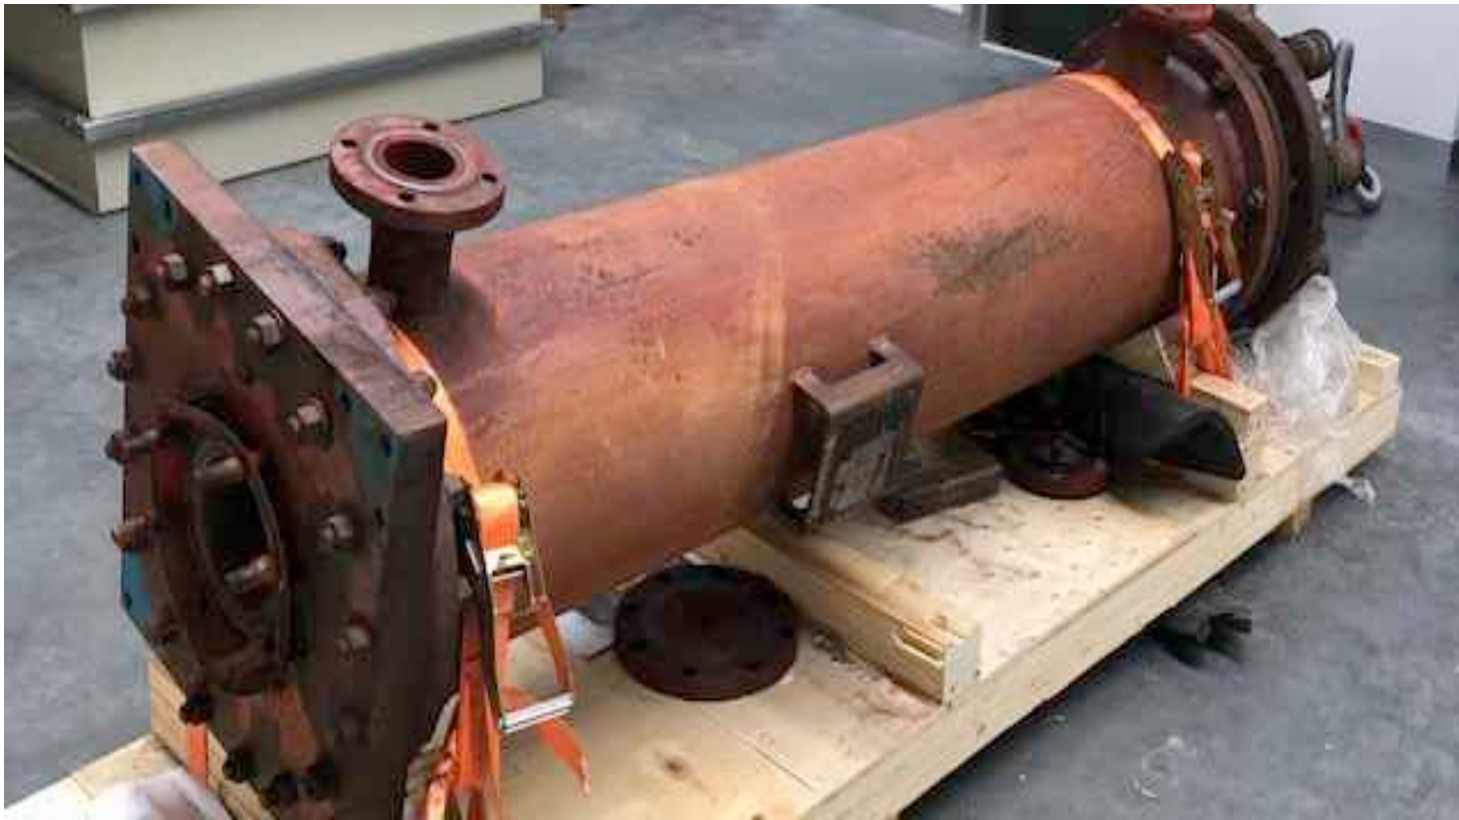
Incoming Exchanger Badly Corroded Steel Parts

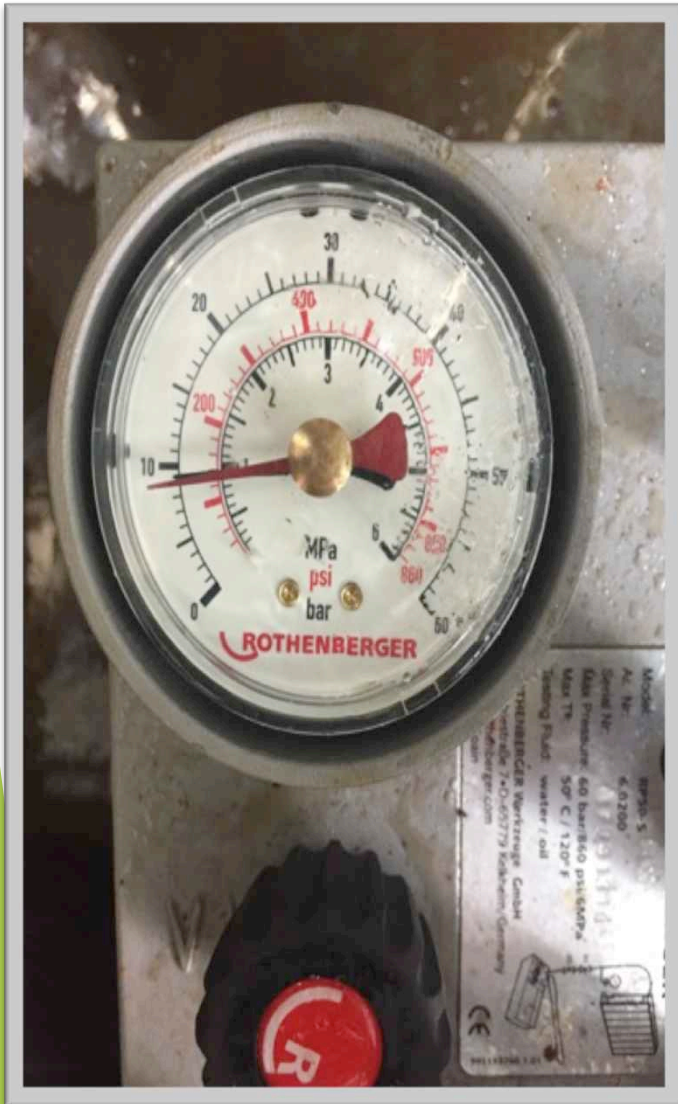
EXAMPLE INITIAL PRESSURE TESTING

▶ Process Loop Successful
@ 9Bar (30min)

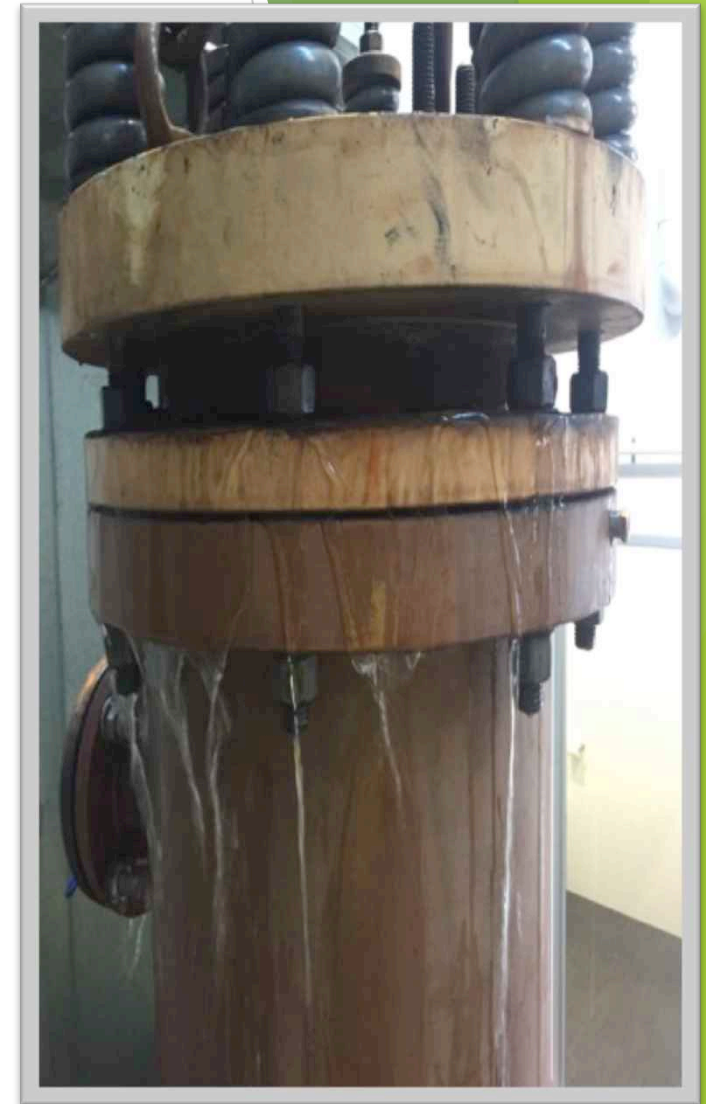
▶ Service Loop Fail,
Leak between Shell
and Compression Ring
@ Tap Pressure

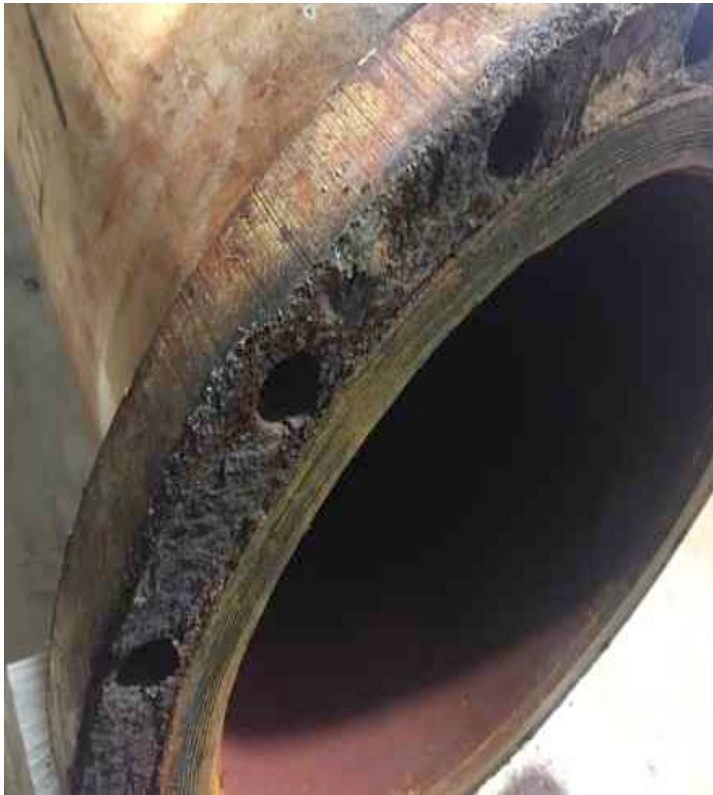
BEFORE

Shell Flange Corrosion

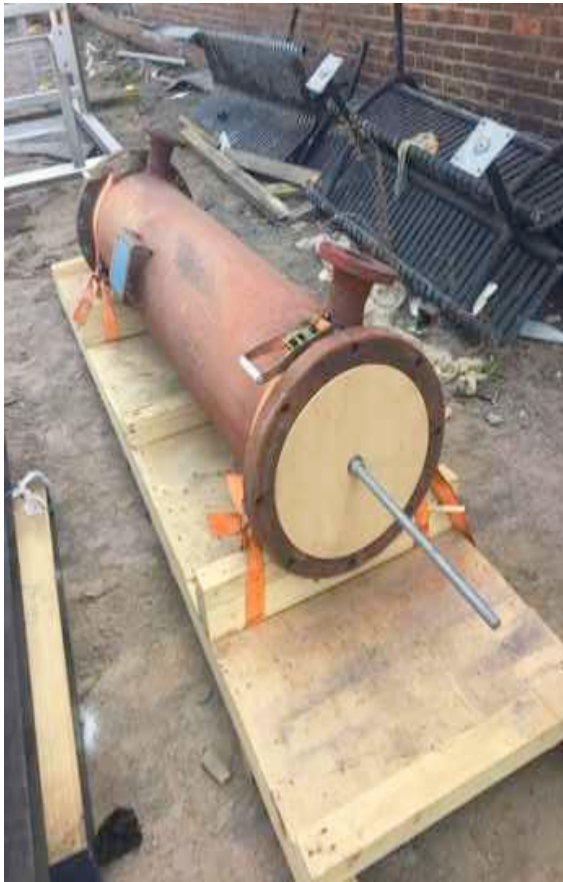
Before

Heat Exchanger Shell

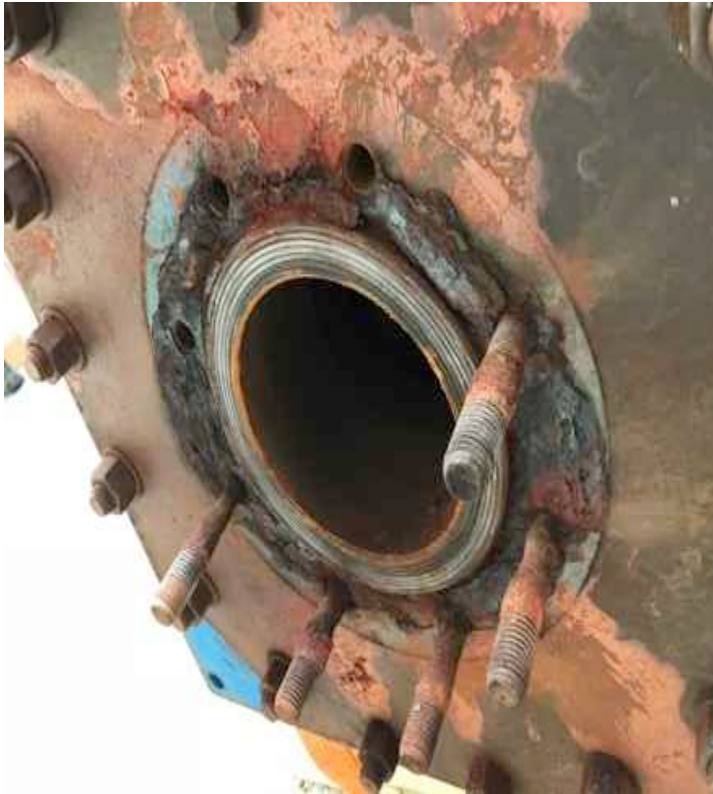
BEFORE

Corrosion Around Nozzle

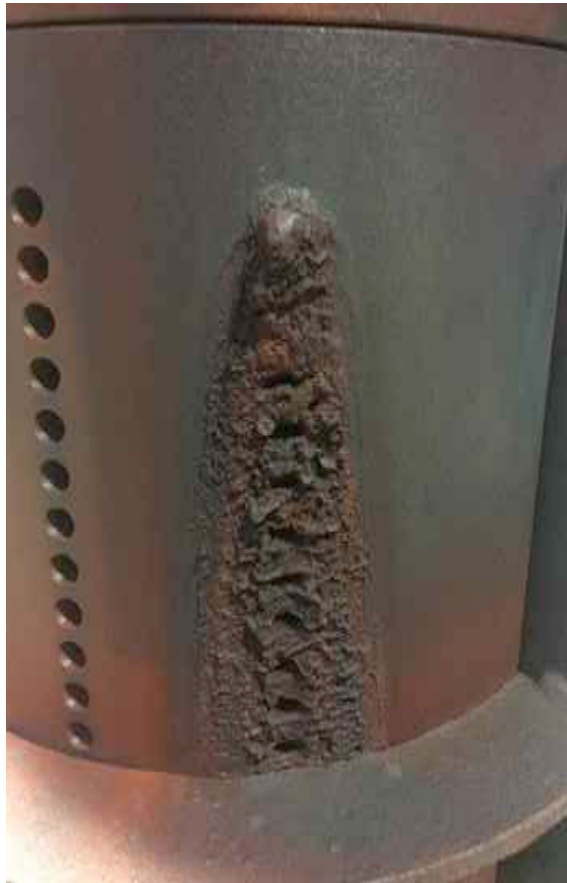
BEFORE

Blocks Steam Side

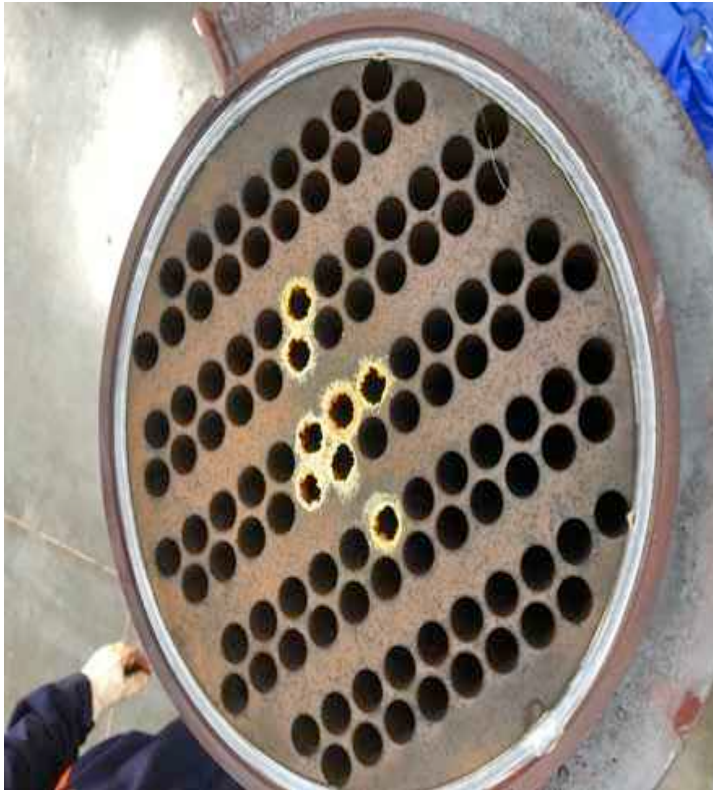
BEFORE

Block Process Side Cleaning

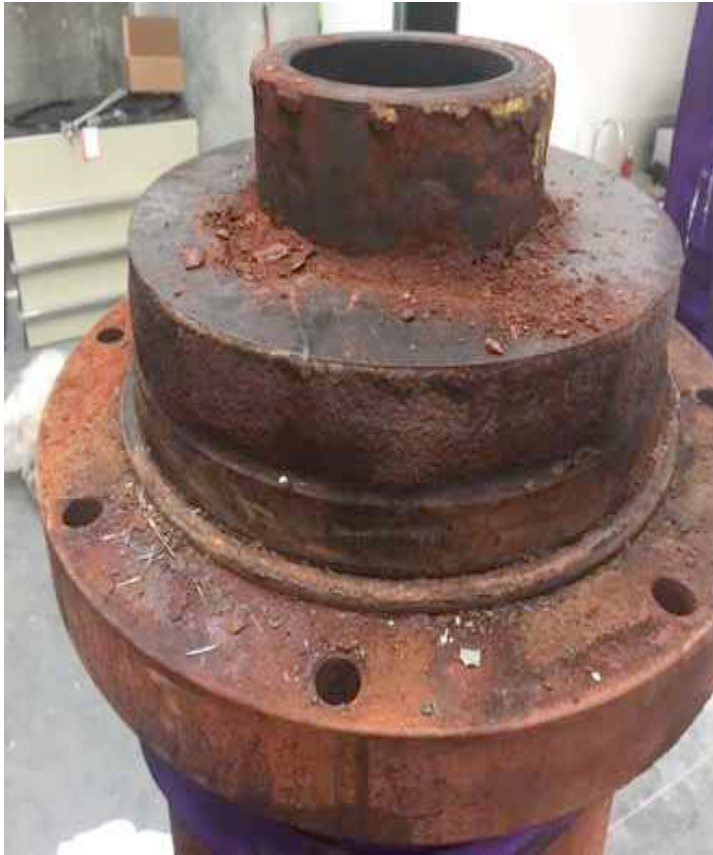
Before

Top Header Assembly

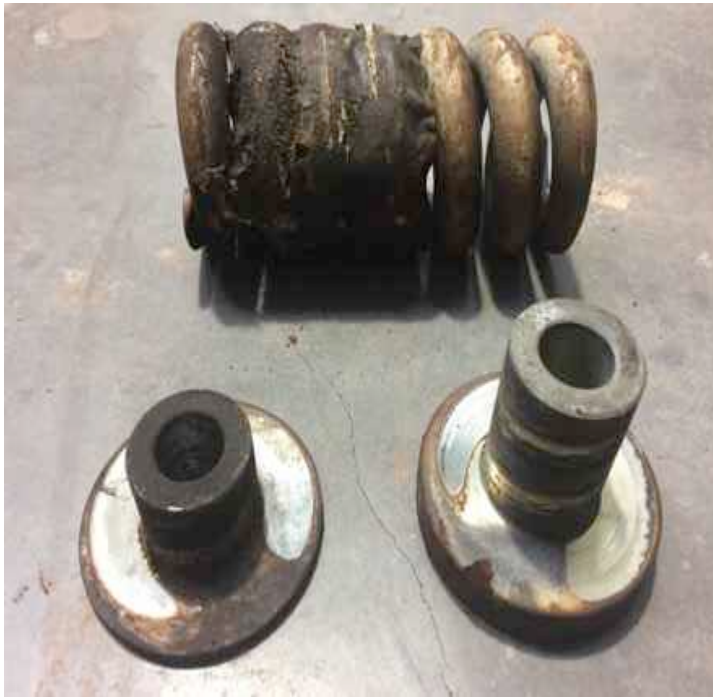
Before

Tensioning Springs

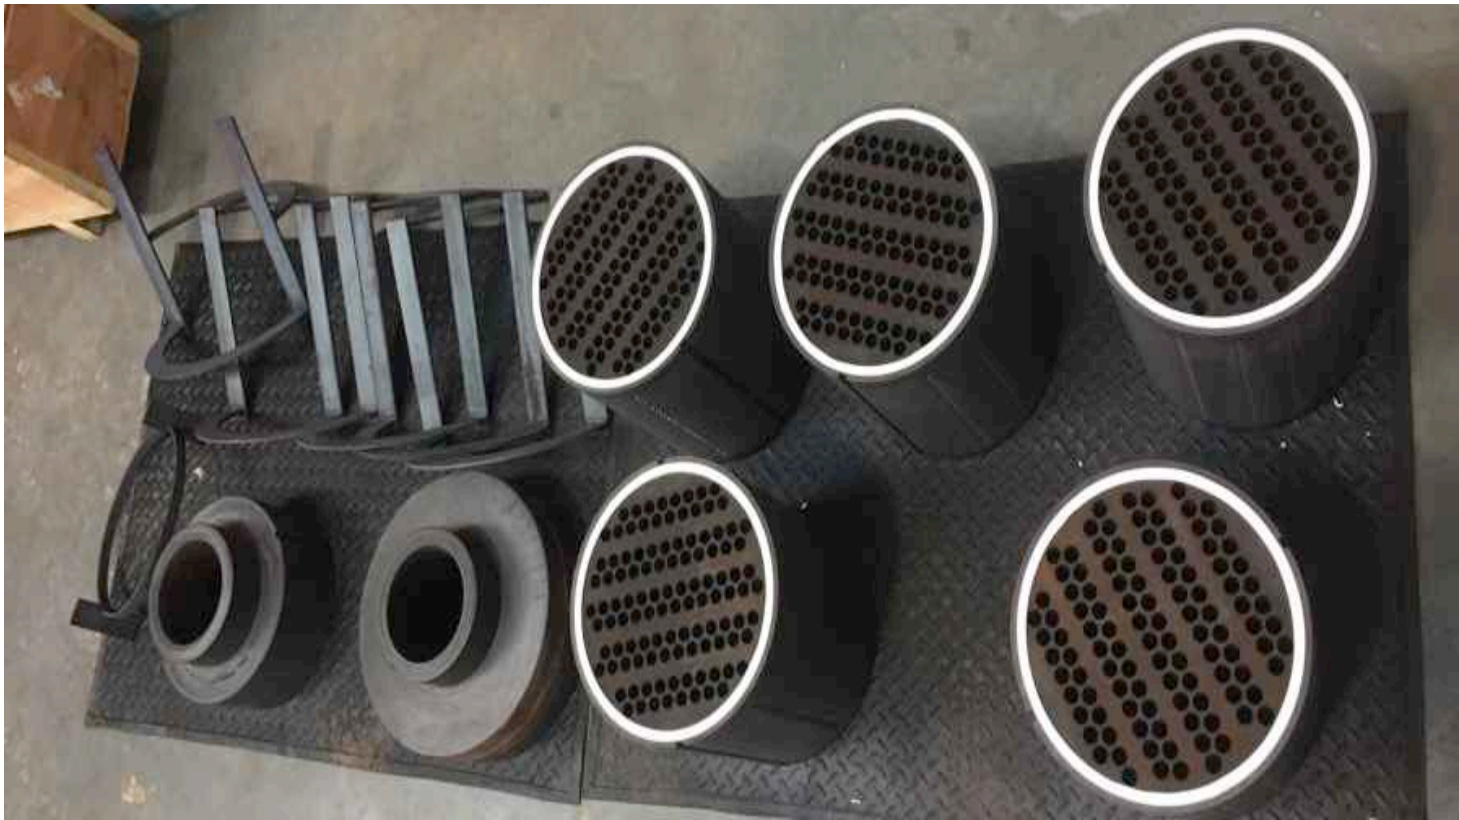
Blocks and Baffles Prepared

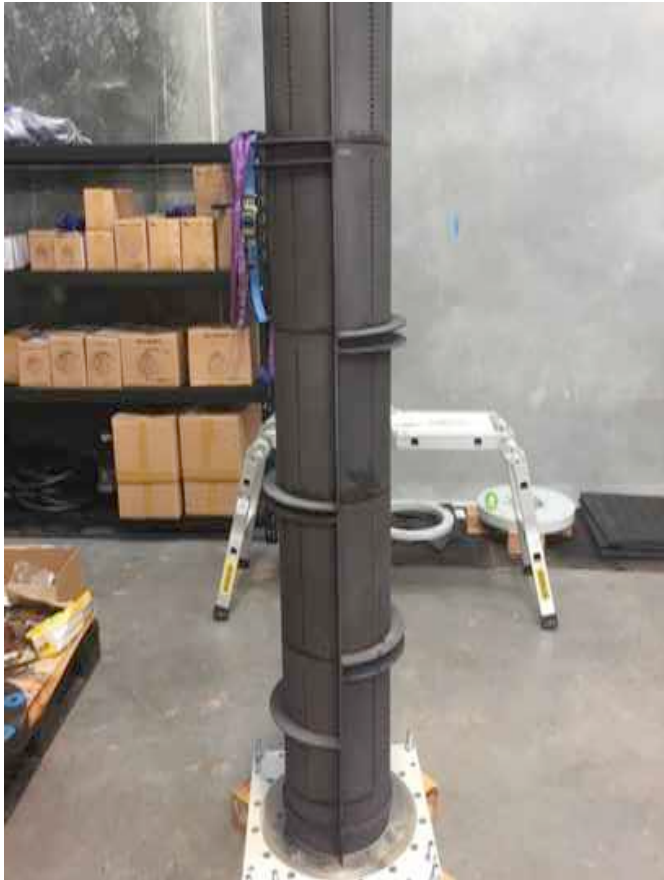
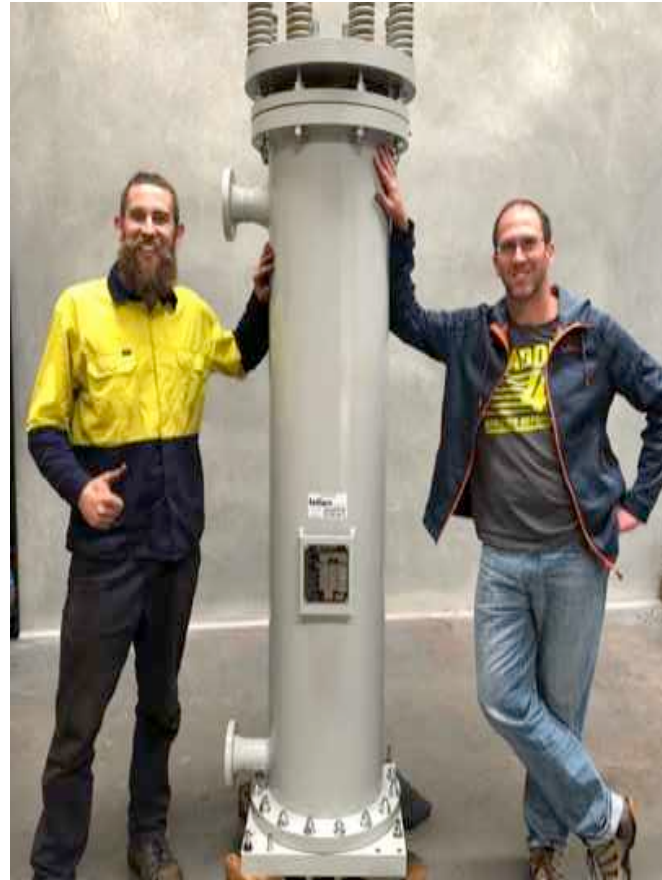
Fully Assembled

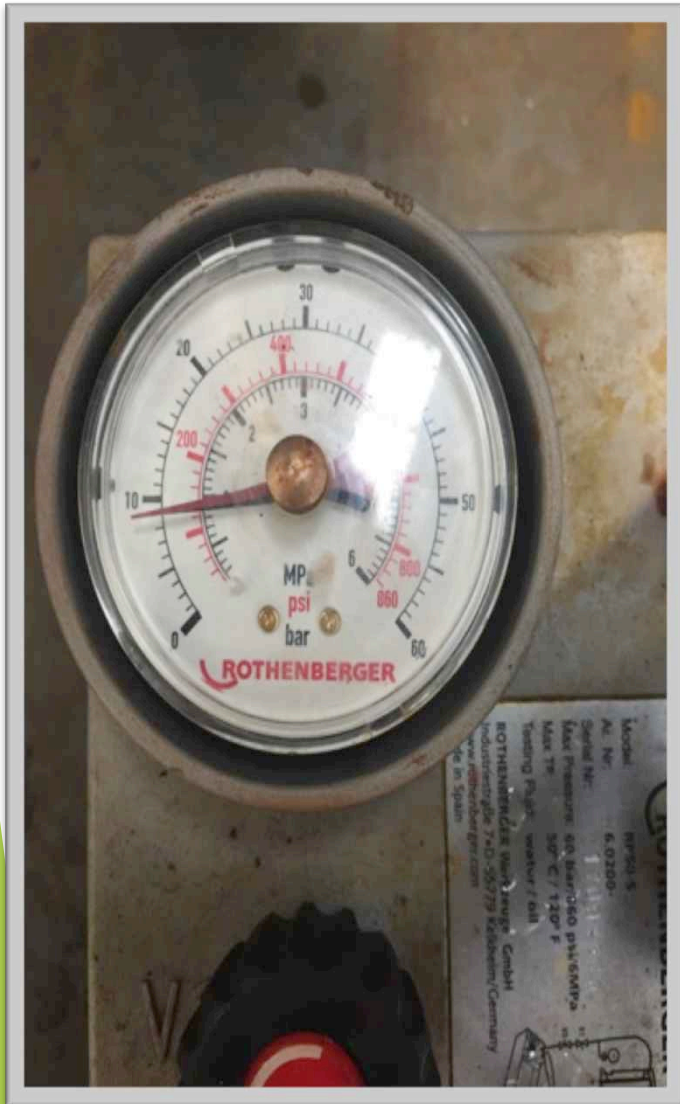
FINAL PRESSURE TESTING

▶ Process Loop Successful
@ 9Bar (30min)

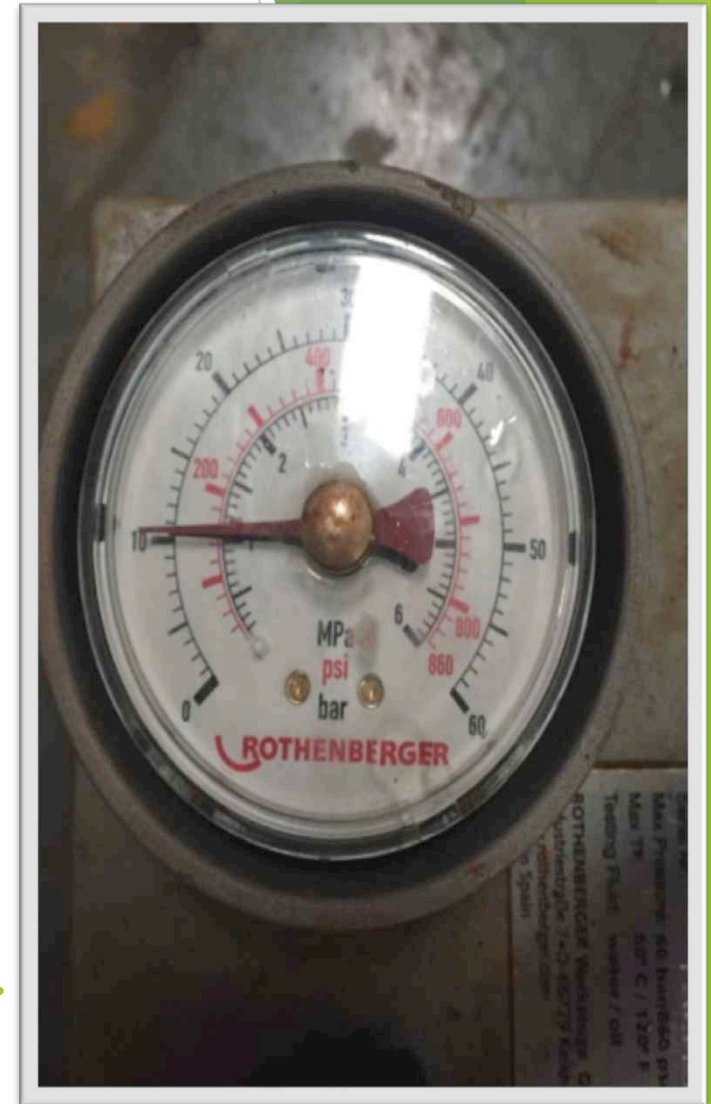
▶ Service Loop Successful
@ 10.5Bar (30min)
