INSPECTION REPORT BY FERGUSON GHS

You Property, Anywhere Perryville MO 63775

Your Property JANUARY 22, 2021

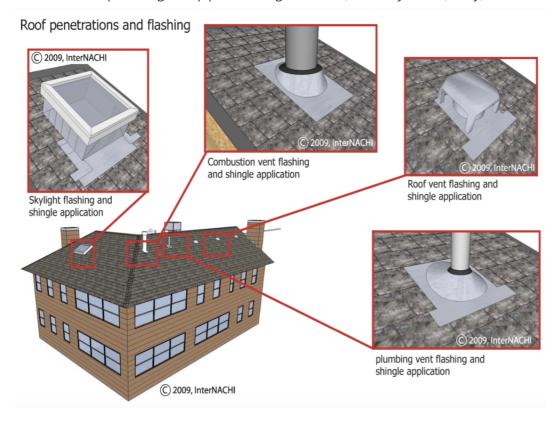
Plumbing Vent Pipes: Plumbing Vent Pipes Inspected

I looked at DWV (drain, waste and vent) pipes that pass through the roof covering. There should be watertight flashing (often black rubber material) installed around the vent pipes. These plumbing vent pipes should extend far enough above the roof surface.

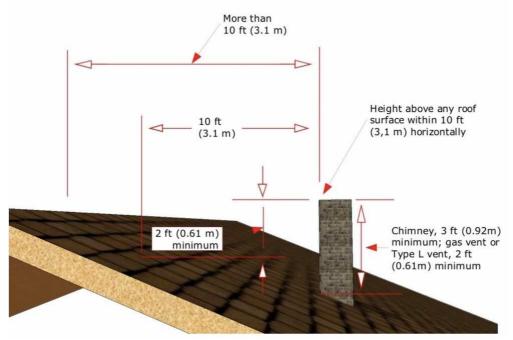
CHIMNEY CLEARANCE DEFECT 3-2-10

I observed indications of inadequate clearances for the masonry chimney stack. The 3-2-10 Rule for masonry chimneys states that a masonry chimney should extend at least 3 feet above the highest point where the chimney passes through the roof, and 2 feet above any portion of a building that is within a 10-foot distance horizontally.

Contact a qualified chimney contractor.

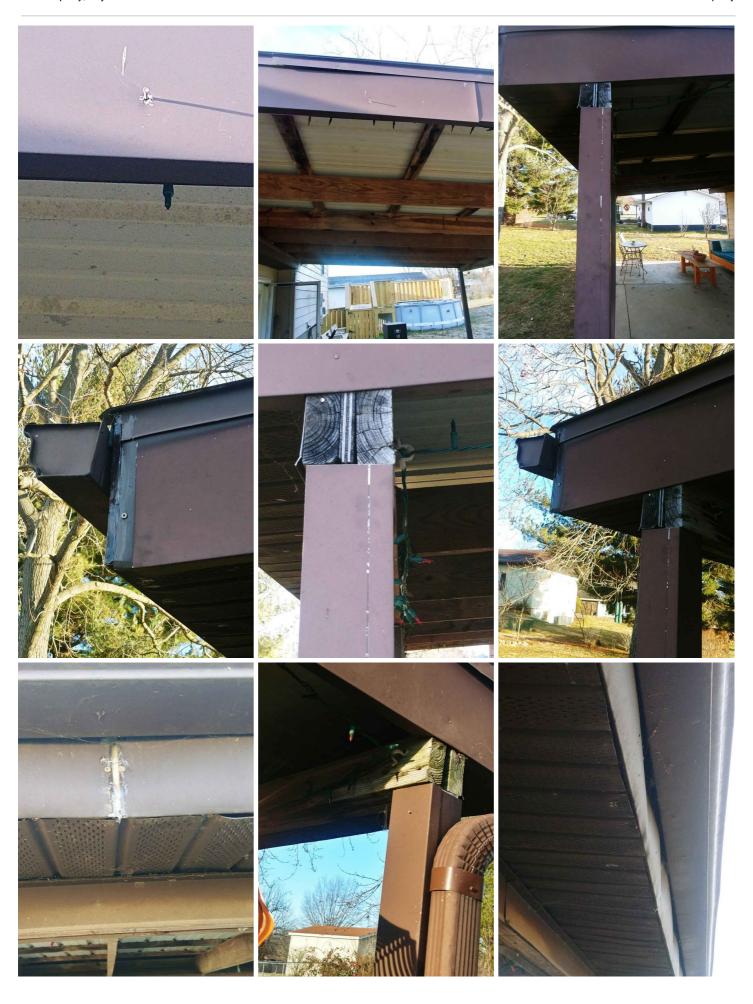
DAMAGE OBSERVED AT EAVES

I observed indications that one or more areas of the eaves were damaged.

Correction and further evaluation is recommended.

Contact a qualified general contractor.

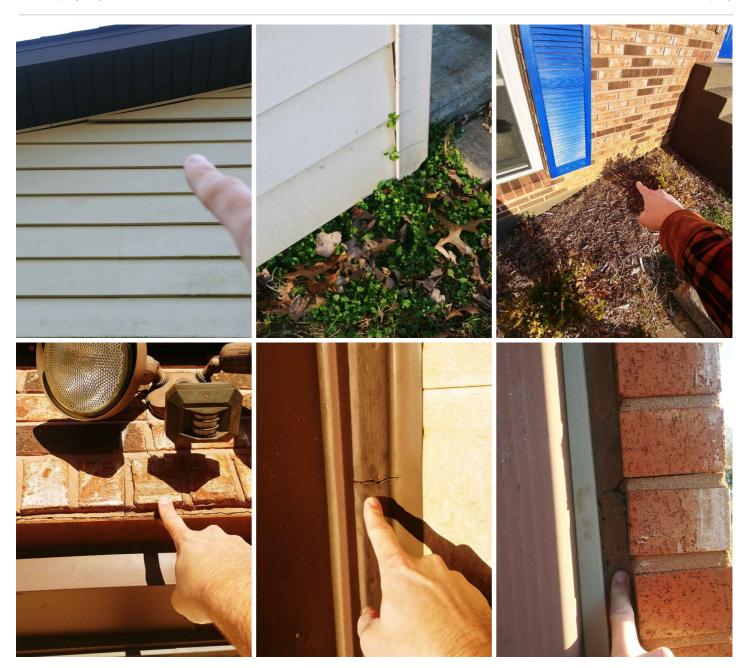
DAMAGED WALL-COVERING MATERIAL

Correction and further evaluation is recommended.

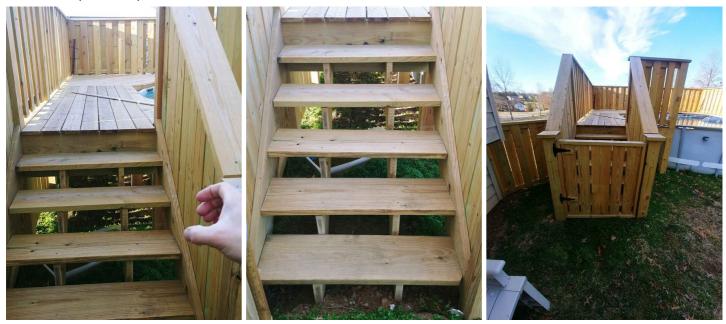
MISSING HANDRAIL

I observed a missing handrail.

There is more than one step here, and I recommend installing a handrail for safety.

Contact a qualified professional.

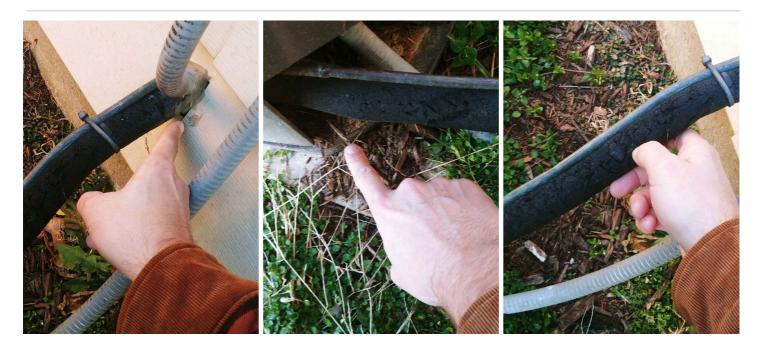
REFRIGERANT LINE INSULATION MISSING OR DAMAGED

I observed missing or damaged foam insulation at the cooling system's refrigerant line, which can cause energy loss and condensation.

Contact a qualified HVAC professional.

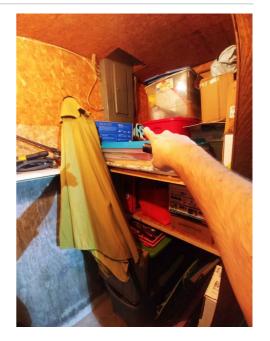
I observed indications of a major defect during the inspection. Major defect. Hazard. Correction and further evaluation is recommended.

Contact a qualified electrical contractor.

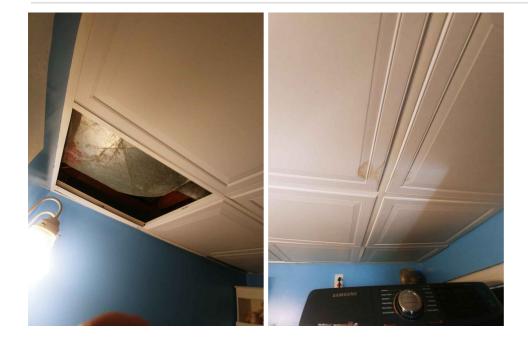
CEILING DAMAGE

I observed damage at the bathroom ceiling.

Contact a qualified handyman.

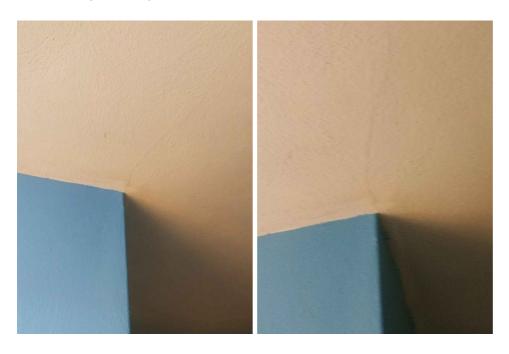
MINOR CORNER CRACKS

Minor cracks at the corners of doors and windows in walls. Appeared to be the result of long-term settling. Some settling is not unusual in a home of this age and these cracks are not a structural concern.

Contact a qualified professional.

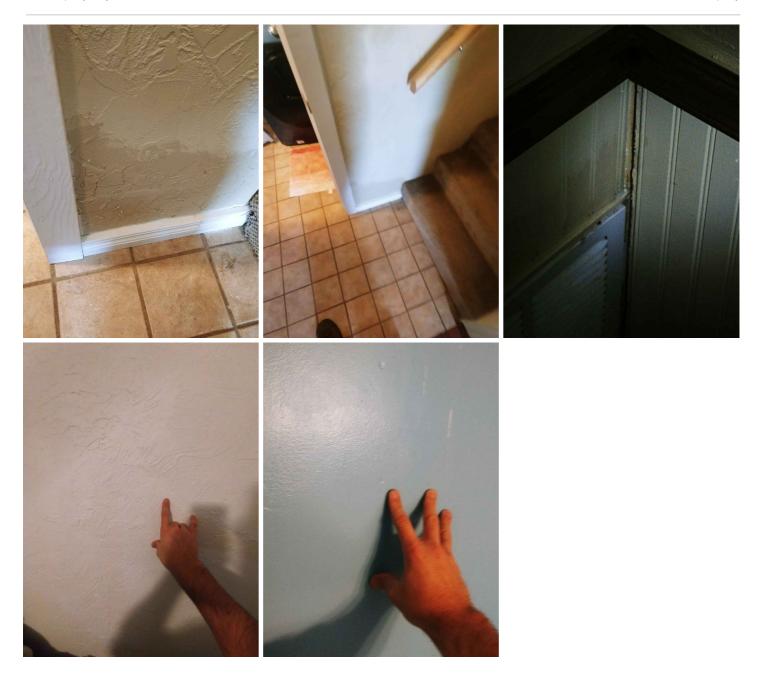
POOR PATCHING

Sub-standard drywall patching observed at time of inspection. Recommend re-patching.

Contact a qualified drywall contractor.
