WETLAND DETERMINATION DATA FORM – Atlantic and Gulf Coastal Plain Region

Project/Site: Axis - Redfish Facility City/County: San Patricio Co. Sampling Date: 11/27/2018
 Applicant/Owner: Axis Midstream Partners, LLC State: TX Sampling Point: R-5
 Investigator(s): R. Ganczak & A. Snellgrove Section, Township, Range: NA
 Landform (hillslope, terrace, etc.): pimple mound Local relief (concave, convex, none): convex Slope (%): 0
 Subregion (LRR or MLRA): LRRT/150B Lat: 27.875746° Long: -97.160668° Datum: WGS 84
 Soil Map Unit Name: Is - Ijam - rarely flooded NWI classification: NA

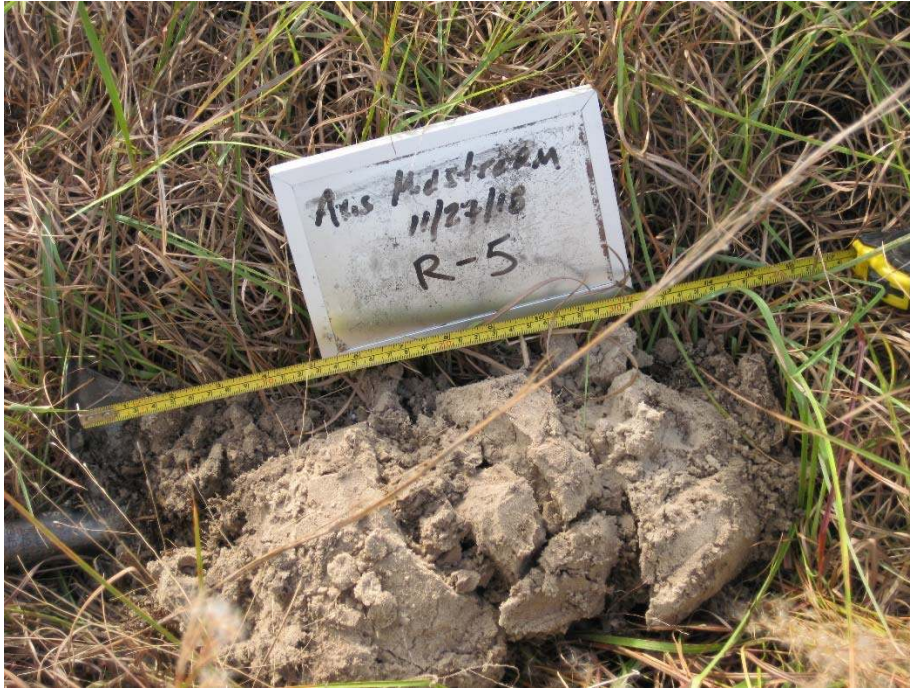
Photo 17 – Soil Sample at Plot R-5

Depth (inches)	Matrix		Redox Features				Texture	Remarks
	Color (moist)	%	Color (moist)	%	Type ¹	Loc ²		
0-15	10YR 6/3	100					sandy silt

Plot does not meet hydric soil criteria.

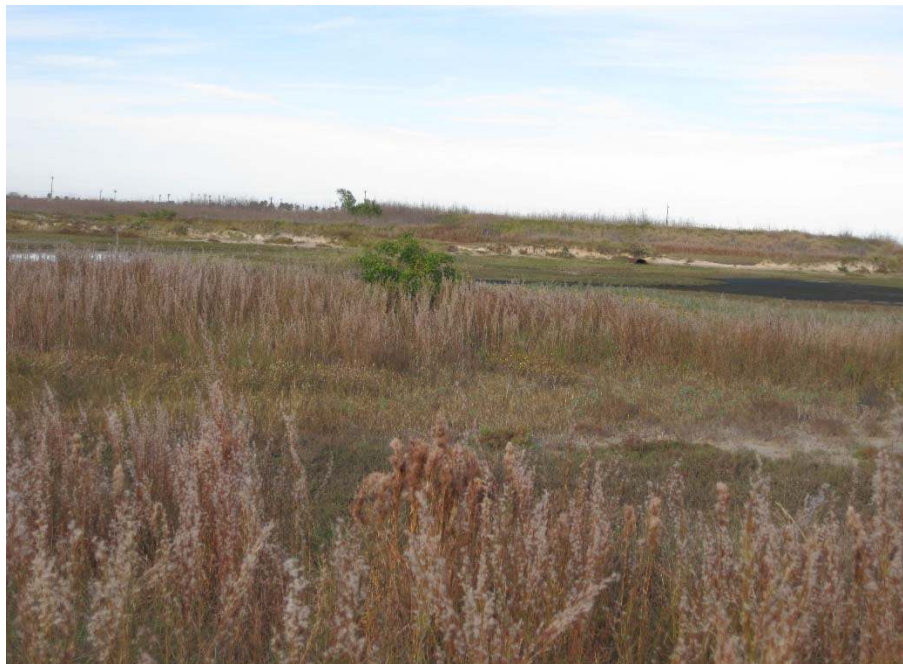
Photo 18 – Vegetation at Plot R-5 looking westerly.

1. <u>none</u>				
2. _____				
3. _____				
4. _____				
5. _____				
_____ = Total Cover				
50% of total cover: _____		20% of total cover: _____		
Remarks: (If observed, list morphological adaptations below).				
Plot meets hydrophytic vegetation criteria (DT & PI).

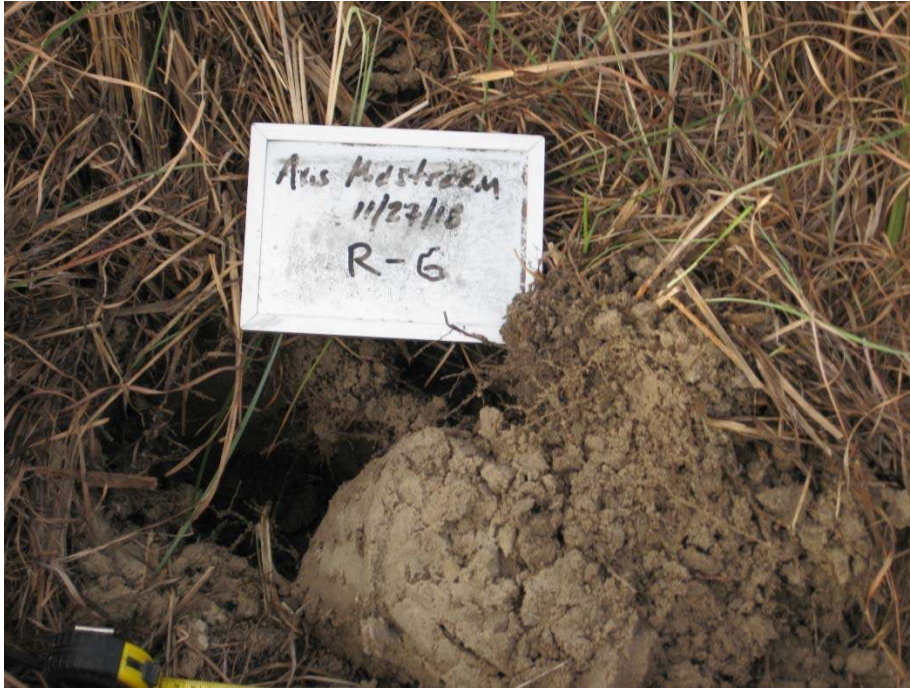
Photo 19 – Soil Sample at Plot R-6

Depth (inches)	Matrix		Redox Features				Texture	Remarks
	Color (moist)	%	Color (moist)	%	Type ¹	Loc ²		
0-6	10YR 5/2	100					sandy loam	
6-15	10YR 7/3	100					sandy loam

Plot does not meet hydric soil criteria.

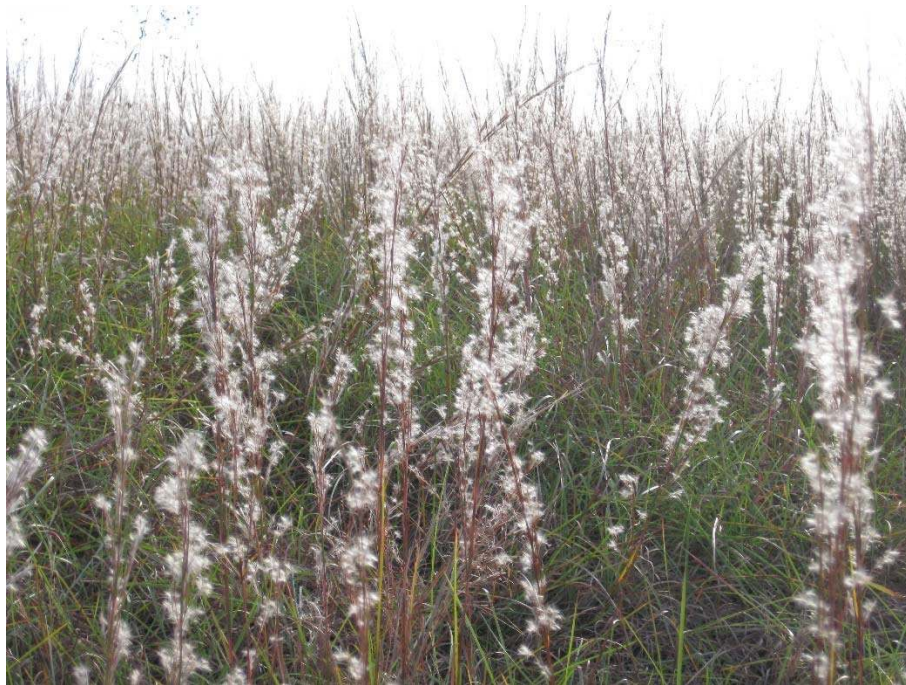
Photo 20 – Vegetation at Plot R-6 looking southwesterly.

1. <u>none</u>				
2. _____				
3. _____				
4. _____				
5. _____				
_____ = Total Cover				
50% of total cover: _____		20% of total cover: _____		
Remarks: (If observed, list morphological adaptations below).				
Plot meets hydrophytic vegetation criteria (DT & PI).

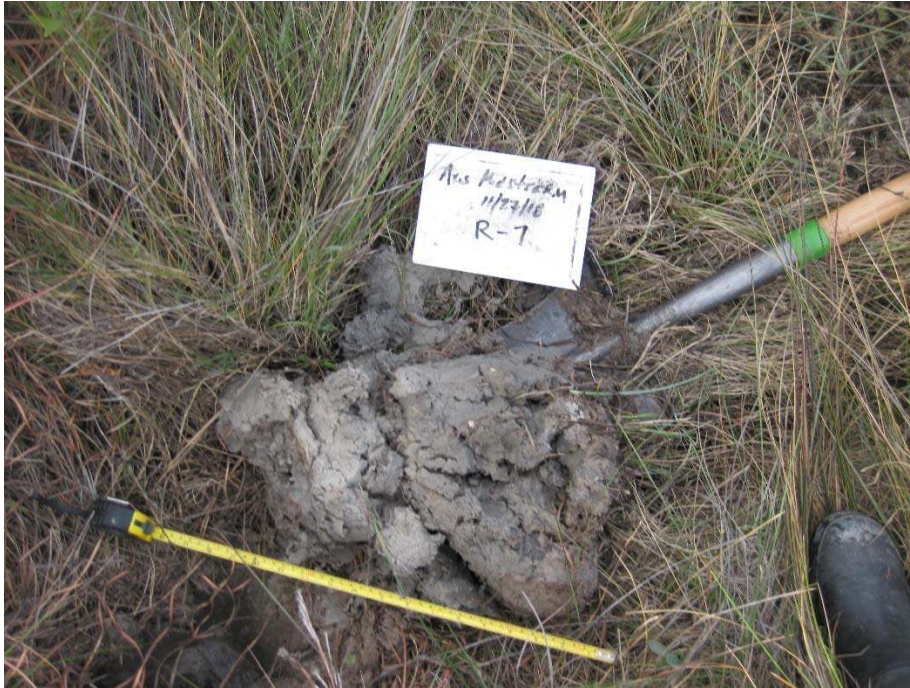
Photo 21 – Soil Sample at Plot R-7

Depth (inches)	Matrix		Redox Features				Texture	Remarks
	Color (moist)	%	Color (moist)	%	Type ¹	Loc ²		
0-7	10YR 4/1	95	10YR 6/1	5	D	M	sandy loam	
7-16	10YR 6/1	100					sandy loam

Plot does meet hydric soil criteria.

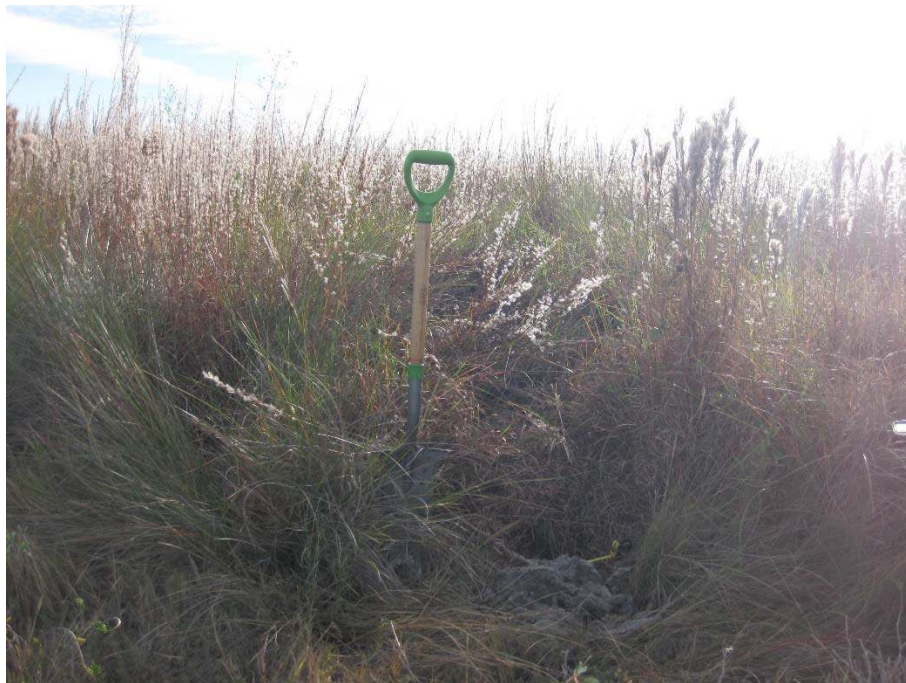
1. <u>none</u>				
2. _____				
3. _____				
4. _____				
5. _____				
_____ = Total Cover				
50% of total cover: _____		20% of total cover: _____		
Remarks: (If observed, list morphological adaptations below).				
Plot meets hydrophytic vegetation criteria (DT & PI).

Photo 22 – Vegetation at Plot R-7 looking easterly. Note elevation change.

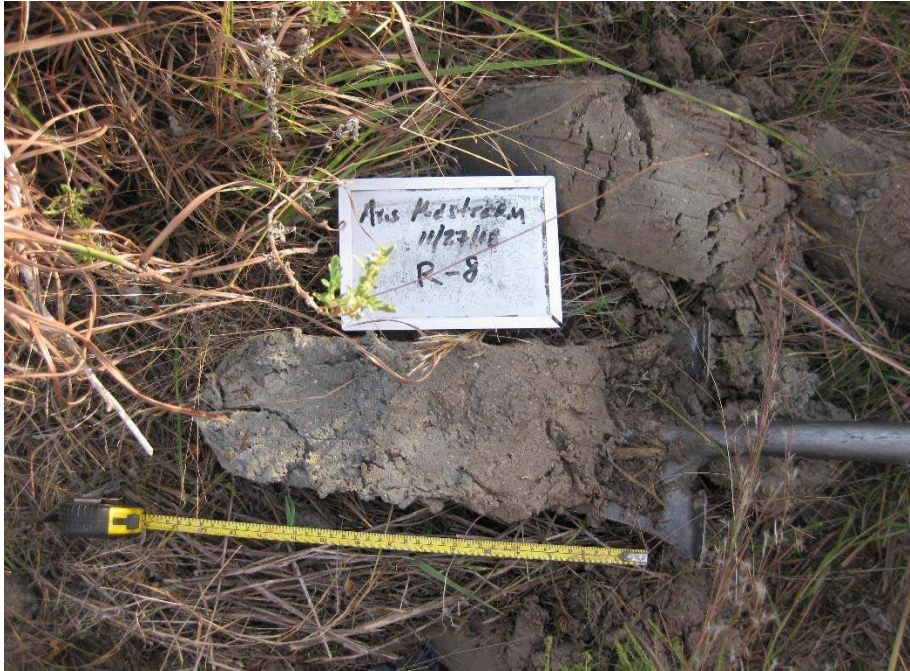
Photo 23 – Soil Sample at Plot R-8

Depth (inches)	Matrix		Redox Features				Texture	Remarks
	Color (moist)	%	Color (moist)	%	Type ¹	Loc ²		
0-8	10YR 5/2	100					sandy loam	shell debris
8-16	10YR 5/1	100					sandy loam	shell debris

Plot does not meet the hydric soil criteria.

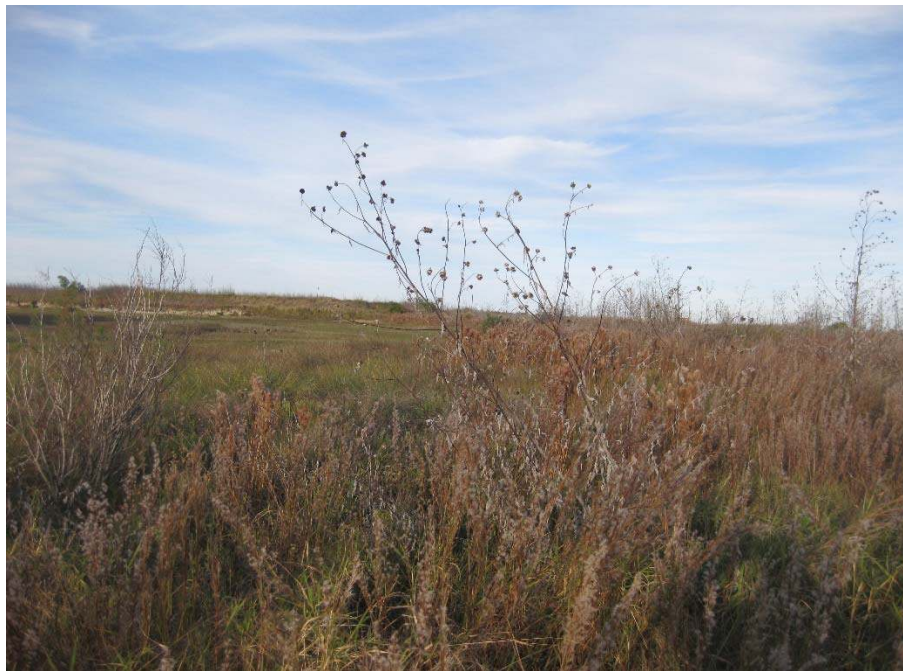
Photo 24 – Vegetation at Plot R-8 looking northeasterly.

1. none					
2.					
3.					
4.					
5.					
_____ = Total Cover				Hydrophytic Vegetation Present? Yes _____ No <u>X</u>	
50% of total cover: _____ 20% of total cover: _____					
Remarks: (If observed, list morphological adaptations below).					
Plot does not meet the hydrophytic vegetation criteria.

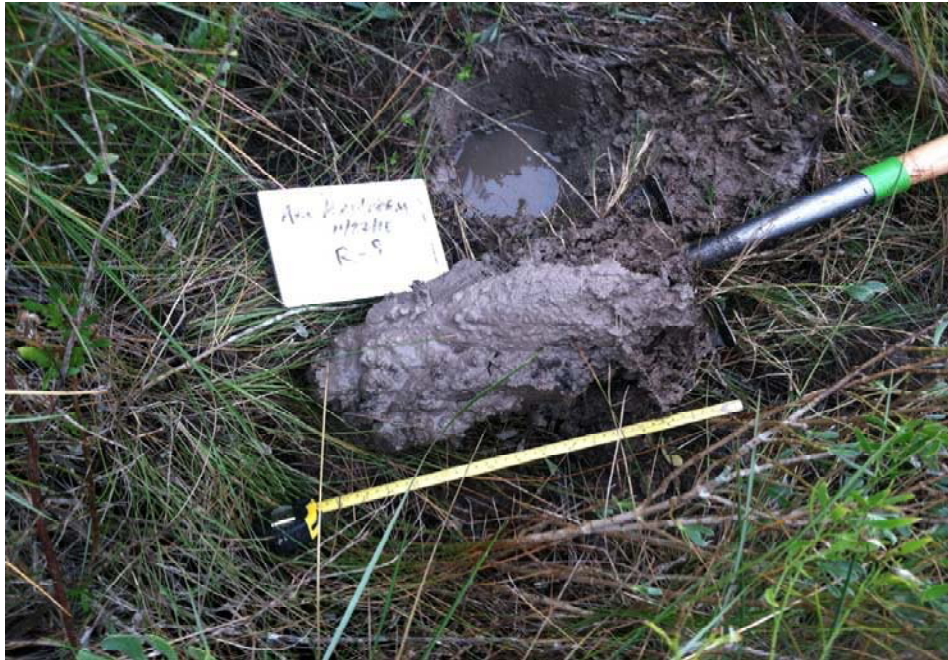
Photo 25 – Soil Sample at Plot R-9

Depth (inches)	Matrix		Redox Features				Texture	Remarks
	Color (moist)	%	Color (moist)	%	Type ¹	Loc ²		
0-10	10YR 4/2	85	10YR 2/1	15	C	M	loam	
10-16	10YR 5/2	100					loam

Plot meets the hydric soil criteria.

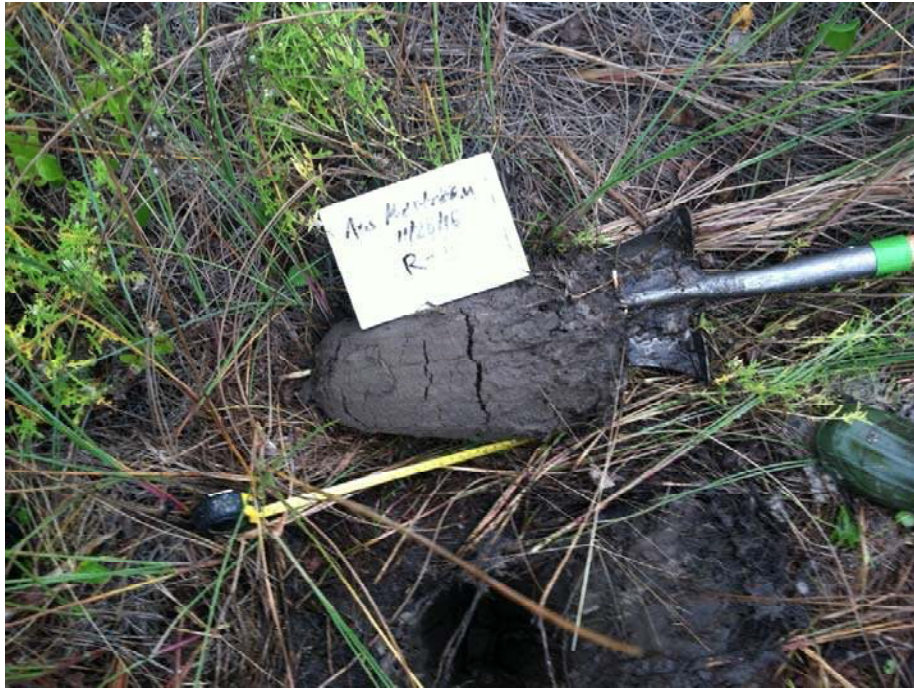
Photo 27 – Soil Sample at Plot R-10

Depth (inches)	Matrix		Redox Features				Texture	Remarks
	Color (moist)	%	Color (moist)	%	Type ¹	Loc ²		
0-2	10YR 2/1	100					sandy loam	
2-15	10YR 3/1	95	10YR 5/1	5	D	M	sandy loam

Plot meets the hydric soil criteria.

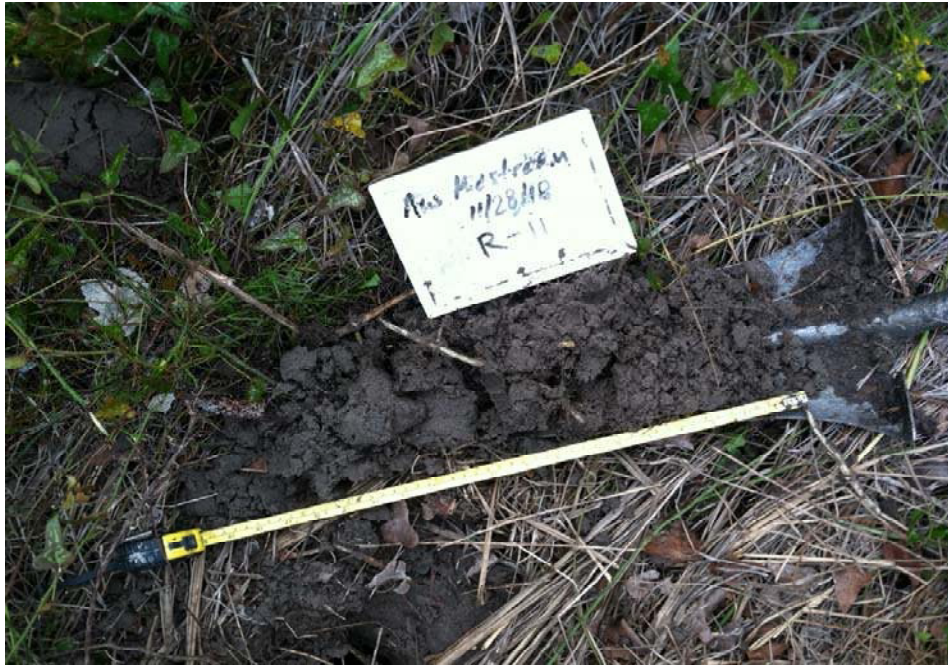
Photo 29 – Soil Sample at Plot R-11

Depth (inches)	Matrix		Redox Features				Texture	Remarks
	Color (moist)	%	Color (moist)	%	Type ¹	Loc ²		
0-16	10YR 4/2	100					sandy loam

Plot does not meet hydric soil criteria.

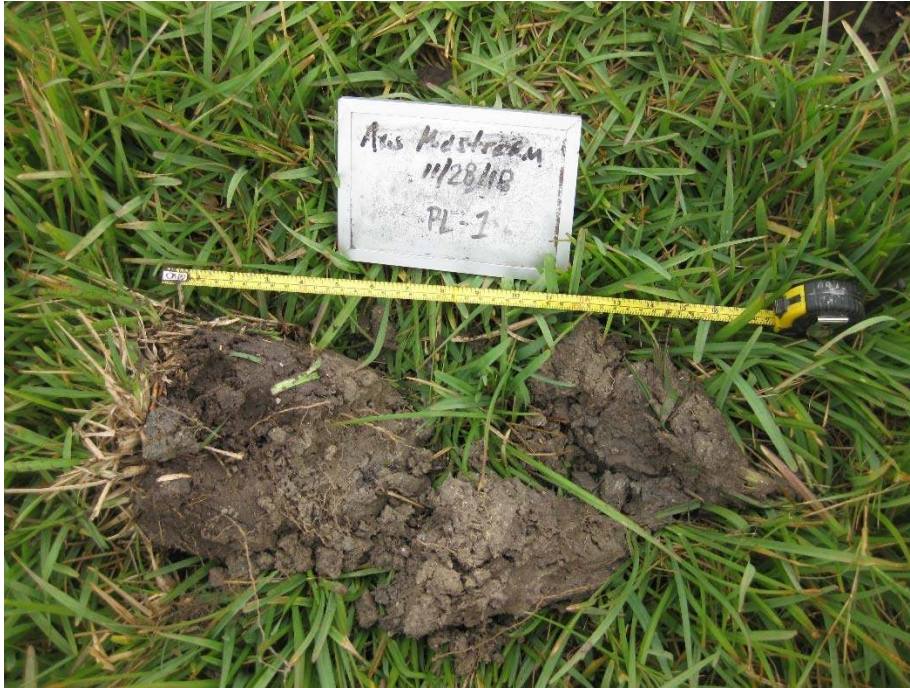
Photo 31 – Soil Sample at Plot PL-1

Depth (inches)	Matrix		Redox Features				Texture	Remarks
	Color (moist)	%	Color (moist)	%	Type ¹	Loc ²		
0-2	10YR 3/1	100					sandy loam	
2-11	10YR 6/2	80	7.5YR 4/6	10	C	M	sandy loam	
			7.5YR 8/6	5	C	M		
			2.5YR 8/1	5	D	M		
11-16	10YR 4/1	70	10YR 4/2	15	D	M	sandy loam	
			7.5YR 4/4	15	C	M

Plot meets hydric soil criteria (F3).

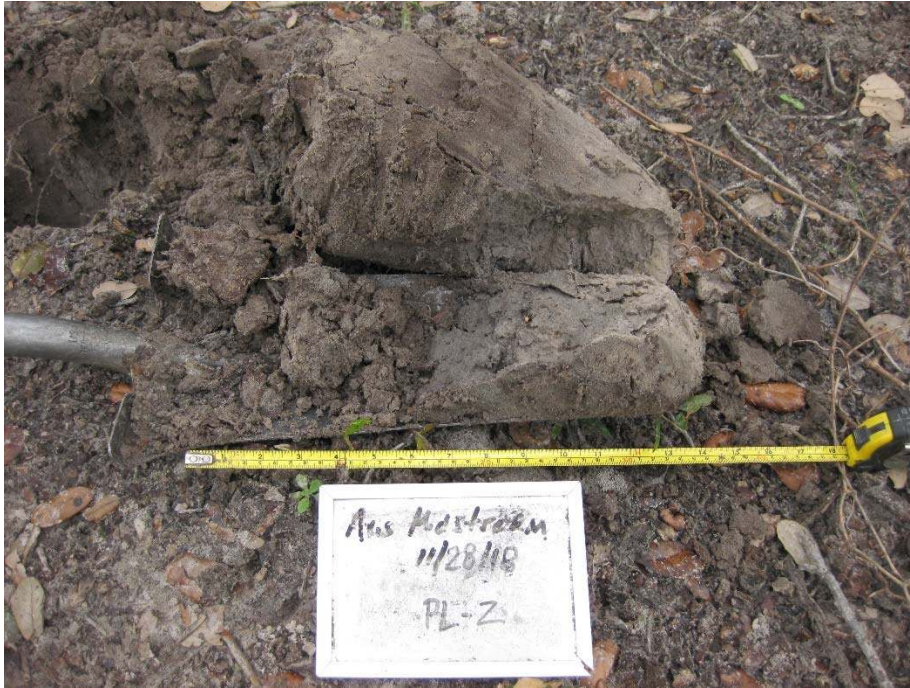
Photo 33 – Soil Sample at Plot PL-2

Depth (inches)	Matrix		Redox Features				Texture	Remarks
	Color (moist)	%	Color (moist)	%	Type ¹	Loc ²		
0-6	10YR 4/1	100					sandy loam	
6-12	10YR 5/1	95	10YR 3/4	5	C	M	sandy loam	
12-16	10YR 7/1	95	10YR 5/4	5	C	M	sandy loam

Plot meets hydric soil criteria.

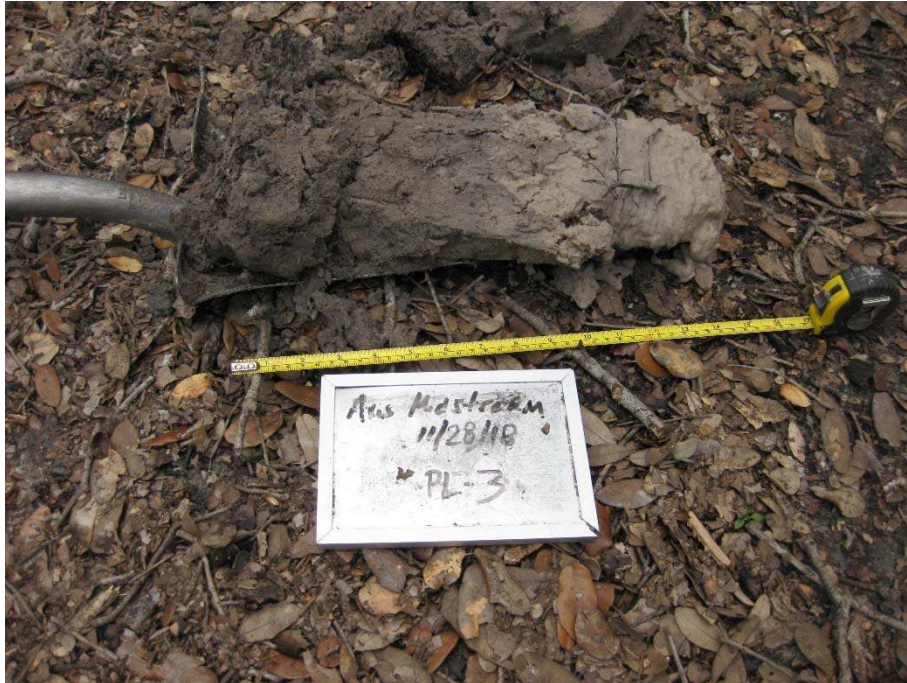
Photo 35 – Soil Sample at Plot PL-3

Depth (inches)	Matrix		Redox Features				Texture	Remarks
	Color (moist)	%	Color (moist)	%	Type ¹	Loc ²		
0-6	10YR 4/1	100					sandy loam	
6-12	10YR 5/1	100					sandy loam	
12-16	10YR 6/1	95	10YR 5/1	5	D	M	sandy loam

Plot does not meet hydric soil criteria.

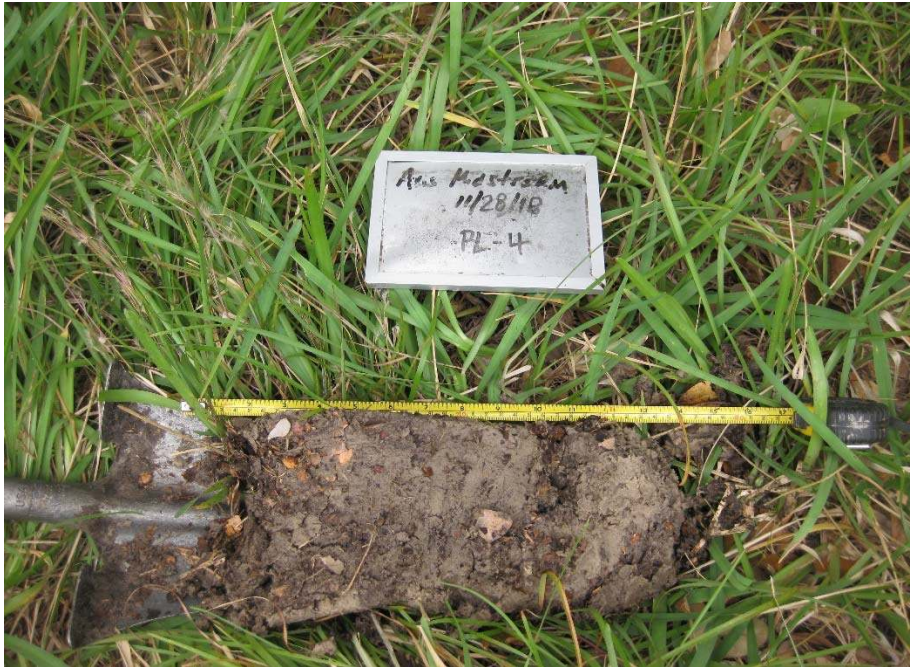
Photo 37 – Soil Sample at Plot PL-4

Depth (inches)	Matrix		Redox Features				Texture	Remarks
	Color (moist)	%	Color (moist)	%	Type ¹	Loc ²		
0-7	10YR 5/2	100					sandy loam	
7-15	10YR 6/2	100					sandy loam

Plot does not meet hydric soil criteria.

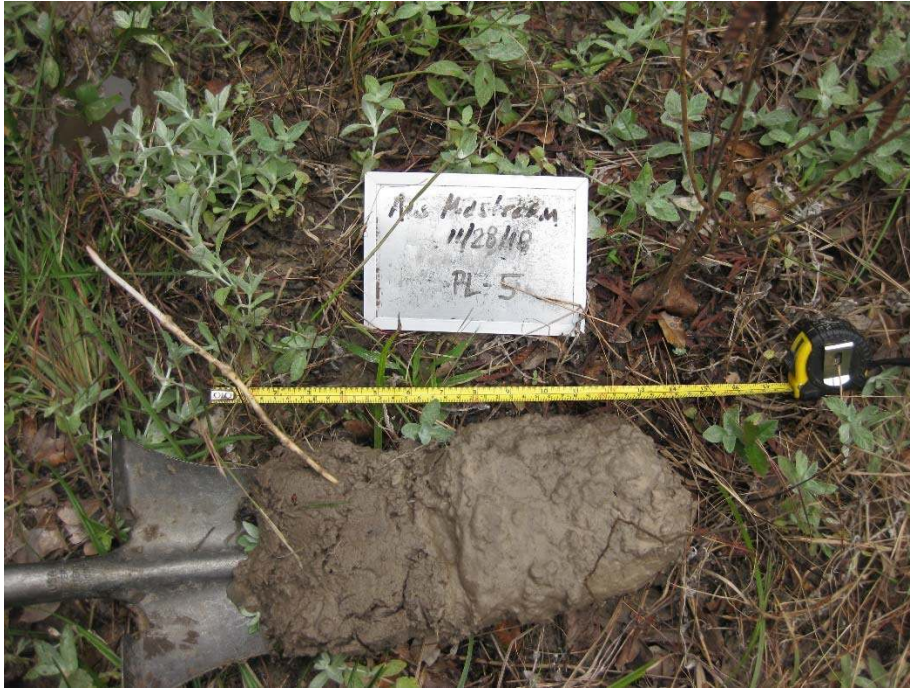
Photo 39 – Soil Sample at Plot PL-5

Depth (inches)	Matrix		Redox Features				Texture	Remarks
	Color (moist)	%	Color (moist)	%	Type ¹	Loc ²		
0-4	10YR 4/2	100					sandy loam	
4-16	10YR 6/2	100					sandy loam

Plot does not meet hydric soil criteria.
