RE: PERMIT APPLICATION – SWG-2018-00789
Axis Midstream Holdings, LLC – Midway to Harbor Island Pipelines & Support Facility
Proposed Pipelines and Support Facilities
San Patricio and Nueces Counties, Texas

Supplemental Field Review Report

**Redfish Bay Facility
San Patricio Counties, Texas**

**Supplemental Wetland Delineation
Redfish Bay Facility
PCS Project # 19012**

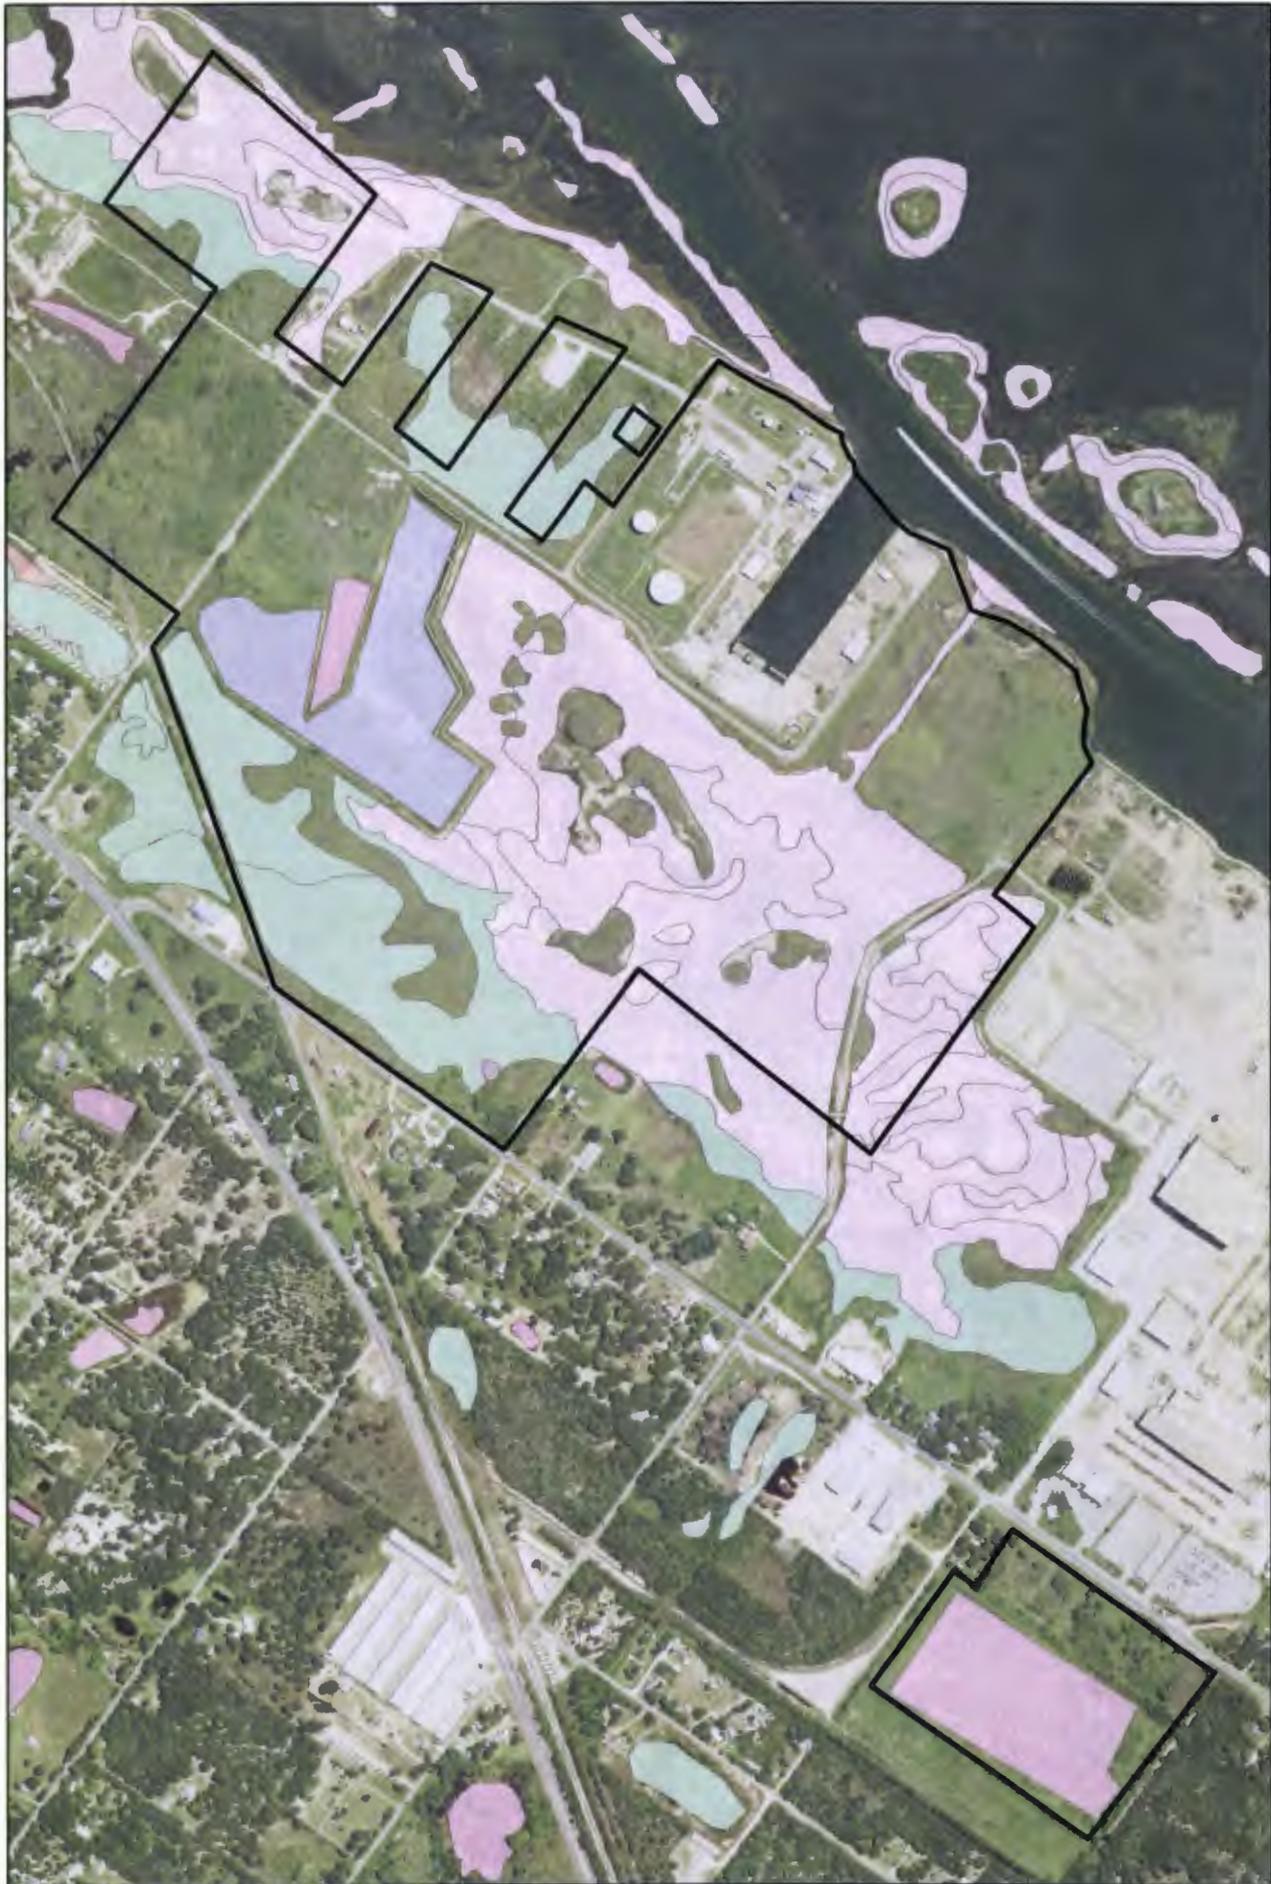
FIGURE 3: NWI MAP
AXIS MIDSTREAM PIPELINE
PROPOSED REDFISH BAY FACILITY
SAN PATRICIO COUNTIES, TEXAS

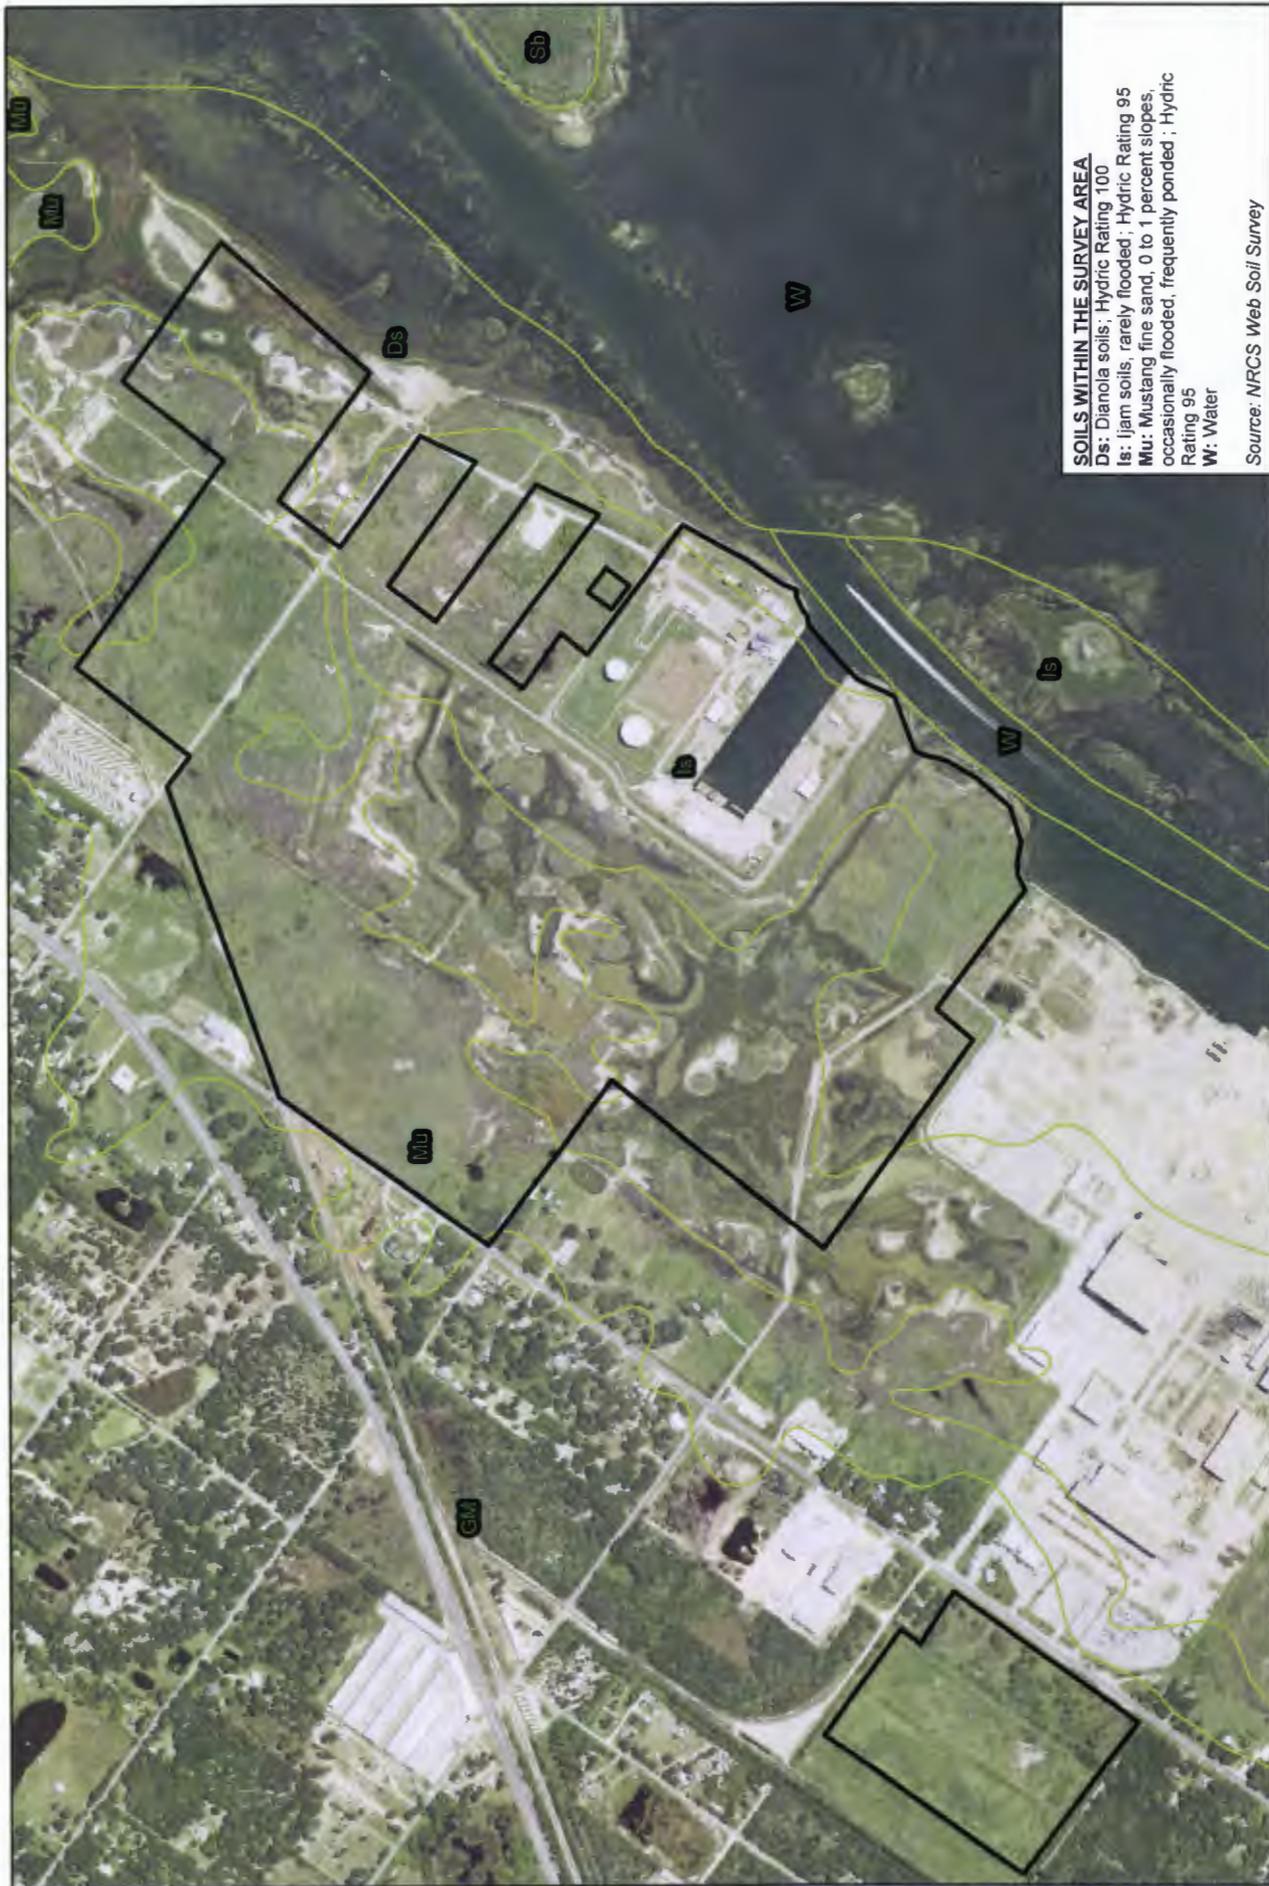
FIGURE 4: NRCS SOILS MAP
 AXIS MIDSTREAM PIPELINE
 PROPOSED REDFISH BAY FACILITY
 SAN PATRICIO COUNTIES, TEXAS

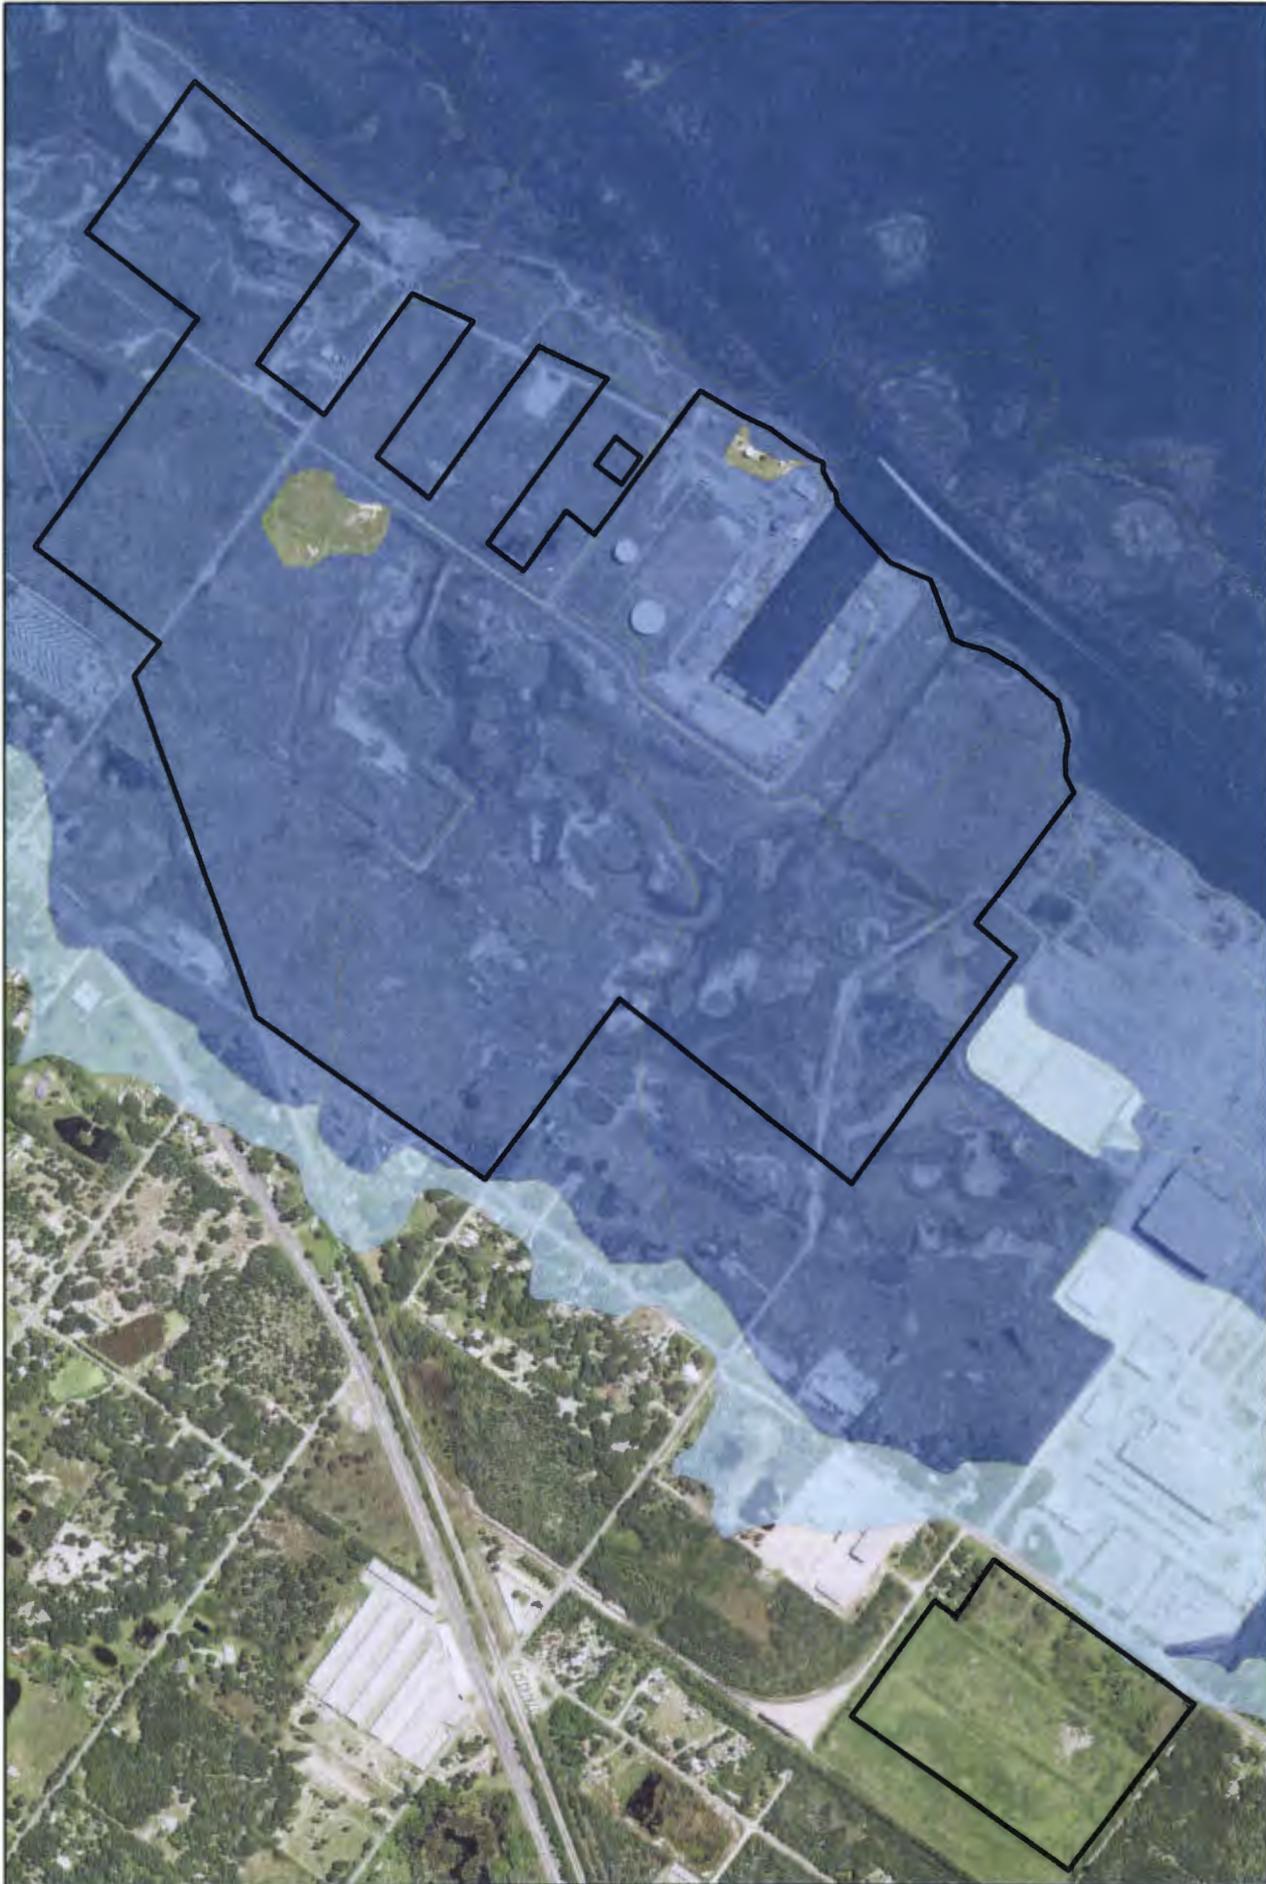
FIGURE 5: FEMA NATIONAL FLOOD HAZARD

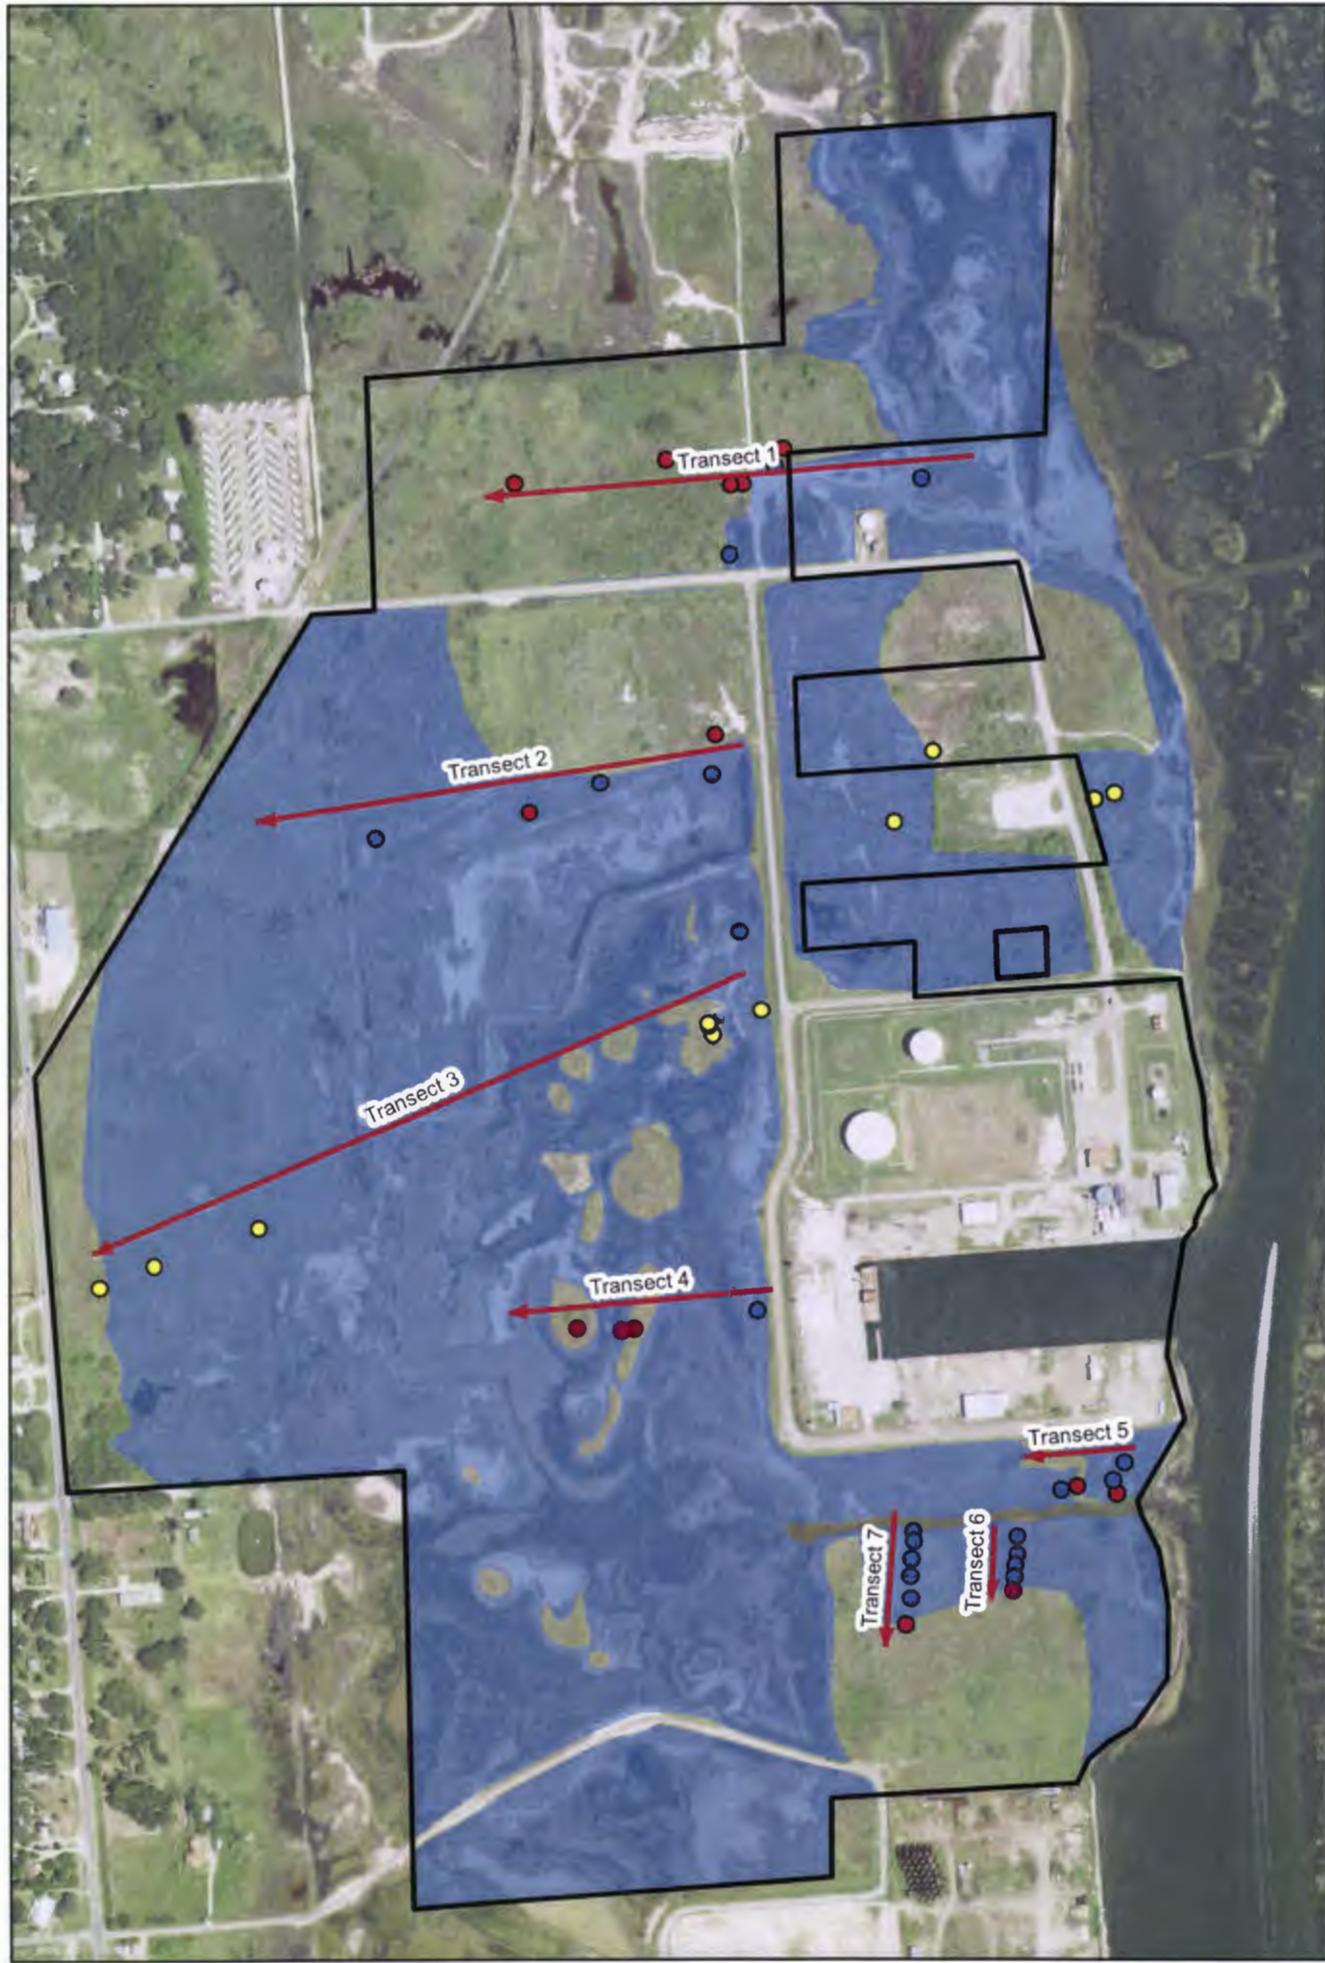
The Redfish Facility consists of an industrial site, historic spoil placement areas and bermed tidal wetlands situated between the Gulf Intracoastal Waterway (GIWW) to the east and FM 2725 to the west (**Figure 6, Redfish**). Elevation within the Redfish Facility site ranges between 0 to 7-ft. above mean sea level. The area drains to the GIWW directly or through a man-made tidal channel. All bermed areas were observed to be connected by culverts.

FIGURE 6: REDFISH WETLAND MAP OVERVIEW

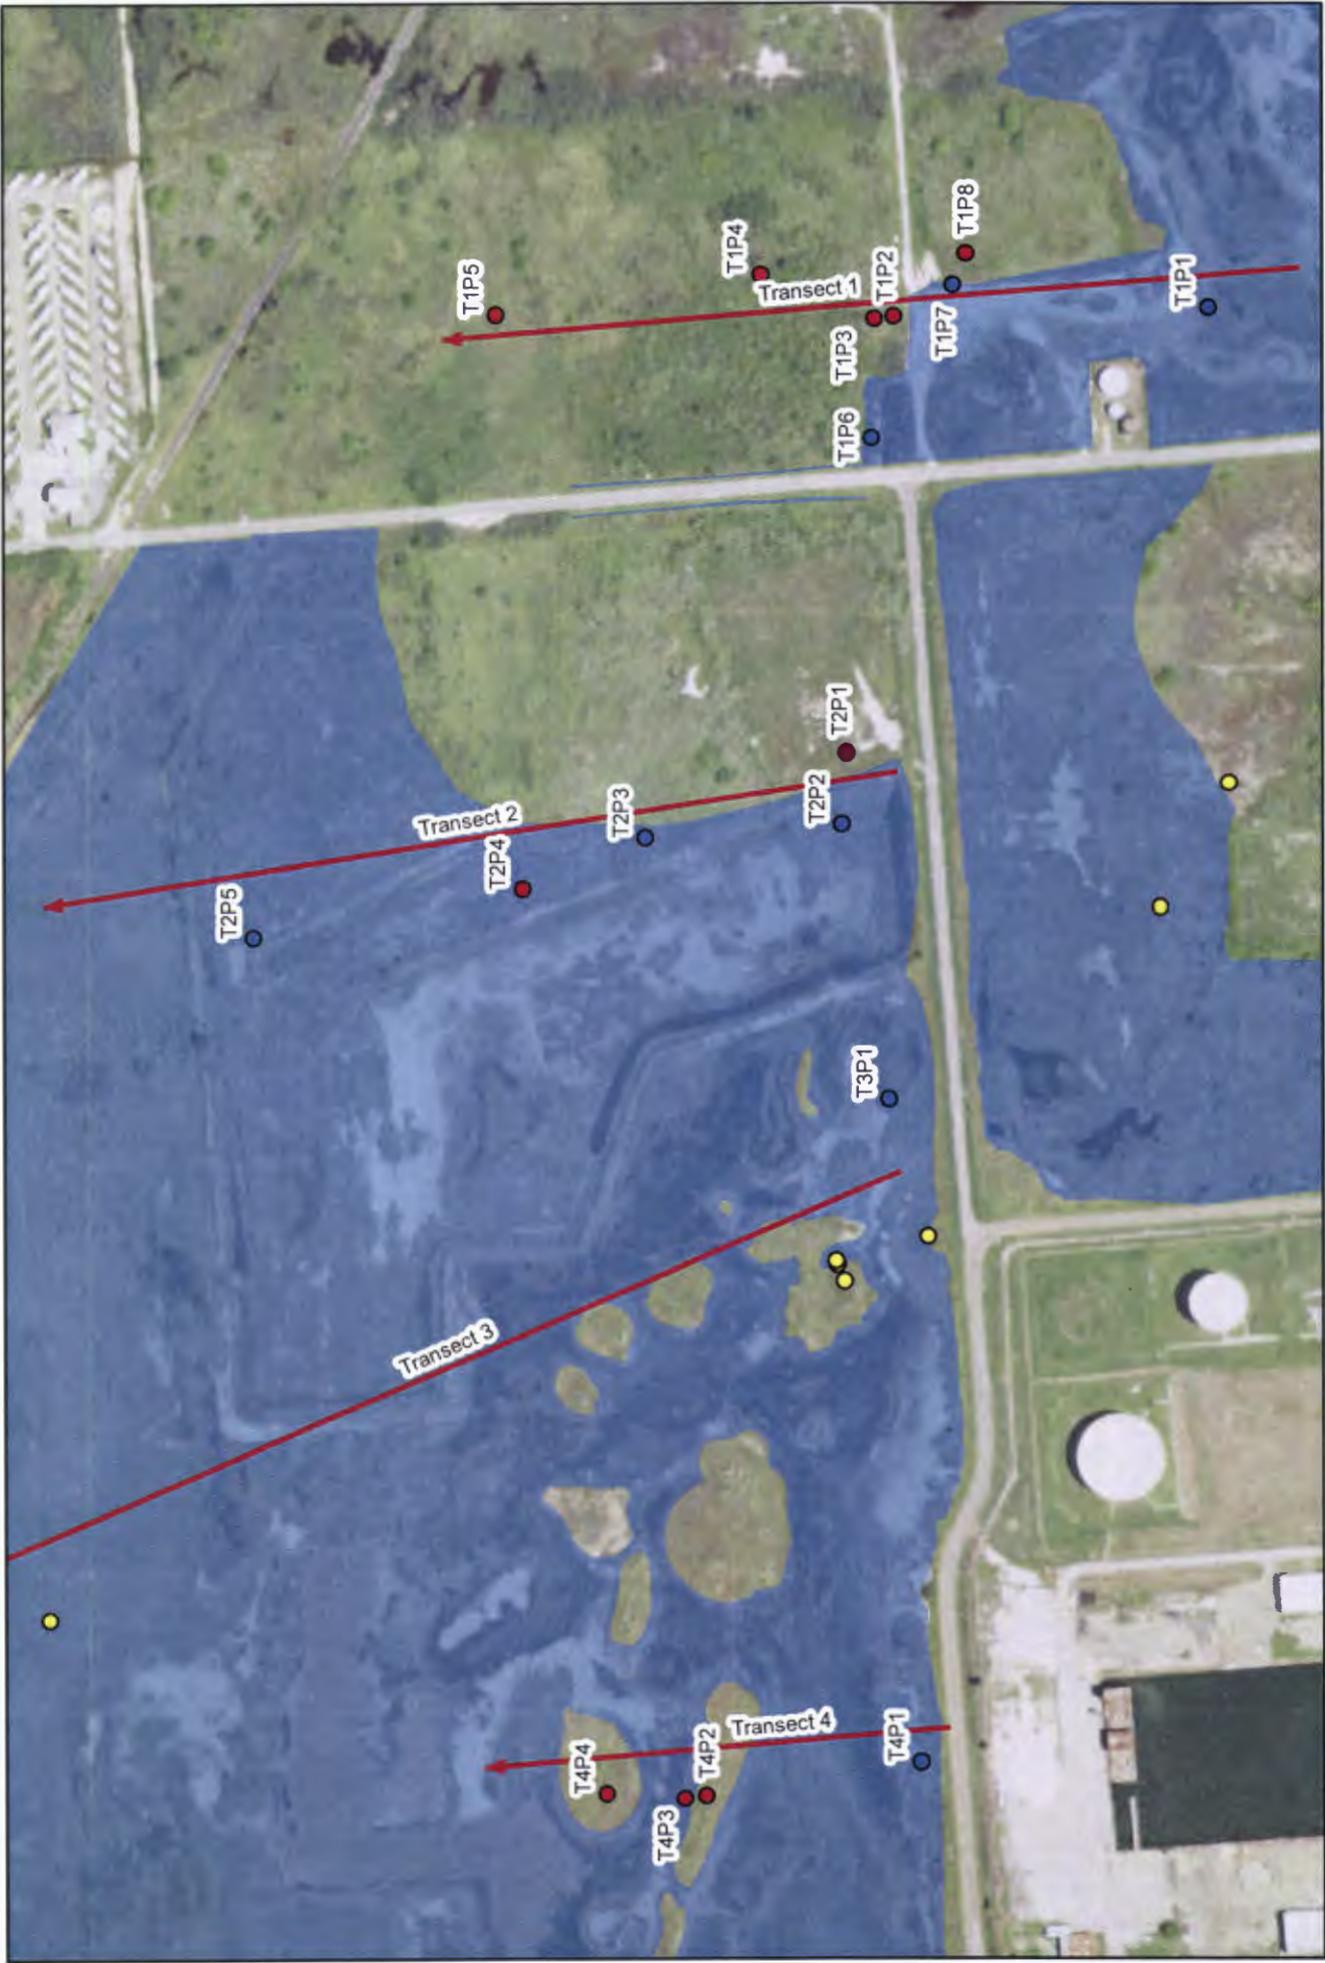
Figure 6A: Redfish Wetland Map

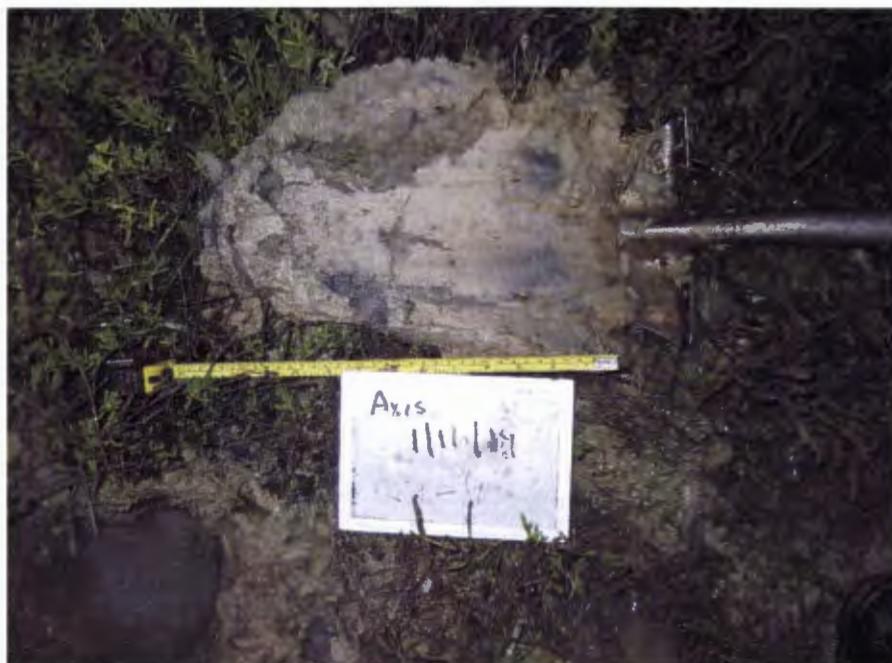
Depth (inches)	Matrix		Redox Features				Texture	Remarks
	Color (moist)	%	Color (moist)	%	Type ¹	Loc ²		
0-7	10YR 6/2	80	10YR 5/1	20	D	M	loamy sand	
7-14	10YR 5/1	97	10YR 4/4	3	C	M	loamy sand

Photo 1 Soil Sample - T1 - P1

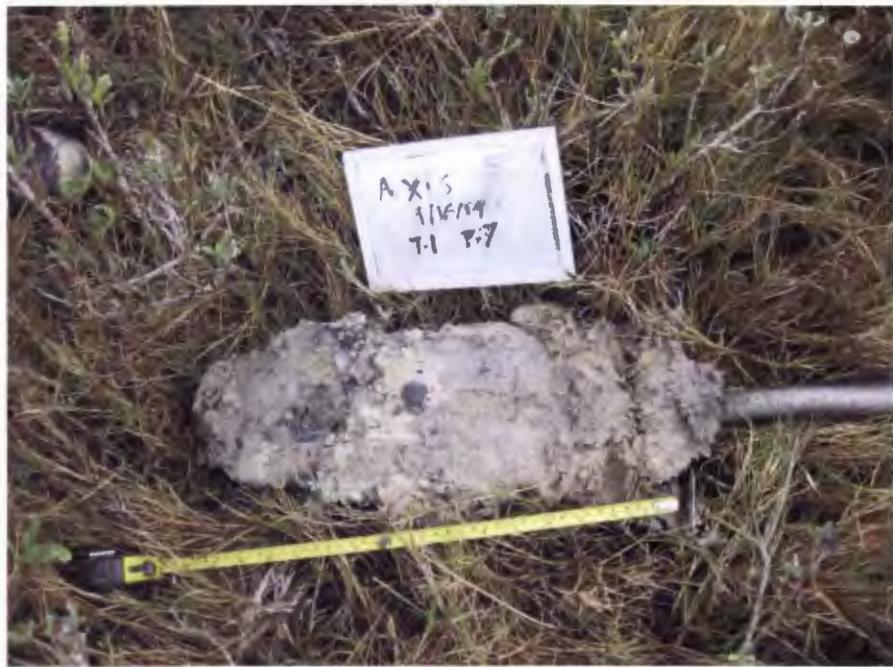
Photo 19 - Soil Sample - T1 - P7

Depth (inches)	Matrix		Redox Features				Texture	Remarks
	Color (moist)	%	Color (moist)	%	Type ¹	Loc ²		
0-7	10YR 4/2	100					loamy sand	shell & gravel debris in matrix
7-17	10YR 5/3	94	10YR 4/1	3	C	M	loamy sand	shell & gravel debris in matrix
			10YR 7/6	3	D	M

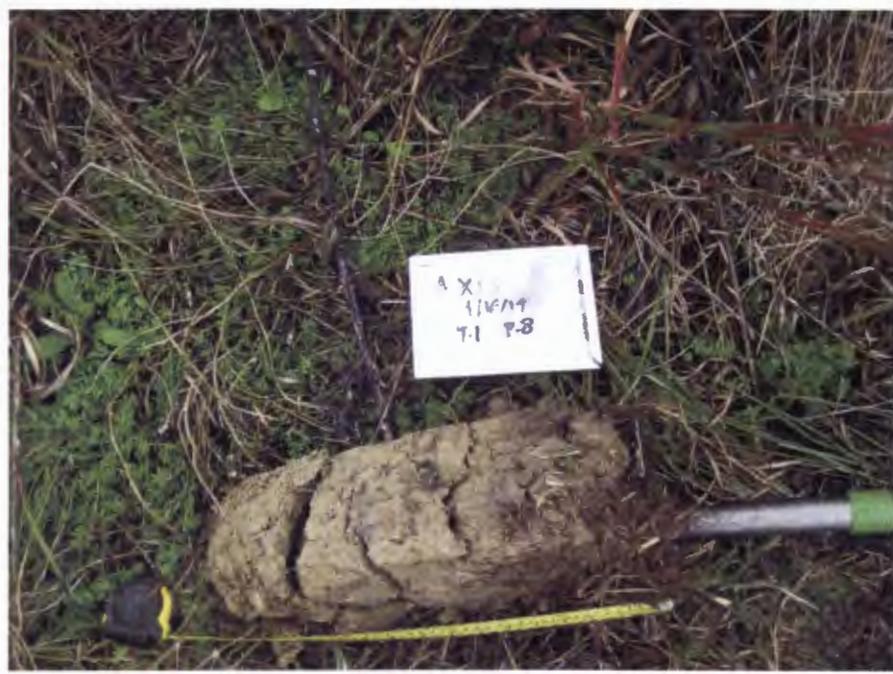
Photo 22 - Soil Sample - T1 - P8

Depth (inches)	Matrix		Redox Features				Texture	Remarks
	Color (moist)	%	Color (moist)	%	Type ¹	Loc ²		
0-4	10YR 6/2	100					loamy sand	shell & gravel debris in matrix
4-16	10YR 7/1	100					loamy sand	shell & gravel debris in matrix

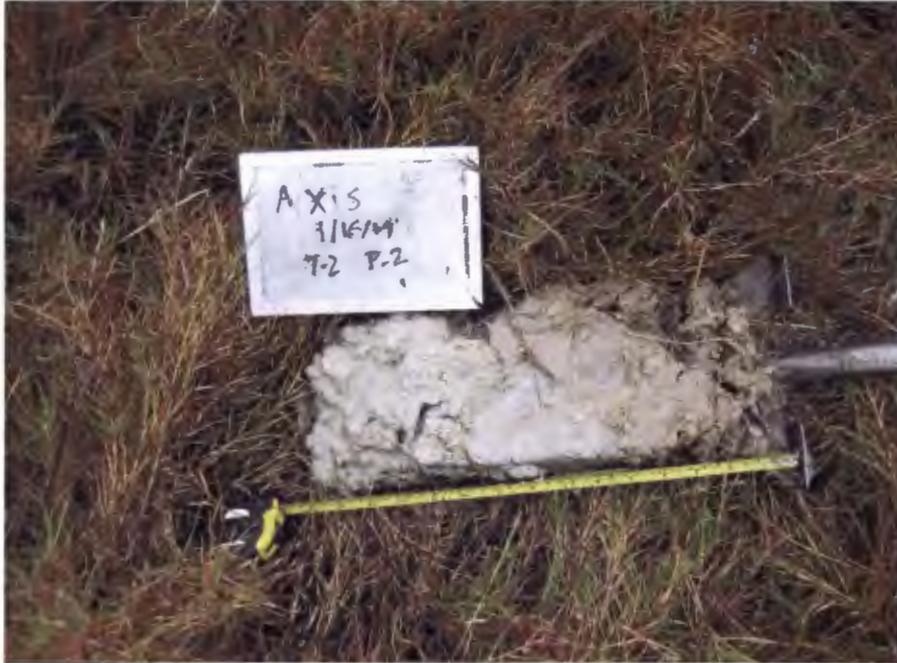
Photo 28 - Soil Sample – T2 – P2

Depth (inches)	Matrix		Redox Features				Texture	Remarks
	Color (moist)	%	Color (moist)	%	Type ¹	Loc ²		
0-16	10YR 6/3	95	10YR 2/2	5	C	M	loamy sand

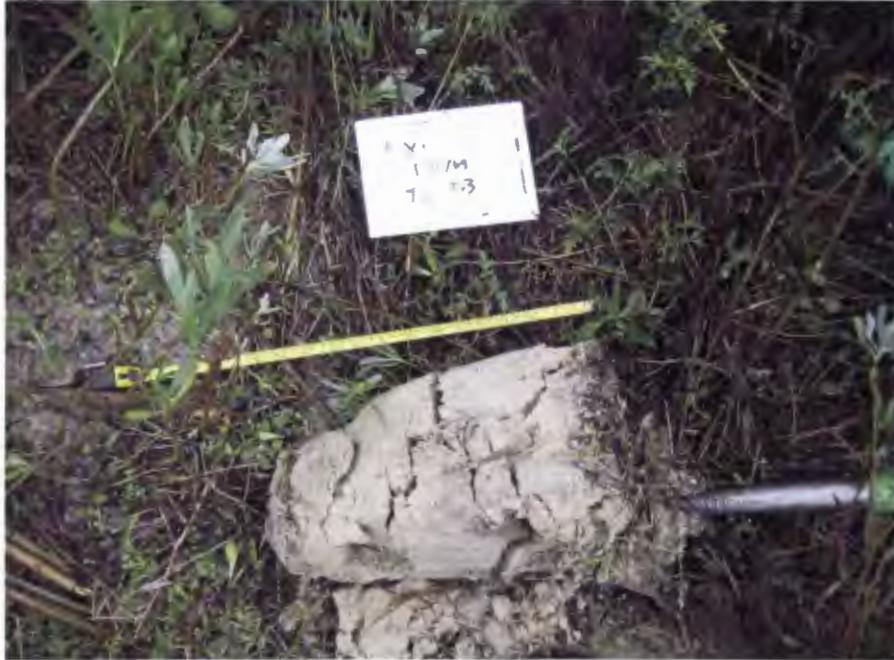
Photo 31 - Soil Sample – T2 – P3

Remarks: Plot meets the hydrology criteria with one primary (A3) and two secondary indicators (C9 & D5). Burrowing crab holes observed.

Profile Description: (Describe to the depth needed to document the indicator or confirm the absence of indicators.)								
Depth (inches)	Matrix		Redox Features				Texture	Remarks
	Color (moist)	%	Color (moist)	%	Type ¹	Loc ²		
0-4	10YR 5/1	50					loamy clay	
	2.5Y 6/4	50						
4-16	2.5Y 4/1	100					clay

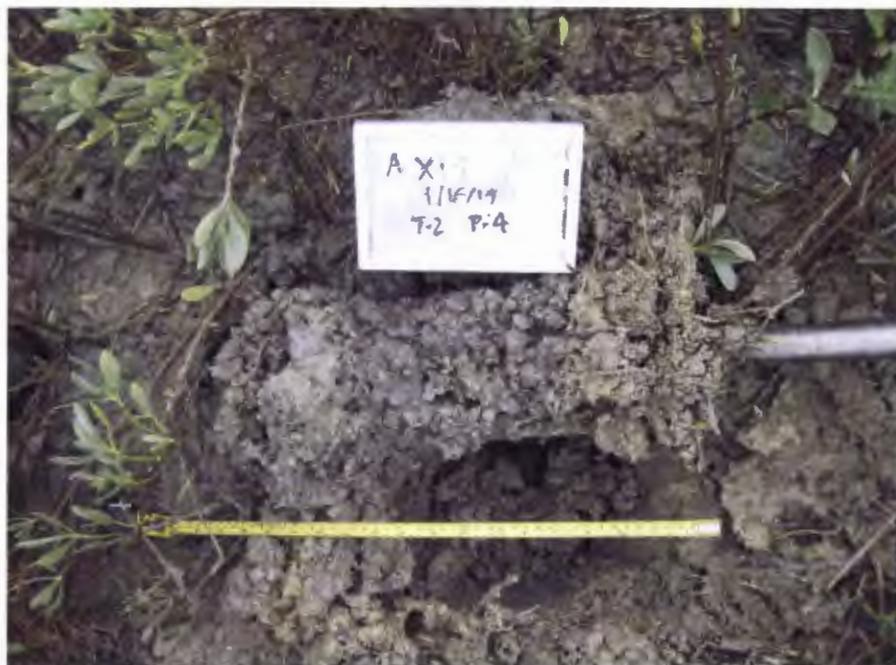
Photo 34 - Soil Sample – T2 – P4

Remarks:
 Plot meets the hydrology criteria with two primary (A2 & A3) and two secondary indicators (C9 & D5). Burrowing crab holes observed.

Depth (inches)	Matrix		Redox Features				Texture	Remarks
	Color (moist)	%	Color (moist)	%	Type ¹	Loc ²		
0-16	10YR 5/2	93	10YR 4/6	7	C	M	loamy sand

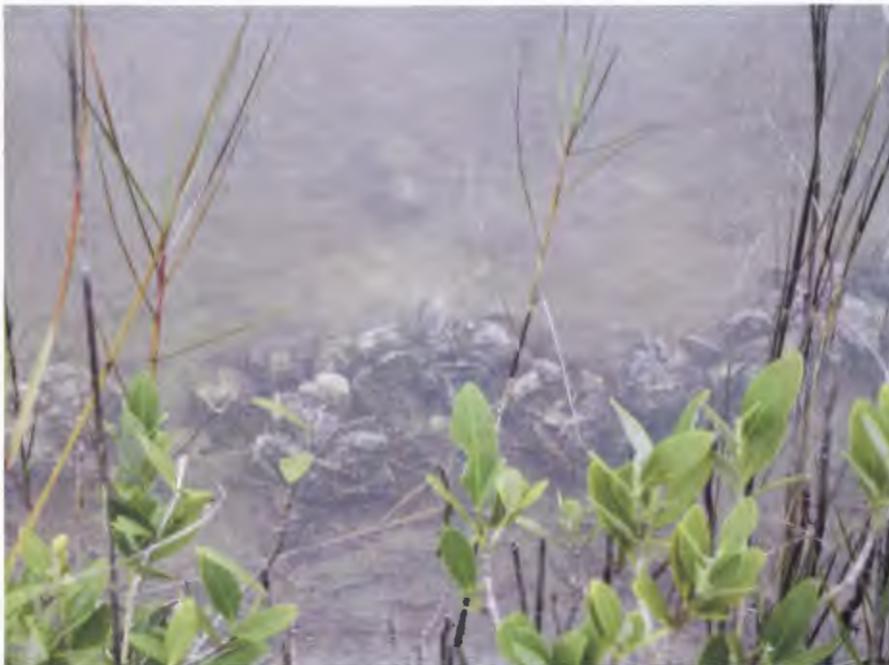
Photo 88 – T7 – P1, Oysters in Man-Made Tidal Drainage Feature
