Soil Remediation Project

Arecon Ltd. has developed many onsite remediation strategies for contaminated soil. One soil remediation project that Arecon designed and implemented utilized a strip-mining approach. The site was carefully delineated in order to fully characterize the vertical and horizontal extent of the contamination. Then the most contaminated soils were excavated thus removing the major sources of contamination.

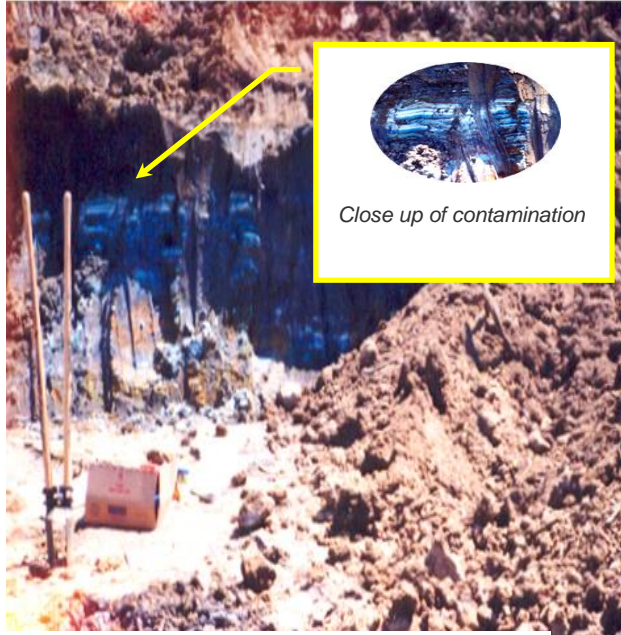
The photograph to the left shows an area where metal hydroxide sludge was encountered during the strip-mining activities.

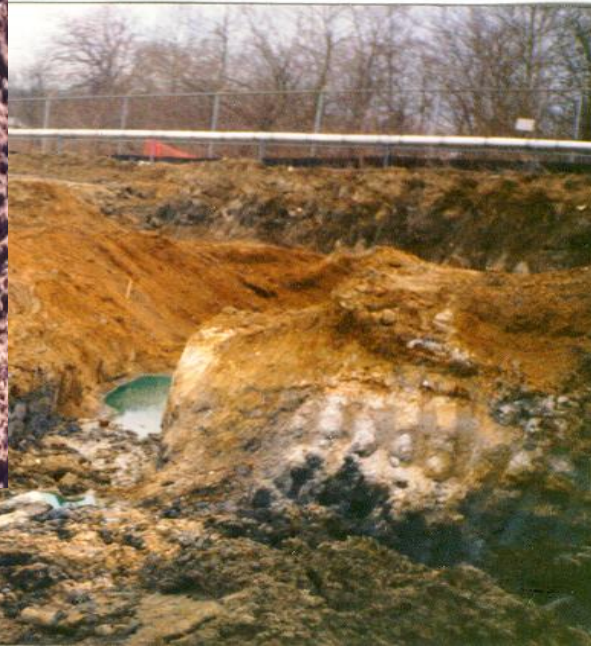
The photograph to the right shows a part of the site that contained buried process tanks. This part of the site was the major source of ground water contamination.

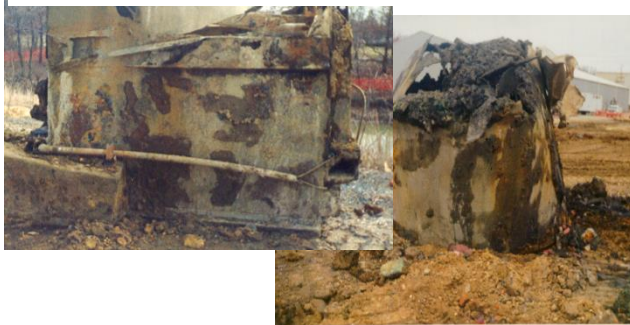
Process equipment containing plating solution and sludge is shown to the left. The equipment was removed from the excavation shown above.

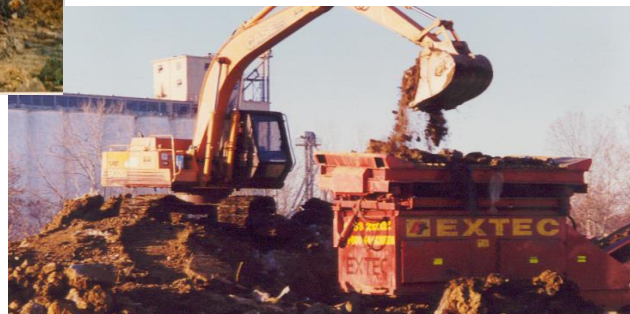
Soil excavated from the strip-mining operation was screened using an Extec screener. Acceptable material was reused onsite as backfill.
