AURORA LAKE

2018 Water Quality Assessment

Project No.: 11079
Date: 3/7/2019

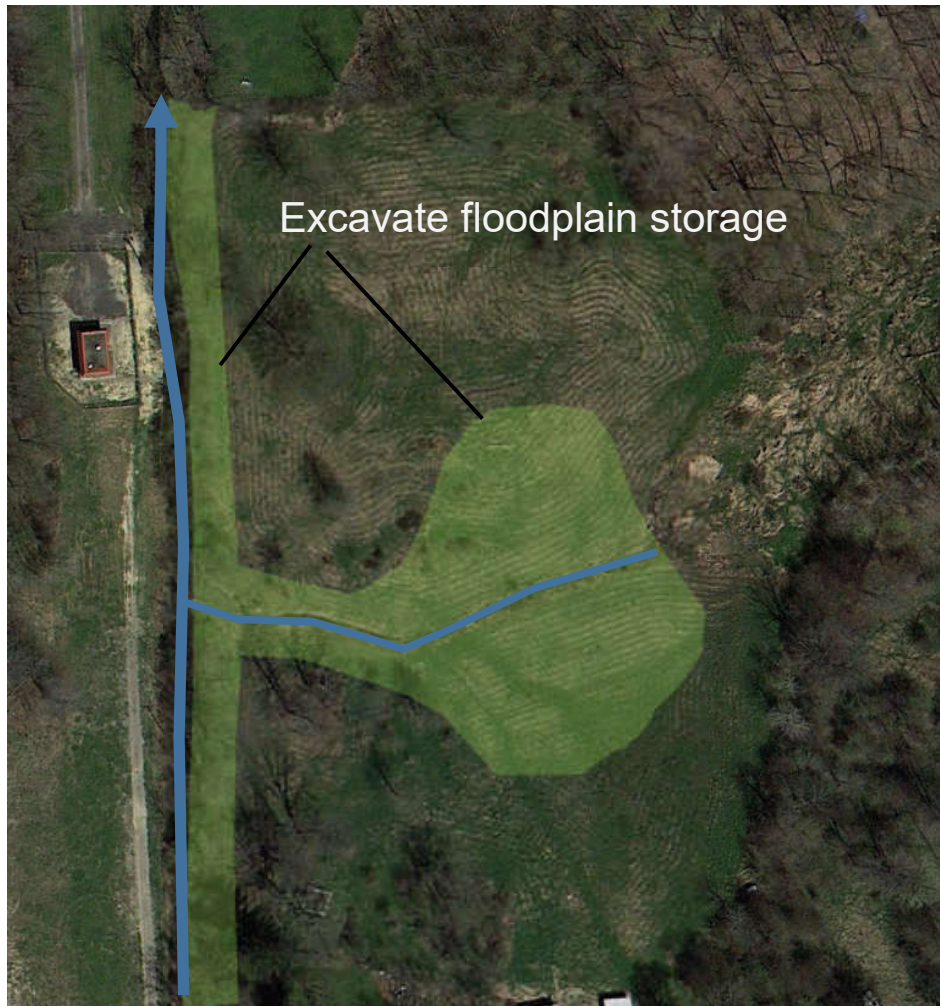
Figure 7. Cochran Road Access Road Ditch

Once the stream hits the Cochran Road right of way, this tributary is heavily modified. The nice forested riparian corridor has been eliminated and the stream has been straightened and ditched for ~2,025ft. A straightened channel condition will continually be unstable and erode streambanks. Ideally, if a small floodplain bench can be restored to one side or the other along with woody plantings, this area would become much more stable and be less detrimental to the water quality. Communication with the Marsh Glen LLC could allow future restoration to the east side of the ditch as it appears this parcel is largely open space preservation for the development. The wetland draining out of the Marsh Glen could also undergo restoration to modify the ditch outlet such that wetland retention time increases.

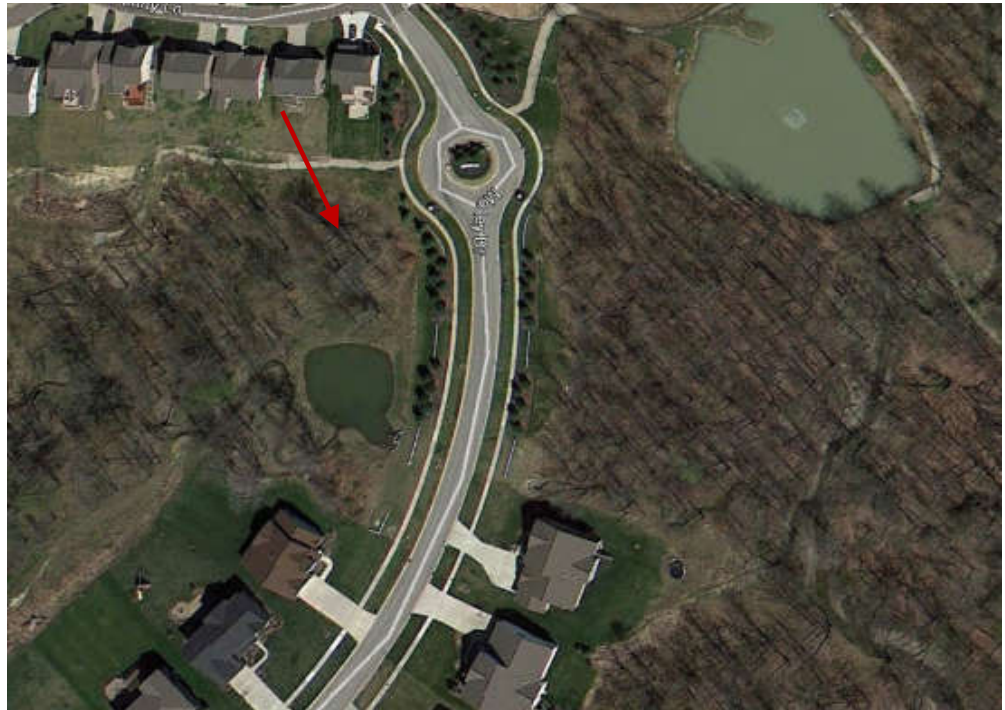
Figure 10. Potential Morley Rd Basin Modification

The Morley Rd development has similar characteristics with respect to density as the Stockwood Drive development. A large decorative pond with several stormwater basins intercepts drainage prior to the discharge to the wooded streams and drainageways (Figure 10). One basin on the west side of Morley Rd should be evaluated for potential improvement. Currently, this is a wet-basin and similar to ponds, wet-basins are negative from a water quality perspective. The location of this particular basin does not serve an aesthetic purpose because it is not surrounded by homes. Instead this basin could be modified to have a lower permanent water level and encourage wetland plant development. This shift towards an emergent wetland basin will have greater water quality benefit by shading open water as well as the inherent filtering capabilities of wetlands.

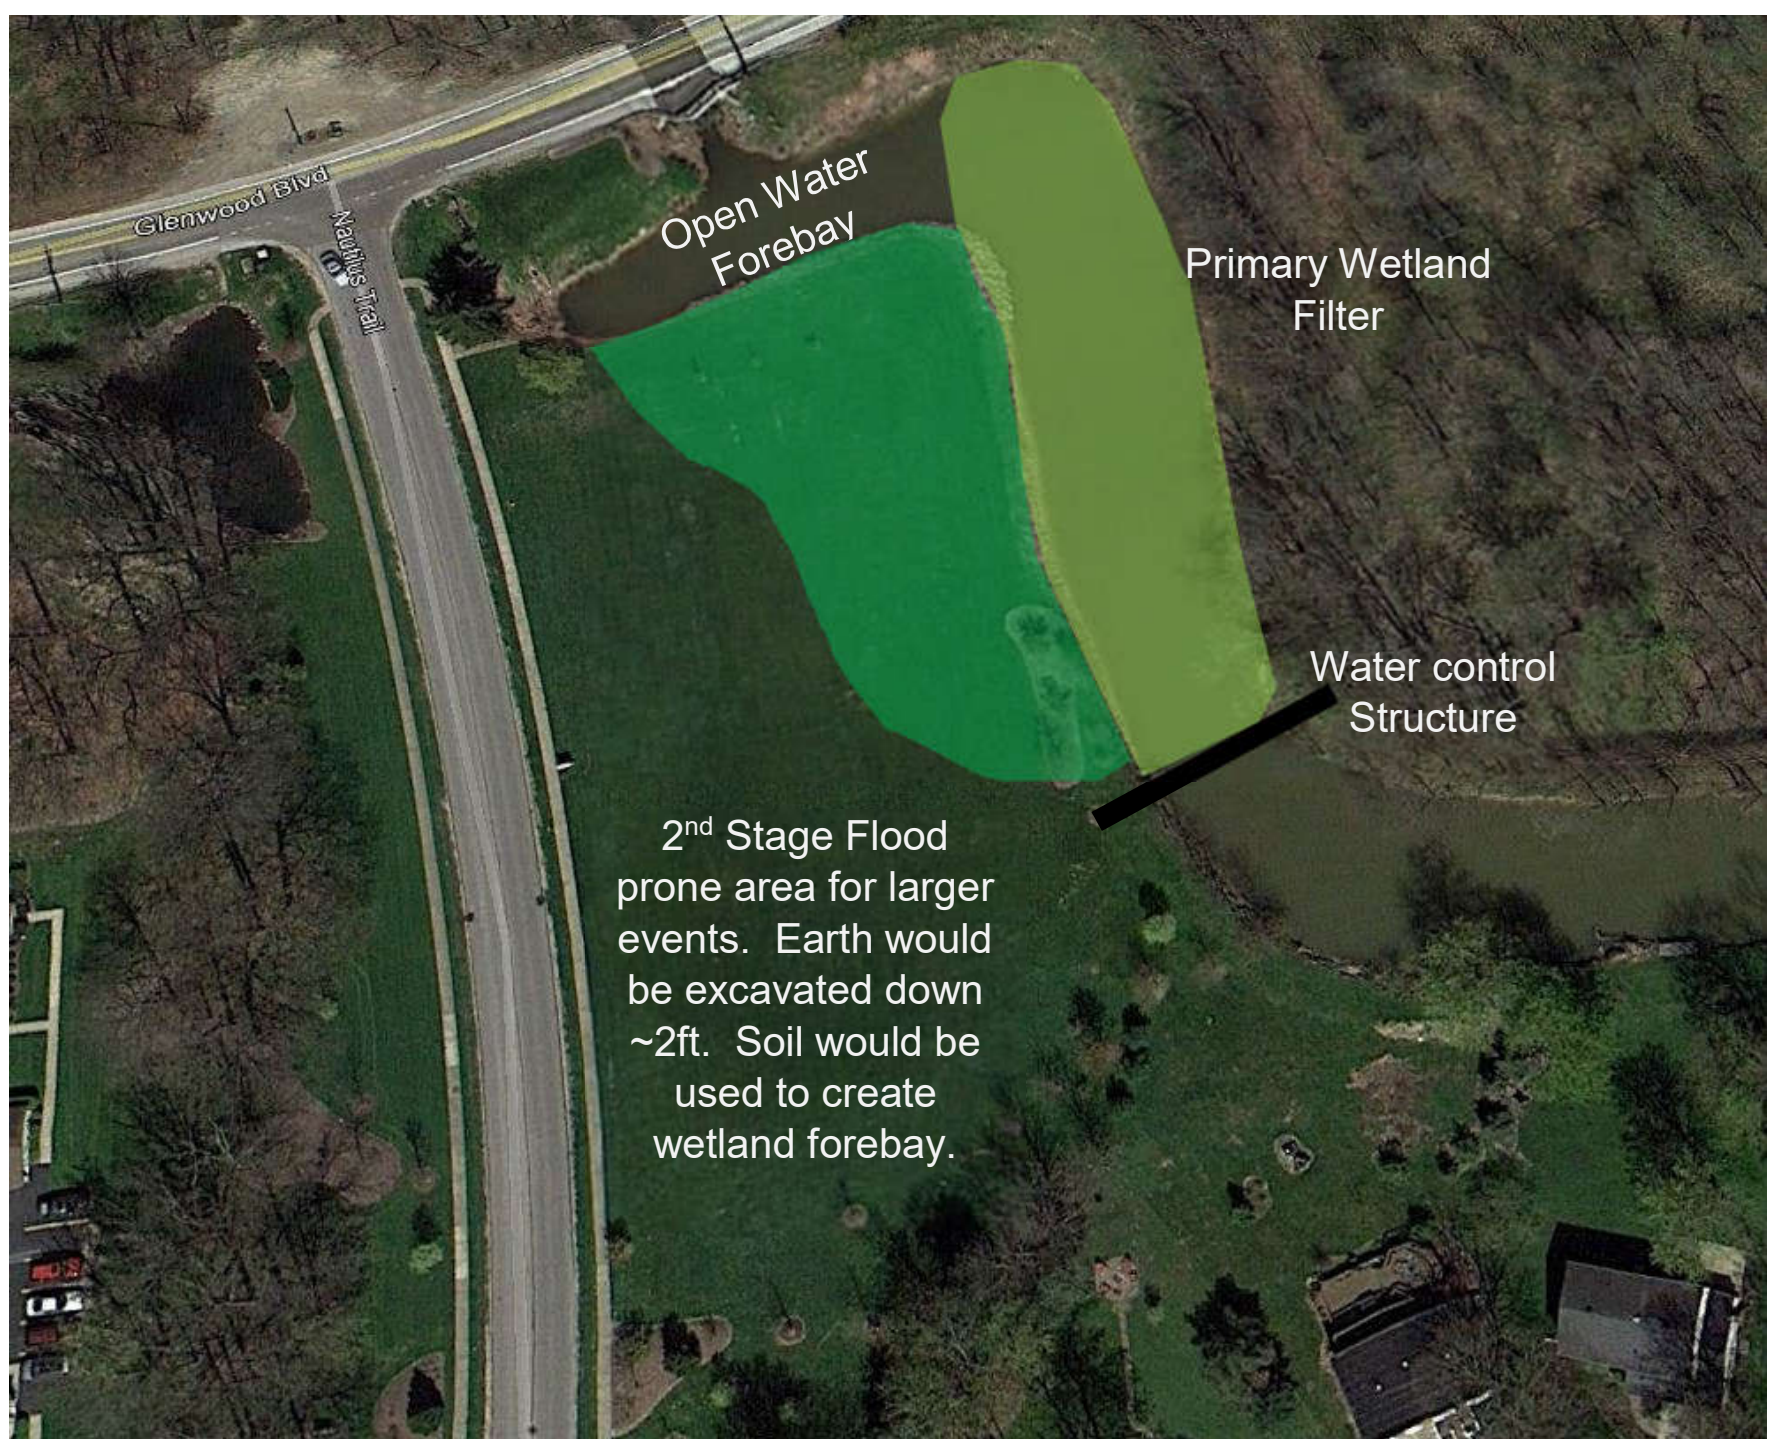
Figure 11. Potential Glenwood Tributary Forebay Modification

The south side of Glenwood the stream has been replaced by an impounded canal. This canal averages 50ft wide and runs for ~5,900ft to the entrance of the marina. Several other canals act as spurs to other developments. The canals are a means for boats to travel to the main lake from the individual residential properties.

It is recommended that the remaining canal system be dredged. Once the forebay is established, or simultaneously while the work is being accomplished, the dredging of the canals will remove any legacy sediment. The forebay will greatly minimize any sediment from being re-deposited in the canal. Residents will see direct activity behind their homes but will benefit from improved navigation of the canals and likely increased water clarity. If water clarity improves, vegetation should be allowed to colonize to a degree. The best staging for dredging activities in the canal system is the large open space at the Glenwood entrance. Other smaller access and staging areas are scarce, but there may be some potential in the vicinity of the Nautilus Trail bridge crossing. However, consultation with a dredging contractor is recommended. EnviroScience has a working relationship with Metropolitan Dredging that specializes in hydraulic dredging, which would be the preferred method here.

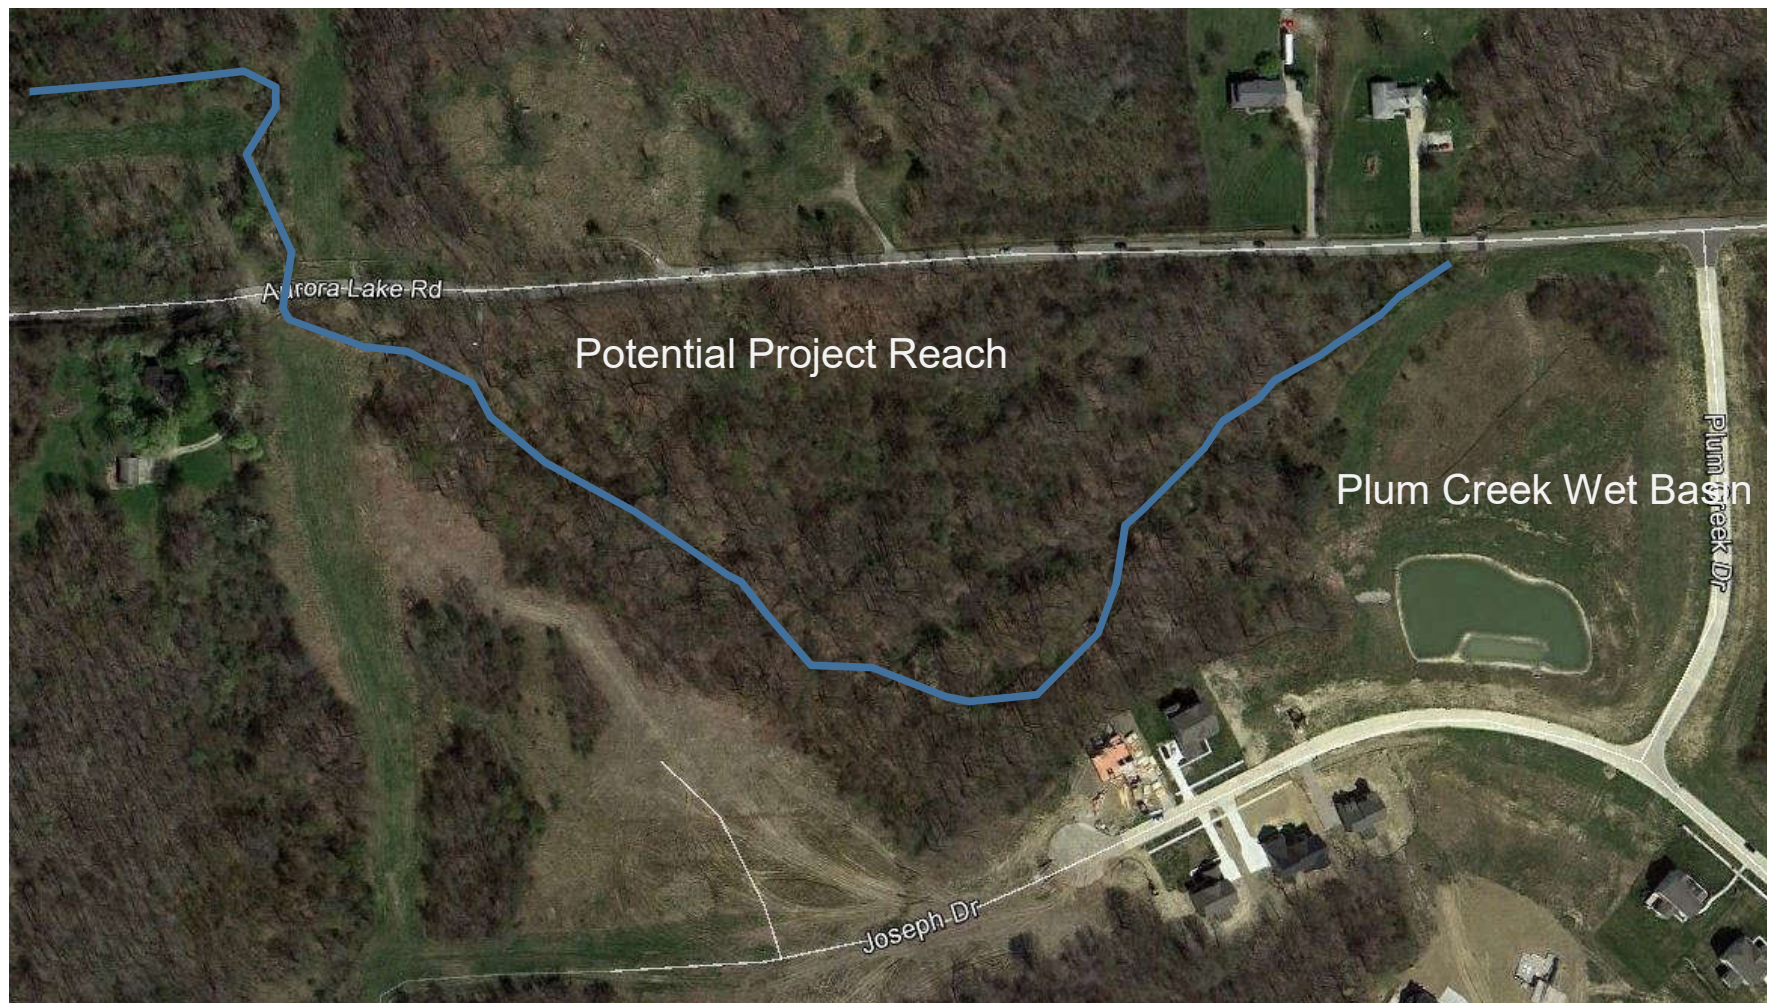
Figure 13. Potential Aurora Lake Road Tributary Channel Restoration

This sub-watershed has essentially a northern fork which originates in Geauga Lake and flows south while the eastern fork drains portions of the Hawthorn and Barrington developments (Figure 12). Similar to the other sub-watersheds, a good portion of the drainageways and streams have intact wooded riparian corridors which is positive. The Barrington development drains portions of a golf course. The concern here is during the summer months the runoff contains elevated levels of fertilizer and pesticides. This study did not specifically test for those parameters but given the distance between the golf course and the lake through natural stream corridors has a likely negligible impact. If the concern persists then EnviroScience could focus analysis on some specific parameters. Runoff and stormwater from the Hawthorn development is intercepted in a wet basin located west of Plum Creek Dr. The preference on dry or wetland basins has already been discussed.

Downstream of the Hawthorn basin, water is conveyed through a natural wooded stream corridor (Figure 13). Access permission was requested but denied to evaluate the property. However, observations from the road crossing and aeriels suggest this channel is incised from its original floodplain. If ownership would be amenable in the future, the area upstream of Aurora Lake Rd and immediately downstream could benefit from channel restoration and re-attachment to the floodplain. More description on the specific activities for restoration and floodplain re-attachment is provided below. The main goal of a project in this reach would be to preserve the existing forested canopy while re-attaching the stream to its floodplain.

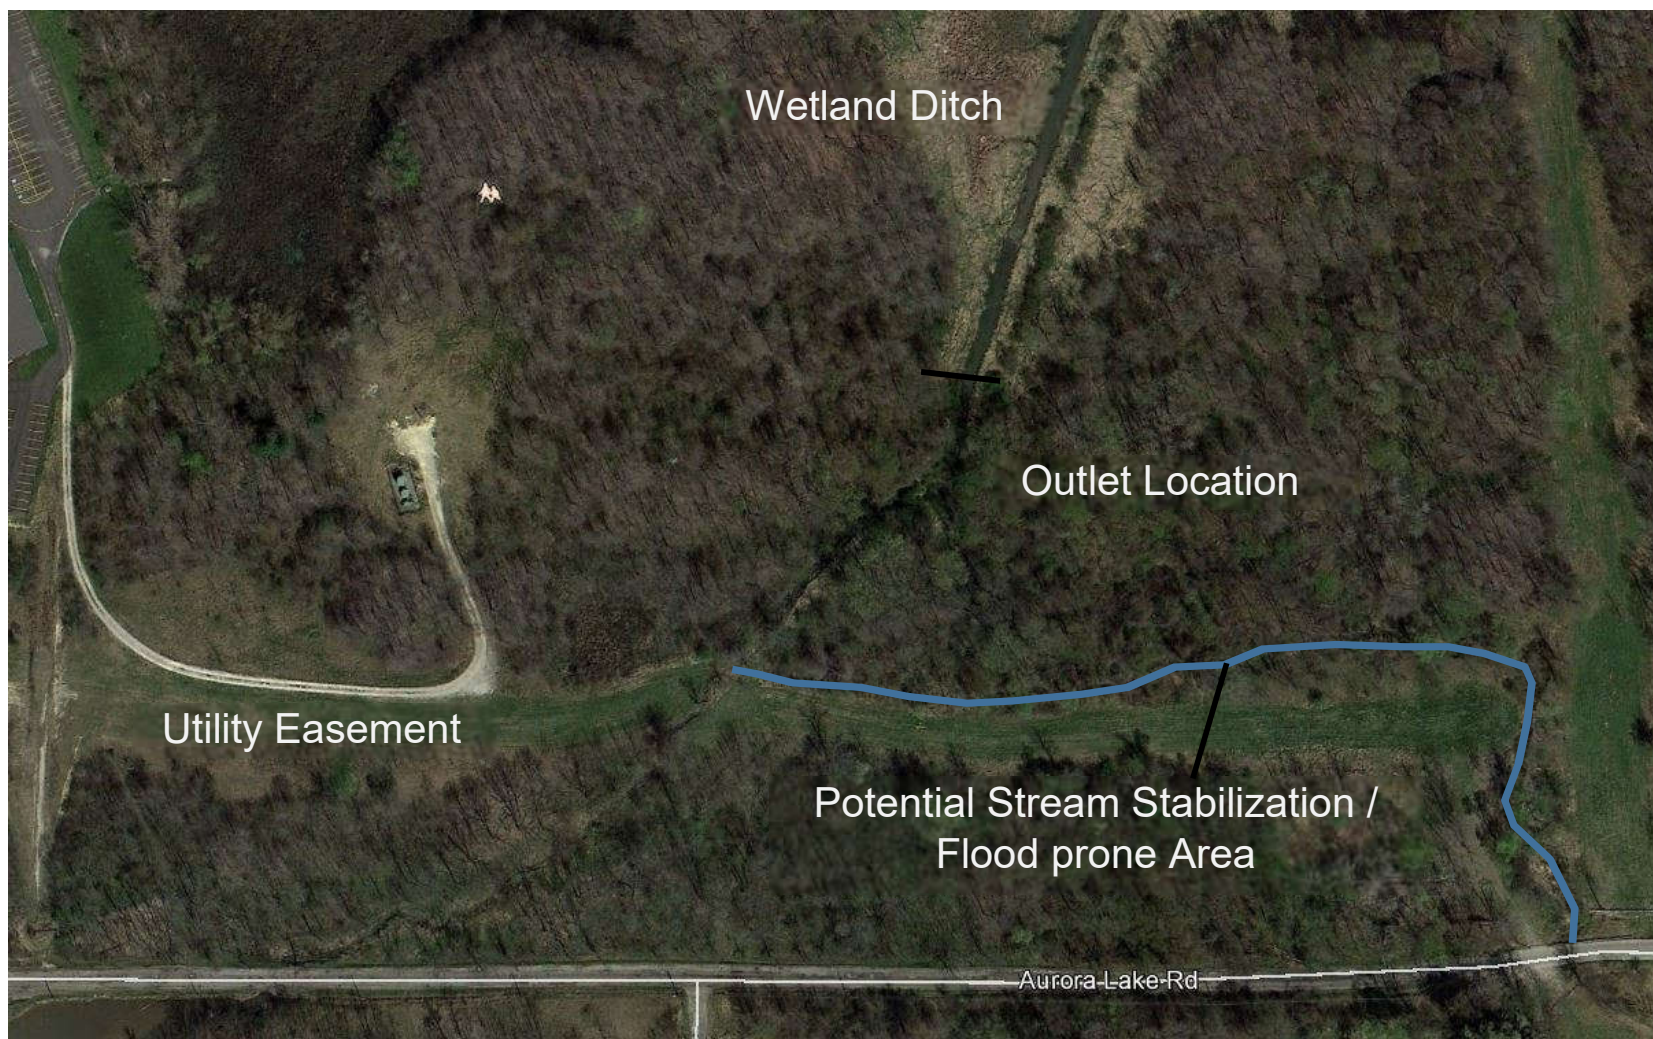
Figure 14. Aurora Lake Rd Tributary

The channel downstream of the wetland outlet is stable and morphologically functional. This channel confluences with the tributary draining the Hawthorn development in the vicinity of a small footbridge and a gas line easement. The Hawthorn branch tributary parallels this easement. The entire channel length along the easement up to Aurora Lake Rd could benefit from channel restoration to improve flood prone area and streambed stability (Figure 14).

The following text regarding in-channel restoration and structures is applicable to each of the sub-watershed discussions. To accomplish the goals described above of improving floodplain accessibility, in-channel riffle structures can be designed and constructed to raise the streambed elevation along the lower reach. These are constructed using imported aggregates sized appropriately so they are not mobile during flood flows. As an alternative to using rock, a less costly but only semi-permanent method would involve constructing logjams at key locations and engineering them such that flood flow does not flank the structures. Projects that require the placement of fill using rock or other hard structures require Federal United States Army Corps of Engineers (USACE) permitting which typically requires 3-6 months of coordination. Projects creating logjams do not require permitting but, in both instances, plan review and coordination will have to occur with the local municipality and floodplain administrator. In-channel projects can be funded through various grant opportunities or private funding. Grant applicants must be a 501C3 organization or a municipality. The design and permitting of in-channel restoration work will typically cost 15-25% of the construction budget. Construction costs are highly dependent on the scope of the work. Cost per lineal foot (LF) of design and construction can range from \$100-450/LF.
