# Log Details - #12

Aurora Lake

AQUA DOC - Visit 12 - 10/1/2026

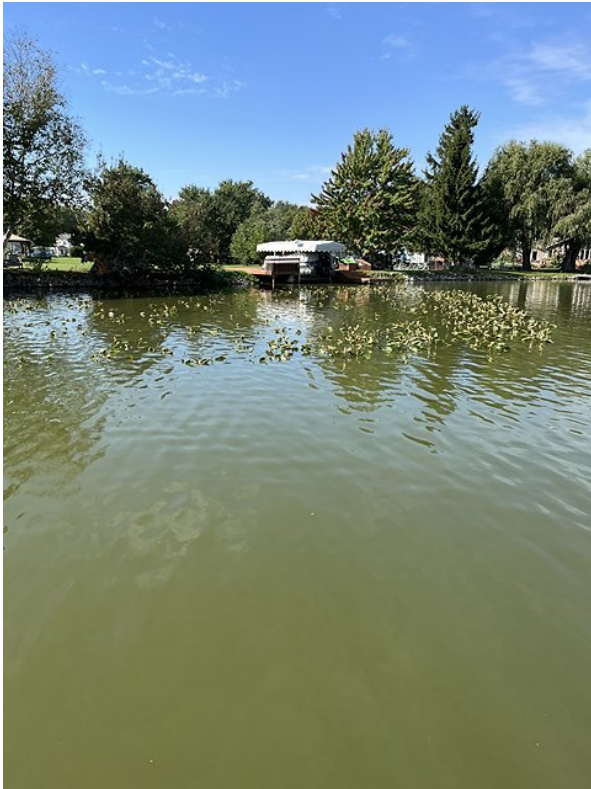
Regressing cow lilies 10/1/2026

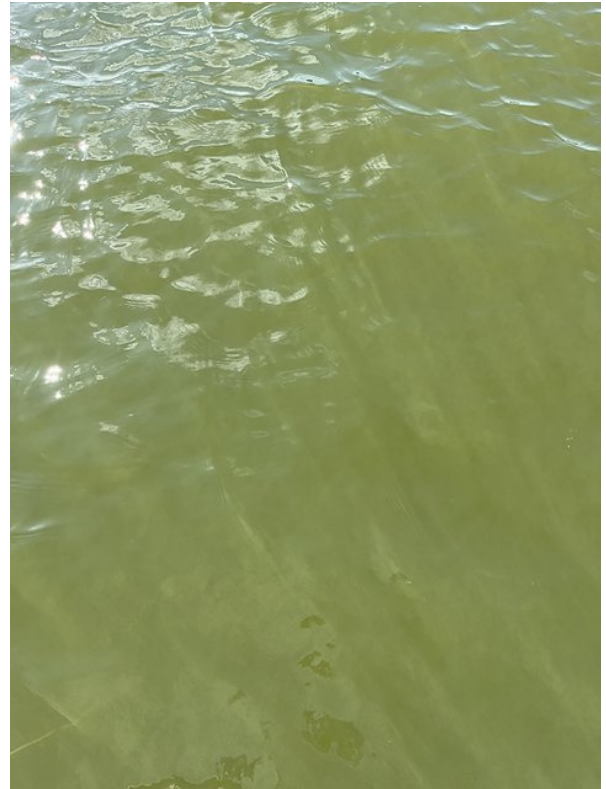
General appearance of water 10/1/2026

AQUA DOC conducted our 12th visitation to Aurora Lake on 10/1/2026. The lake continues to experience reduced algal density in visual observation as well as with collected data. No applications were necessary during today's visit and we continued our regular monitoring procedures. A depth profile, spatial chlorophyll a data, and wet chemistry samples were all collected during today's visitation.

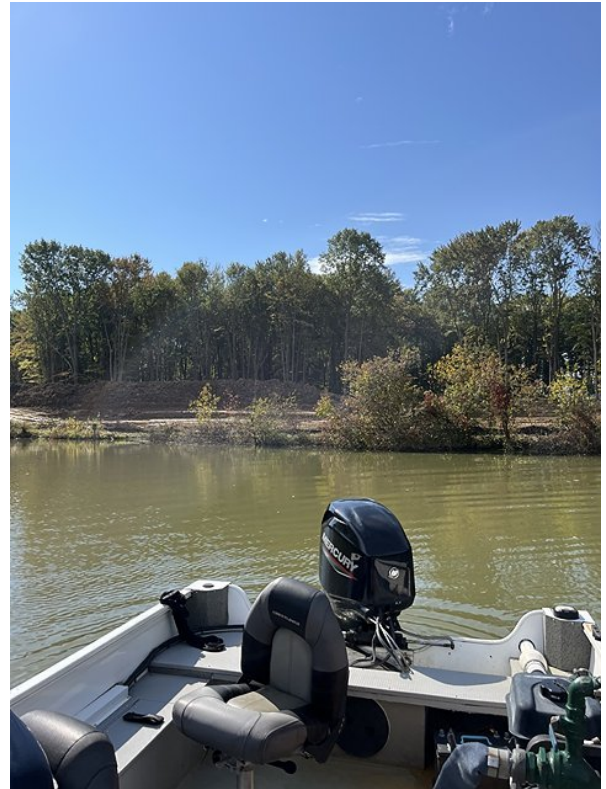
Construction near AL9 10/1/2026

AL9: 3.35
