SUBSTRUCTURE CONSIDERATIONS FOR SUCCESSFUL ACCELERATED BRIDGE REPLACEMENT PROJECTS

*David W. Whitmore, P.Eng., Vector Corrosion Technologies Ltd., (204) 489-6300, davidw@vector-corrosion.com
J. Chris Ball, Vector Corrosion Services, (813) 501-0050, chrisb@vcservices.com*

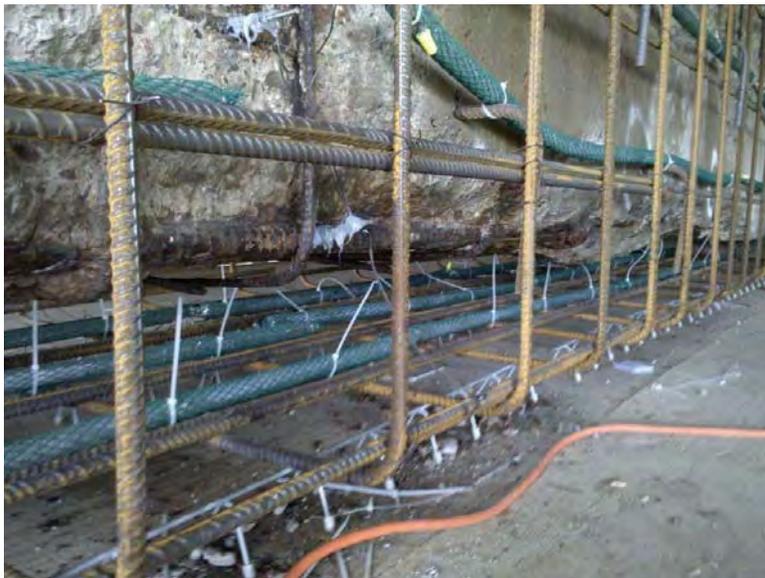
Figure 2: Pier Cap Repair Using Reinforced Concrete Encasement with Distributed Galvanic Anodes, George Wade Memorial Bridge Rehabilitation, 2011

For structures with more substantial concrete and corrosion damage, a reinforced concrete encasement containing additional reinforcing steel provides a one-step repair, corrosion protection and strengthening option. This technique can be accomplished on abutments, columns or pier caps.

To provide cathodic protection to both the existing corroded steel and the new reinforcing in the encasement, distributed galvanic anodes or impressed current cathodic protection are an important consideration.

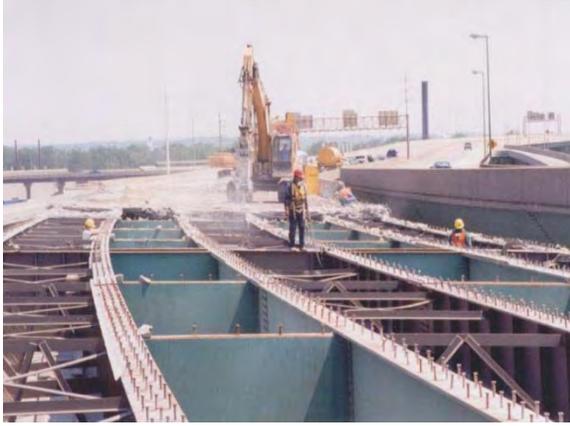
Figure 3: Bridge Deck Replacement

The rehabilitation project included a complete replacement of the concrete deck but the long-term performance of the repair substructure was a concern. After the corrosion investigation was completed on the 66 hammerhead piers, it was determined that 23 were in a low concrete damage, high corrosion potential condition. The repair strategy for these piers was Patch Repair with Global Protection using Norcure electrochemical chloride extraction, a technique that removes chloride ions from concrete and restores the rebar to a passive condition.

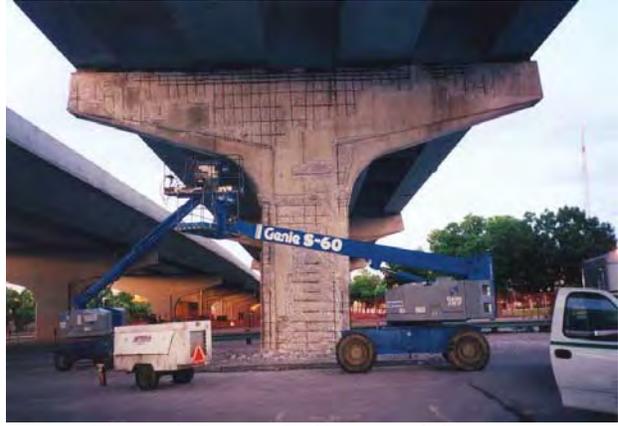
Figure 4: Removal of Damaged Concrete

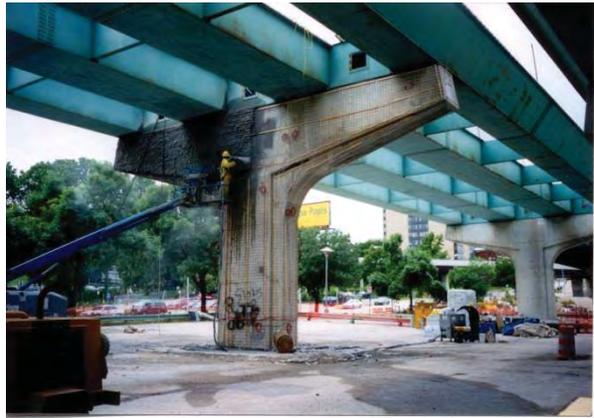
Figure 6: Concrete Repairs

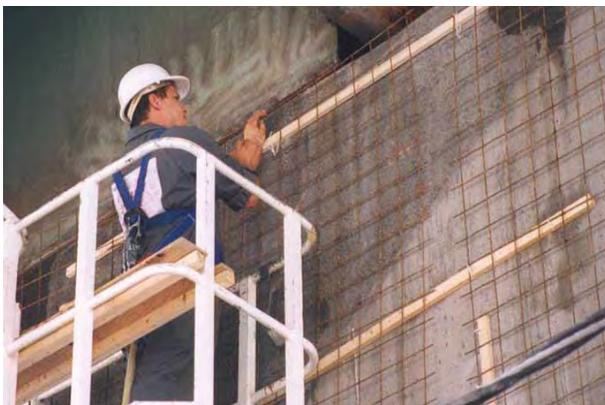
Figure 7: Temporary Anode Placement

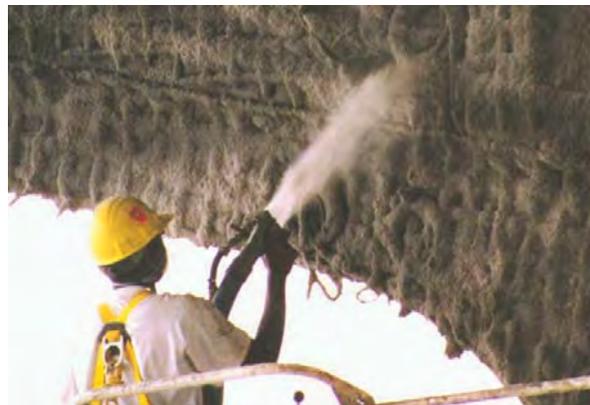
Figure 8: Temporary Electrolyte Installation

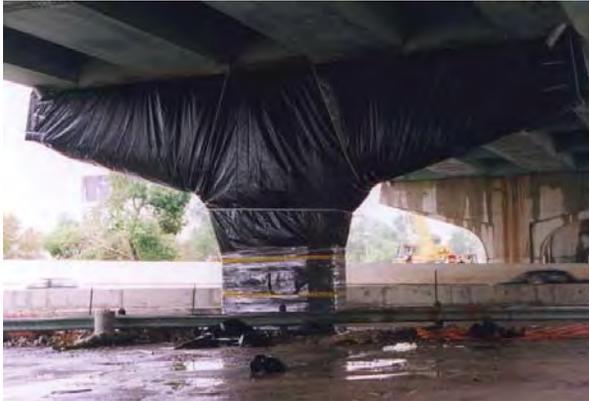
Figure 9: Norcure ECE Treatment in Progress

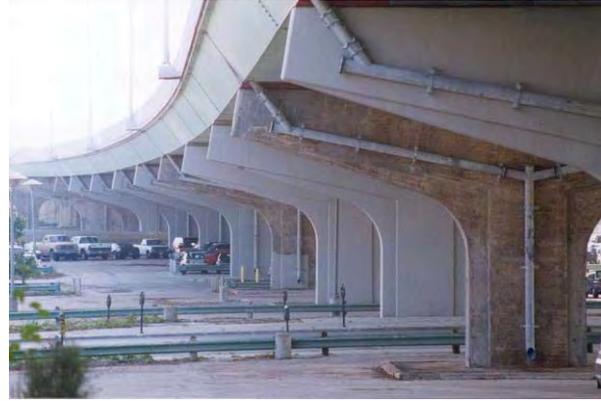
Figure 10: Replacement of Drains and Coating Application

Since the hammerhead piers were to remain in a corrosive environment, all 66 were protected from future chloride contamination with a chloride-resistant coating.

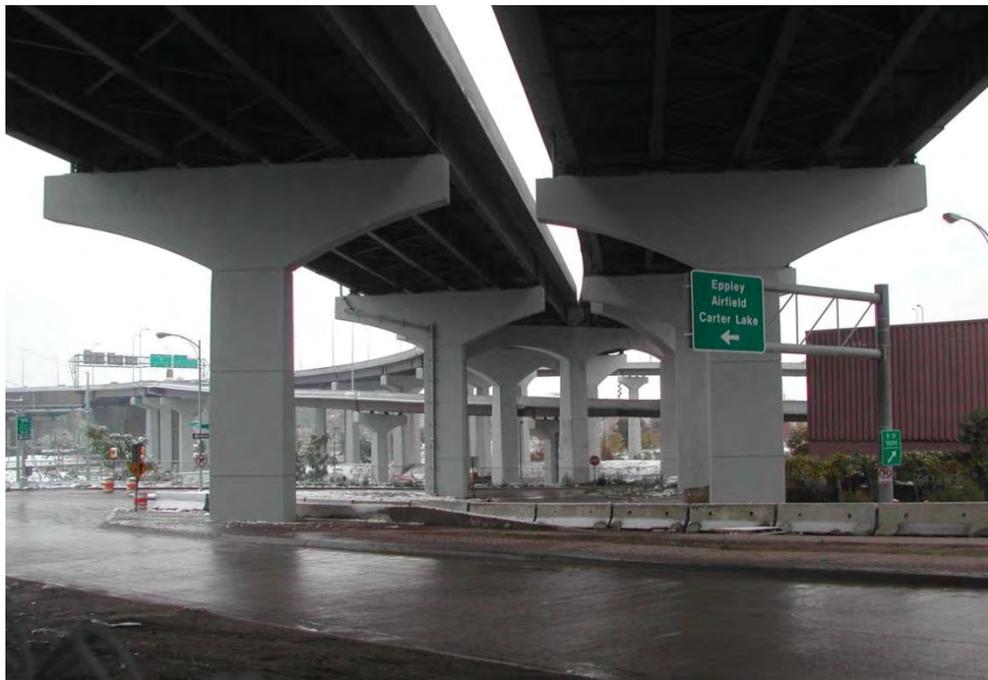
Figure 11: Completed I-480 Viaduct Rehabilitation

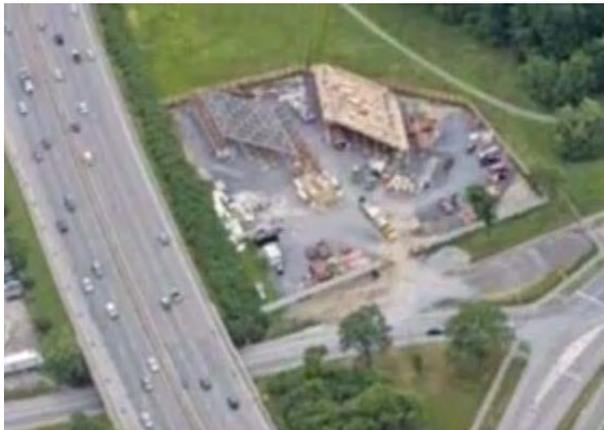
Figure 12: Construction of New Prefabricated Superstructures

The project design was to rapidly remove and replace the 48-year old eastbound and westbound superstructures while reusing the existing (rehabilitated) concrete abutments. The new prefabricated superstructures, consisting of steel girders and concrete decks, were built on a site adjacent to the Island Park Bridge.

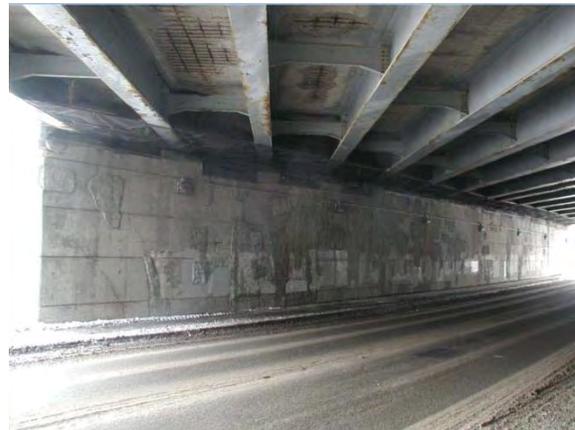
Figure 13: Condition of Existing Abutments

While the new superstructures were under construction, the concrete abutments were rehabilitated. The abutments were substantially damaged with high risk of future corrosion. The engineers selected a Reinforced Concrete Encasement with Cathodic Protection strategy for the abutments. This was accomplished by re-facing the abutment walls with a structural overlay containing additional reinforcing steel. To protect the reinforcing steel in the existing chloride-contaminated concrete, Galvanode DAS distributed galvanic anodes were placed in the overbuilt section.

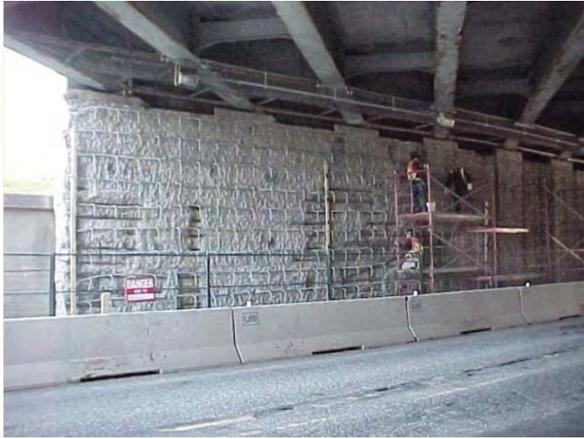
Figure 14: Re-facing of Existing Abutments

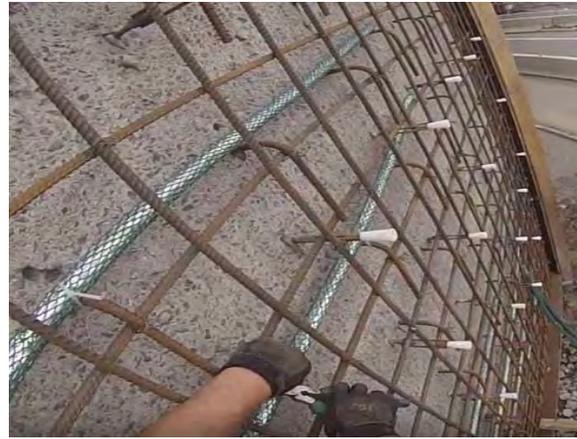
Figure 15: Distributed Galvanic Anodes and Additional Reinforcing Steel

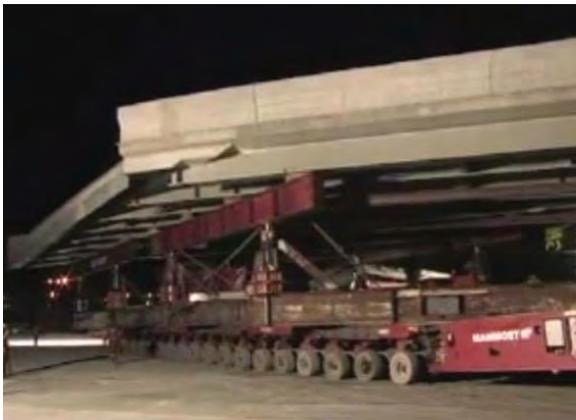
Figure 16: SPMT Moving a New Prefabricated Superstructure

Both bridges were replaced in a 16 hour period from Saturday, August 11th at 8:00pm until the bridge was reopened Sunday August 12th at 12:00pm. SPMT units were used to rapidly remove and replace the superstructures.

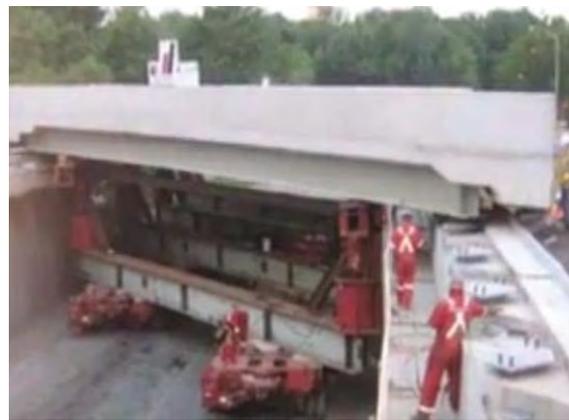
Figure 17: New Superstructure In-place
