Multi-Way Stop Warrant Analysis

Intersection: Lely Resort Blvd. @ Wildflower Way / Lely County Club

Collier County Growth Management Department

Traffic Operations Section

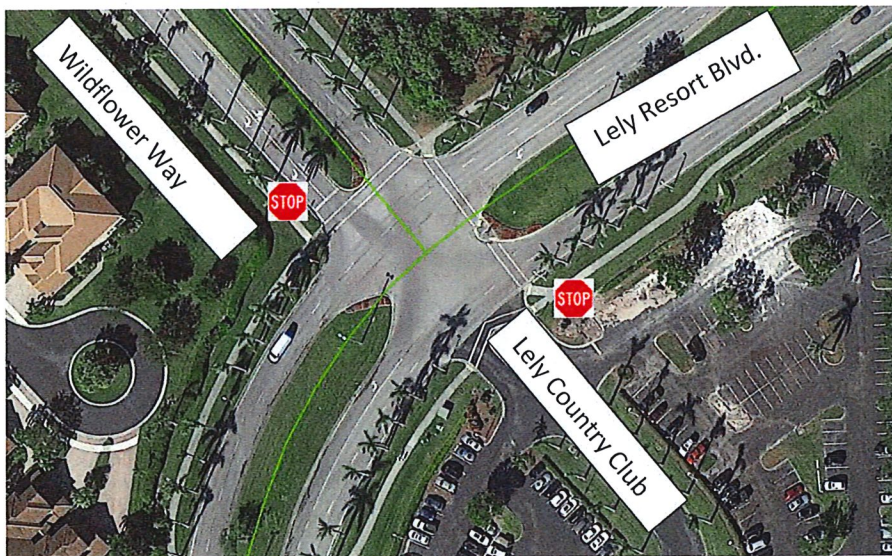
Figure 2, Intersection Map

This intersection is comprised of Lely Resort Blvd and Wildflower Way which are four-lane, median divided roadways and Lely Country Club which is a two-lane roadway that serves as egress to a business. Lely Resort Blvd and Wildflower Way are functionally classified as Access Class Arterials.

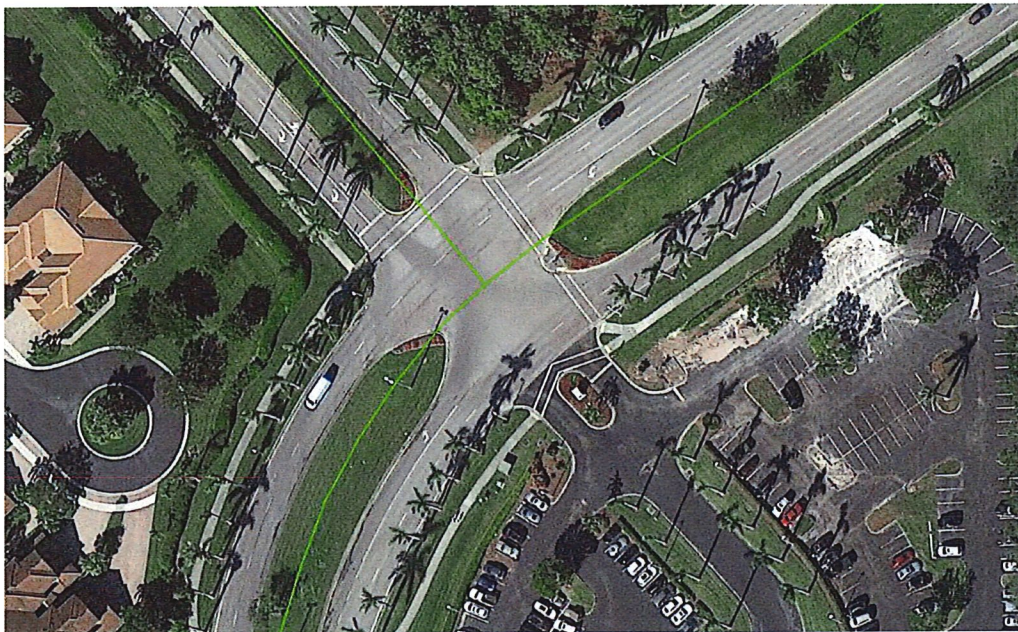
The intersection crash history was reviewed from 2014 through present (Appendix B). During this five year plus time period, there was a total of 10 recorded crashes near the intersection. The MUTCD required five or more crashes in a 12-month period that are susceptible to correction by a multi-way stop application.

2019	2 reported crash	Crash Data Metric warrant are not met
2018	3 reported crash	Crash Data Metric warrant are not met
2017	0 reported crash	Crash Data Metric warrant are not met
2016	4 four reported crashes	Crash Data Metric warrant are not met
2015	1 one reported crashes	Crash Data Metric warrant are not met
2014	0 reported crashes	Crash Data Metric warrant are not met

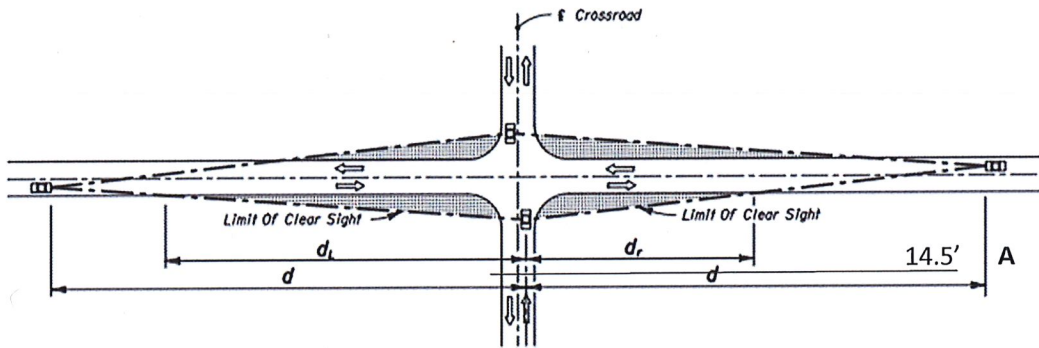
Sight Line Compliance based on Road Geometry

PICTORIAL
2 LANE UNDIVIDED

Design Speed	d	d _L	d _r
30 mph	335	240	150
35 mph	390	275	175
40 mph	445	315	200
45 mph	500	350	225
50 mph	555	390	250
55 mph	610	430	275

Design Speed	d	d _L	d _r
30 mph	420	295	190
35 mph	490	345	220
40 mph	560	395	250
45 mph	630	445	280
50 mph	700	495	310
55 mph	770	495	345

A: ~14.5 From edge of Road to Decision Point / Driver

d: ~ based on speed

An engineering field review has shown that this intersection does provide adequate sight distance for the turn movements.

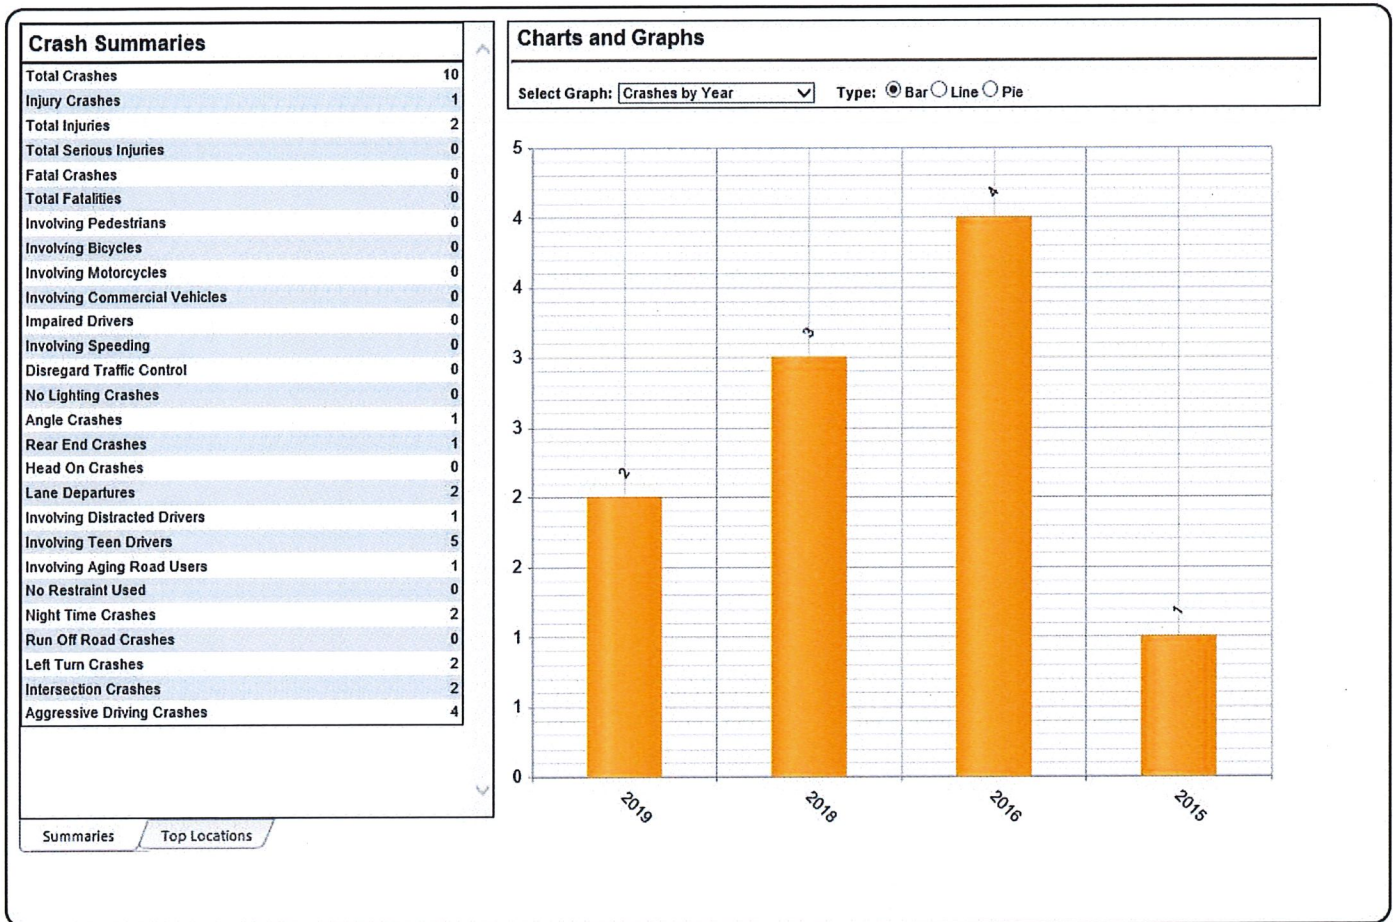
Time Frame: 2019, 2018, 2017, 2016, 2015 and 2014

Guideline Merits: Past 12 Months (5 or more)
