Uniform Mitigation Verification Inspection Form

Inspection Date: 7-Jan-21		
Owner Information:		
Owner Name: Sandra Bullock		Contact Person:
Address: 708 Sandy Dr		Home Phone:
City: Palmetto FL	Zip: 34221	Work Phone:
County: Manatee		Cell Phone: 867-5309
Insurance Company:		Policy #:
Year of Home: 2007	# of Stories: 1	Email: SandyStar@aol.com

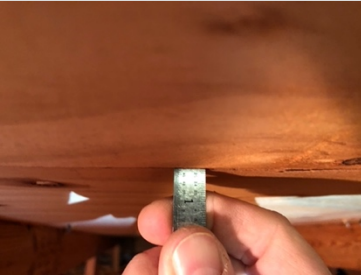
Roof Deck Thickness

- B. Plywood/OSB roof sheathing with a minimum thickness of 7/16" attached to the roof truss/rafter (spaced a maximum of 24" o.c.) by 8d common nails spaced a maximum of 12" in the field-**OR**- Any system of screws, nails, adhesives, other deck fastening system or truss/rafter spacing that is shown to have an equivalent or greater resistance than 8d nails spaced a maximum of 12" in the field or has a mean uplift resistance of at least 103 psf.

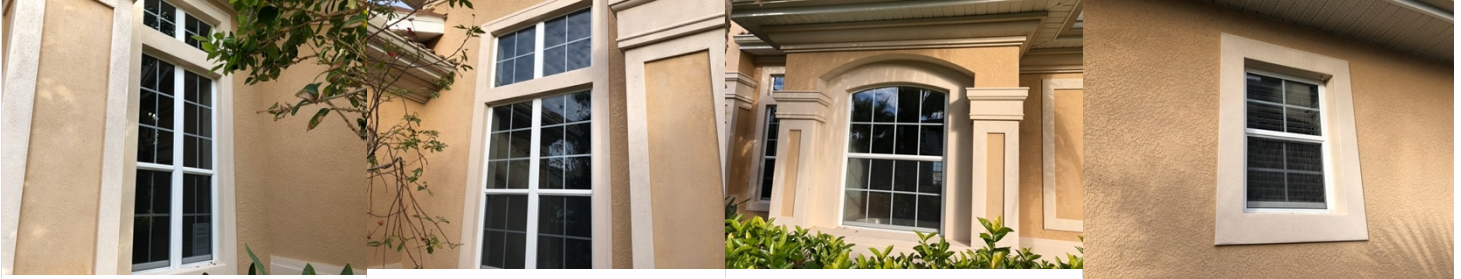
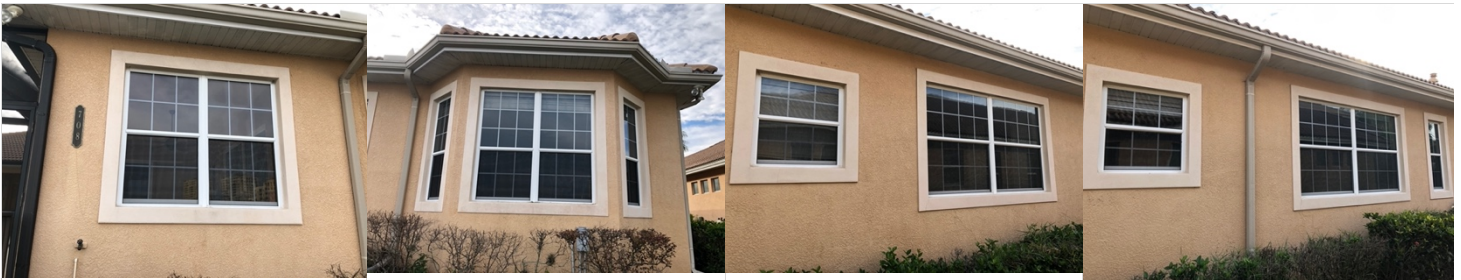
Windows

Not Impact Rated
No Pic Required
