## **Evaluation of NFRA -base under Freeze-Thaw tests and Water submergence tests**

Authors: Jorge Pluma Reyes, Tanner Jolly, Eltahry Elghandour, Mohammad Noori

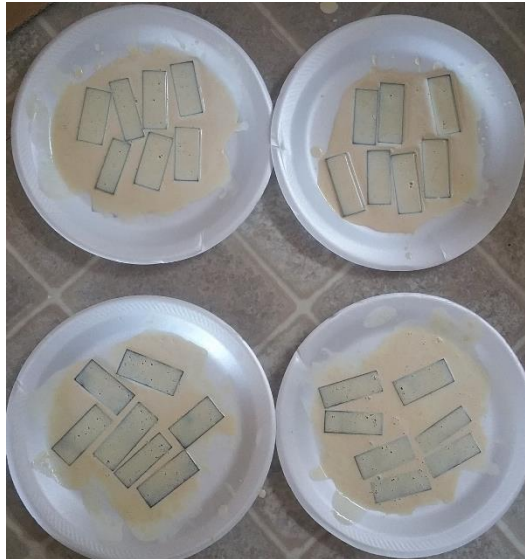
Figure 2. Seven clean and seven rusted cut pieces coated with NFRA<sub>1</sub>-base

Clean steel and rusted steel coupons were cleansed for application of the NFRA -base coating. The clean steel coupons were thoroughly cleaned with cycles of sanding, degreaser, acetone, and water washing. The rusted coupons were only rinsed in water to preserve the rust and allow it to interact with the NFRA -base coating. Multiple specimen were cut to carry out a freeze-thaw and salt water submergence test for seven days following application.

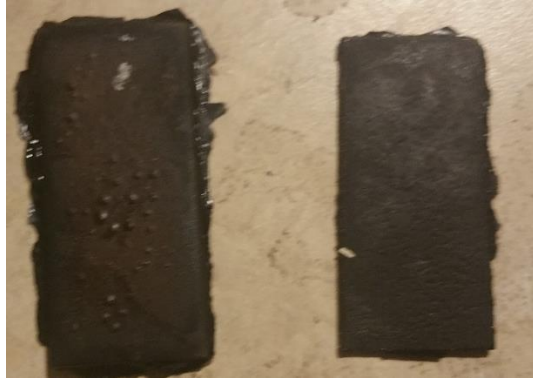
Figure 3. Day 1: Clean (left) and rusted (right) specimen before test

The experimental setup for the freeze-thaw tests consisted of exposing the specimen under room temperature for 5 minutes and then inserting it in a cool environment of -10 degrees Celsius. The specimen was maintained in that environment for 10 minutes, and then submerged to warm tap water for a period of 30 seconds. Thereafter the specimen was visually inspected for any signs of cracking or delamination damage. This was repeated 3 times to observe if multiple cycles would enhance any visible damage.

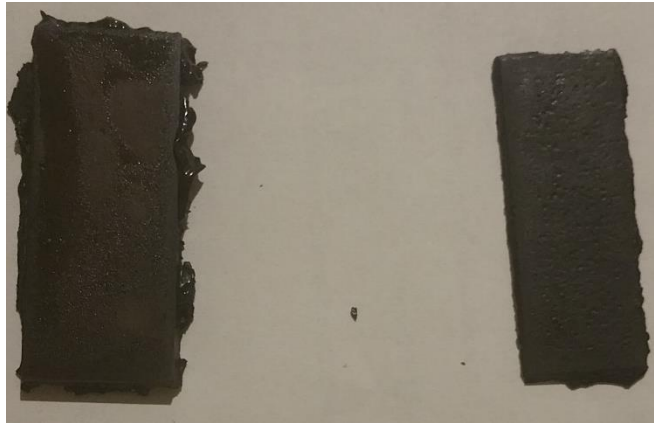
Figure 5. Day 5: Clean (left) and rusted (right) specimen before test

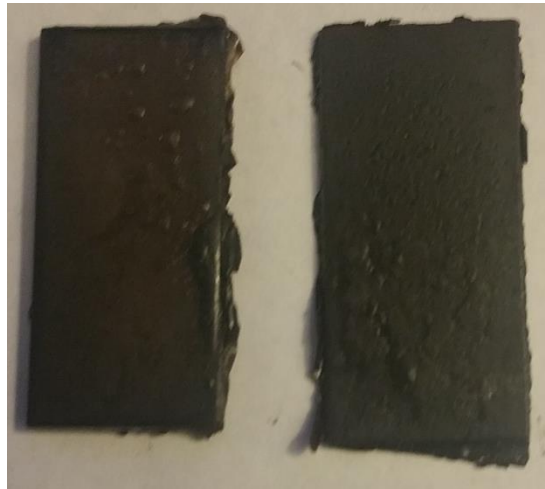
Figure 7. Day 7: Clean (left) and rusted (right) specimen before test

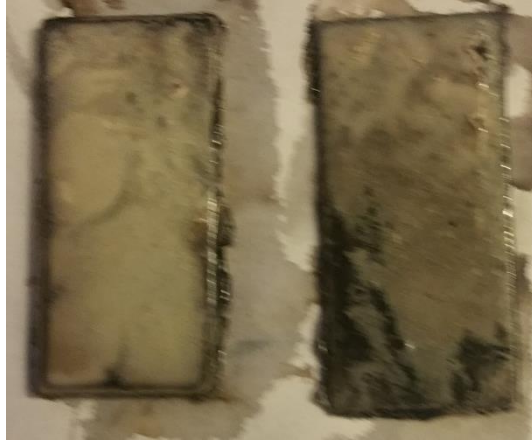
Figure 8. Day 7: After last cycle's 30 sec. submersion under warm tap water.

The results for days 1-7 were identical with no visible damage from cracking or delamination. Although curing times were different for each of these days, the behavior was the same when undergoing the freeze-thaw test. The only visible event that occurred was the outer coating layer washing off during the 30 second period under the tap water. A conclusion can be made that for the first seven days after application of the **NFRA** - base coating can endure temperature changes from a -10 degrees Celsius environment to temperatures of warm tap water (approximately 45 degrees Celsius) and experience no damage from cracking or delamination.

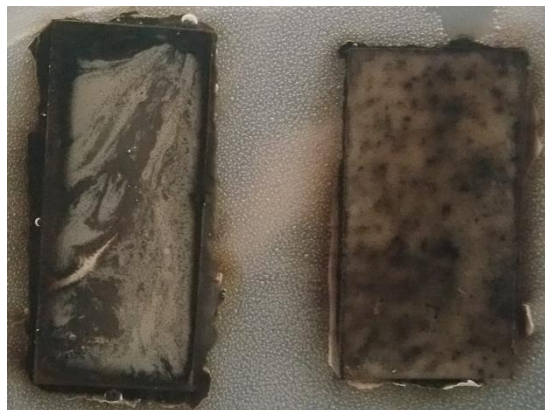
Figure 9: Day 3: Clean (left) and rusted (right) specimen at moment of submersion

The experimental setup for the salt water submersion tests consisted of submerging the specimen under an environment of salt water with a salinity of 3%. Lab grade sodium chloride salt was added to a clean tub of tap water and measured to 3% based on mass ratios. The specimen were submerged in water for 10 minutes and then taken out of the salt water for visual inspection. This was repeated 3 times to observe if multiple cycles would enhance any visible damage.

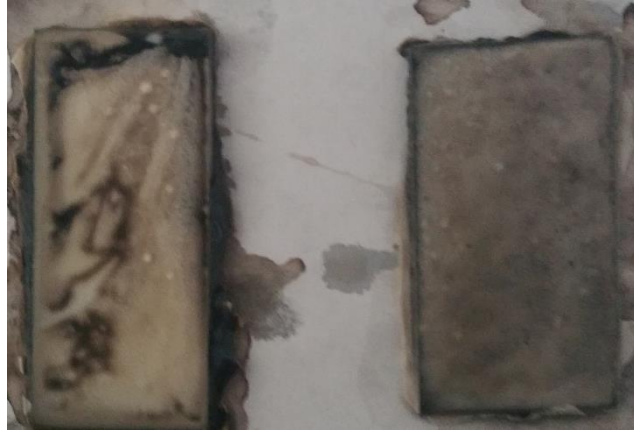
Figure 10. Day 3: After all cycles

Like the freeze-thaw tests, the salt water submersion tests yielded identical visual results with no damage seen from salt water exposure. The only event that occurred through visual inspection was the washing off of the outer coating layer from the water submersion. It can be concluded that no visual damage happens to the specimen from salt water exposure during the first seven days after application. The next steps are to analyze the specimen under an SEM machine to observe changes in the chemical composition.

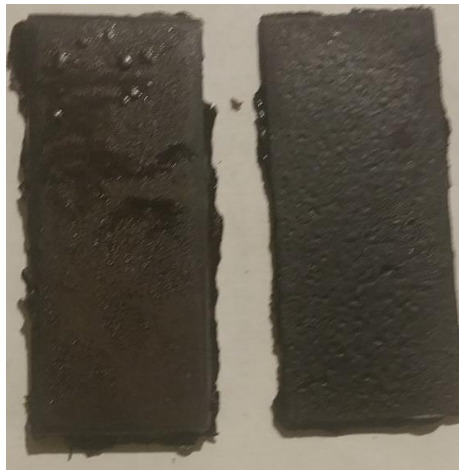
Figure 11. Day 5: Clean (left) and rusted (right) specimen before submergence

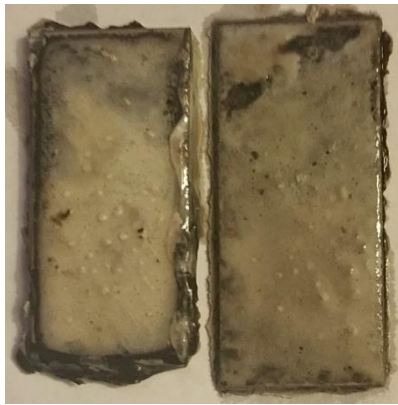
Figure 13. Day 7: Clean (left) and rusted (right) specimen after first cycle

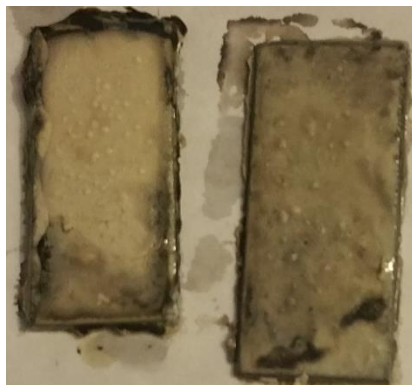
Figure 14. Day 7: After all cycles
