## Case Study: A249 Key Street – Emergency Central Reservation VRS Repair

### Project Overview

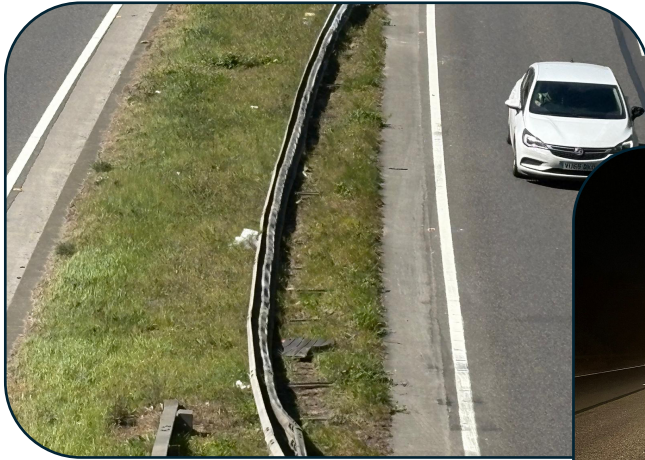
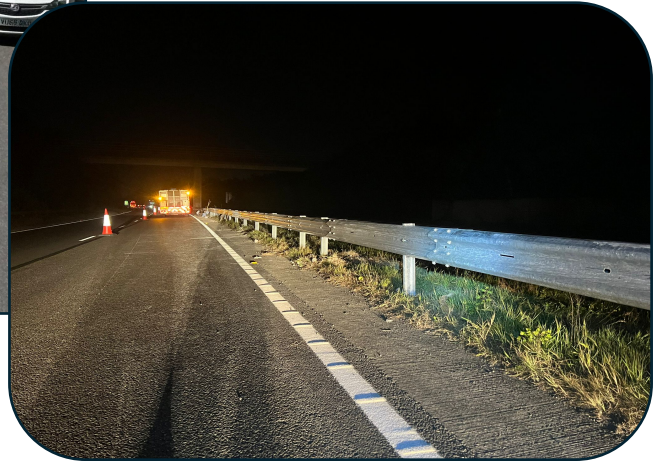
- Multiple sheared and deformed posts
- Significant impact damage to the tensioned corrugated beam
- Displacement of concrete socket foundations
- Loss of containment capability across the affected length

- Supply, delivery, and installation of 30 no. replacement posts
- All posts installed into concrete sockets to enable faster future maintenance
- 71m of replacement tensioned corrugated beam
- Removal and disposal of all damaged components
- Full reinstatement of system tension and alignment
- Compliance checks against current VRS standards
