Industrial Development at North MacLean, 4653 - 4691 Mount Lindesay Highway, North Maclean, Queensland

Year 2 Annual Compliance Report (February
2025 - February 2026)

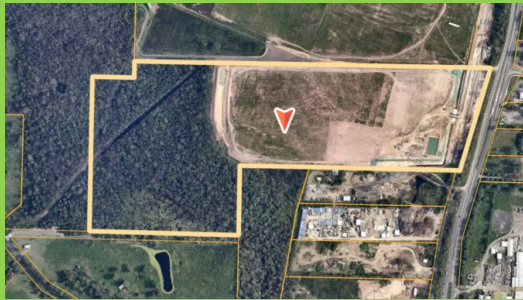
Inset 1 – 07 December 2025, Aerial Imagery of Site (Source: Near Map, 2026)	
2	<i>To avoid and mitigate Harm to Protected Matters, the approval holder must not Clear more than:</i> a) 20.15 hectares (ha) of Koala habitat b) 20.15 ha of Grey-headed Flying-fox Habitat c) 20.15 ha of Greater Glider Habitat.	Year 2 Compliance All clearing associated with the Action was undertaken in accordance with the Approval during Year 1. No more than 20.15 ha of relevant Habitat has been cleared.	N/A

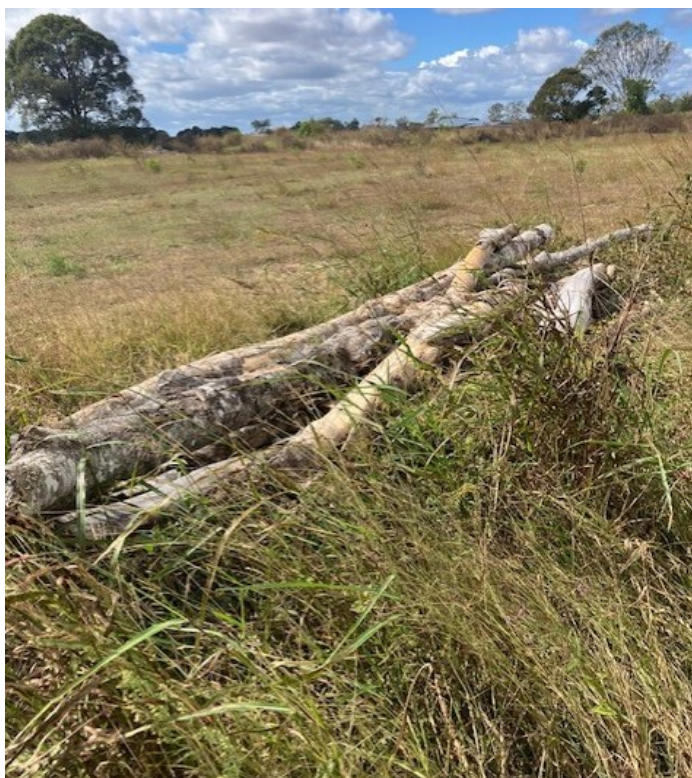
10.3.2 Flood Risk Management

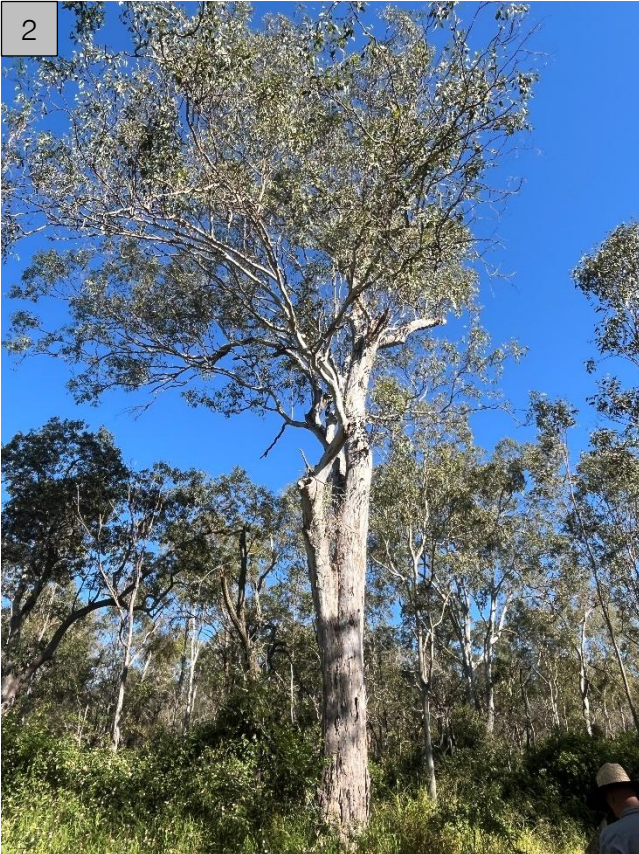
Image 2: An example of a veteran tree with hollow habitat located in the western woodland aspect of the site

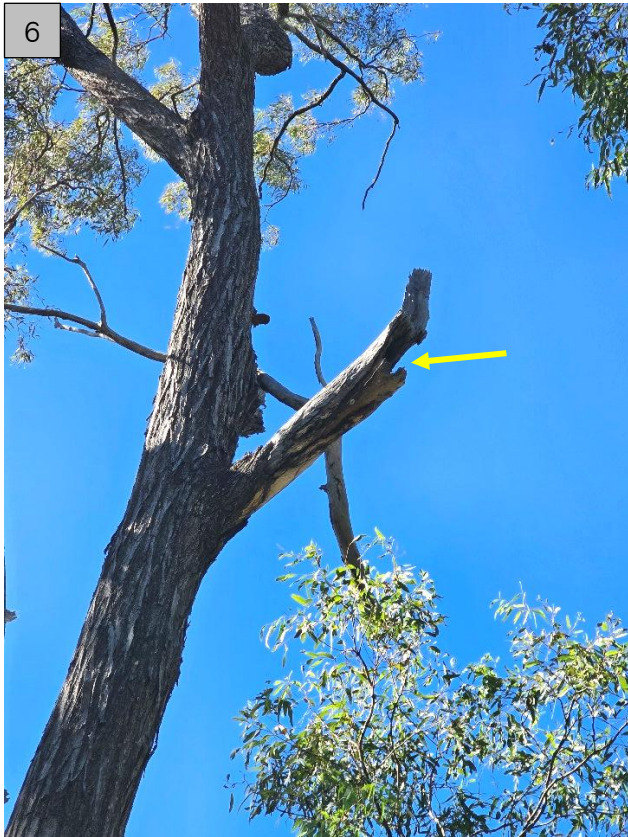
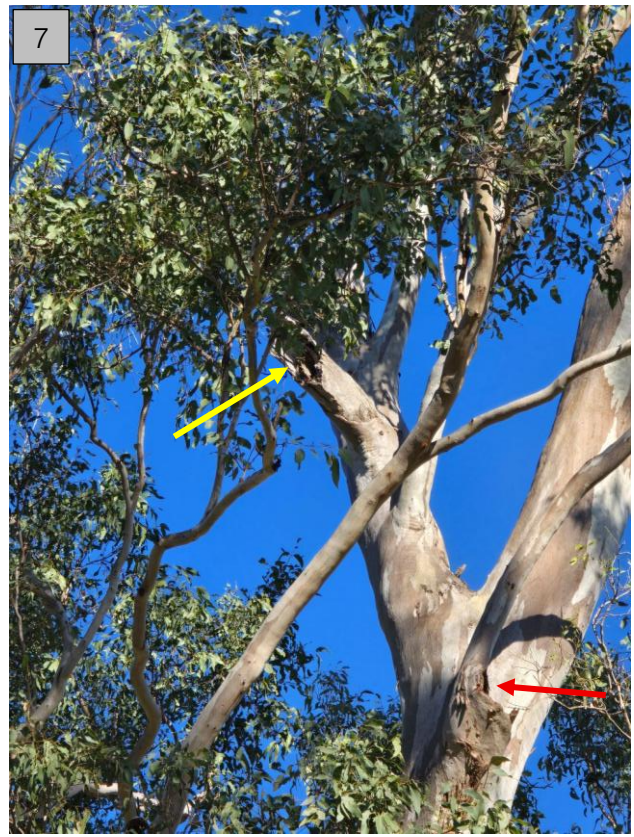
Images 6 & 7: Examples of natural formed hollows where branches have previously failed, indicated by the yellow and red arrows. (Arbor Australis, 2025)

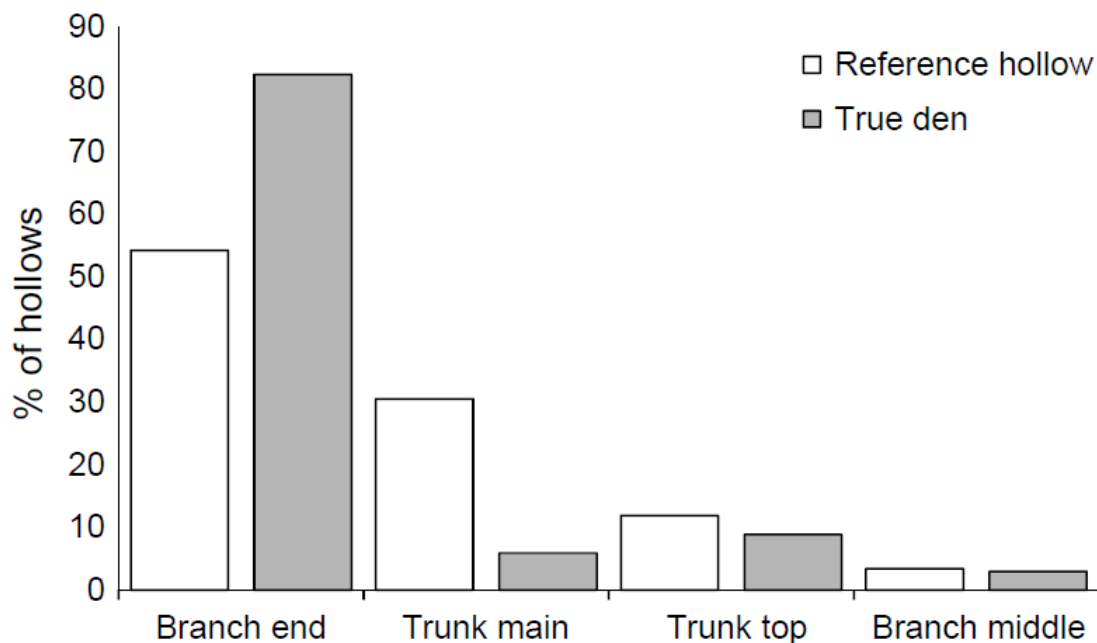
Graph 1: Extract from Hoffman *et al.* (2022) showing utilisation of hollow type.

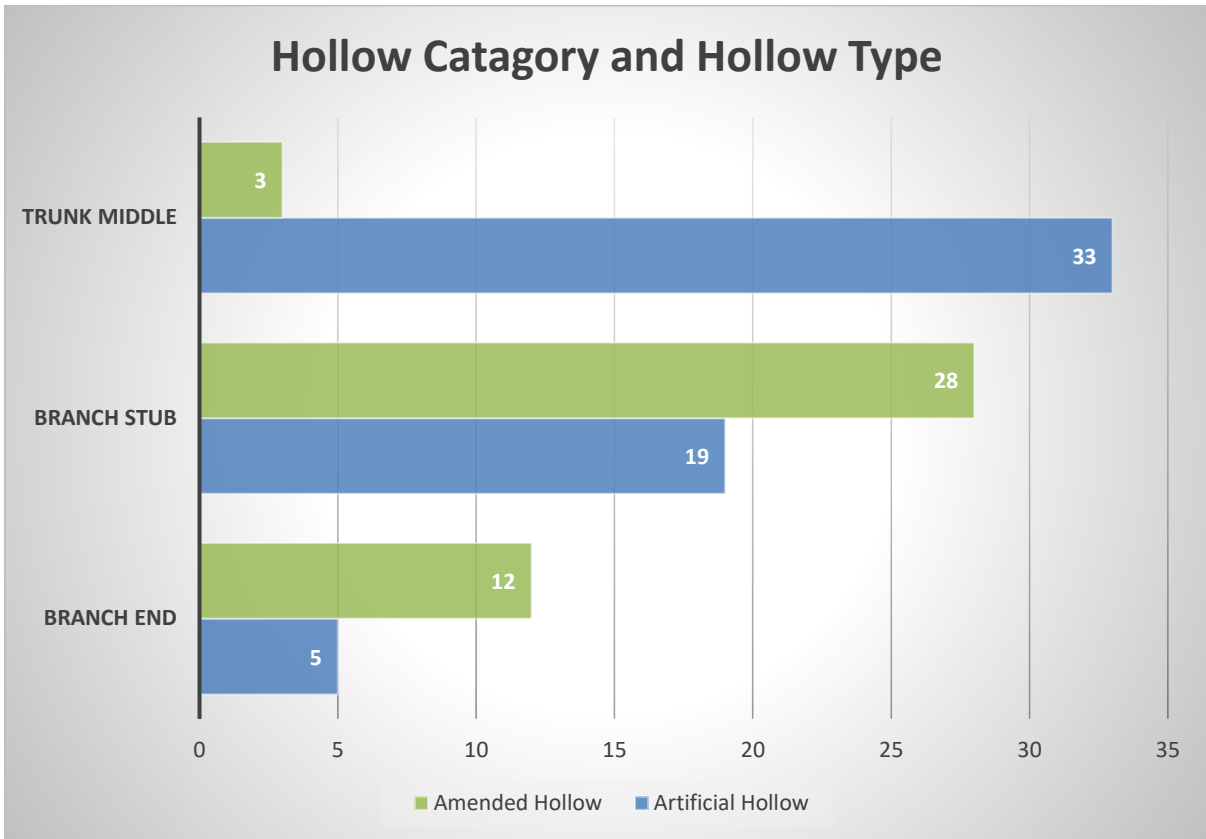
Graph 4: Proportional suitability of trees onsite greater than 500mm DBH.

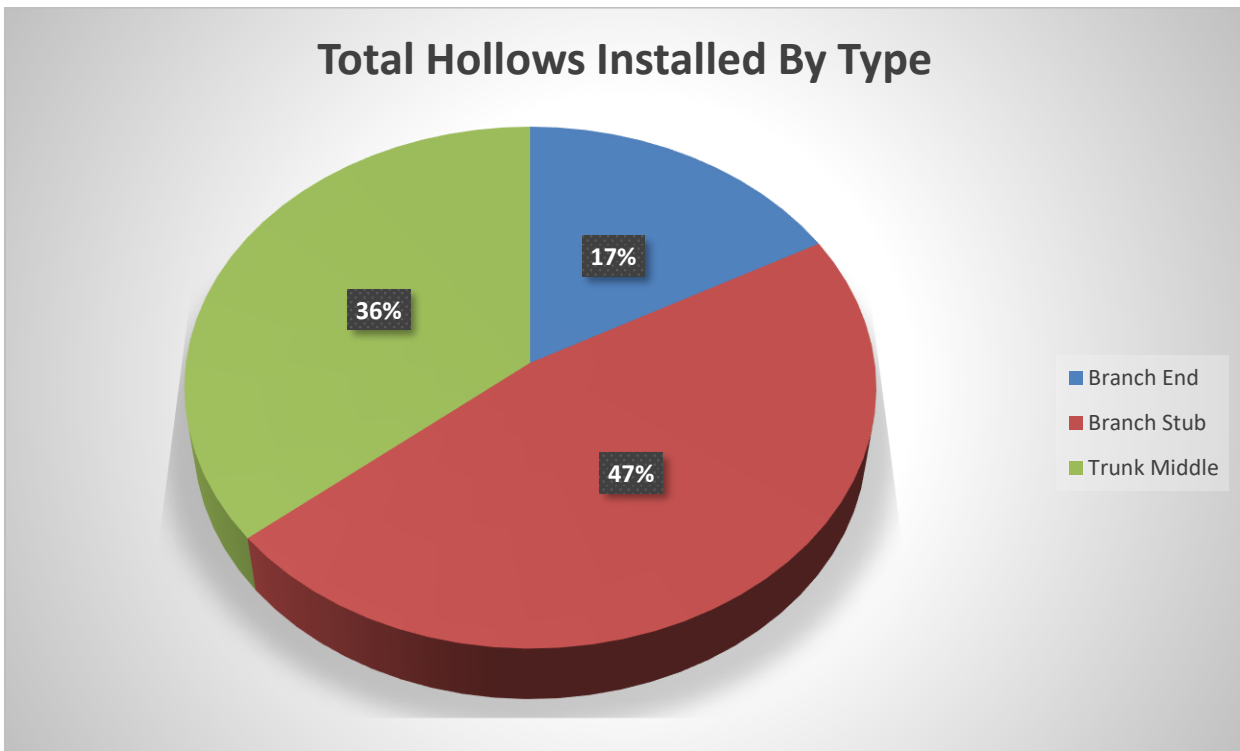
Graph 5: Proportionality of Hollows by type.

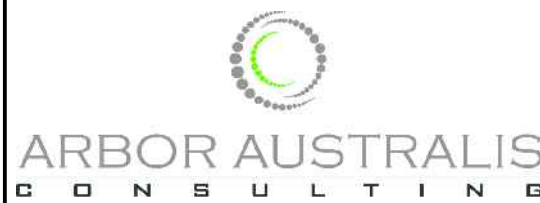
Arbor Australis Consulting

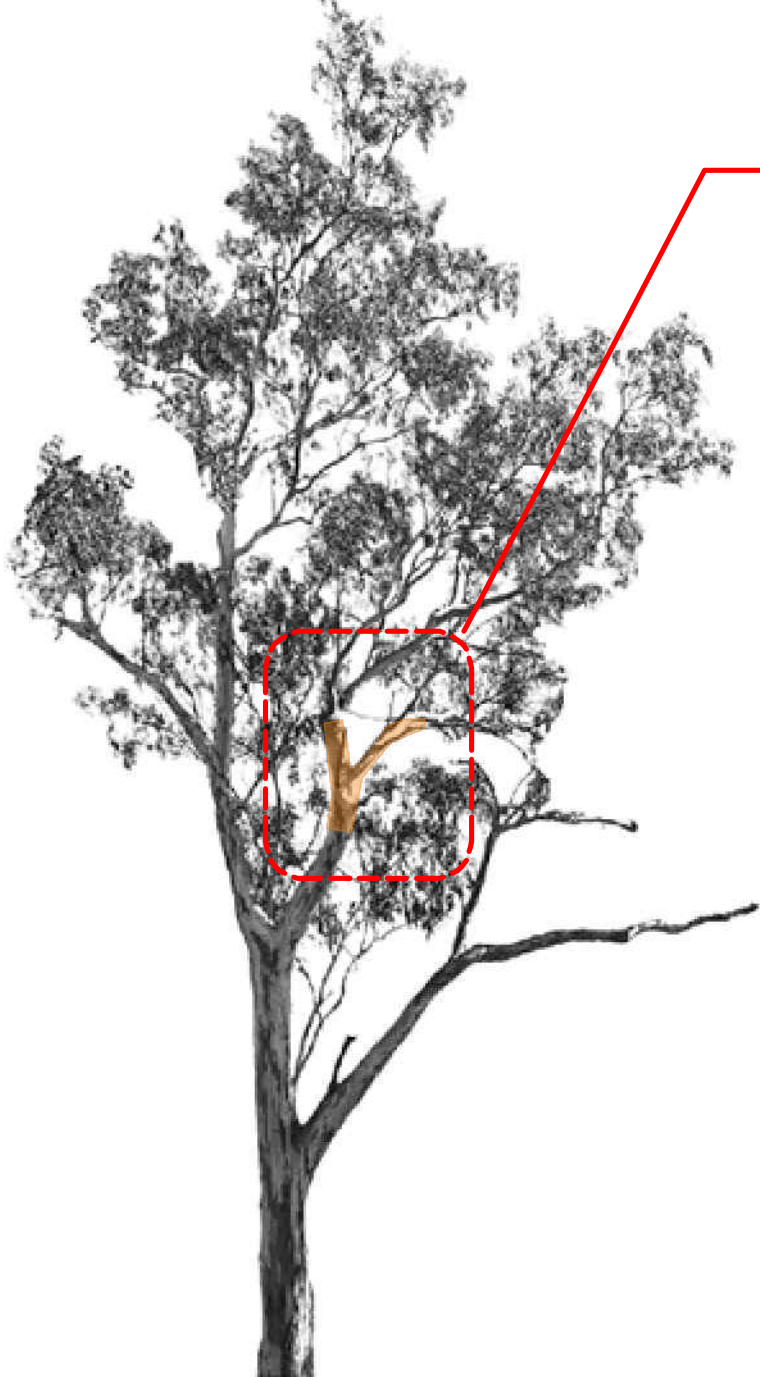
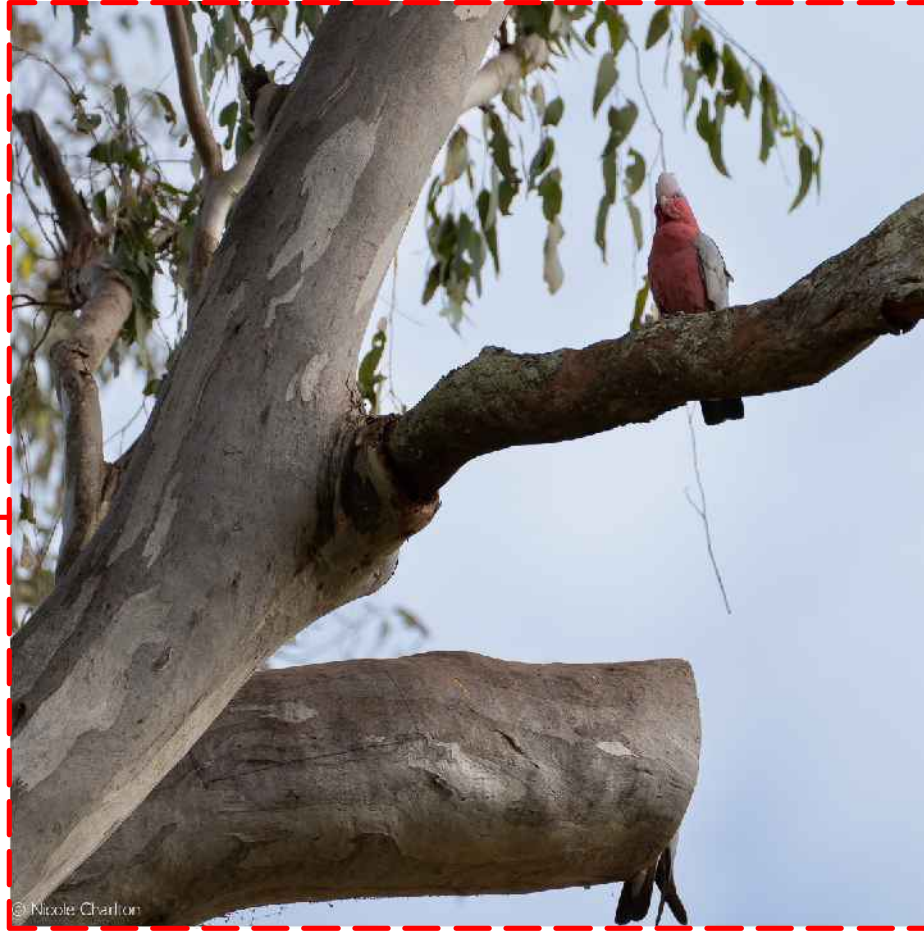
BLOW - UP ELEVATIONS

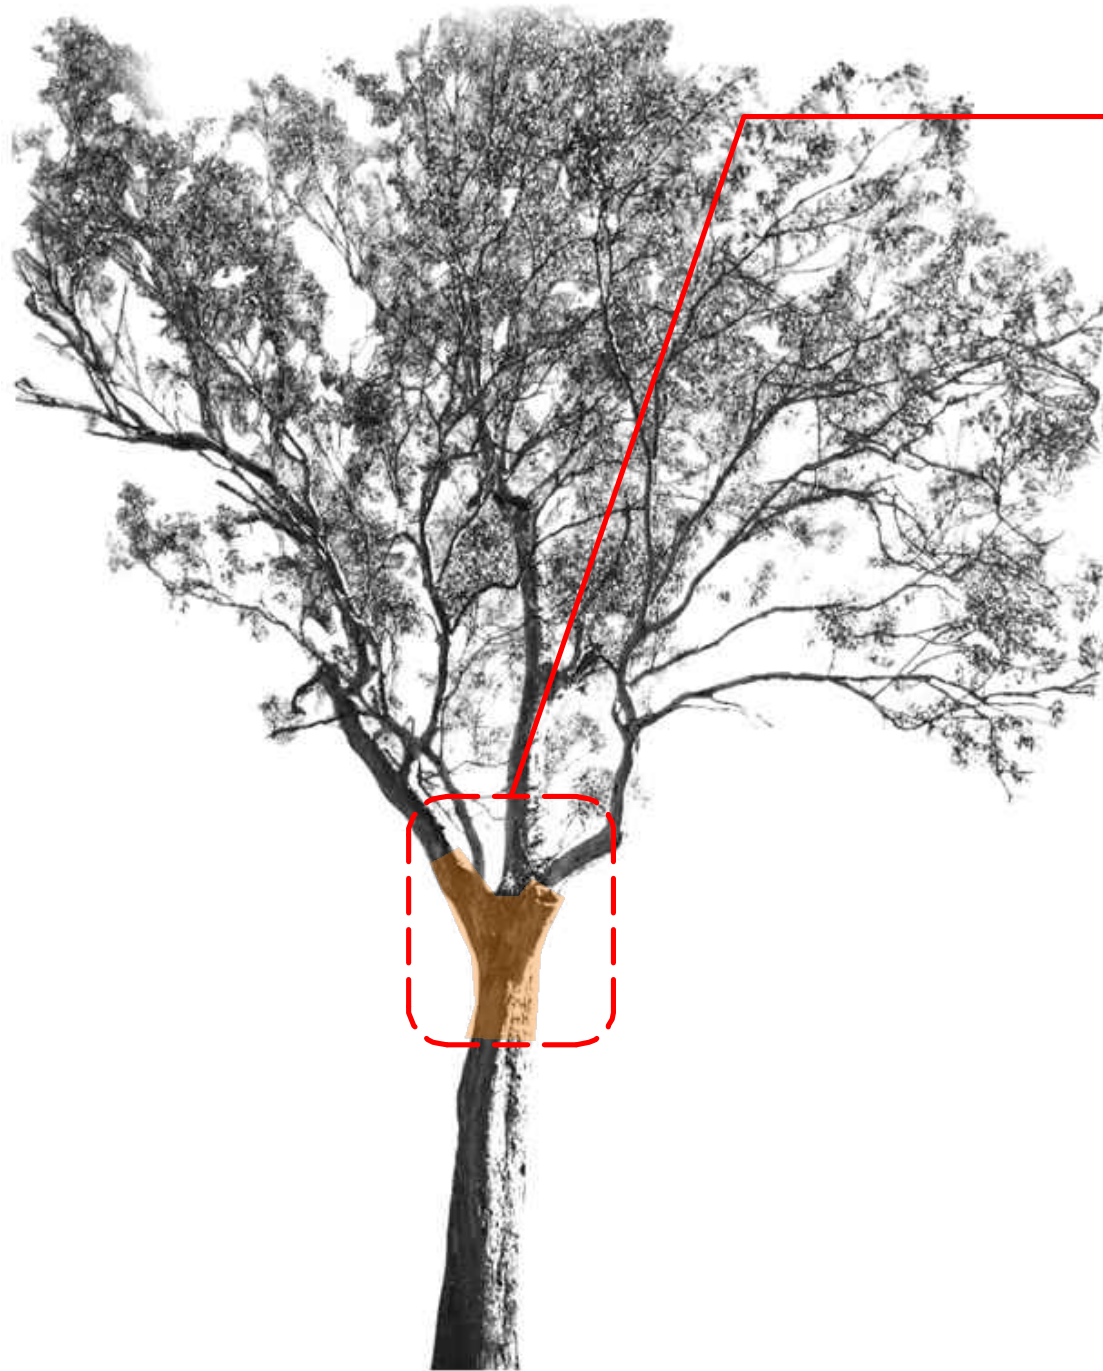
Branch Stub Hollows are carved in a branch stub close to the branch union with the entrance through the end of the cut or broken branch and the denning chamber within the trunk of the tree. Trees suitable for branch stub hollows are typically greater than 600mm in trunk diameter, are early mature, and have a stem diameter of 400mm or greater at or above the minimum installation height (refer to installation notes).

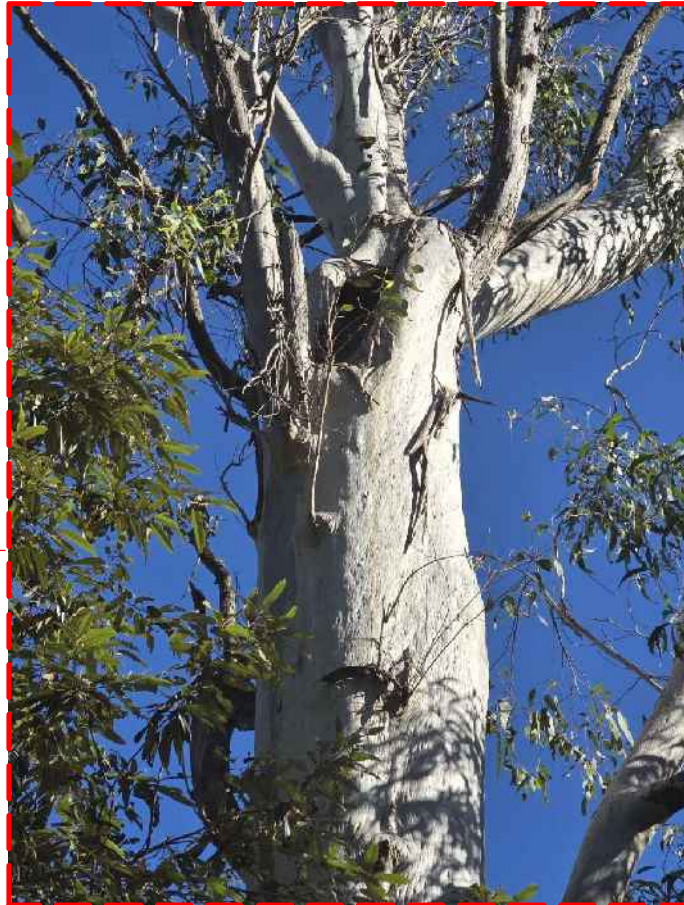
Trunk Top Hollows are carved in a vertical trunk with the denning chamber below the entrance in the trunk. Trees suitable for Trunk Top Hollows are typically greater than 600mm in trunk diameter and have a history of past crown failure. They are early mature and have a stem diameter of 300mm or greater at or above the minimum installation height (refer to installation notes).
