STATE of the POUDRE

A River Health Assessment

Executive Summary

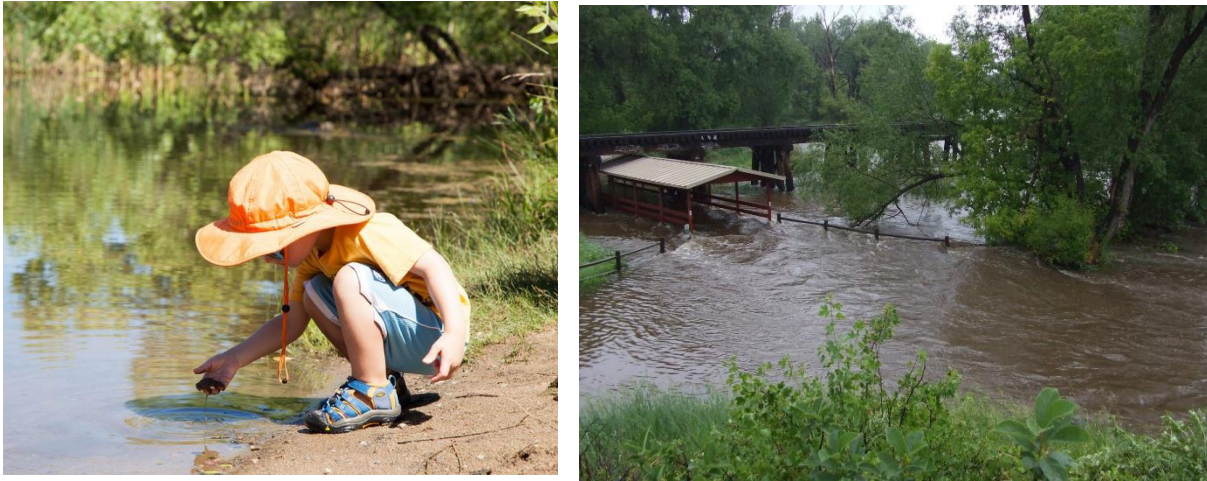
Figure 1.2: A healthy and resilient river is a river that sustains basics functions (such as water quality) during the years with average precipitation and also provides protective benefits such as (floodwater attenuation and infrastructure protection) during extreme wet or dry years.

The *health* of the river system is a reflection of its ability to perform its normal suite of functions, thereby providing the benefits our community values and depends upon (Figure 1.2). *Resilience* of the Poudre River is interpreted from two perspectives in this assessment:

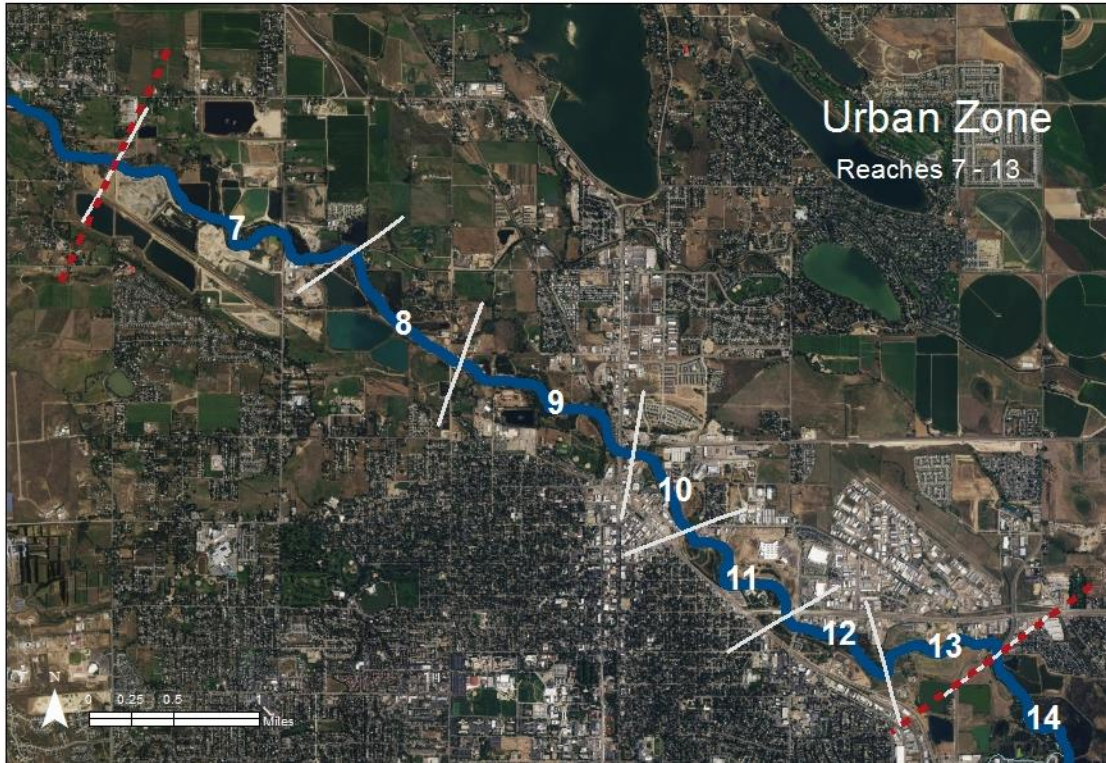
Figure 2.3c and d: Each zone in the SOPR study area and their corresponding reach breaks shown on land imagery.

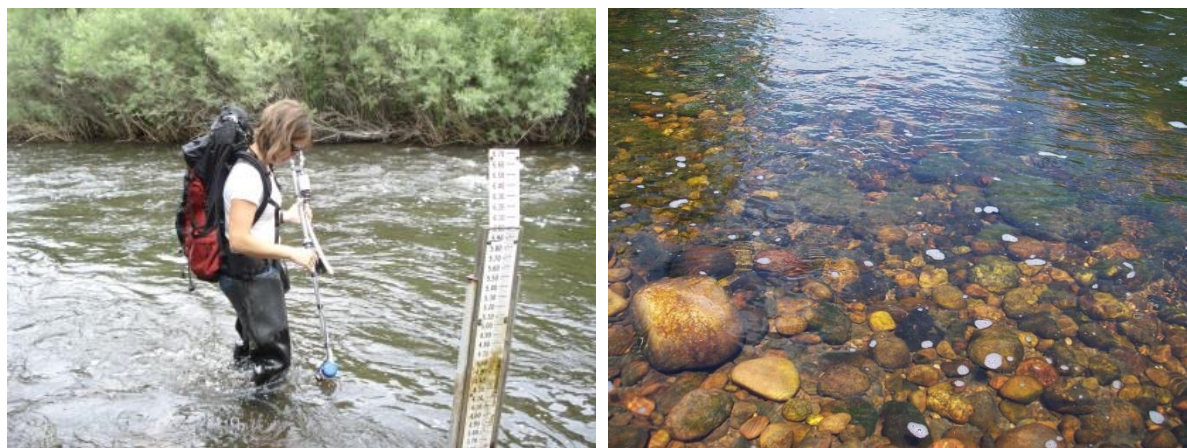
Figure 2.6: At left, Jill Oropeza, Water Quality Services Manager analyzes water quality in the upper Poudre River. To the right, clear water, clean cobbles and low levels of undesirable algae are signs of good water quality.

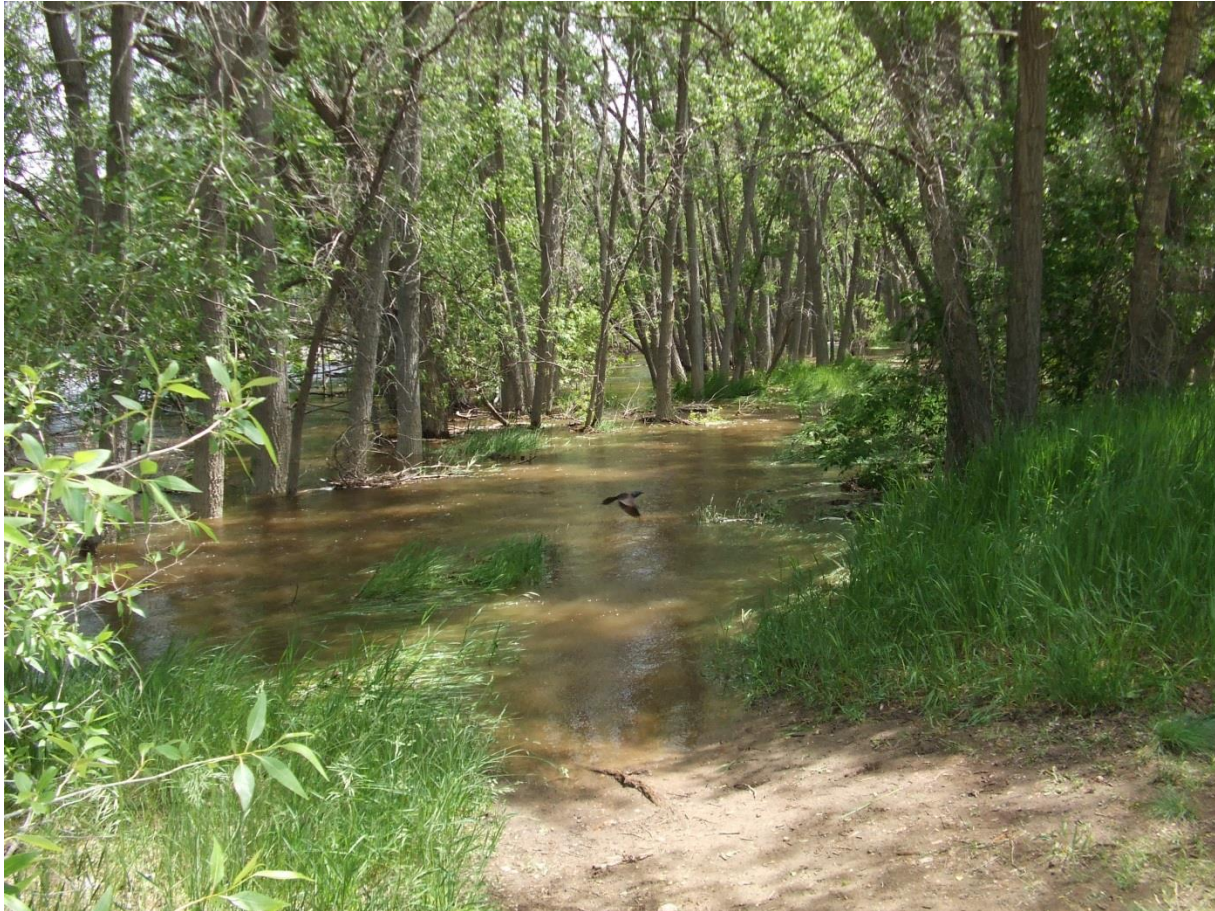
Figure 2.7: A riparian area with good floodplain connectivity as demonstrated by the seasonal flooding that occurs and the healthy riparian forest sustained by floodwaters.

The floodplain connectivity indicator has only a single metric, **floodplain extent**. This is a measure of the width of the riparian zone that is flooded on a regular basis and which supports riparian species and processes (Figure 2.7). The extent of the five-year return interval floodplain was mapped using a Hydraulic Engineering Center – River Analysis System (HEC-RAS) model provided by the City of Fort Collins. Digital terrain data for the model came from a 2014 LiDAR survey and additional channel cross-section data from land surveys (King Surveyors, Spring 2013 and Spring 2014). The model covered the river reach from just upstream of Shields Street to just downstream of I-25. Channel widths were manually measured using aerial imagery at each modeled cross-section and then subtracted from the modeled water surface width to get the resulting floodplain width. For reaches upstream of where HEC-RAS model results were available, current aerial imagery was used to estimate the width of the 5-year floodplain. The degree of floodplain encroachment was estimated by evaluating evidence of land-use change and comparison to similar reaches for which modeled results are available.

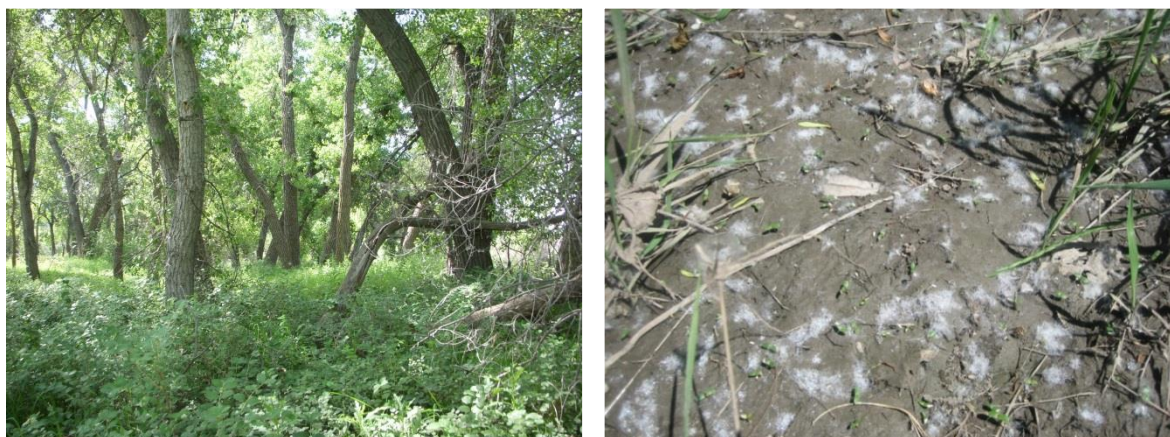
Figure 2.8: Riparian forest with moderate structural diversity (left). Recently deposited plains cottonwood seeds on bare moist soil, shown in the photograph at right illustrate the ideal conditions for successful cottonwood germination.

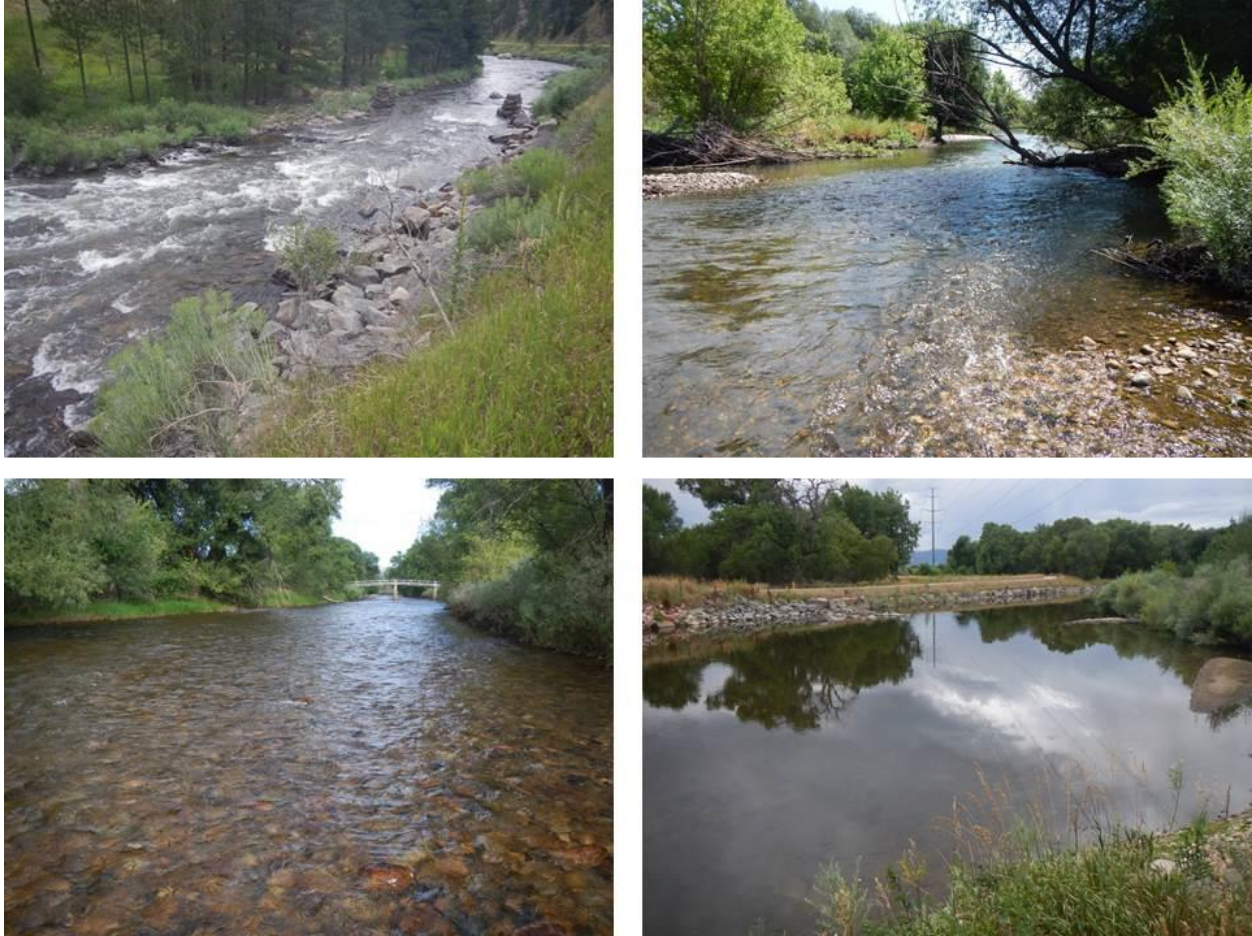
Figure 2.9a-d: Examples of different coarse-scale habitat conditions (clockwise from top left) include a) steeper plane-bed channel in the Canyon zone with large boulders providing diverse habitat, b) pool-riffle sequencing with large-wood helping create pool scour, c) homogenous run habitat lacking diverse coarse structure especially pool habitat, and d) homogenous glide habitat created from backwater conditions at the diversion dam downstream.

The physical structure indicator grade is the average of two metrics that consider different scales of river structural diversity (Figure 2.9). The **coarse-scale** and **fine-scale** physical structure metrics were both graded based on field observations of the 22.6 river miles that were visited. Grades for the reaches on the 1.3 miles that were not observed in the field were extrapolated from similar reaches, guided by aerial imagery. Coarse-scale physical structure grades were based on qualitative estimation of the diversity of water depth/velocity combinations, topographic complexity of the bed and banks, and physical structure of the reach compared to the natural reference (Figure 2.9). Fine-scale structure grades relied heavily on field observations of interstitial space availability, bed armoring, embeddedness, and algae in riffles (Figure 2.10).

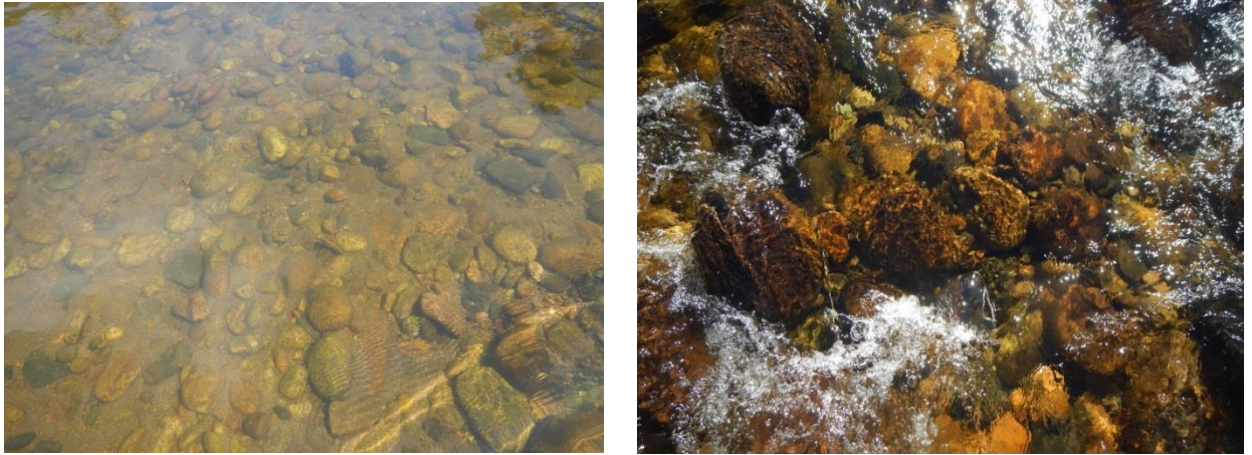
Figure 2.10: Field observations of interstitial space availability, bed armoring, embeddedness, and algae in riffles helped inform the fine-scale metric grades.

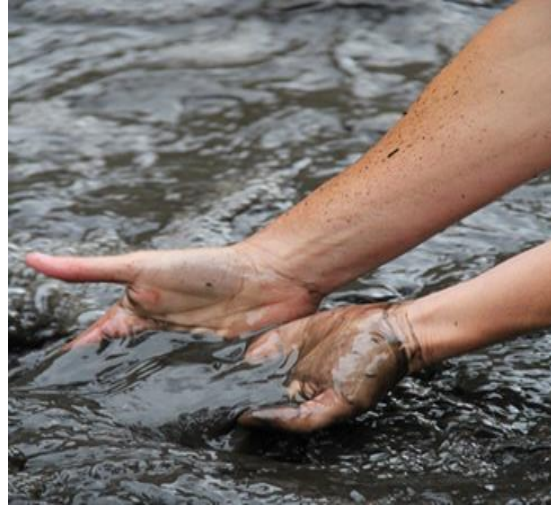
Figure 3.2: Post fire erosion creating turbid waters.

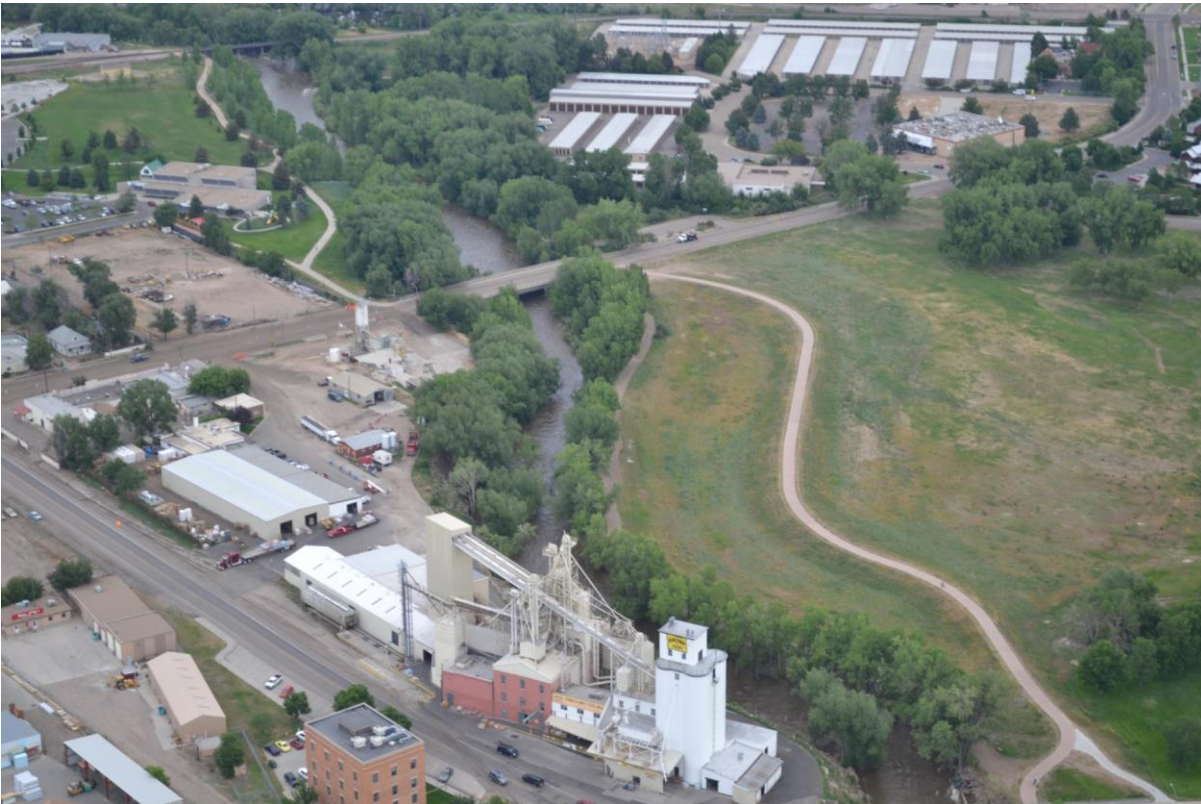
Figure 3.4: Development in the historical riparian area is a stressor on reaches in the Urban and Plains zones.

All commercial, industrial, infrastructure, transportation, and residential land uses in the riparian zone may be considered stressors (Figure 3.4). Commercial/industrial land uses are mainly retail and manufacturing facilities that introduce a substantial amount of artificial roof, impervious surface, bare ground, or open water cover types to the riparian zone. Infrastructure areas contain the structures, systems, or facilities that serve the public interest. Roads and railways were mapped as transportation corridors, and paved paths were considered part of the transportation corridor when they were associated with a road. Residential development is typified by suburban moderate-density housing. Residences in the riparian zone are relatively few, with most being single-family units with manicured/landscaped lots or lawns. Some high-density housing units are present in the Urban zone. These land uses are considered direct impacts to the riparian condition, affecting vegetation structure, habitat connectivity, and contributing area. They also severely limit active floodplain function since they need to be protected via channelization, berms, and fill.

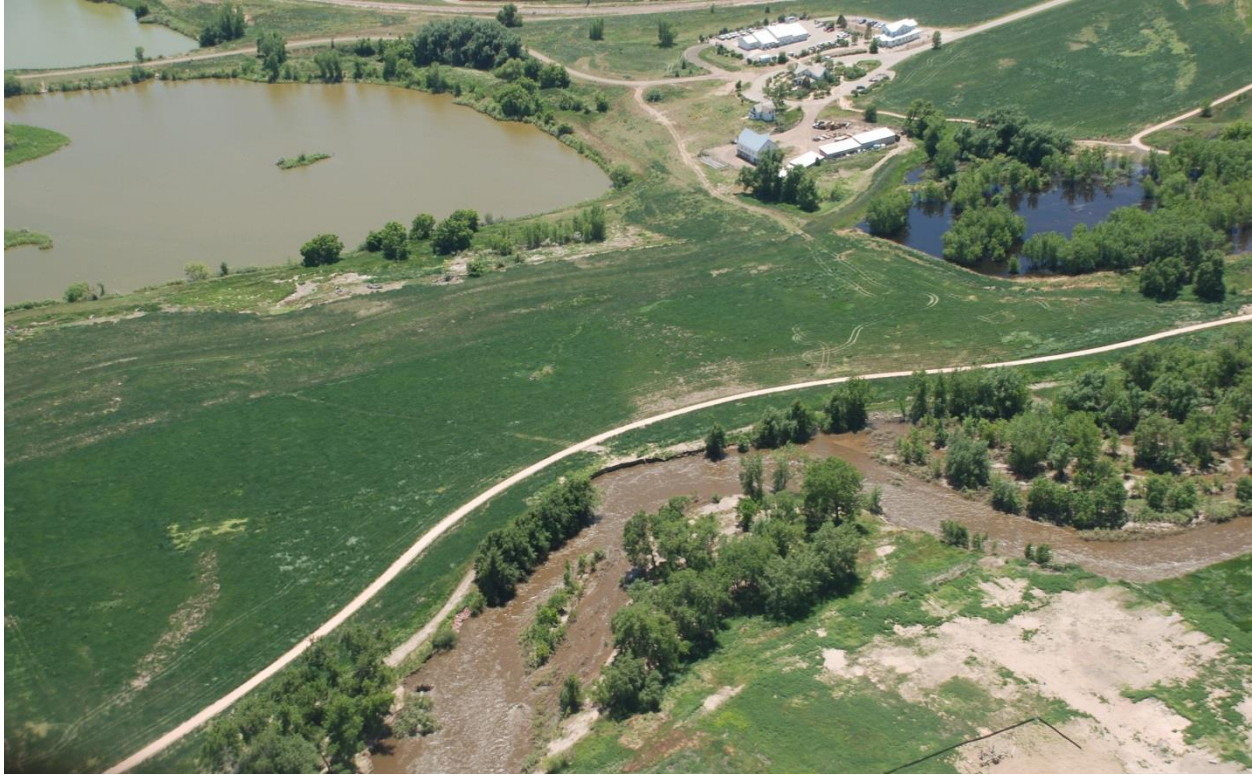
Figure 3.6 While open space and parks management of lands in the floodplain primarily has a positive influence of river health, infrastructure such as the bike bath in this photo is often located so close to the river that it's protection disconnects the river from a functional riparian zone .

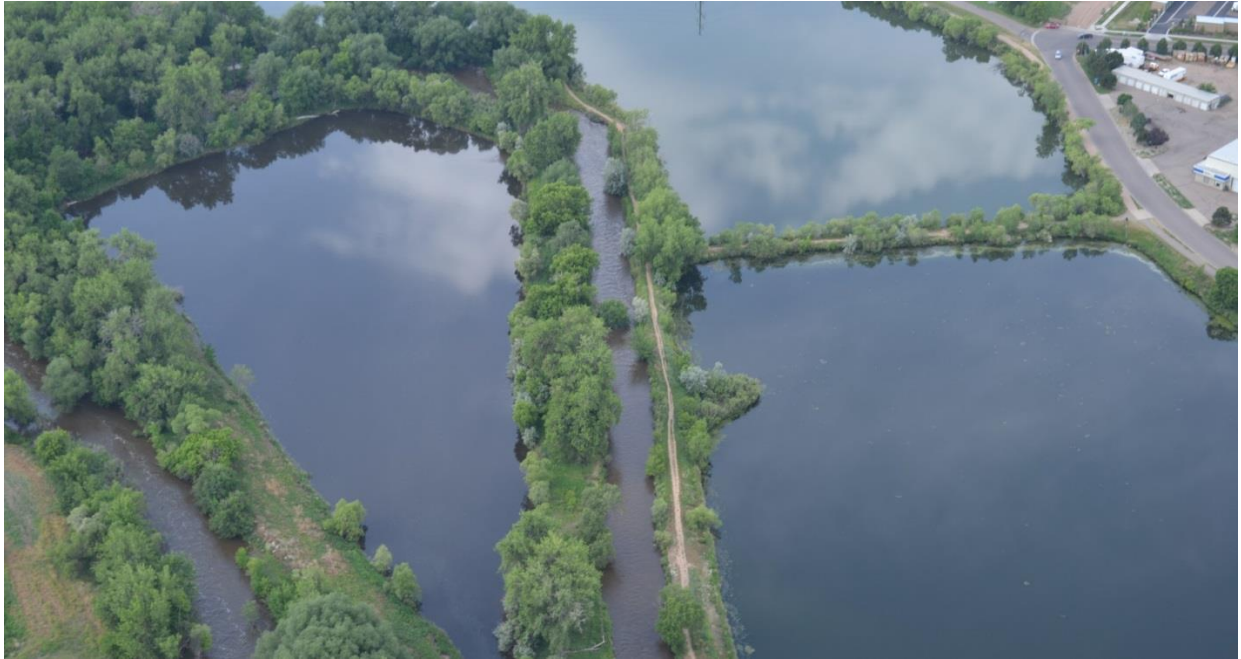
Figure 3.7: Gravel pits and ponds are a common floodplain land use in the Urban and Plains zones.

Gravel pits and ponds account for eight percent of the SOPR riparian zone land cover (Figure 3.7). Gravel mining has been a prominent industry along the Poudre floodplain corridor almost since the town was first settled. In the City of Fort Collins natural areas alone, there are more than 30 former gravel pits and ponds. Most of these are excavations filled with alluvial groundwater that are separated from the river by berms or dams. Gravel ponds represent a conversion of vegetated riparian habitat into open water, and therefore they are a direct and severe impact on riparian condition. In some cases—where they are not fully surrounded by berms and gravel pits—ponds still offer some floodplain function by providing area for overbank flows to spread, but ponds provide no floodplain roughness. Bermed gravel pits and ponds contribute to instability and poor resilience by introducing the risk of catastrophic failure and avulsion (*i.e.*, rapid abandonment of a river channel and the formation of a new one). Recovery from massive avulsions is slow and unpredictable, and it can be quite expensive if the issue must be actively addressed. The numerous examples where Front Range rivers cut new channels through gravel pits and ponds during the 2013 flood provide direct evidence of these potential risks and the consequences. Gravel pits and ponds also affect groundwater dynamics, habitat connectivity, and (potentially) water quality.

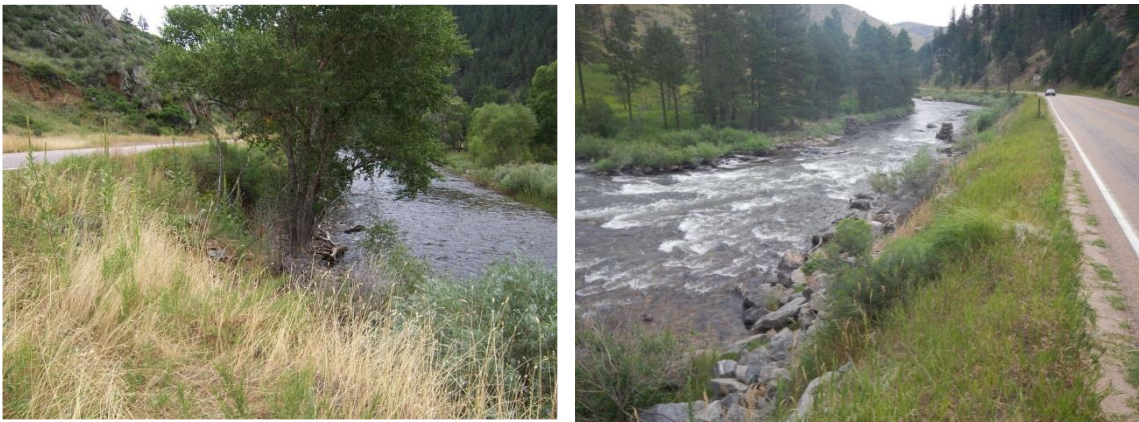
Figure 3.8: Highway 14 road fill encroachment in the riparian floodplain is common in the Canyon zone.

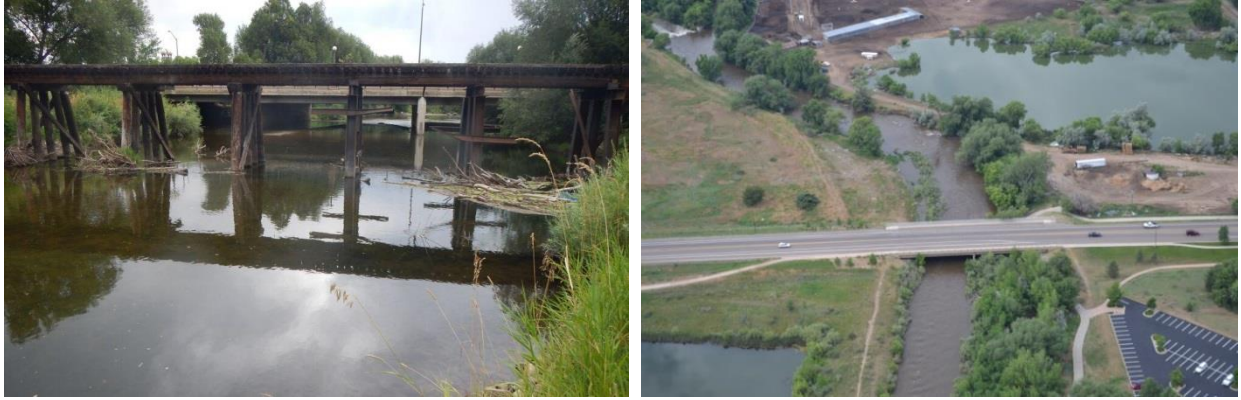
Figure 3.9: Twenty-two bridges span the Poudre in the study area. At left, a railroad trestle and College Avenue and at right Prospect Road.

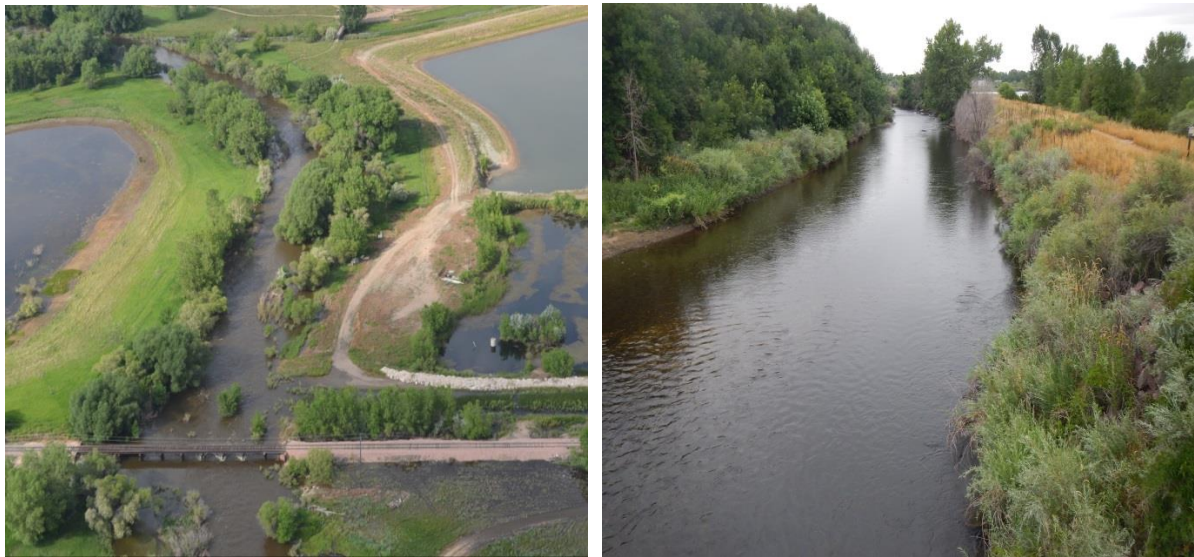
Figure 3.10: Channelization and berms are common on the Poudre River as shown in the two photographs here.

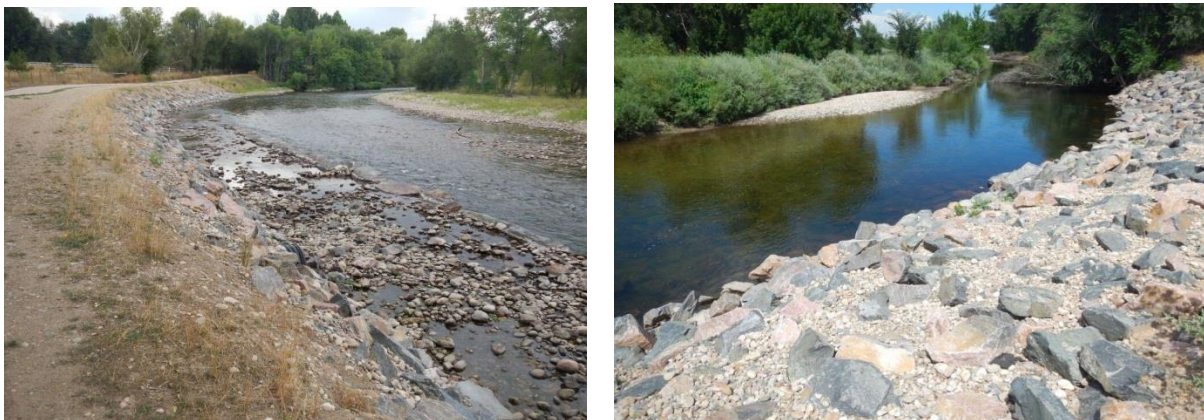
Figure 3.11: Bank and channel armoring is employed to increase channel resistance, protect above and below ground infrastructure or prevent river migration.

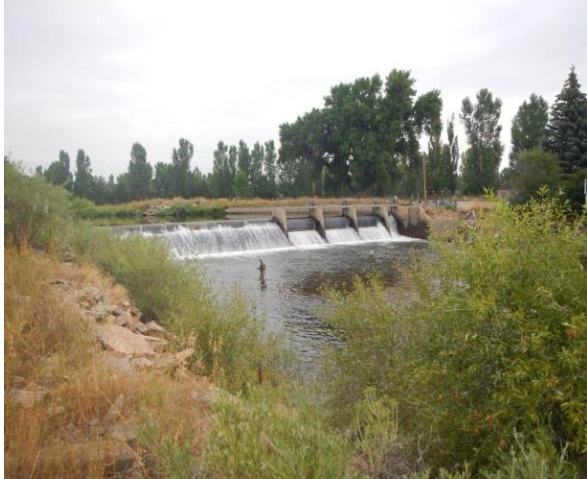
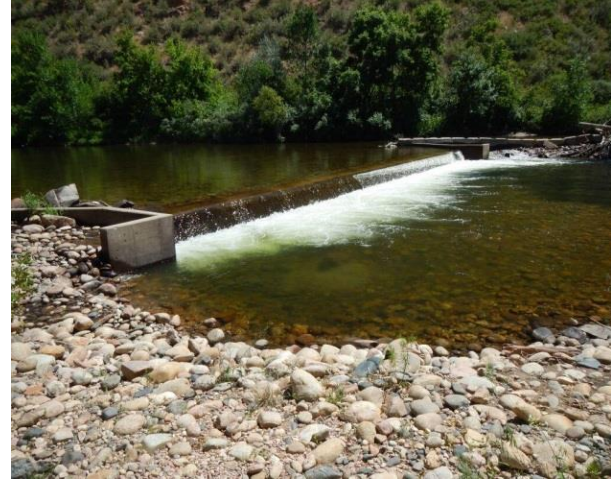
Figure 3.12: There are nineteen major structures or dams on the study area. Some pose major barriers for fish (left), while others are much lower and may be passable at some times of the year (right).

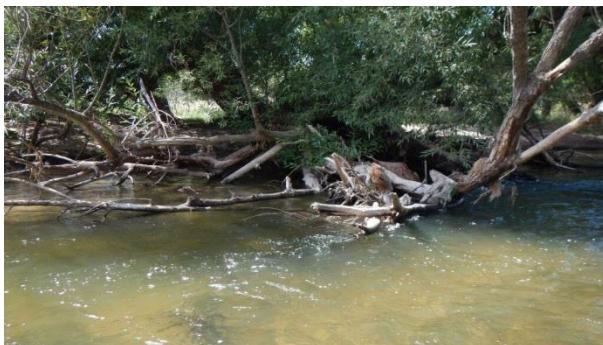
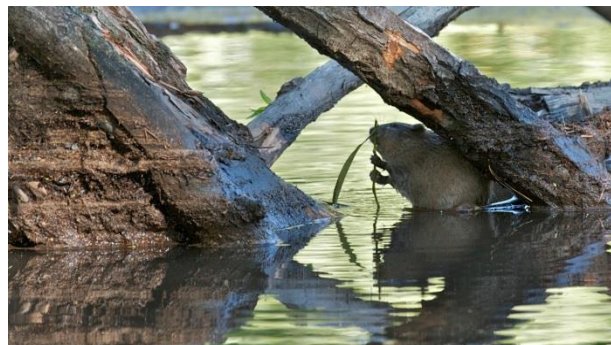
Figure 3.13: Large woody material in the river creates important structural complexity and habitat diversity for fish and other aquatic life (left). Beavers play an important role in the cycling of large wood in river systems (right).

Woody material was historically a very important driver of river form and function on the Poudre, but in-stream wood has become scarce in its modern-day stabilized and channelized form (Figure 3.13). Riparian development and deforestation led to a decreased supply of wood, but berms, channelization, and armoring are also important factors that limit accumulation of woody material. Unconfined rivers normally accumulate wood as they migrate through forested riparian zones, entraining trees via active bank erosion or when dead wood on the floodplain is rafted in during floods. Both of these mechanisms are now severely limited in the study area. Moreover, when large woody material does become entrained in the river, it is often physically removed as part of maintenance programs. In a natural state, large woody material and log jams in the river create overhead cover, hydraulic diversity, and structural diversity by impounding water and/or inducing localized scour that forms pools. Even today, some of the deepest pools and most complex habitat are in locations where wood has been allowed to collect and become integrated into the channel.

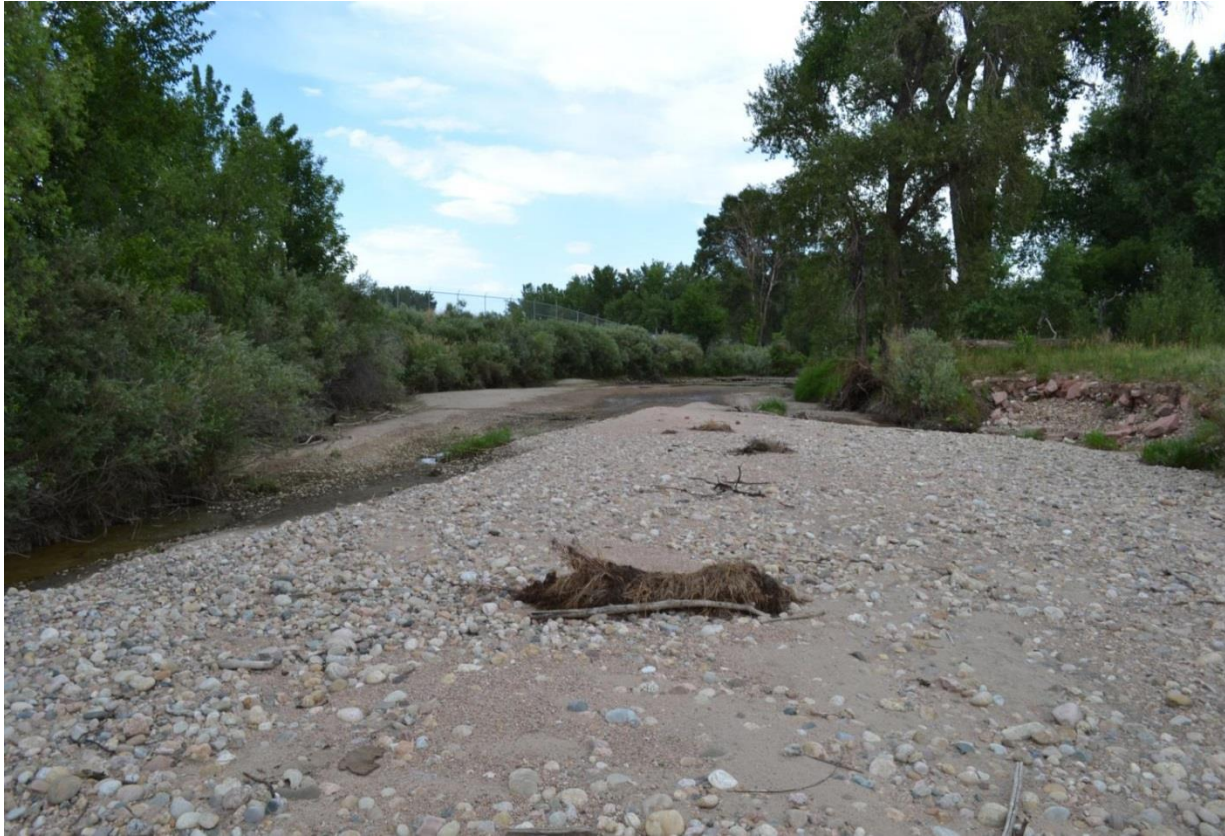
Figure 4.2: Extremely low base flows occur regularly in reach 13.

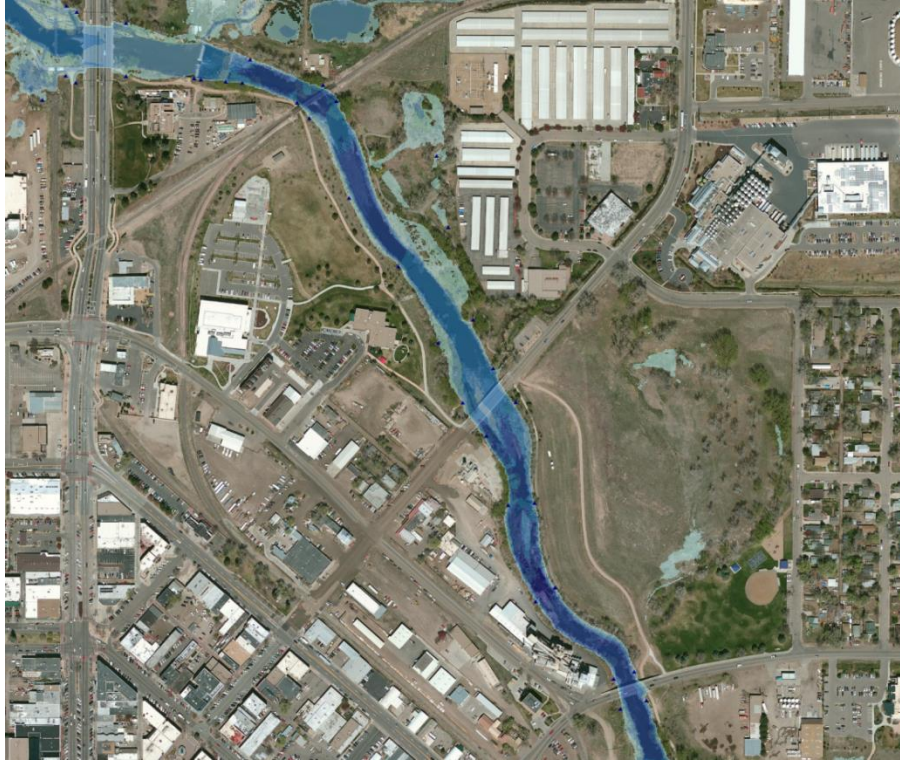
Figure 4.4a: The five-year water surface extent between College Ave. and Lincoln St. (reach 10) shows an entrenched channel with limited floodplain connectivity due to natural bedrock and constructed berms.

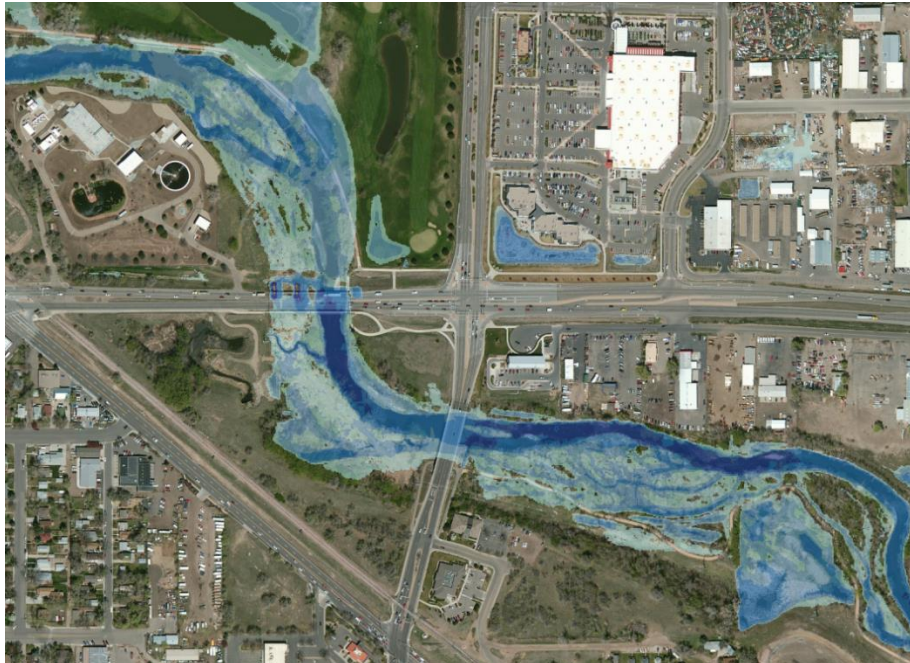
Figure 4.4b: The five-year water surface extent from the Woodward campus to upstream of the Timnath Canal Diversion (lower end of reach 11 and upper half of reach 12) shows a less entrenched channel with a better-connected floodplain.

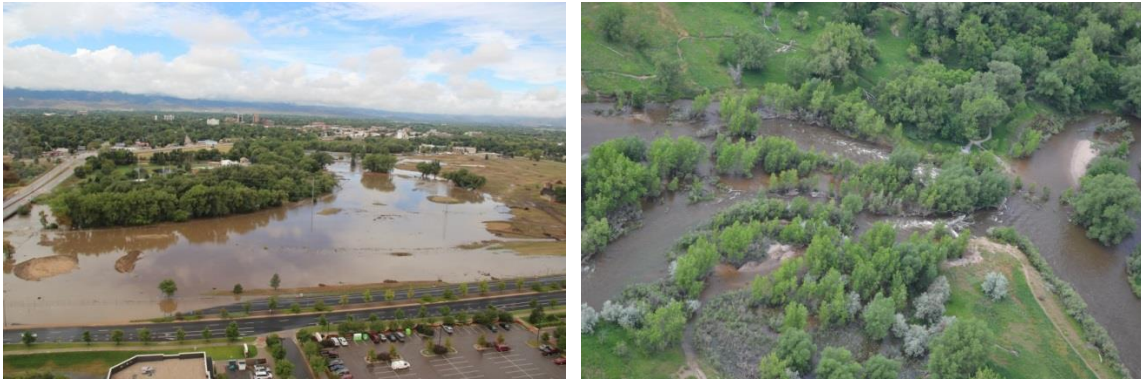
Figure 4.5: Floodplain connectivity is critical for river health, and it also reduces risk to infrastructure. During extreme high flow events, where floodplain-river connectivity is poor and development in the riparian zone is extensive, there is greater risk of flood damage to infrastructure. The photograph at left shows a connected floodplain at a former golf course (currently the Woodward site and Homestead Natural Area). Near the bottom left of the photograph, however, the intersection of Lemay Avenue and Mulberry Street limits floodplain connectivity and floodwaters threatened to over top Lemay Avenue. In contrast (right), at the ELC, the riparian zone is managed for natural habitats and the topography allows for the river to be connected to the immediate zone next to the river, resulting in a resilient situation

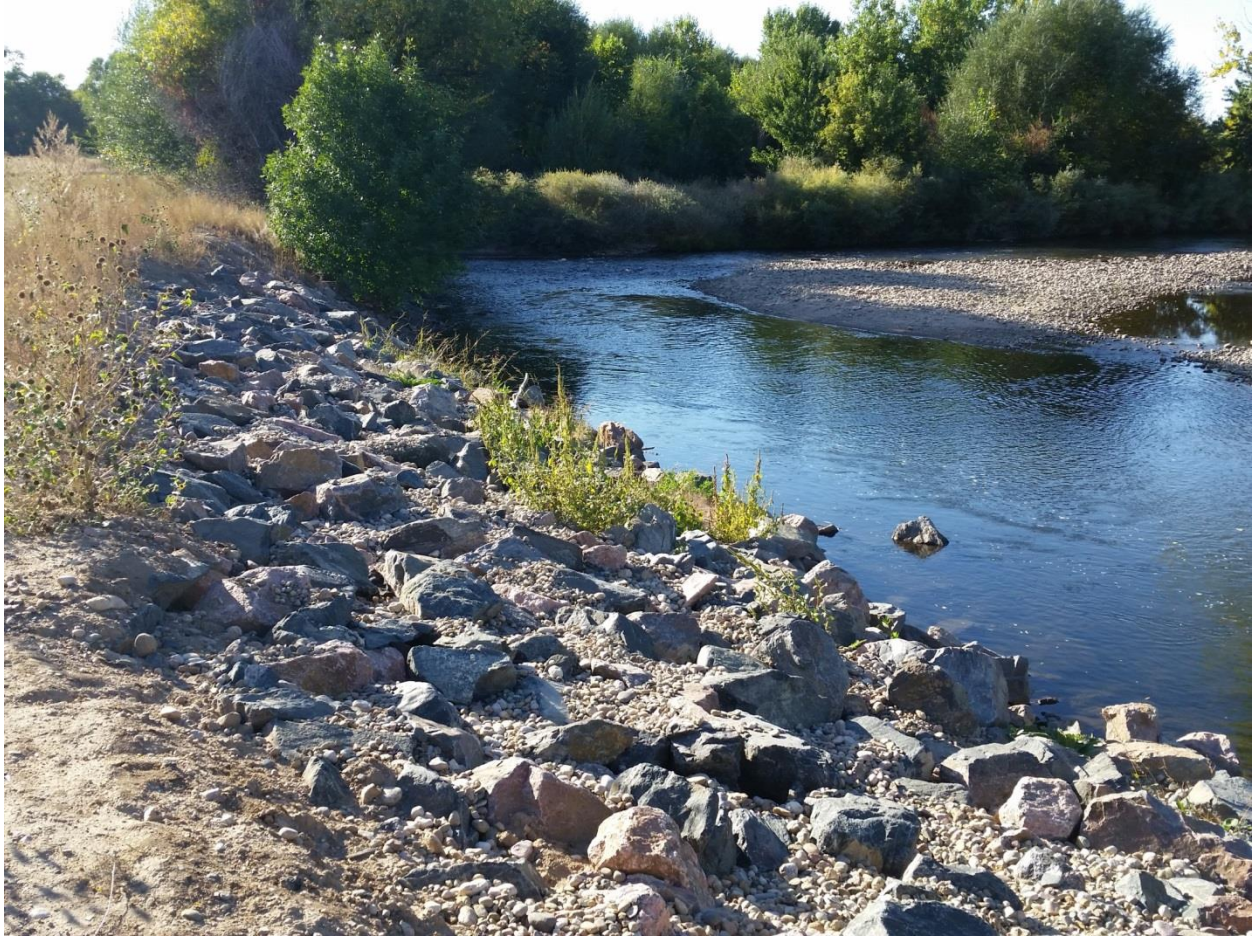
Figure 4.7: A highly functional riparian forest can be adjacent to very poor-scoring riparian zone. This location of this photograph is provided in Figure 4.6b.

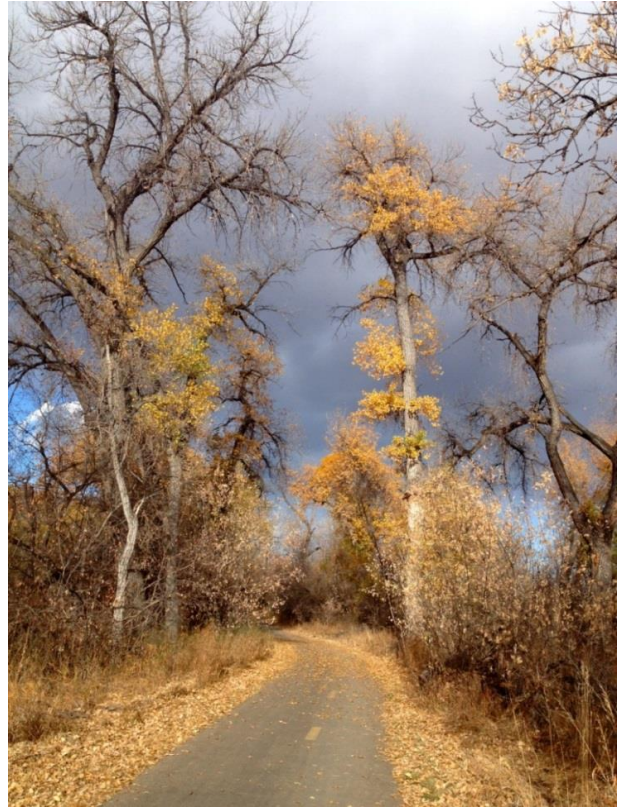
Figure 4.8: Canopy and subcanopy dominated by native cottonwoods and associated desirable “vertical complexity” are observed adjacent to the multi-use Poudre Trail at Lions Park in the Rural zone.

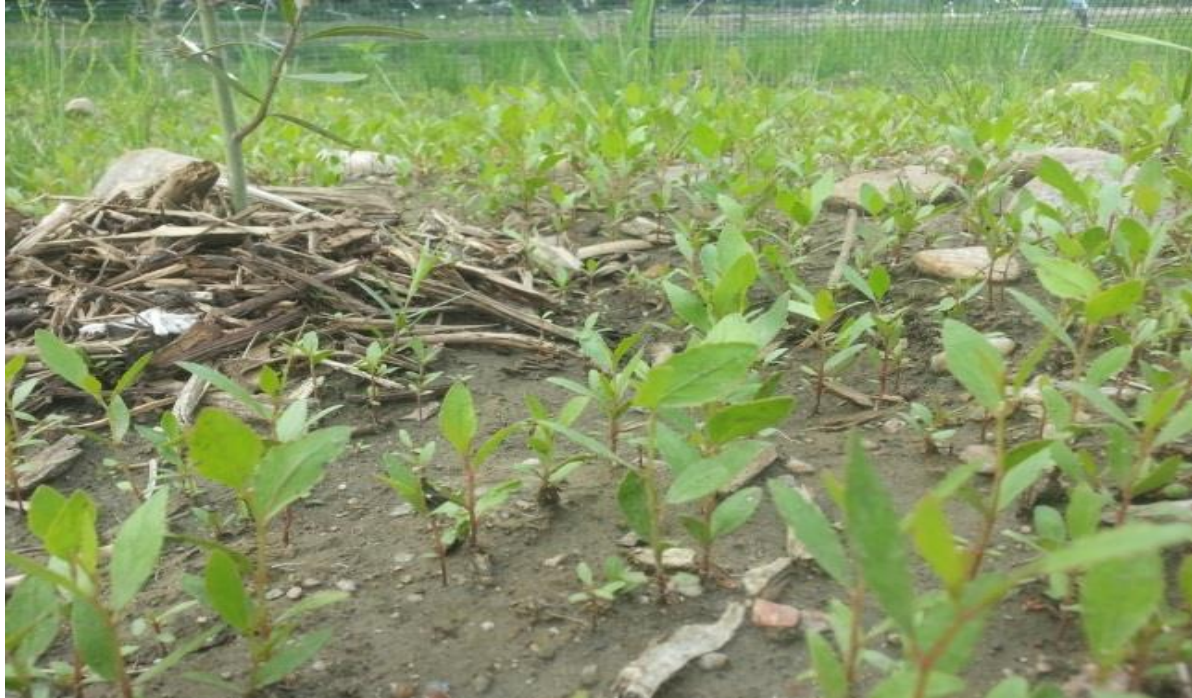
Figure 4.9: Germinating cottonwood seedlings established readily at McMurry Natural Area when physical connectivity was restored such that annual spring flows provided basic habitat conditions.

Regeneration of native tree species—particularly cottonwoods— has been substantially curtailed by effects of water management and disconnection of the river from its floodplain. Owing to various floodplain alterations, such as channelization and berms, the opportunity for establishment of native trees has been limited, but it does still occur and it was common in forested and subcanopy patches (Figure 4.9). In cover types where native tree species regeneration would be expected—including canopy and sub-canopy forest, scrub-shrub and emergent wetland—this metric averaged a C, ranging from D+ in wetlands to B- in scrub-shrub patches. Regeneration was good in scrub-shrub patches because they tend to be near the channel and exposed to overbank flows. [Note that the lack of tiny seedlings or very young saplings was not taken to indicate a lack of regeneration, because regenerative floods are relatively uncommon events. Therefore, the main criterion for judging regeneration was the presence or extent of a multi-generational age structure.

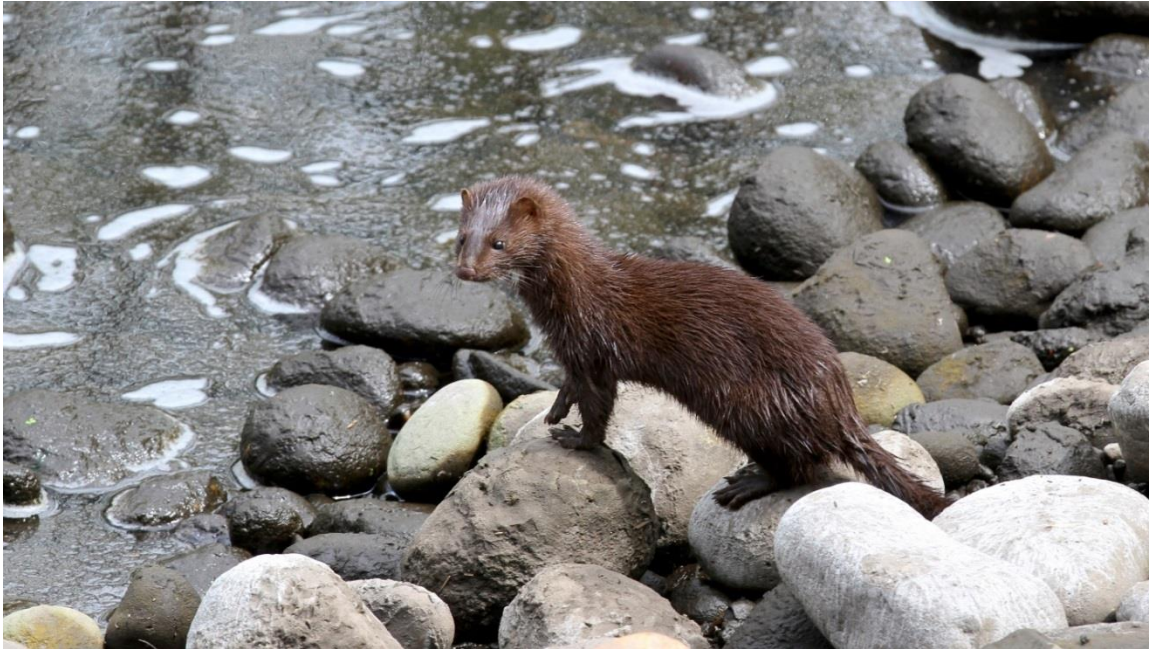
Figure 4.10: The presence of mink along the Poudre near is an indication that the food webs they rely on as predators (and associated habitats of their prey) is fairly intact.

The habitat connectivity metric is a measure of the degree to which riparian habitat is biologically connected with surrounding riparian habitat, or conversely, the degree to which habitat has become fragmented or isolated. Habitat connectivity ranged from an A- in the Canyon zone and ELC to a D- in the heart of the Urban zone. While D- indicates very poor connectivity, it also signals that connectivity has not been totally eliminated. Organisms can still move throughout the entire study area, even if rates of movement may be greatly reduced through the urban bottleneck). Connectivity has been fairly well preserved upstream and downstream of the developed urban areas, and even in the Urban zone there are islands of good-quality riparian habitat that provide refuge to the animals that do make it through dangerous and stressful areas (Figure 4.10).

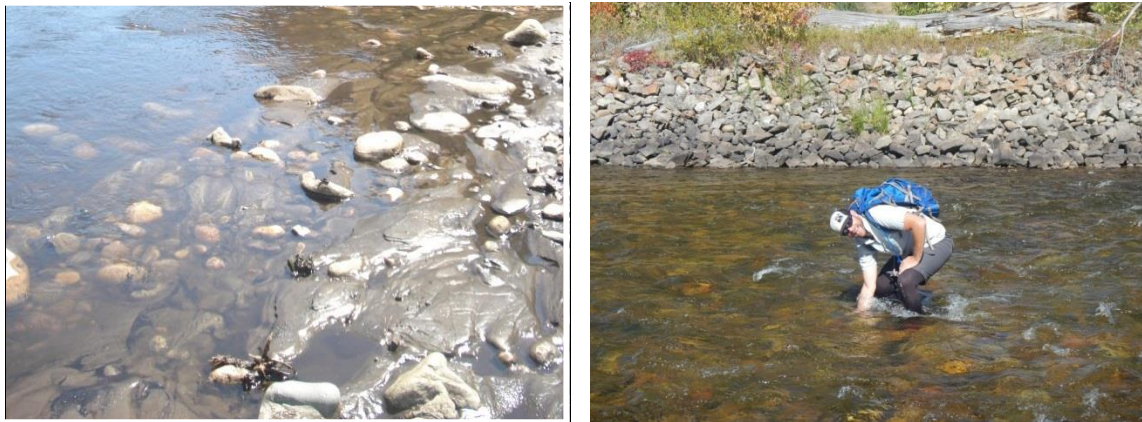
Figure 4.12: Fine sediment deposited following fires clogs spaces between the cobbles. This eliminates important habitat for aquatic insects and spawning fish (left). Team member Johannes Beeby reaches down to check the embeddedness of cobble while scoring the fine scale metric.

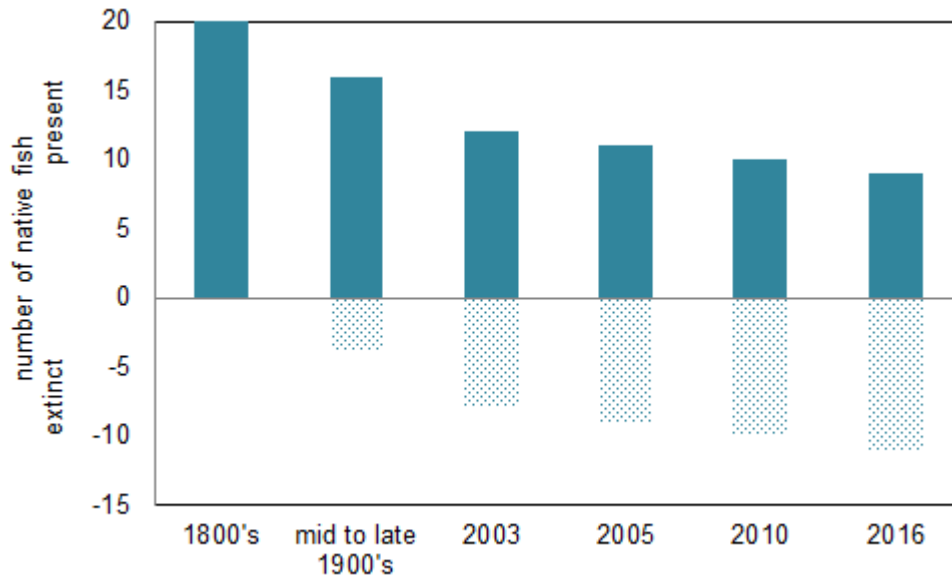
Figure 4.16: The number of native fish species in the Poudre River has steadily declined over time.
