STATE of the POUDRE

A River Health Assessment

Executive Summary

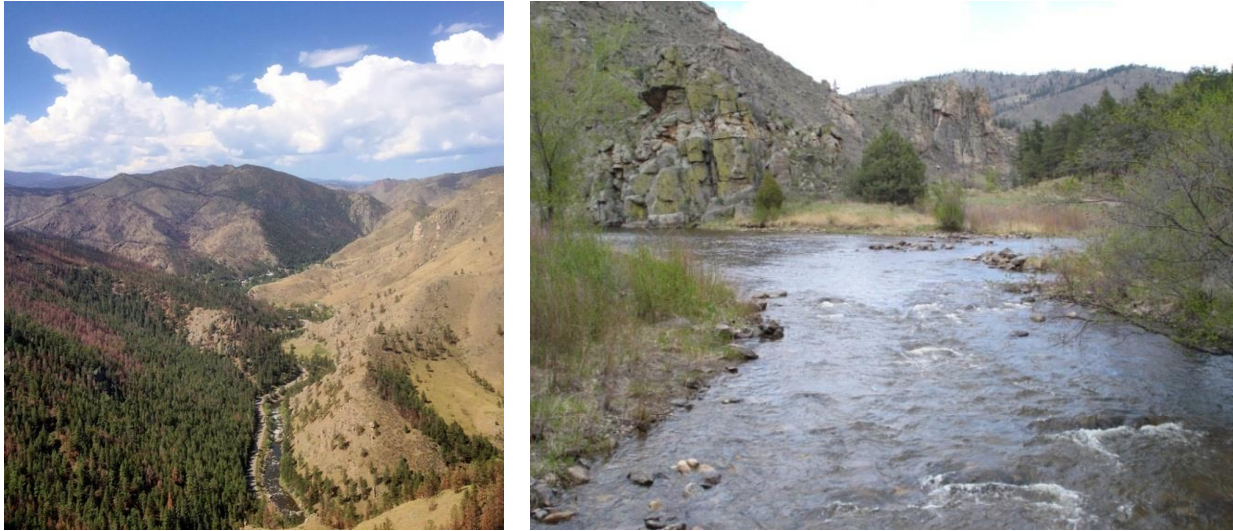
Figure 5.2: In the Canyon zone, the river is bounded by a narrow floodplain and confined between steep canyon walls, rocky hills and/or the CO Highway 14.

Geology governs the character of the Canyon zone. Relatively steep and straight, the river is bounded by a narrow floodplain and riparian corridor that is confined between steep canyon walls and rocky hills (Figure 5.2). The influence of peak flows on the floodplain is therefore limited, and naturally-resistant rock banks are insensitive to the rushing waters. A narrow band of riparian vegetation provides wildlife habitat and a critical migration corridor. The forested watershed is mostly undeveloped, and to a large extent, its natural hydrologic, geomorphic, and biogeochemical processes are intact, providing support for river health (Table 5.2).

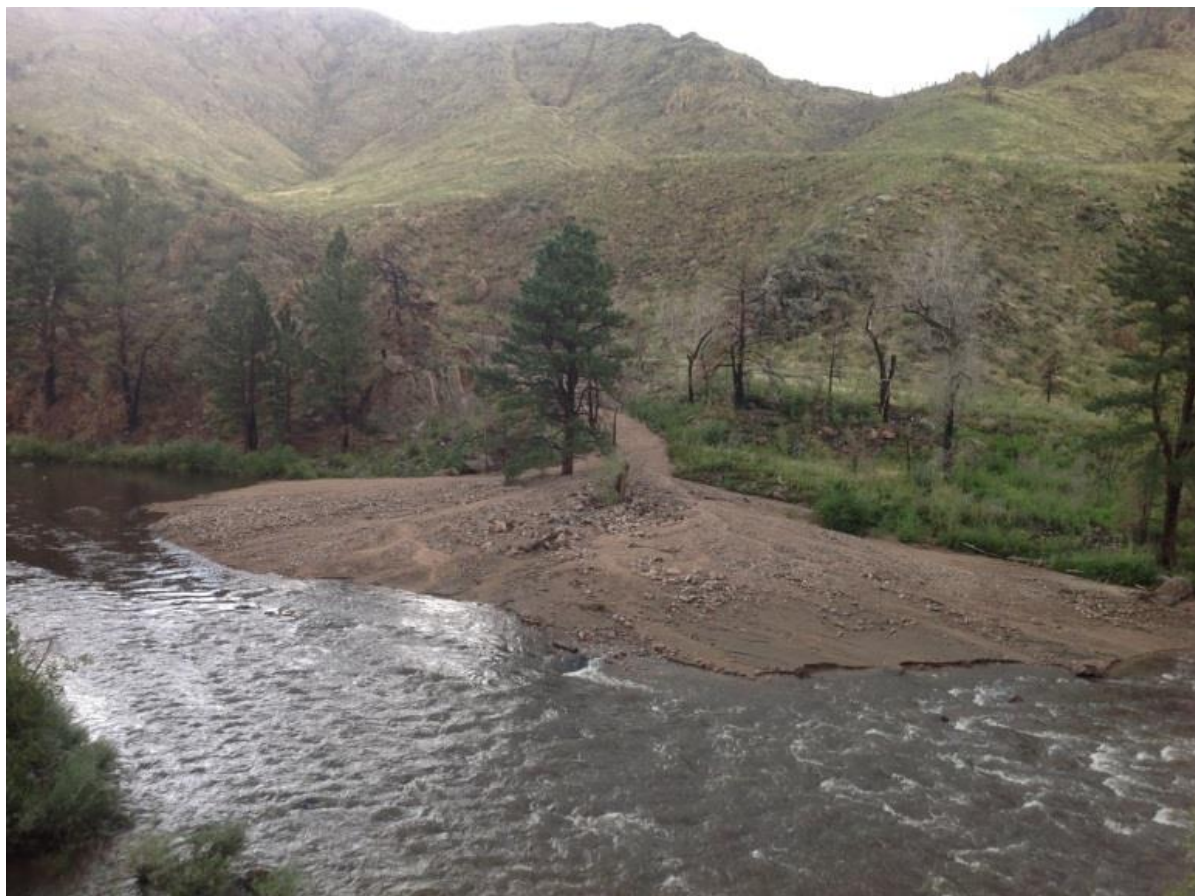
Figure 5.3: Post-fire land erosion causing a major debris flow into the Poudre near the upper Landing Campground.

The overwhelming sediment regime stressors are the large dams that interrupt sediment continuity, so scores for the continuity metric fall below the recommended range downstream of the North Fork confluence. The land-erosion metric scored slightly below the recommended range due to the impacts from recent fires, and this score will improve as the burn scars revegetate. In addition, the Coalition for the Poudre River Watershed and several stakeholder groups, including the City of Fort Collins Utilities, have developed an Upper Poudre Resilience Watershed Plan. The purpose of the plan is to improve watershed resilience through watershed restoration activities aimed to reduce risk of future wildfires and post-fire erosion (Figure 5.3).

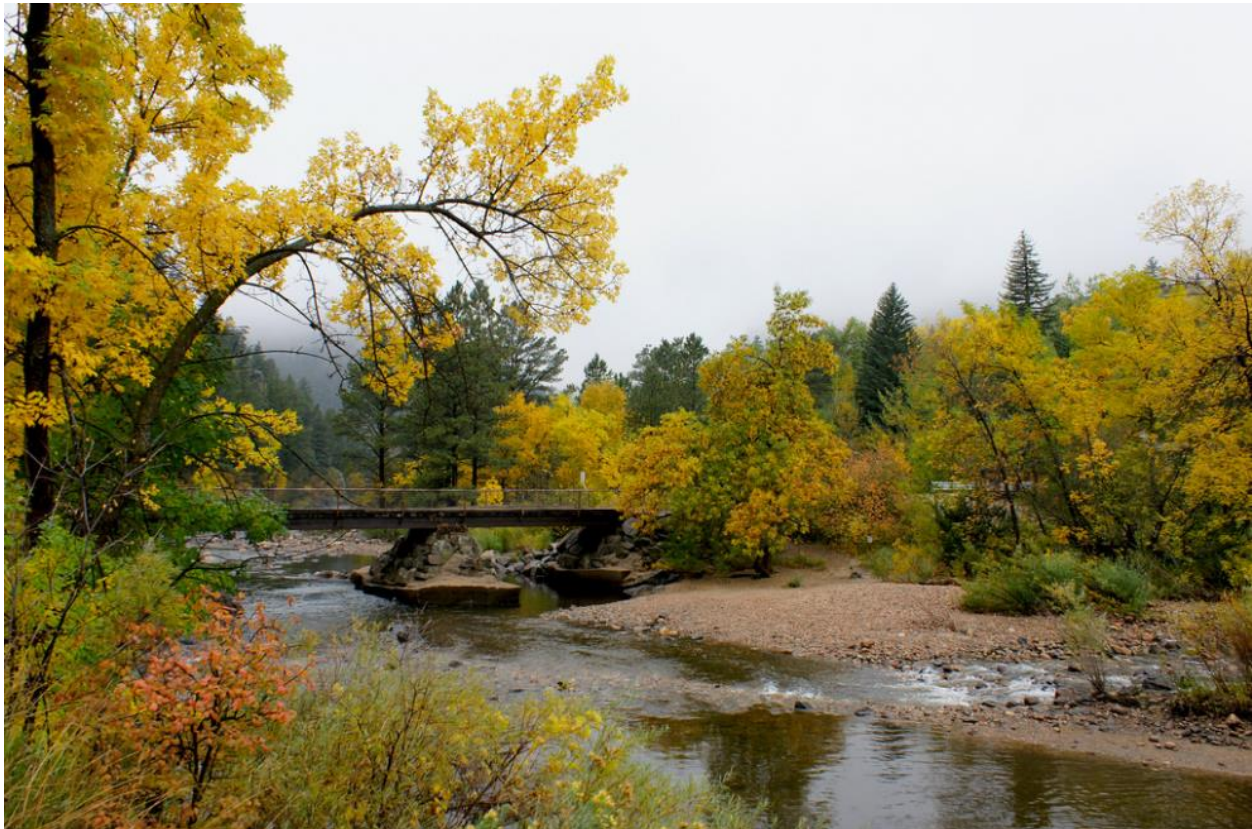
Figure 5.3: In the Canyon zone the confluence of the North Fork (the largest tributary in the canyon) into the main stem at Gateway Natural Area influences water quality parameters and therrefor habitat foraquatic wildlife.

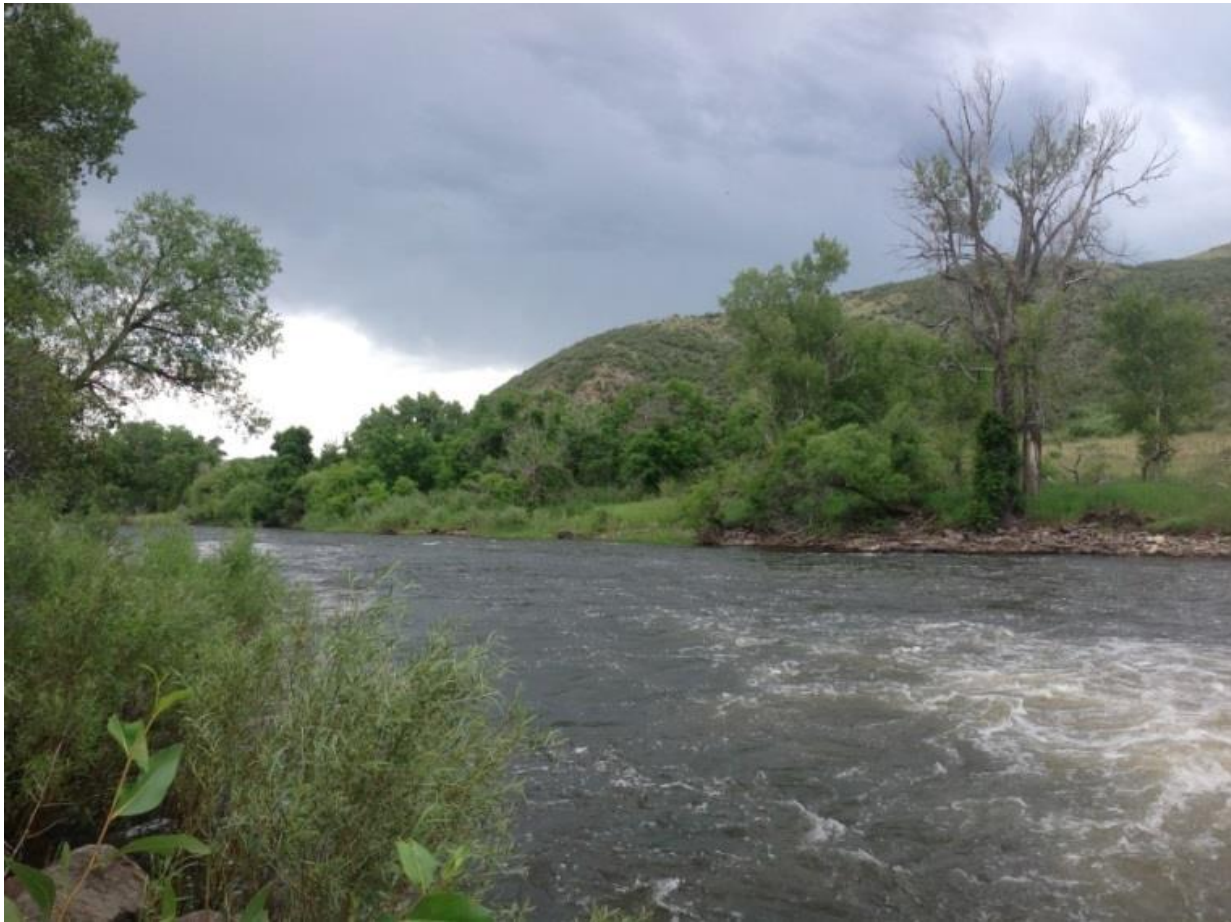
Figure 5.4: As the river exits the canyon, the gradient begins to slacken, and the native river type shifts to a meandering channel that maintains form and structure through dynamic equilibrium between erosion and sediment supply.

The Poudre transitions from a confined to an unconfined river in the Rural zone, which is a fundamental shift in geomorphic river type (Figure 5.4). In the unconfined reaches downstream of the canyon, the floodplain and riparian zones become critical drivers of river health. Lacking resistant geology, a functional floodplain would be able to dissipate flood waters and their potentially destructive energies. Riparian vegetation provides roughness, which slows flows while lending structural integrity to river banks, serving as important wildlife habitat, and acting as the source of organic material that forms the base of the aquatic food chain. The gradient begins to slacken in this zone, and the native river type shifts to a meandering channel that maintains form and structure through dynamic equilibrium between erosion and sediment supply (Figure 5.4). The Rural zone is still classified as cold-water river, with water temperature standards based on the requirements for supporting trout. The Rural zone is where land use shifts from wildland to rural development, and agriculture, eventually phasing into urban development (Table 5.3).

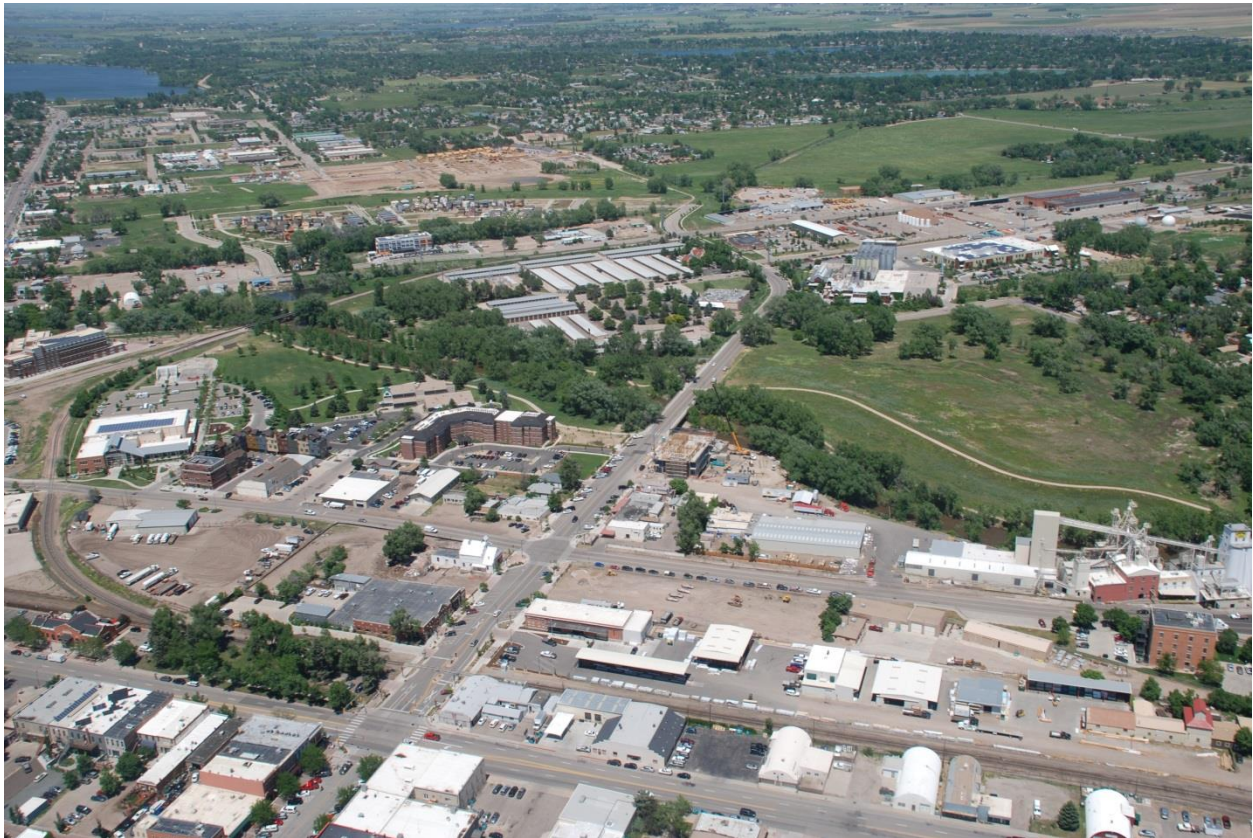
Figure 5.6: The river takes a narrow course through the heart of the Urban zone where the Linden Street crosses the River.

As the river courses into and through town, its gradient slackens further and the Poudre begins its transition towards becoming a warm-water river (Figure 5.6). In this zone, the river's natural form would have been multiple channels interwoven into a braided pattern, running through an expansive and unconfined floodplain. Riparian vegetation would have formed a complex mosaic of habitats, providing critical support to river functions and health. Floods and disturbance were historically common and would have shaped most ecosystem processes (Table 5.4).

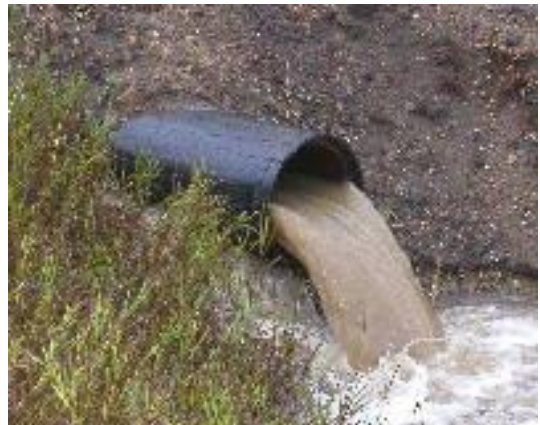
Figure 5.7: In addition to its construction site sediment and erosion control program, the City's LID Program requires on-site infiltration of stormwater to help prevent in-stream impacts associated with increased imperviousness.

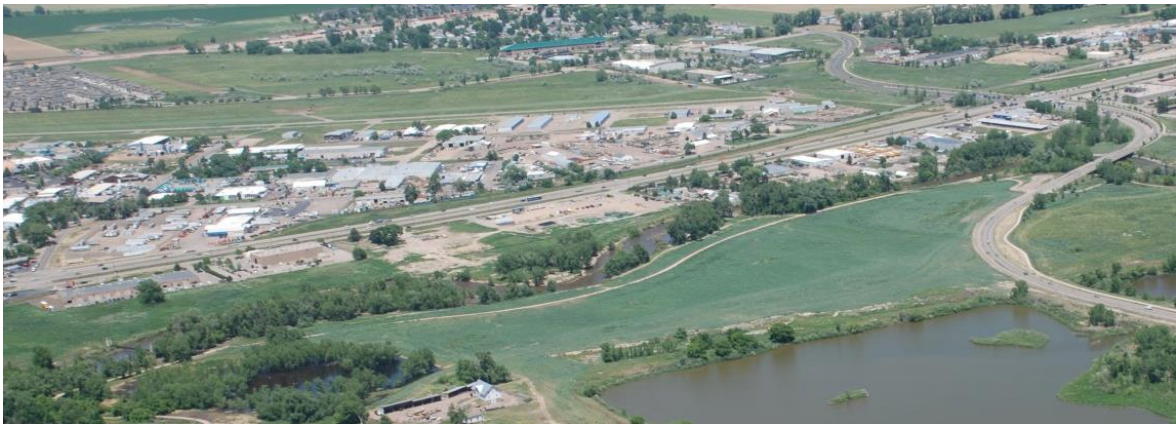
Figure 5.8 At the lower end to the Urban zone the river is bordered on its northern side by industrial development along Mulberry Avenue, while on its south side the floodplain begins to open up as the land is owned by the City's Natural Areas Department.

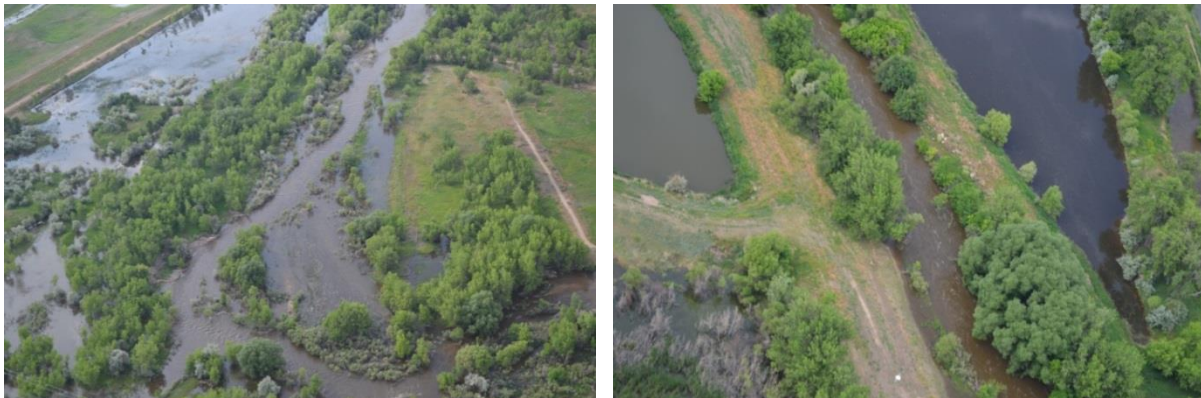
Figure 5.10: In the Plains zone the river has some opportunity for good connectivity with the floodplain which results in higher function through the system and allows for periodic flooding of the riparian zone (left). However, through much of the Plains zone the channel is continues to be highly confined by ponds and berms on either side drastically altering its function (right).

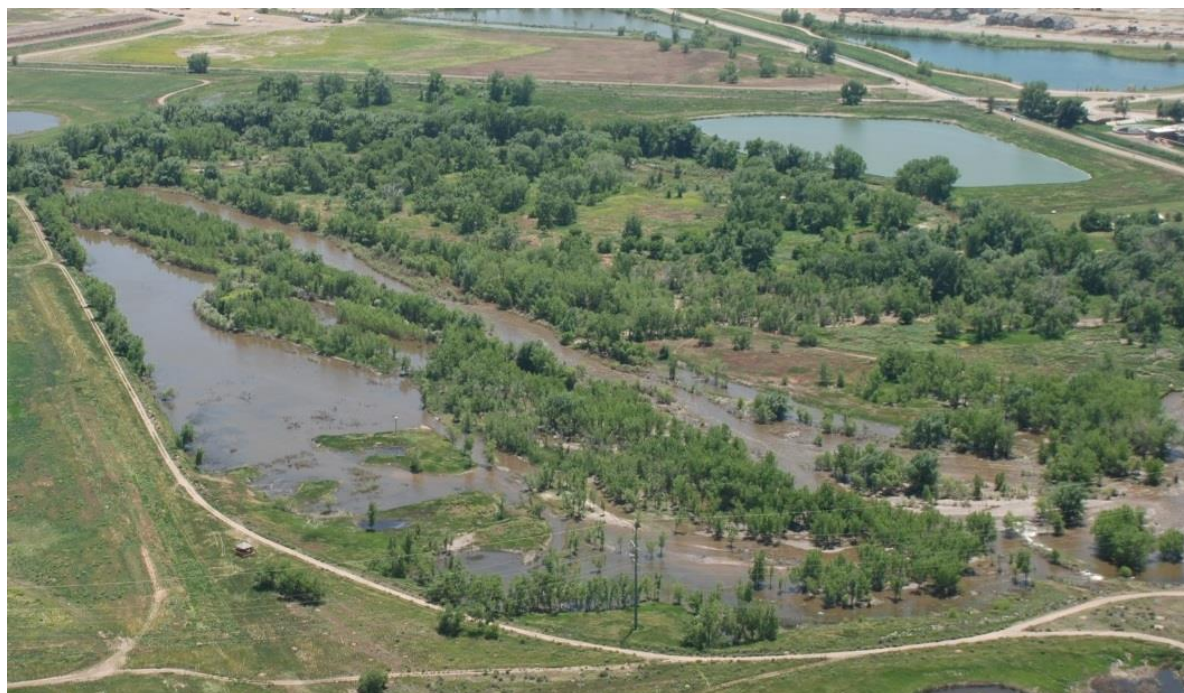
Figure 5.11: In the Plains zone, a stretch of multi-thread channel exists in the broad floodplain preserved at Colorado State University’s ELC south of Prospect Road (above). The river in the ELC is a contrast to the simplified river form that exists in much of this zone.

The ELC has some of the highest-quality—or at least most extensive— riparian habitat in the SOPR study area (Figure 5.11). In this reach, the split channel creates a wide riparian zone. Although variously wooded and an outstanding resource, much of the habitat in the interior is essentially “high and dry” and disconnected from the river; therefore, its ability to support river health is diminished.

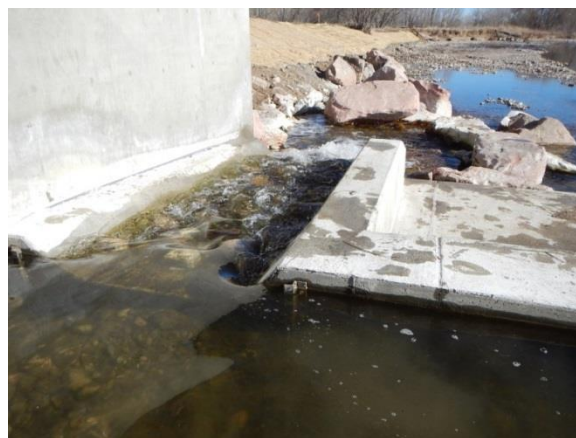
Figure 5.12: Recently installed fish passageway at the Fossil Creek Inlet Ditch just downstream of Prospect Avenue.

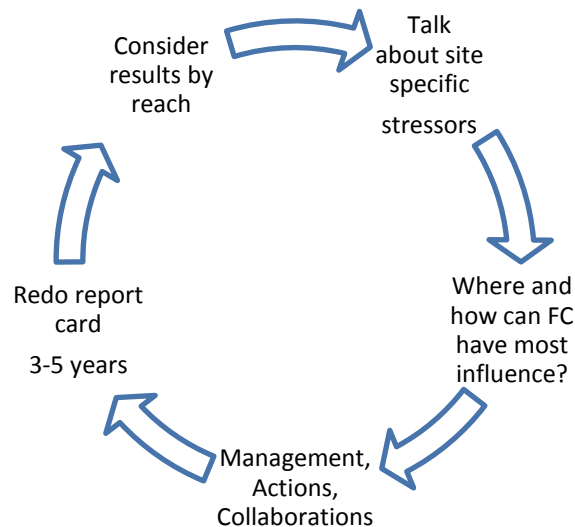
Figure 6.2: Diagram illustrating the process whereby the SOPR may be applied to inform management priorities and track river health trends over time.

Continuing this project through repeat assessments on a periodic basis (3-5 years) allows it to serve as a tool for following a “plan, do, check” management approach. Using this strategy, the results of SOPR assessments can first be considered by City staff and collaborators. Next, reach and metric specific goals, scores and stressors can be linked to create management priorities (Figure 6.2). Then the subsequent version of the State of the Poudre can help us reflect, or “check” on the progress we are making towards our goals.
