Replacing Morgan Plus 8 Speedometer Cable

By Maurice W. 20 July 2023

**No speeds on my Morgan – replacing a mechanical speedometer drive cable.
Applicable mainly to Plus 8's and Plus 4's using the Rover LT77 or R 380 gearbox.**

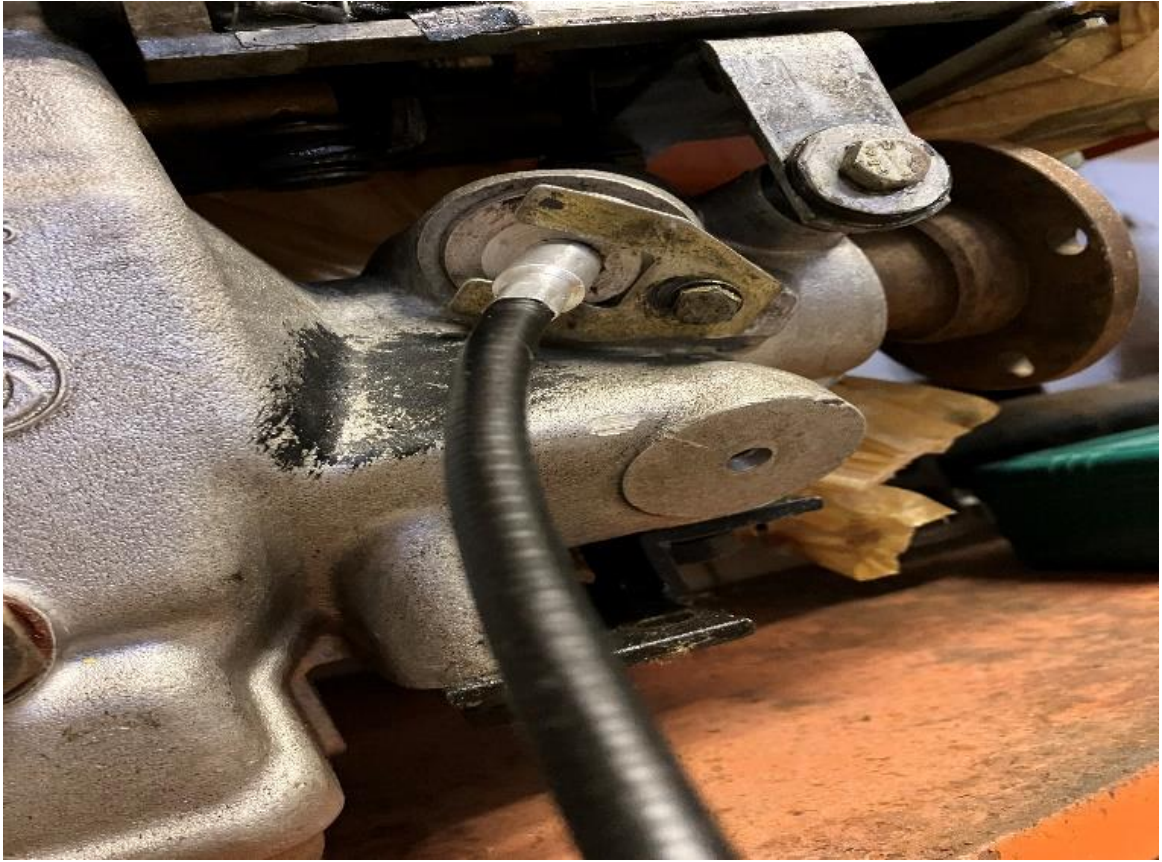
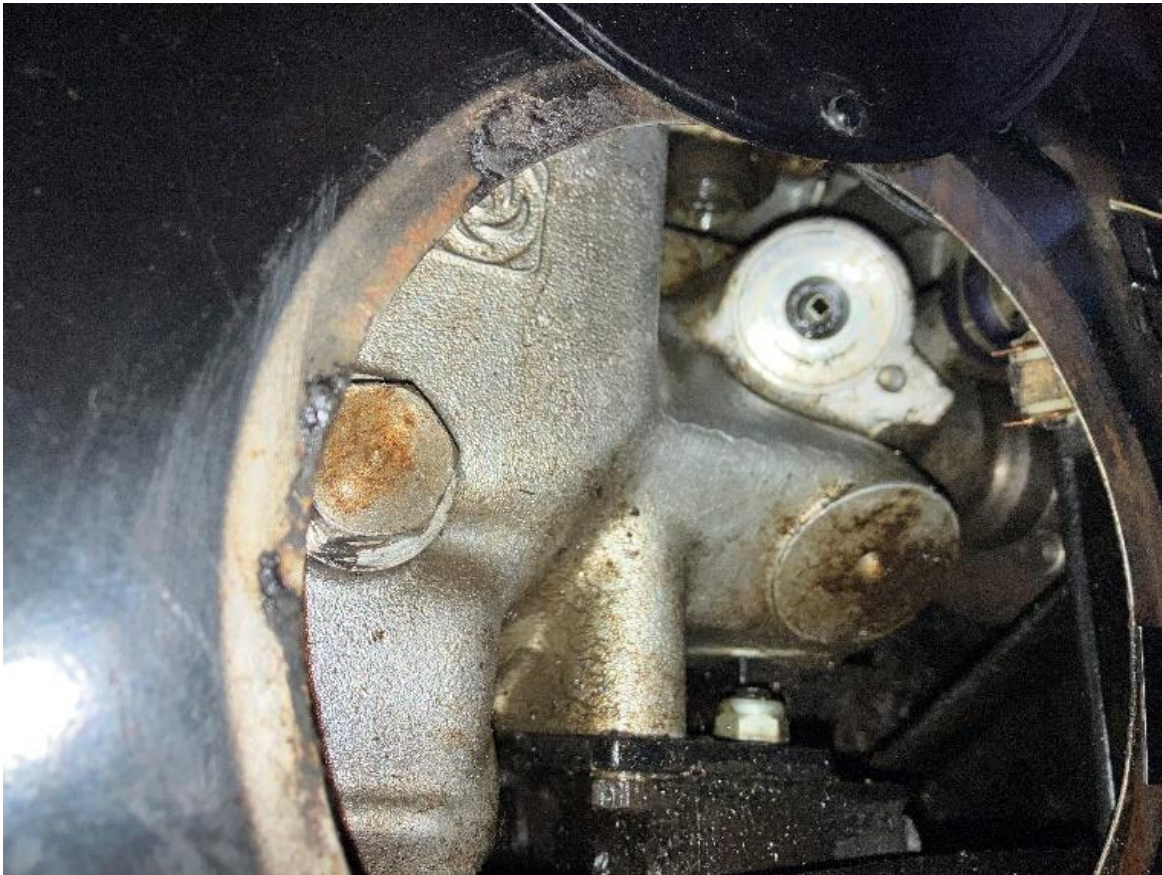
Then with the aid of a mirror, unless you're very agile, you'll see the gearbox end of the cable secured by a forked plate held on by a single 10mm bolt (see photo). Using a socket on a long extension, remove the bolt and the plate and the cable becomes free.

Position the gearbox end of the cable into the gearbox drive outlet. At this point you'll realise that you can't get your fingers in to re-insert the 10mm bolt and securing plate.

You can just see the tapped hole on the gearbox through the rearmost circular aperture. I used thick grease to hold the socket, bolt and securing plate in place, and then with loads of patience screw into the hole in the gearbox casing.
