Replacing Morgan Plus 8 Cylinder Head Gasket

By Dave B

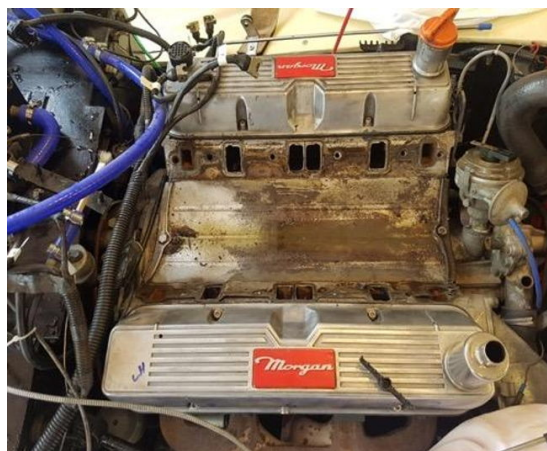
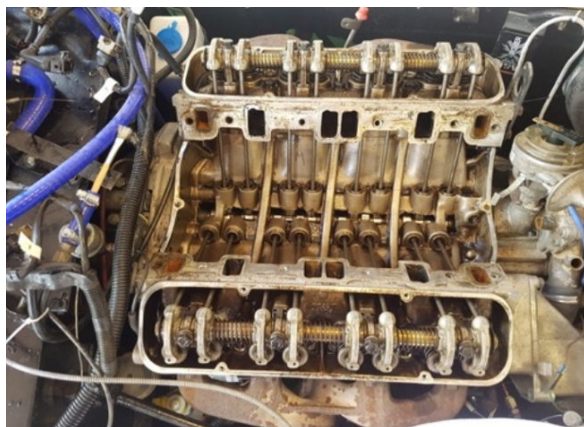
Next it was the rocker covers which are secured by 4 cap head screws and remove rocker gasket, the rocker shaft with rockers was removed next then onto the heads themselves there are 14 bolts on each head to be removed.

This depends on the age of the engine as the older engine had 8 bolts and used different head and manifold gaskets, the later type which mine is use thin steel head and inlet manifold gaskets as opposed to the composite gaskets used on the older type. The inlet manifold gasket fits in a valley between the two heads and the push rods are under the valley. The push rods were removed and put in a cardboard sheet in the order they came out to make sure they went back

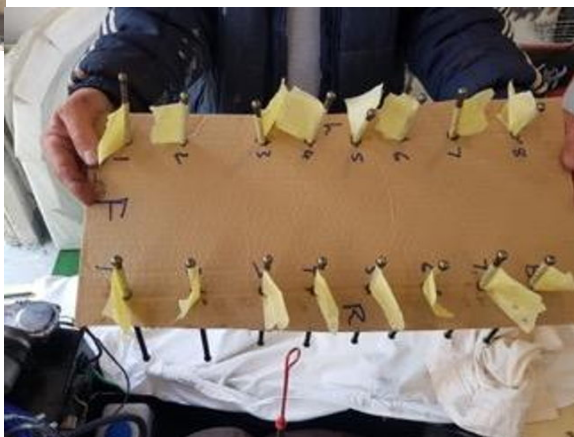
and the faces are polished and must not be damaged.

As you can see from the photo there are some deposits on the face of the head this can easily be removed with a cloth and WD40. With the heads removed the cylinder bores could be inspected and to my delight they were in perfect condition no lip at the top of cylinder no scores and the original honing marks were still visible.

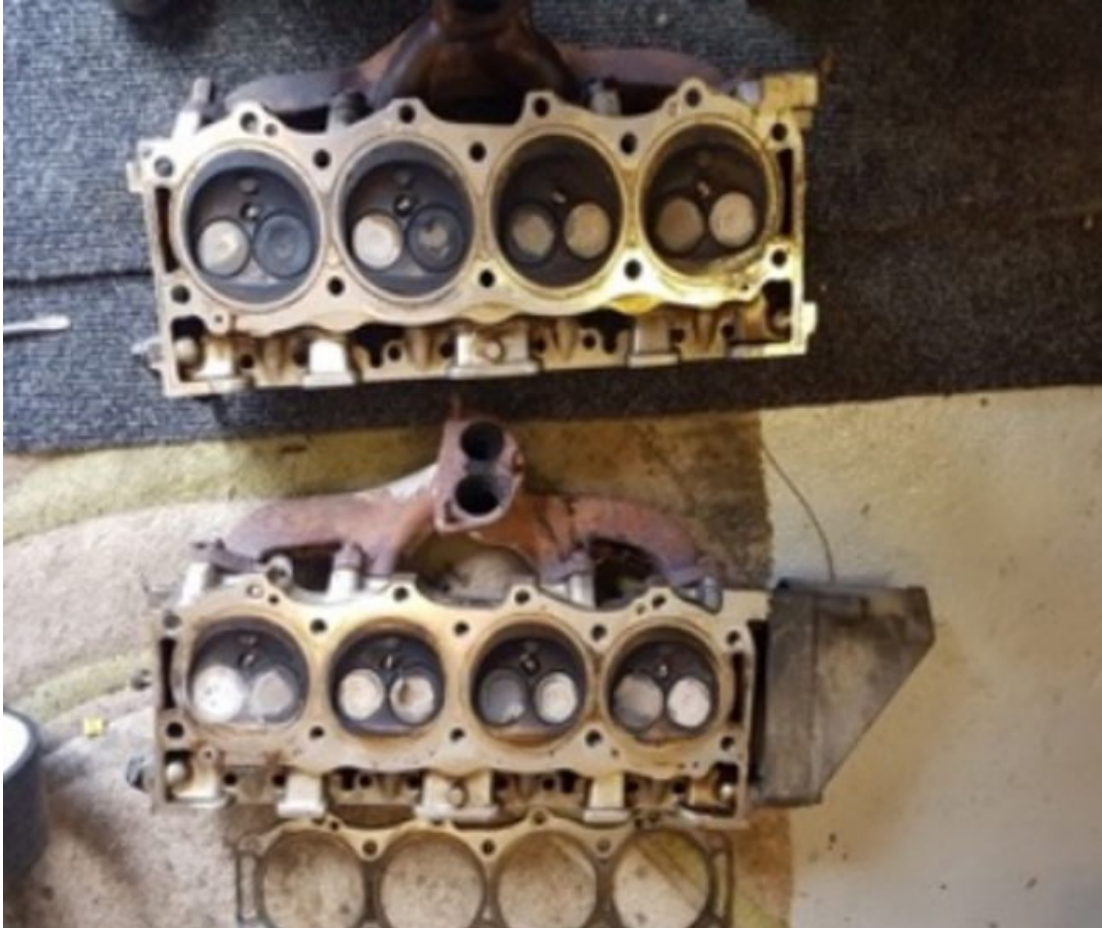
The heads were cleaned and all found to be in very good condition with very little carbon deposits on the valves no oil burns or marks on the valve stems so I decided not to decoke the valves as they were clean and the seats in good condition and I thought why fix what ain't broken.

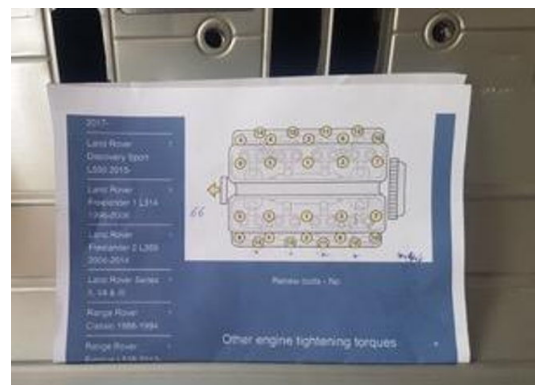
The inlet manifold is the next to fit and this is torqued to 10 lbs ft from centre out and then to 32 lbs ft. The air inlet fitted fuel and coolant pipes refitted rocker covers with new rubber gaskets and new screws fitted.

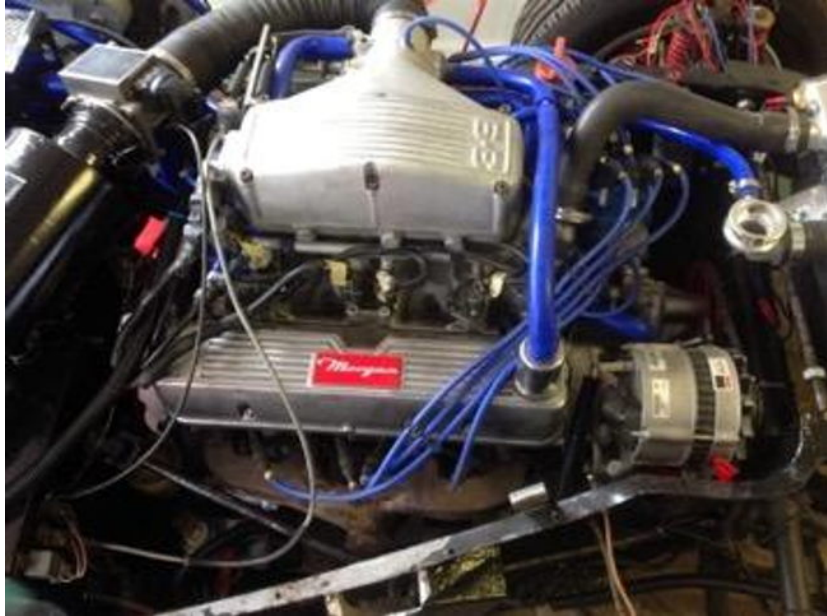
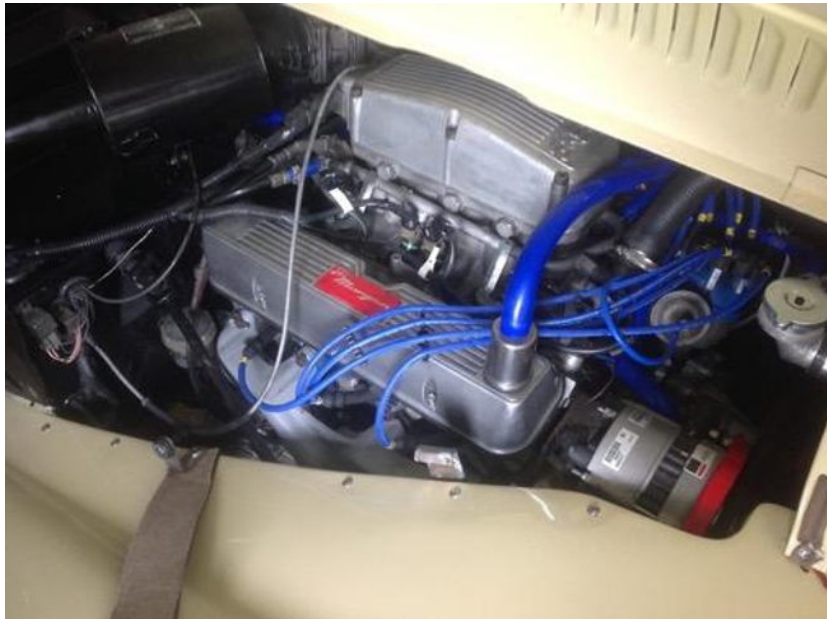
All hoses refitted alternator and belt, plug leads vacuum pipe exhaust manifold and various wires replaced and everything checked. Oil changed and filter coolant in I use 60/40 mix anti-freeze as the car only gets used in good weather.
