A Marvelous Mystery

In pursuit of a catboat legend

Part 9: Some Re-Assembly Required

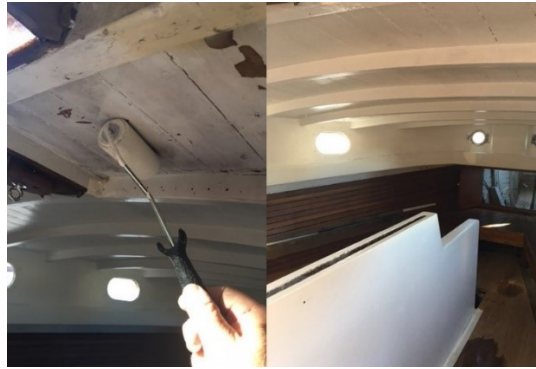
do it. So over a warm/dry week in October I took on the task. First up was the bilge. It had been pressure washed in June and was still remarkable clean. So this went quickly. It now sports two coats of bilge-paint gray . As expected, the cabin was another matter. Yet after four days of applied elbow grease, and efforts with both brush and roller, the job was finished. It looks fantastic. **(Figure 1)**

Figure 1: Before and after views of the dreaded cabin painting)

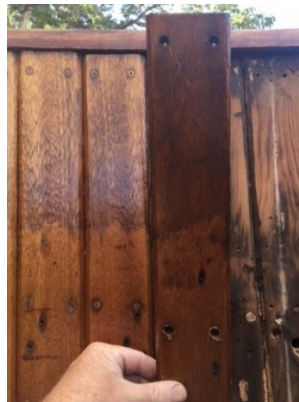
To gain access to the hose and fitting we had to remove a large section of mahogany beadboard that shrouded the lining of the cockpit. **(Figure 2)** In so doing we noticed that the hose from the

Figure 2: Cockpit beadboards were carefully removed to gain access to the hose

manual bilge pump exited the transom from above the waterline. Perhaps a previous restoration had accidentally switched the exhaust and bilge pump hoses? To fix the situation we removed the underwater exhaust fitting and plugged, epoxied and faired the hole. We then installed a new, above-the-waterline fitting for the bilge pump and connected a new length of bilge hose to the new fitting and back to the deck-mounted Guzzler manual bilge pump.

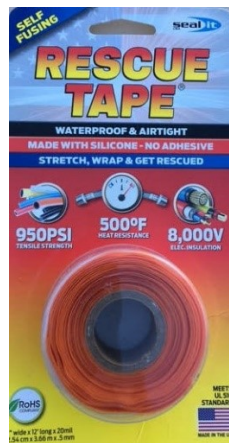
Figure 4: Rescue Tape excels at repairing marine exhaust systems

expensive hose, we decided to repair it with Rescue-Tape, a remarkable stuff especially designed for this purpose. **(Figure 4)**.

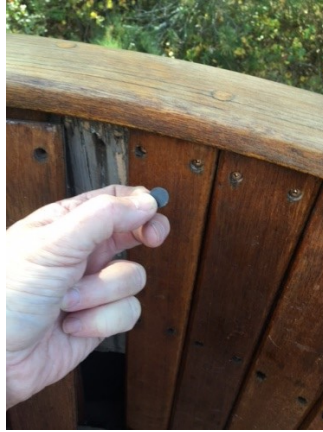
When we re-installed the beadboard we plugged the screw holes with removable plastic bungs. **(Figure 5)** We did this to make access to these critical hoses more convenient. No more drilling

Figure 5: Plastic bungs made future beadboard removal easy

out glued wood plugs to remove a board.. Simply pop out the bung and unscrew the board. Some may complain that this ruins the aesthetic but we decided to err on the side of practicality. I'm not sure most people will even notice.

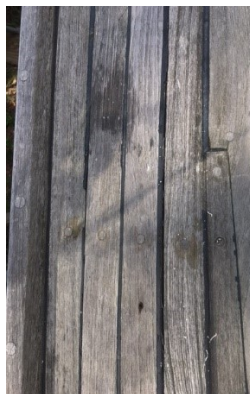
As shown in **Figure 6**, sections of MARVEL's beautiful teak deck had pulled away from the underlying structure. The culprit turned out to be random patches of delaminated marine

Figure 6: Damaged teak deck sections required challenging repair methods

plywood underlayment. Most deck repair locations afforded easy access and could be addressed with penetrating epoxy (to re-laminate the plywood) and/or installation of new sections of marine ply. However, several required the removal of the mahogany bead-board that shrouds the boat's cockpit to gain access to very tight spaces. **Figure 7** shows how this was accomplished.

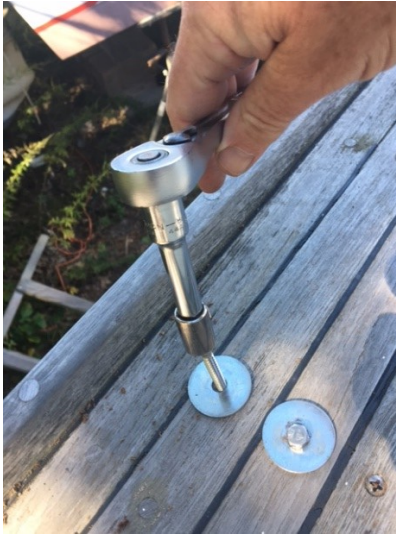
Figure 7: Deck repairs utilized long screws and fender washers to unwarped deck sections

As with the engine and bilge pump hoses, beadboard sections were carefully removed. This exposed the failed underlayment. Penetrating epoxy was injected and a new, backer-piece of marine plywood affixed. It allowed us to remove the original deck screws and insert long bolts backed with large fender washers. Tightening the bolts allowed the fender-washers to pull the bulging deck section back flush. Once the epoxy had cured, the bolt/fender-washer hardware was backed out and proper marine-grade deck screws inserted in their place. The beadboard was reinstalled as a last step. In this way, we repaired a number of semi-inaccessible deck sections.

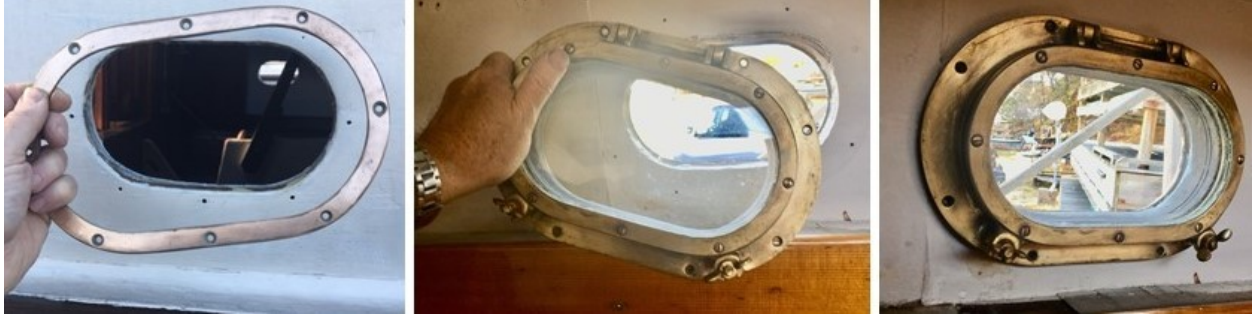
Figure 10: Porthole exterior surrounds and internal portlights were reinstalled

Once the epoxy hardened, the surrounds and portlights were reattached or reinserted and fastened into place. (**Figure 10**)

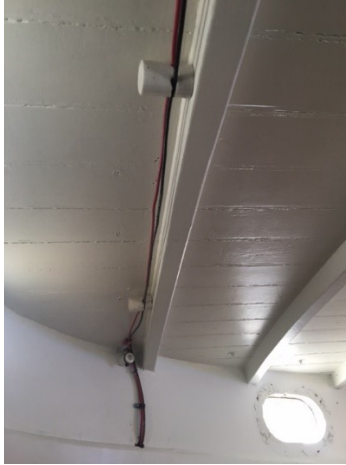
Figure 12: For historical reasons we rewired the running lights using the existing knobs.

from the days of knob and tube wiring. (Perhaps when MARVEL was restored in the 1920's?) Located just beneath the forward cabin wall they must have supported wires that delivered electricity to the port and starboard running lights directly above. As a nod to the historical nature of this discovery, we decided to repower the boat's running lights using these antique fittings but restrung them with marine-grade, 21st century wire and connectors. (**Figure 12**)

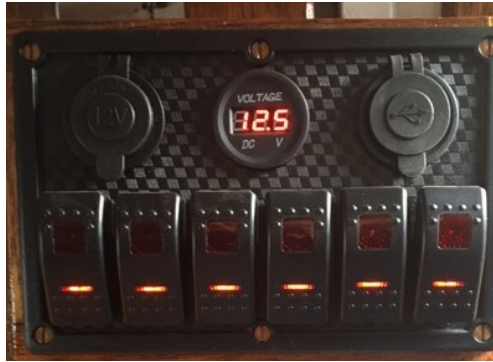
Figure 14: The new breaker panel offered many features not even invented for the old panel

of the companionway (**Figure 14**). This provided digital monitoring and readout of the battery voltage and provided USB and 12 Vdc outlets. We also replaced all of MARVEL's running lights with energy efficient LED versions.

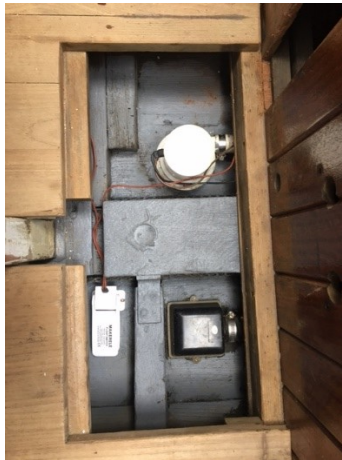
Figure 15: The automatic bilge pump and the intake for the manual Guzzler share bilge space

Along with the redirected bilge pump hose described earlier, we upgraded both the deck-mounted, manual Gusher pump draw hose and filter and the Rule automatic electric pump and its hose. **(Figure 15)** Hopefully these will see very little action in the seasons ahead.

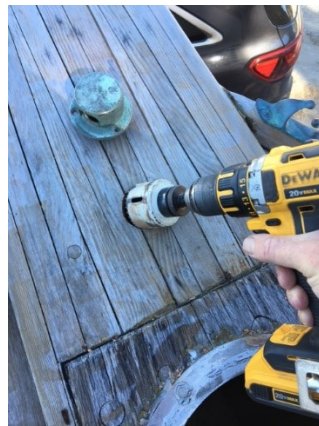
Figure 17: Installation of the antique hawser pipe was straightforward with a drill hole saw

A few minutes of well-placed drilling with a hole saw just ahead of the mast partner allowed us to install the fixture and feed the 300 feet of anchor line into the locker with little aggravation. (Figure 17).

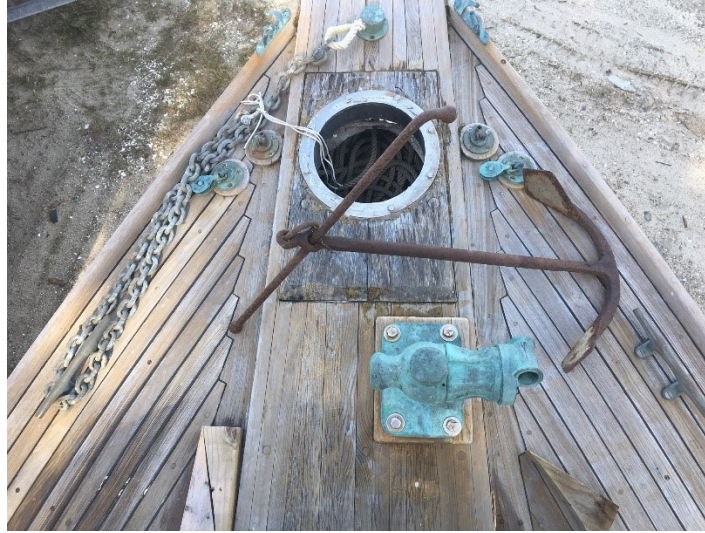
Figure 18: The new hawser pipe, line and chain should work well with the antique anchor.

This should work nicely with the turn of the century wrought iron yachtsman's anchor shown in **Figure 18**. It was donated to the cause by Westport resident Carroll Williamson. We plan to have this anchor sand blasted and hot dip galvanized by the Duncan Galvanizing Company during the winter months. (DGC at 69 Norman St # 2, Everett, MA 02149 Phone: 617-389-8440). It will serve as our vintage-proper "working hook." A new, 25 lb Danforth that came with the boat, will provide storm anchor capabilities.

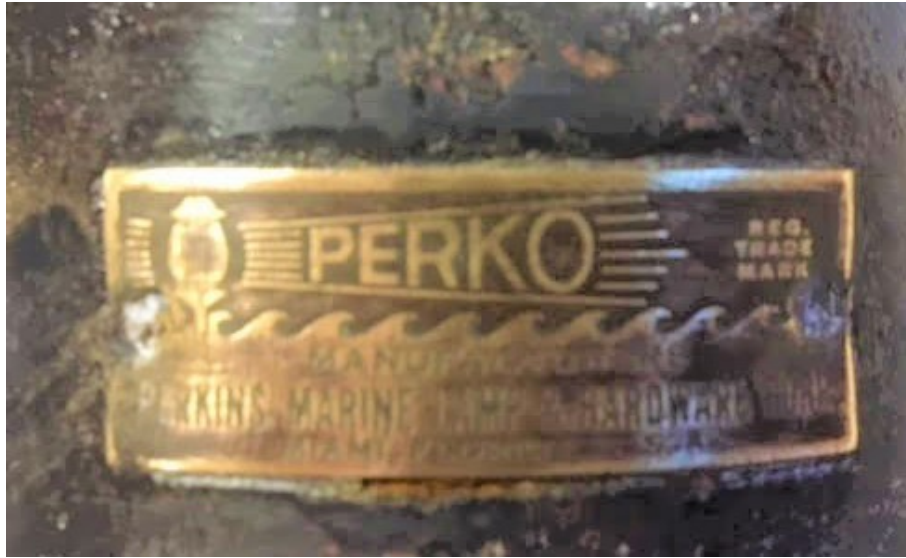
Figure 20: Brass “boilerplate” logo found on the Perko Turbine Ventilator

from one of their early catalogues. One MAIB reader directed us to remove paint from a spot at the base of the ventilator. Sure enough, there lay the brass PML&H boiler plate (**Figure 20**).

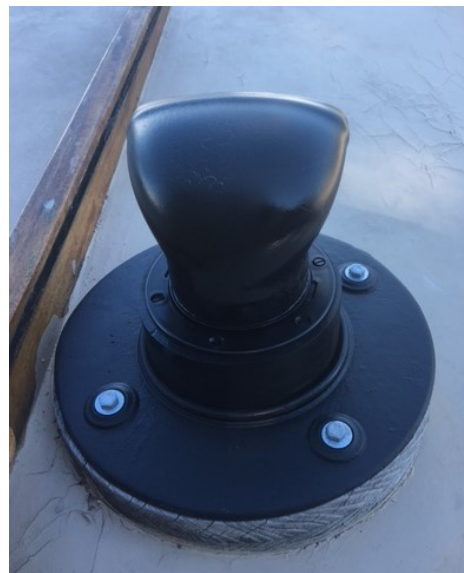
Figure 21: The addition of a rubber cowl turned the water deck iron into a ventilator

Since the Shipmate is no longer aboard, we decided to replace the ventilator with a more conventional cowl vent. We did so by simply snapping a SeaDog rubber vent onto the Charlie Noble mount to the water deck iron. (**Figure 21**)

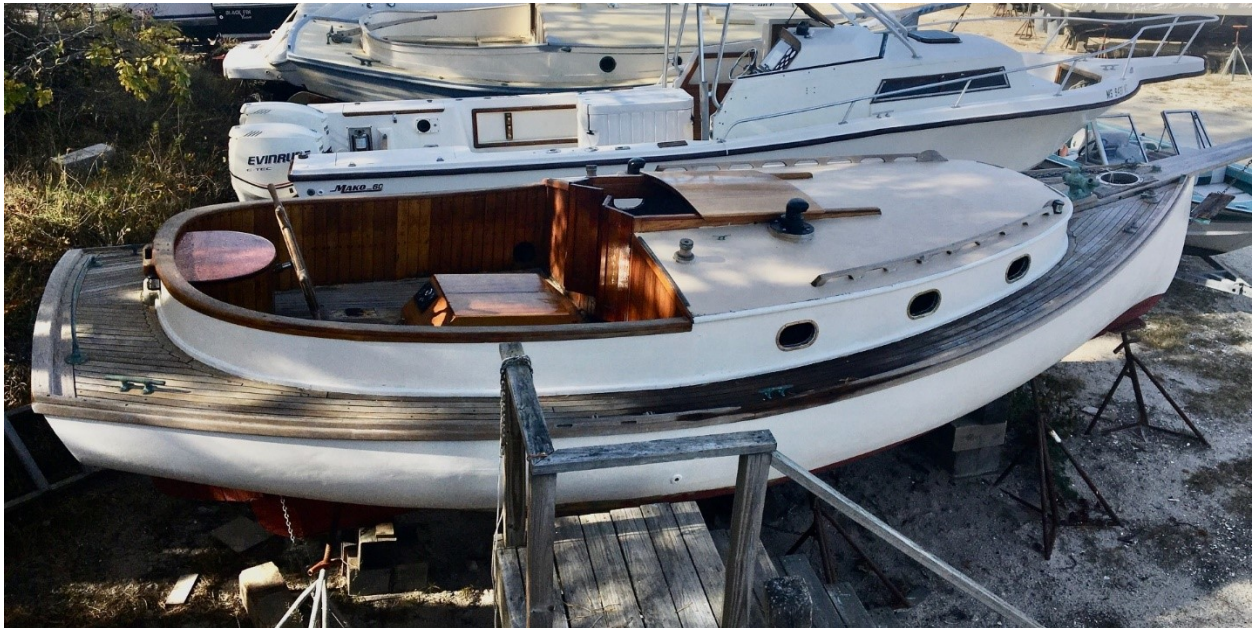
Figure 25: MARVEL/SUNNYSIDE/SUSAN fully restored and ready for splashdown next spring
(To be continued in the spring)
