Your board has received some emails requesting additional information about the \$33,000 expenditure to correct an erosion issue within the Village on Boxford Ct. There were concerns that the trustees may not have evaluated the situation correctly and rushed in accepting responsibility. This is the boards' response to those concerns. We hope that you will agree that the board is working in the best interest of all property owners residing in the Village of Greentrails.

Village of Greentrails Parks Board of Trustees

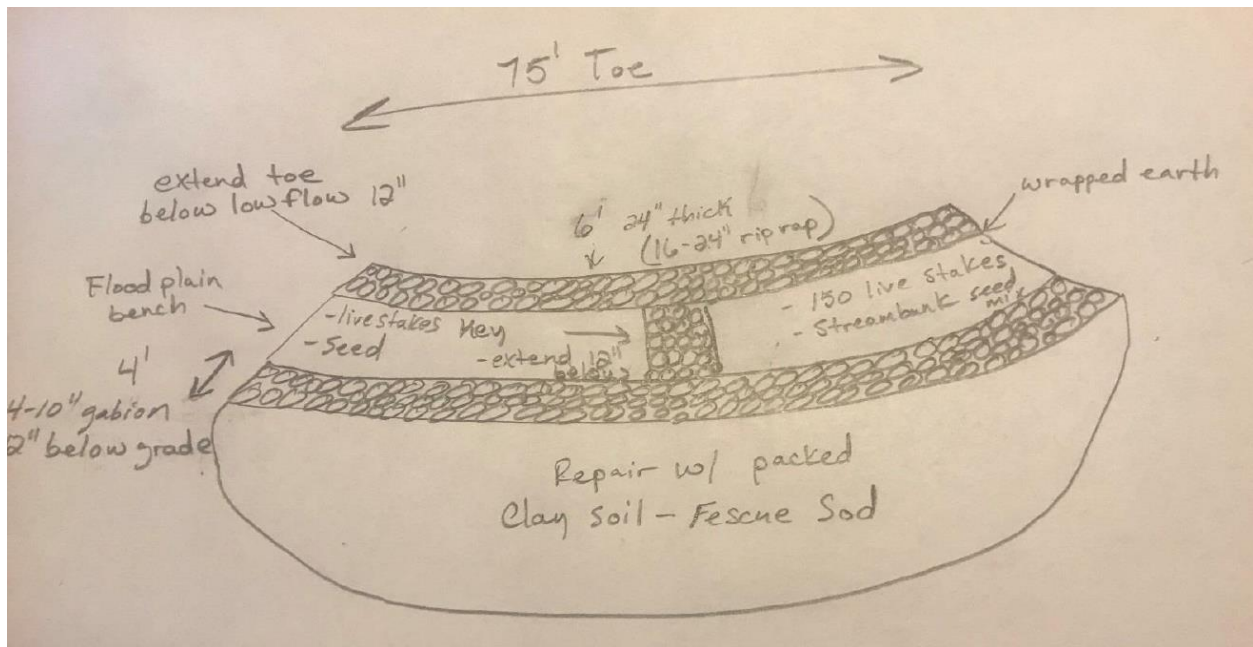
Diagram of work to be done:

STREAMBANK REPAIRS: DJM will utilize a Track Hoe and Skid Steer to perform debris removal, Excavation and grading, reinforced toe installation, Clay Fill installation and compaction, and creation of the floodplain bench. Reinforced Toe Installation will be created with 18-24" Rip Rap extended 12" below Low flow grade. Toe is anticipated to be 75' long x 6' wide x 24" deep. Above the toe will be wrapped earth extending into the created floodplain bench. Additional stabilization for large rain events will include a rock berm above the floodplain Bench 75' long x 4' wide x 12" deep. Please see shop drawing and details below.

SITE RESTORATION: Restoration will include a native streambank stabilization seed mix, SC150 ECB, and 150 4' live stake species including Elderberry, Sandbar Willow, and Buttonbush installed within the created floodplain bench. All access and disturbed areas outside of the Floodplain bench will be vegetated with Fescue Sod and be brought back to original state.
