Windstorm Mitigation Report (OIR-B1-1802)

Deerwood Gardens Condominium Association, Inc.

Bldg 14, 11511 113th St, Units A-C

As of 6/15/2023 | FPAT File# MIT2320130

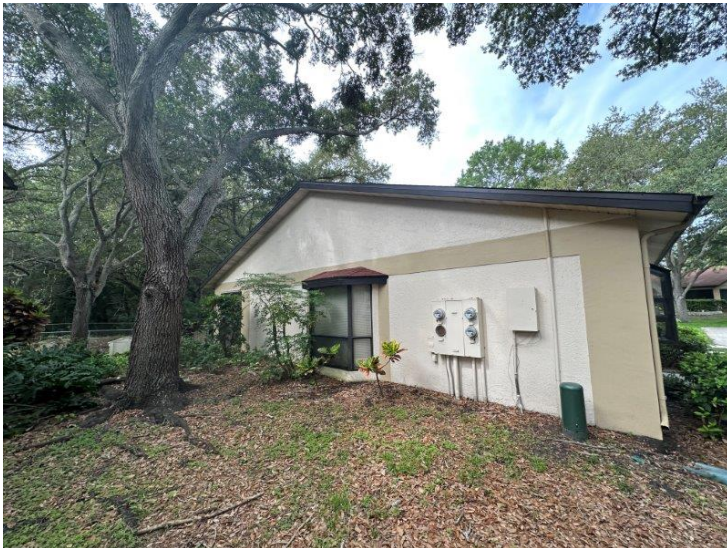
Exterior Elevation

Comments: | Other Roof
Inspection verified a gable roof shape. |

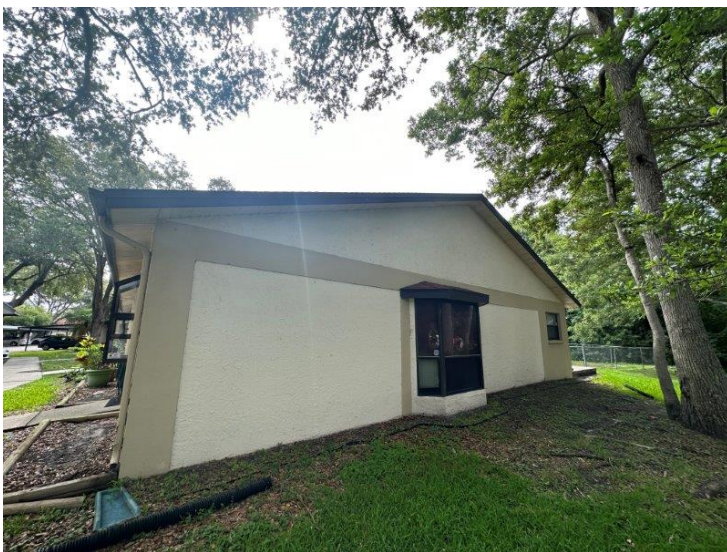
Exterior Elevation

Comments: | None or Some Glazed Openings
Inspection verified some opening protection. Not all glazed openings were protected with impact resistant coverings. |

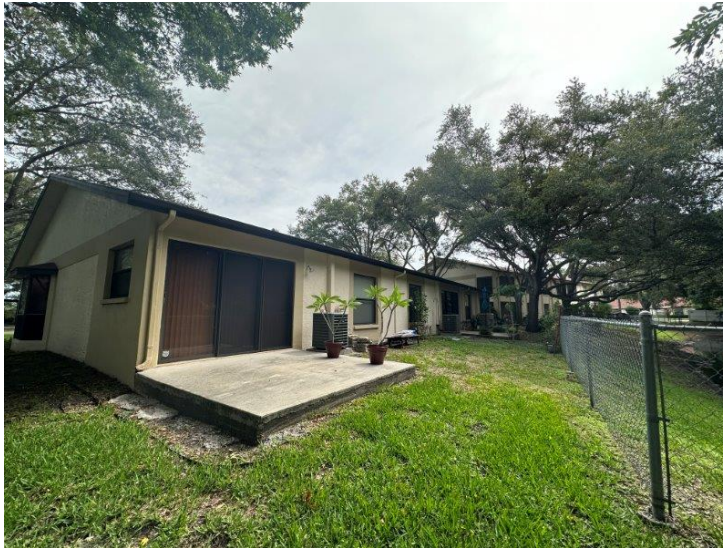
Roof Permit Information

Comments: | FBC Equivalent
The roof covering was replaced in 2011. The roof permit was confirmed and the permit number is PER-H-CB11-04091. This roof was verified as meeting the building code requirements outlined on the mitigation affidavit. |

Building Combination BLD
REROOF: 40 SQ GAF FL10124.1 : 4/12 + #30 WARRIOR FELT
(BLD 14)

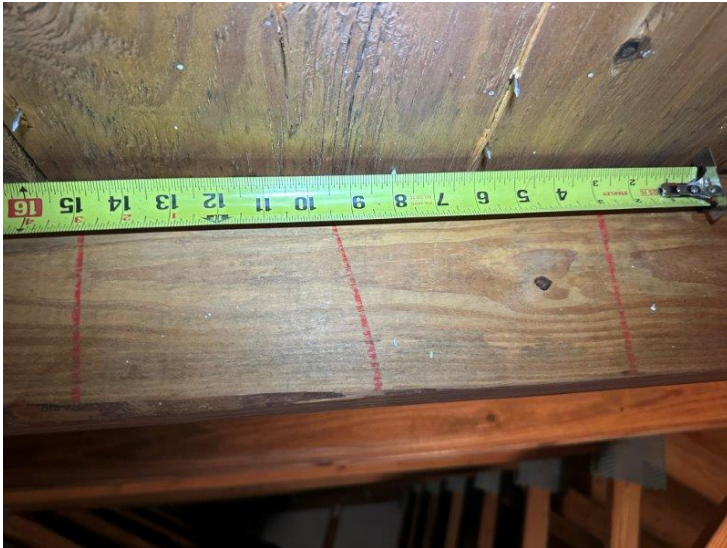
Roof Construction

Comments: | Level A
Inspection verified 1/2" plywood roof deck attached with 6d nails at a minimum of 6" on the edge & 12" in the field. |

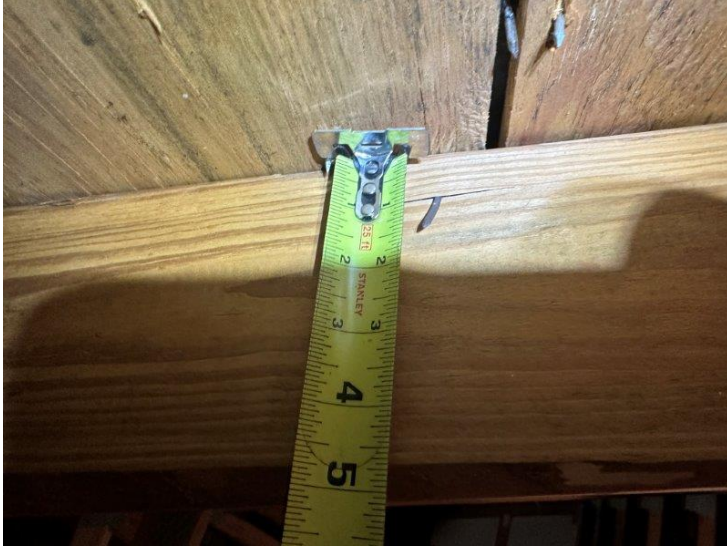
Roof Construction

Comments: | Clips
Inspection verified embedded straps fastened with a minimum of three nails. |

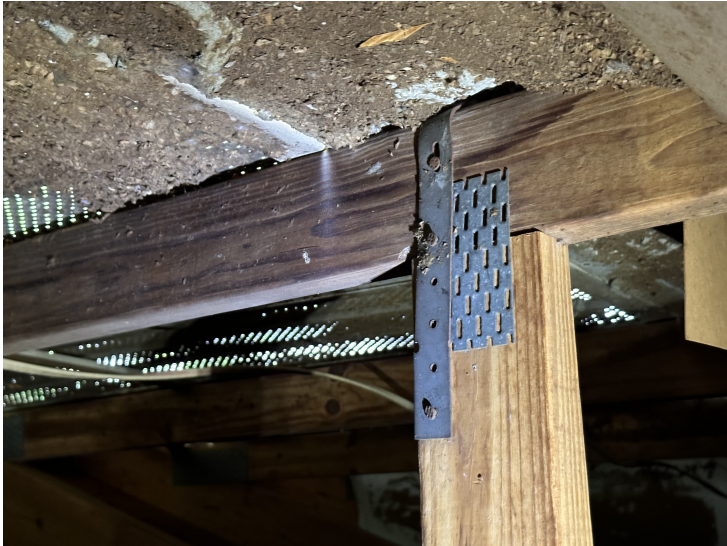
Roof Construction

Comments: | No
At the time of inspection, no SWR was verified. |
