Windstorm Mitigation Report (OIR-B1-1802)

Deerwood Gardens Condominium Association, Inc.

Bldg 9, 11511 113th St, Units A-F

As of 6/15/2023 | FPAT File# MIT2320130

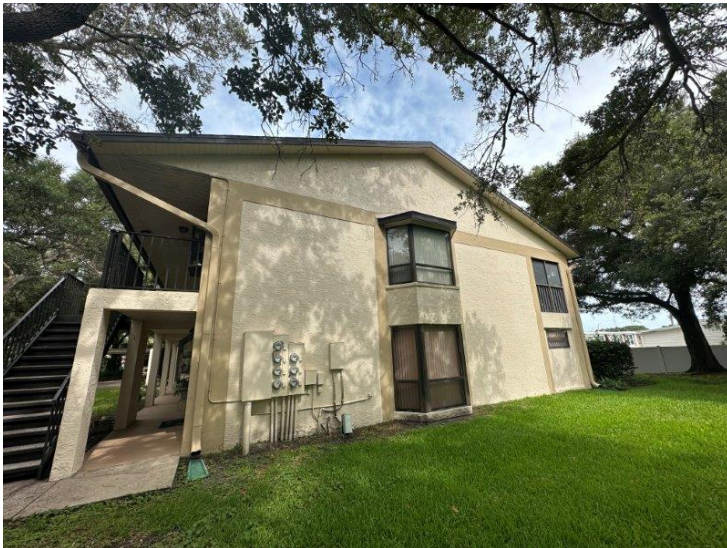
Exterior Elevation

- 5. Roof Geometry:** **Other Roof**
Comments: Inspection verified a gable roof shape.
- 6. SWR:** **Unknown or Undetermined**
Comments: At the time of inspection, no SWR was verified.
