# Home Inspection Report

*Prepared For: John and Jane Doe*

55 Sample Street  
Sample, IN 46219

Inspection Date: 06/06/2019

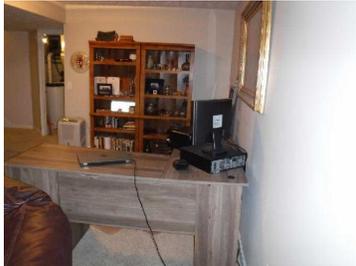
Not Inspected/Not Present: General Conditions: Many areas throughout the home and garage could not be fully accessed or inspected due to home owner furnishings, belongings and stored items. We recommend additional evaluation when entire property is accessible.

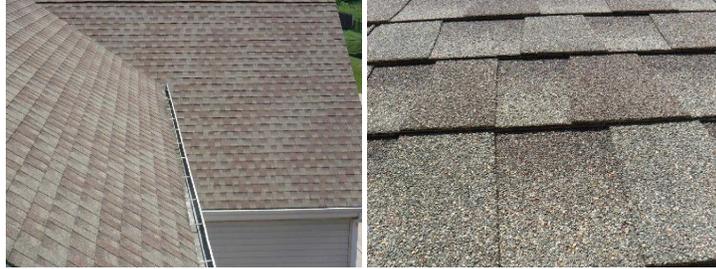
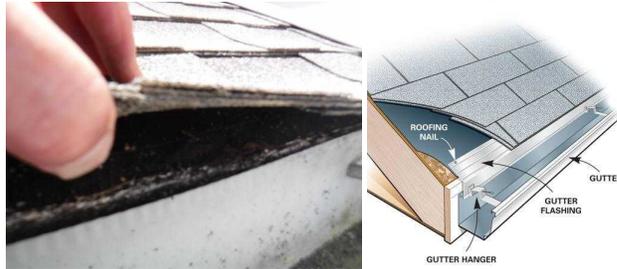
Maintenance/Improvements: **Flashing:** No flashing (edge/snow guard) installed from roof to gutters, prone to possible leaks and fascia damage due to ice damming. Recommend install flashing. (see graphics for example of proper flashing.)

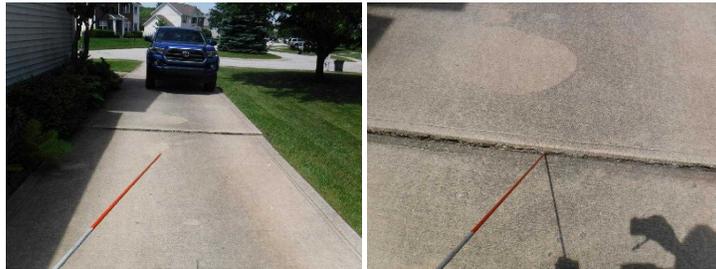
Driveway: A displacement of more than 1" in height. This represents a trip hazard, recommend estimate for repair or replacement by a qualified contractor.

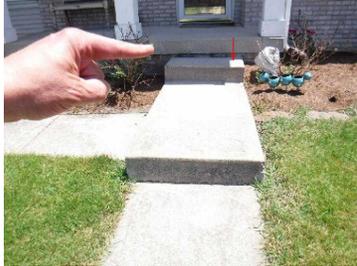
Steps/Stoops: **Non conforming step risers. Trip hazard. Recommend repair/replace by a qualified contractor.**

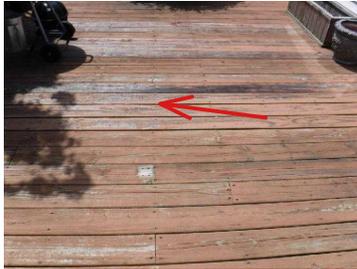
Maintenance/Improvements: Deck: **Recommend cleaning and resealing.**

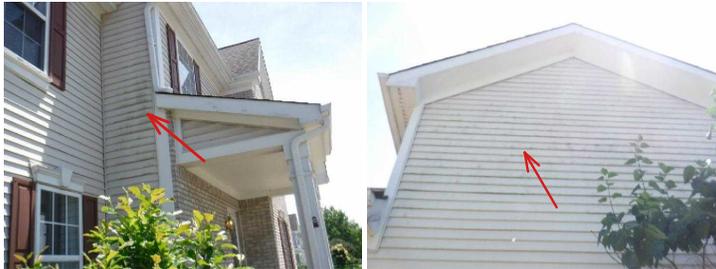
Maintenance/Improvements: Type: Vinyl siding - **Moss like substance on siding should be removed periodically.**

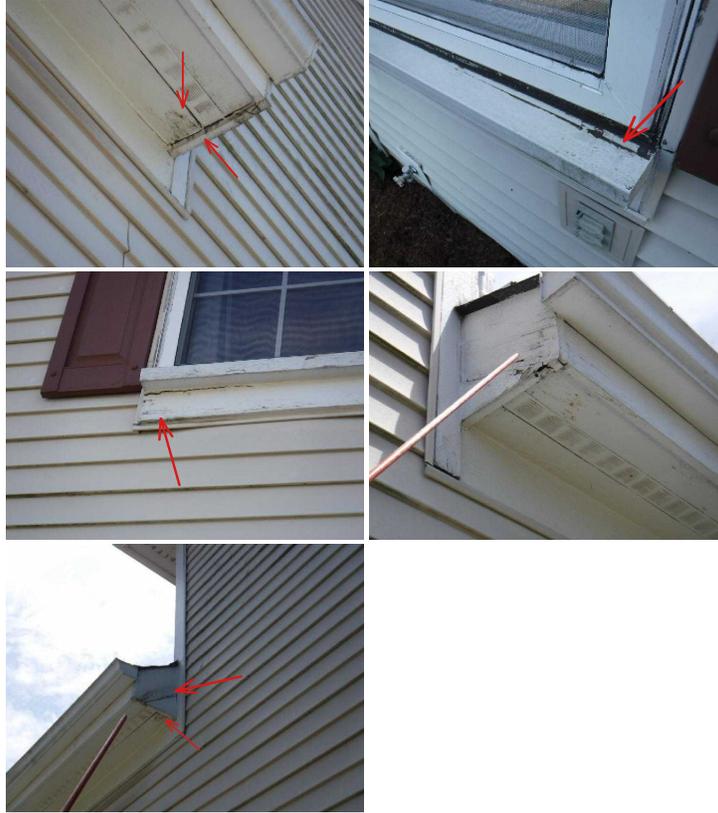
Trim: **Some rot or near rot has been found on trim. Rot found on fascia and soffits in multiple places. Recommend wood trim, soffit and fascia evaluation and repair by a qualified contractor.**

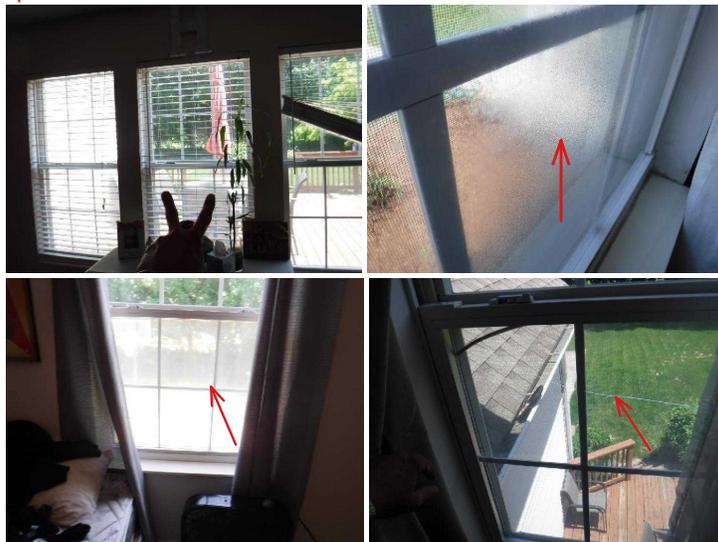
Windows: Broken Thermo-seals on multiple windows. Eight noted and one with broken glass. Recommend evaluation of all windows and repair or replace as necessary by a qualified window contractor.

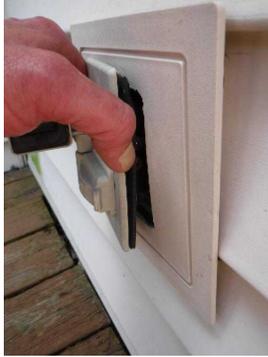
Exterior Electric Outlets: Loose outlet at deck. Recommend repair by a qualified electrician.

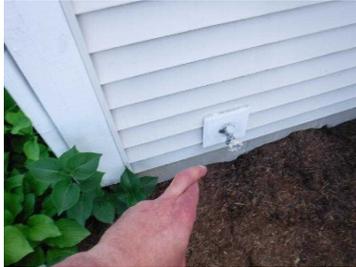
Hose Bibs: All hose bibs were inoperative at time of inspection. Recommend evaluation and repair by a qualified contractor.

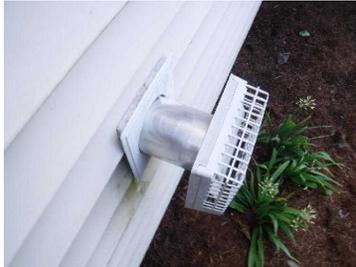
Maintenance/Improvements: Vents: Dryer vent extends out excessively. Recommend repair.

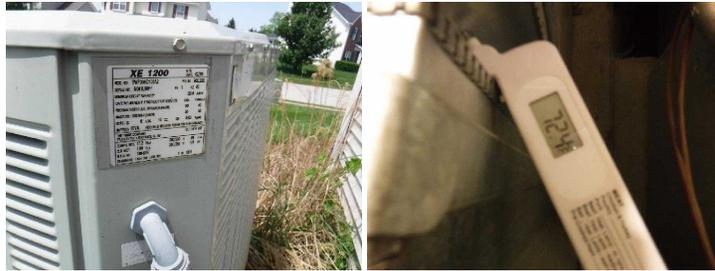
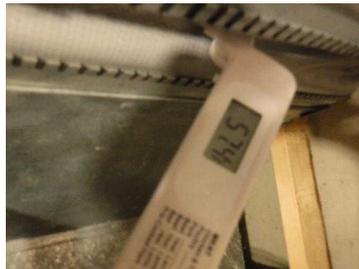
A/C System Operation: Minimally Functional at the time of inspection - **The unit is currently in service beyond the average design life. Recommend evaluation and estimate for replacement by a qualified HVAC contractor.**

**Minimum differential temperature of 15 degrees. A qualified air conditioning contractor is recommended to evaluate and estimate replacement.**

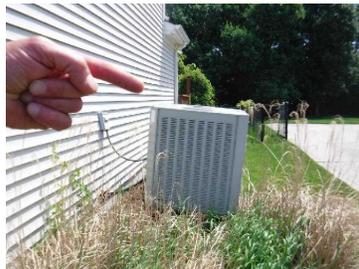
Exterior Unit: **Unit not level. Recommend leveling for optimum performance.**

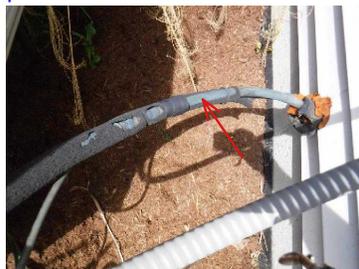
Refrigerant Lines: **Torn and/or missing insulation. Replace by a qualified HVAC professional.**

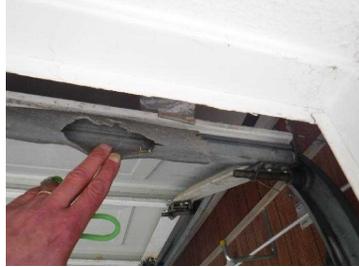
Garage Doors: **Damage door seal. Recommend replace.**

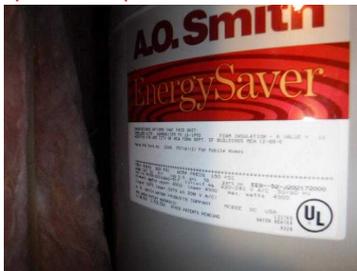
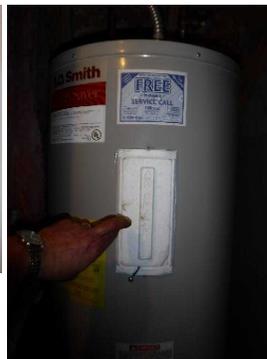
Water Heater Operation: Functional at time of inspection - **Water heater has exceeded design life. Missing heating rod doors (safety hazard). Recommend replacement by a qualified plumber.**

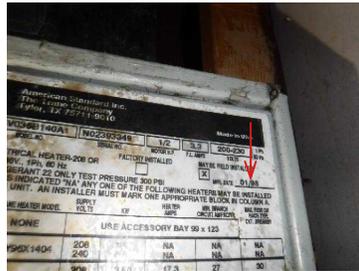
Heating System Operation: Functional at the time of inspection - **Furnace existing beyond design life. Recommend evaluation and estimate for replacement by a HVAC professional.**

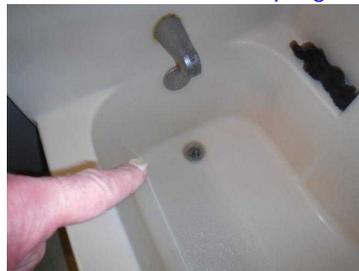
Tub/Surround: **Drain plug inoperative. Recommend replace.**

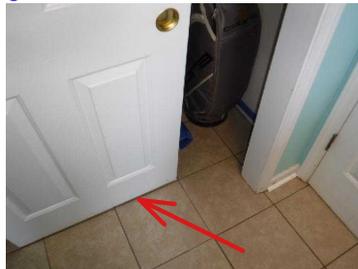
Closet: Door guides are missing on closet sliding doors. Recommend replace floor door guides.

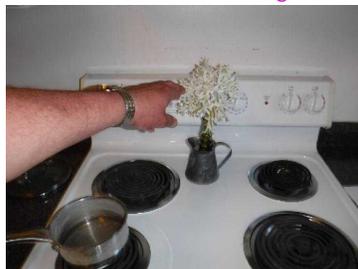
Cooking Appliances: Stove/oven does not have tilt safety harness installed at floor. Recommend installing safety harness by a qualified contractor.

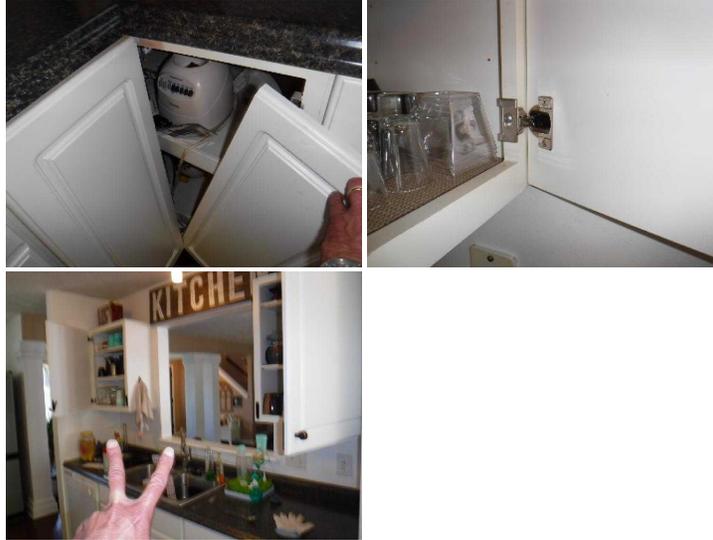
Cabinets: Broken hinge on lazy susan door. Malfunctioning hinges on cabinets on each side of sink. Recommend repair by a qualified contractor.

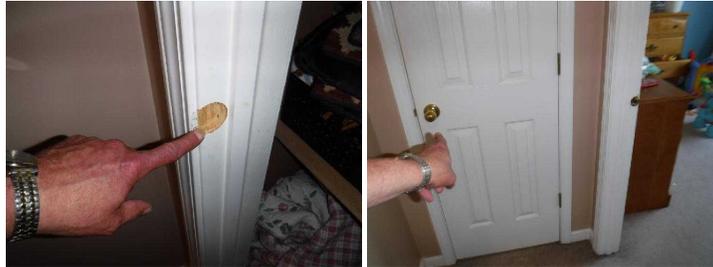
Closet: Second floor hallway. [Missing closing hardware.](#) [Recommend replace.](#)

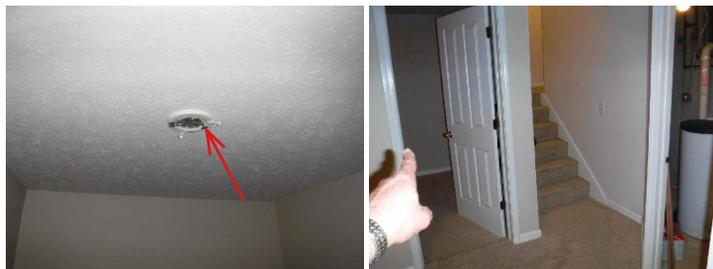
Maintenance/Improvements: Ceiling: Basement Bonus Room. [Missing light cover.](#) [Recommend replace.](#)

[Noted:](#) This room had no HVAC vent installed.

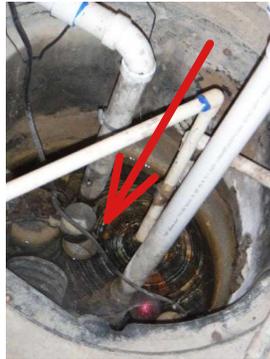
Maintenance/Improvements: Sump Pump: Submerged - Functional at the time of inspection - Recommend installation of water-powered or battery powered back-up sump pump to protect basement finishes.

Recommend installation of sealed cap and low float pump to prevent moisture/smell entry into basement.

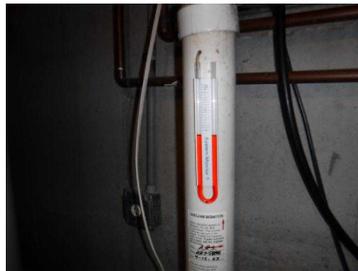
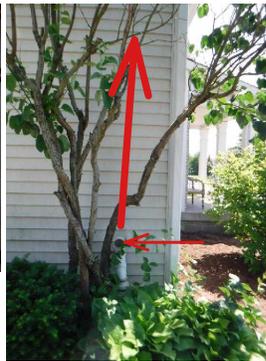
Maintenance/Improvements: Radon Unit: The radon unit was not functional at the time of inspection. The radon discharge was too low and should discharge 8 feet above ground level. Recommend repair by a qualified contractor.

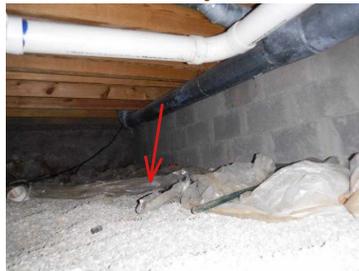
Maintenance/Improvements: Moisture Barrier: Plastic moisture or vapor barrier not covering entire crawl space.  
Recommend adjust or add to barrier as needed.

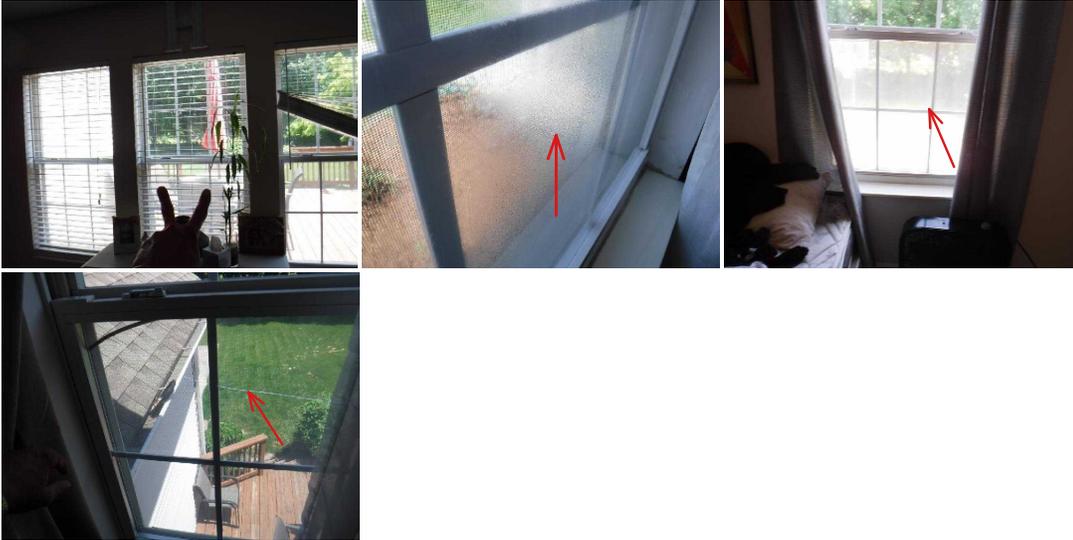
1. Windows: Broken Thermo-seals on multiple windows. Eight noted and one with broken glass. Recommend evaluation of all windows and repair or replace as necessary by a qualified window contractor.

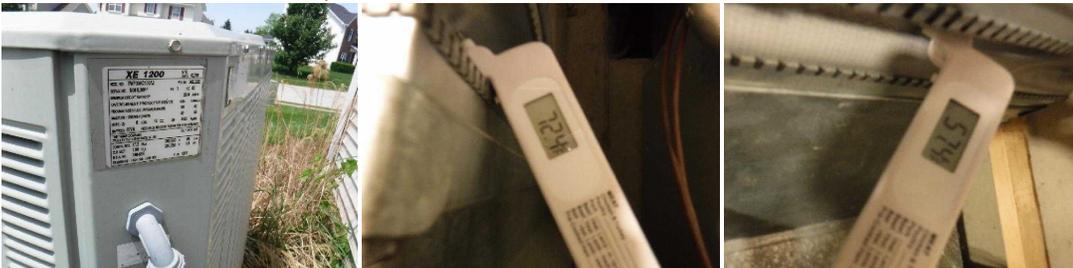
2. Outside AC System A/C System Operation: Minimally Functional at the time of inspection - The unit is currently in service beyond the average design life. Recommend evaluation and estimate for replacement by a qualified HVAC contractor.

Minimum differential temperature of 15 degrees. A qualified air conditioning contractor is recommended to evaluate and estimate replacement.

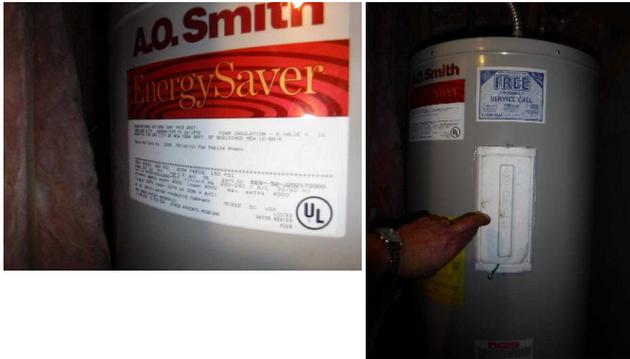
3. Basement Water Heater Water Heater Operation: Functional at time of inspection - Water heater has exceeded design life. Missing heating rod doors (safety hazard). Recommend replacement by a qualified plumber.

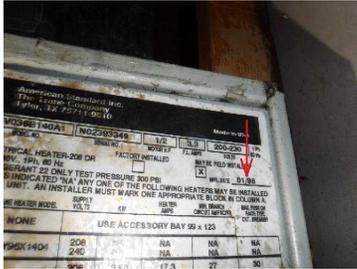
4. Basement Heating System Heating System Operation: Functional at the time of inspection - **Furnace existing beyond design life. Recommend evaluation and estimate for replacement by a HVAC professional.**

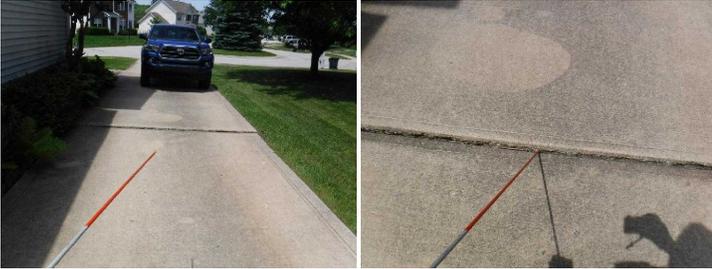
1. Driveway: A displacement of more than 1" in height. This represents a trip hazard, recommend estimate for repair or replacement by a qualified contractor.

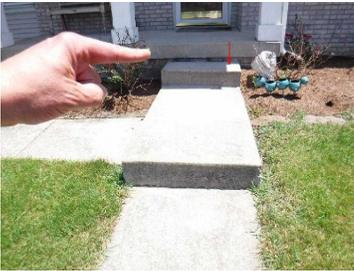
2. Steps/Stoops: Non conforming step risers. Trip hazard. Recommend repair/replace by a qualified contractor.

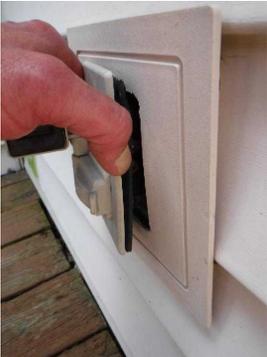
3. Exterior Electric Outlets: Loose outlet at deck. Recommend repair by a qualified electrician.

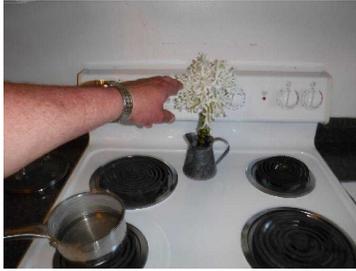
4. 1st Floor Kitchen Cooking Appliances: Stove/oven does not have tilt safety harness installed at floor. Recommend installing safety harness by a qualified contractor.

These are used to secure the range to the wall or floor to prevent tipping over and causing serious injury.

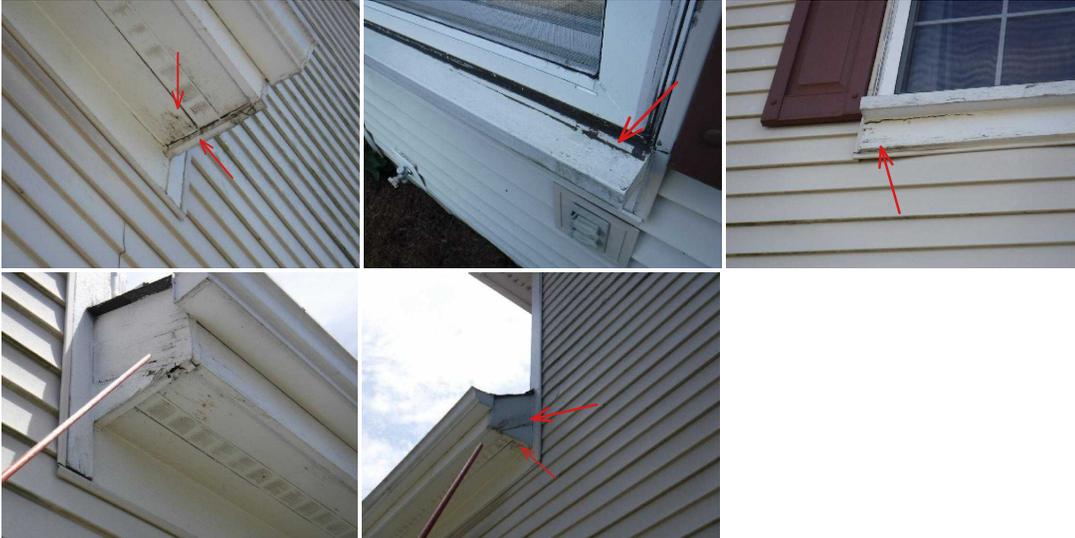
1. Trim: Some rot or near rot has been found on trim. Rot found on fascia and soffits in multiple places. Recommend wood trim, soffit and fascia evaluation and repair by a qualified contractor.

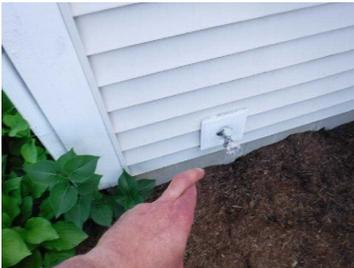
2. Hose Bibs: All hose bibs were inoperative at time of inspection. Recommend evaluation and repair by a qualified contractor.

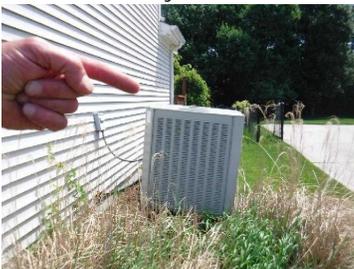
3. Outside AC System Exterior Unit: Unit not level. Recommend leveling for optimum performance.

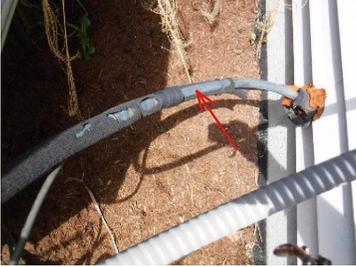
4. Outside AC System Refrigerant Lines: [Torn and/or missing insulation](#). [Replace by a qualified HVAC professional](#).

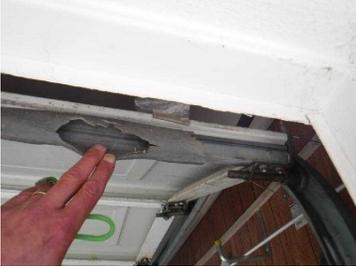
5. Attached Garage Garage Doors: [Damage door seal](#). [Recommend replace](#).

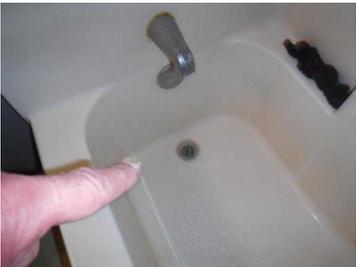
6. 2nd floor main Bathroom Tub/Surround: [Drain plug inoperative](#). [Recommend replace](#).

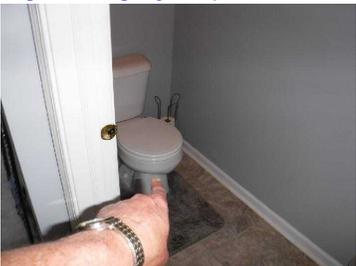
7. Master Bathroom Toilets: [The toilet is loose at the floor and may require replacement of the wax seal and/or tightening by a qualified contractor](#).

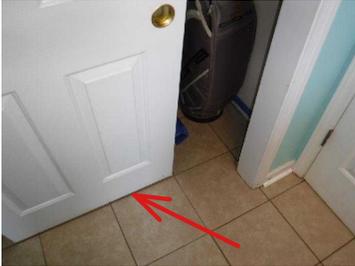
8. 1st Floor Laundry Room/Area Closet: [Door guides](#) are missing on closet sliding doors. Recommend [replace floor door guides](#).

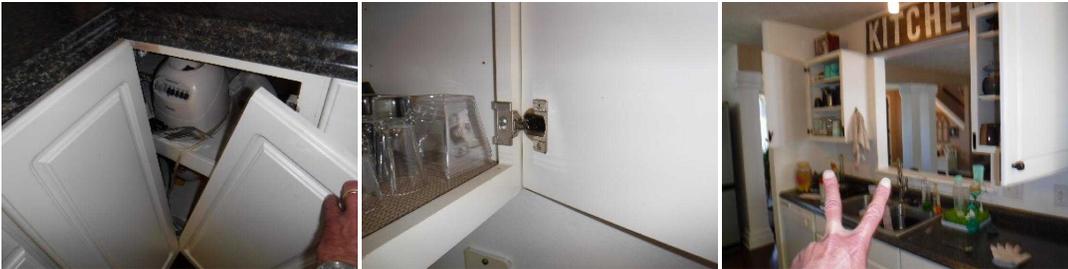
9. 1st Floor Kitchen Cabinets: [Broken hinge](#) on lazy susan door. [Malfunctioning hinges](#) on cabinets on each side of sink. Recommend [repair by a qualified contractor](#).

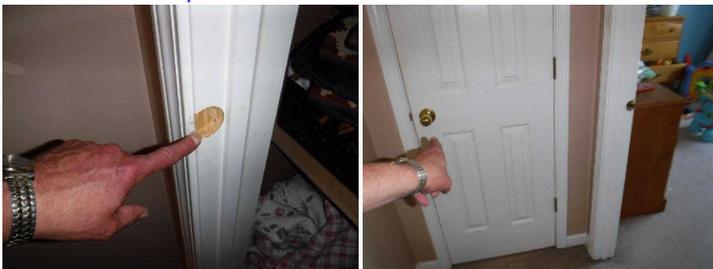
10. General Comments all Living Spaces Living Space Closet: Second floor hallway. [Missing closing hardware](#). Recommend [replace](#).

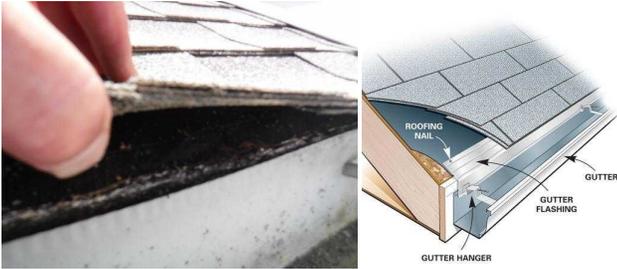
1. Flashing: No flashing (edge/snow guard) installed from roof to gutters, prone to possible leaks and fascia damage due to ice damming. Recommend install flashing. (see graphics for example of proper flashing.)

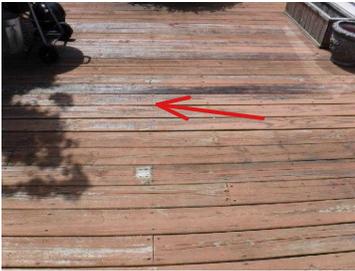
2. Deck: Recommend cleaning and resealing.

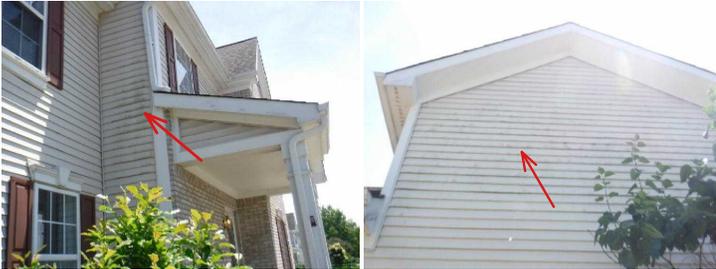
3. Main Exterior Surface Type: Vinyl siding - Moss like substance on siding should be removed periodically.

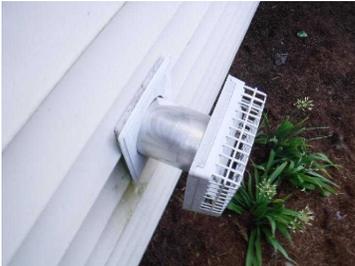
4. Vents: Dryer vent extends out excessively. Recommend repair.

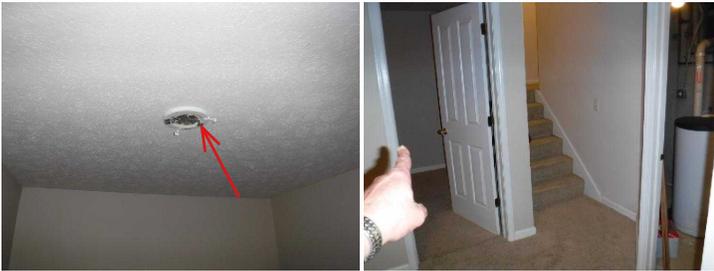
8. General Comments all Living Spaces Living Space Ceiling: Basement Bonus Room. Missing light cover. Recommend replace.

Noted: This room had no HVAC vent installed.

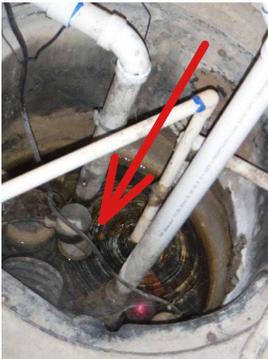
9. Main Basement Sump Pump: Submerged - Functional at the time of inspection - Recommend installation of water-powered or battery powered back-up sump pump to protect basement finishes.

Recommend installation of sealed cap and low float pump to prevent moisture/smell entry into basement.

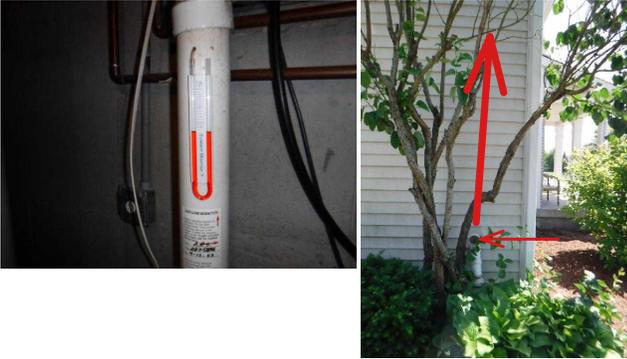
10. Main Basement Radon Unit: The radon unit was not functional at the time of inspection. The radon discharge was too low and should discharge 8 feet above ground level. Recommend repair by a qualified contractor.

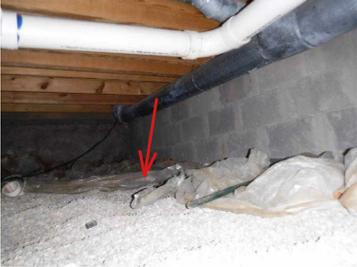
11. North Crawl Space Moisture Barrier: Plastic moisture or vapor barrier not covering entire crawl space. Recommend adjust or add to barrier as needed.

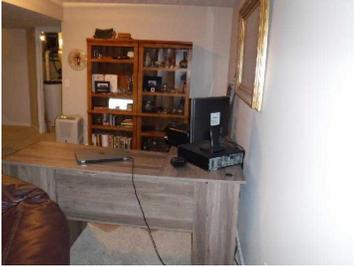
1. General Conditions: Many areas throughout the home and garage could not be fully accessed or inspected due to home owner furnishings, belongings and stored items. We recommend additional evaluation when entire property is accessible.
