## Sewer Lateral Inspection Report

**Inspection Address:** 6500 Anywhere St., Indianapolis, IN 46219

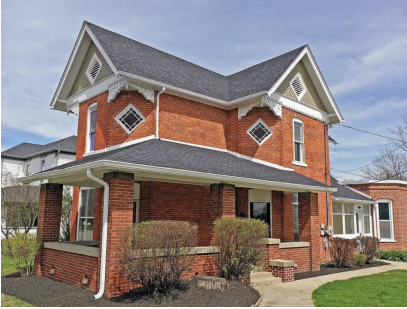
**Clean Out Present/Location:** Outside/Left side of property

**Line Type:** Clay Tile, SDR

**Issue With Line (Roots/Grease/ETC):** Two breaks within the line

- The scope was performed from the outside cleanout along the left side of the home. There is a 4in PVC cleanout cap that is attached to a 4in clay tile cleanout. The line from this point to the city main is ran mostly in 6in clay tile with one 10ft section of line that has been repaired and replaced with 6in SDR. Overall the line is in decent condition with no major roots, offsets, or bellies; However two large breaks were found within the line at the top of the pipe. One at 11ft and one at 26ft, both breaks are sections of the clay tile that have cracked and broken apart leaving nothing but dirt for the top of the line. Over time with rain and settling these broken sections of line can collapse and fill with dirt causing backups and risk further damage to the line and home. The line at the time of service is currently fully open and flowing but it's impossible for Spawco to predict for how long it will remain in its current condition. We recommend the breaks be repaired/replaced as soon as possible to prevent any further damage.

- We recommend acquiring two estimates for the breaks; one for excavation and replacement of a section of the line; and another one to re-line the broken sections as an alternate option for repair. Both options will resolve the issue and vary in cost.
