# *Asset Maintenance & Management Plan*

## Table of Contents

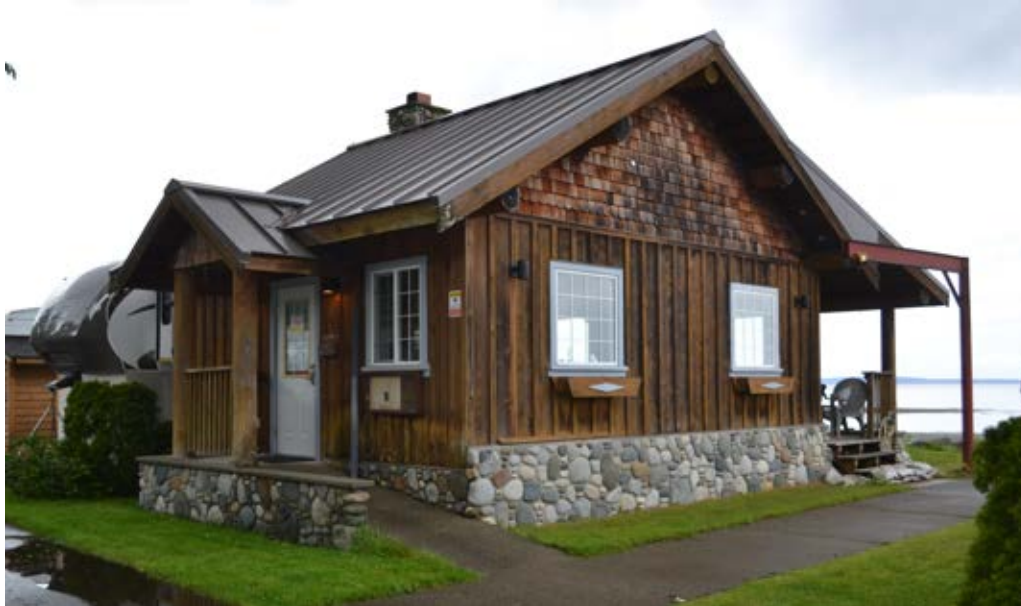
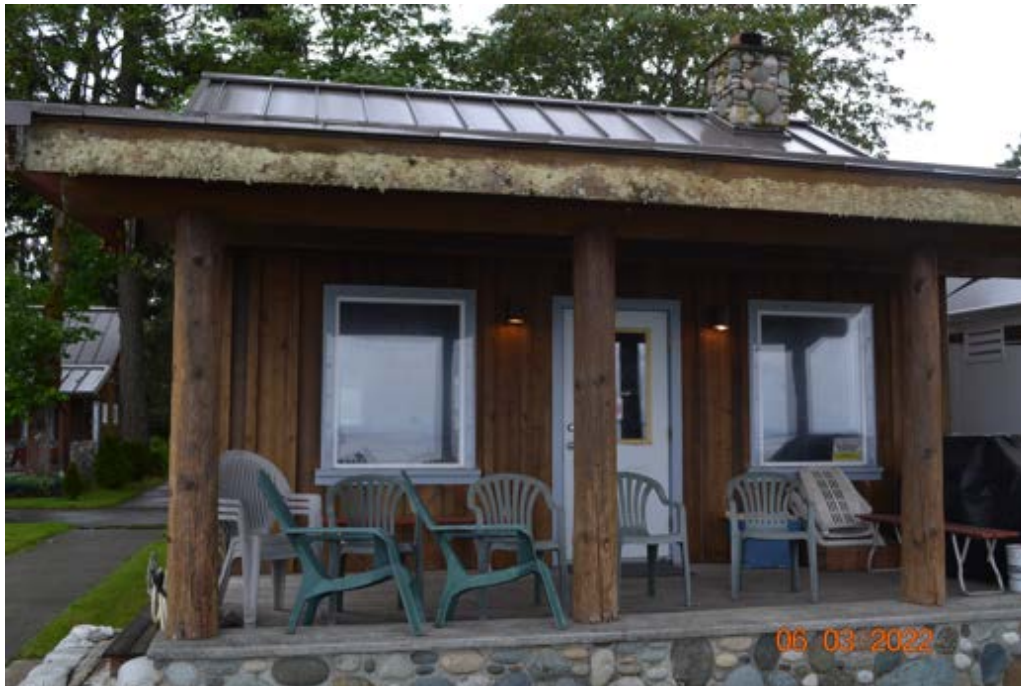
### 7.1 B1-001 Clubhouse

Building Component	Observed Ranking	Comments
Roof		Metal Roof is in new condition. Exterior, decks, rails, and facias have been power washed and rotten boards replaced 2022-2023.
Exterior Walls		Exterior, decks, rails, and facias have been power washed and rotten boards replaced in 2022-2023. Exterior has had one coat of stain; second coat may be needed.
Interior		Interior should be painted and a deep clean done.
FF&E		Furniture is worn, cumbersome and could be replaced to make it more functional. Water tank is working but consider replacement soon.
Foundation		Observed to be in good condition; some minor drainage issues near entry/Campsite #7 should be addressed,

Asset	Overall Assessment	Comments
B1-001 Clubhouse		With maintenance and exterior renovations done in 2022/2023, the structure is in good condition. Interior could use paint, new FF&E to make the clubhouse more functional as a social lounge for campers. In 2030-2031, the need for upgrade of rails and deck structure/ramp should be assessed for required renewal and/or repairs.

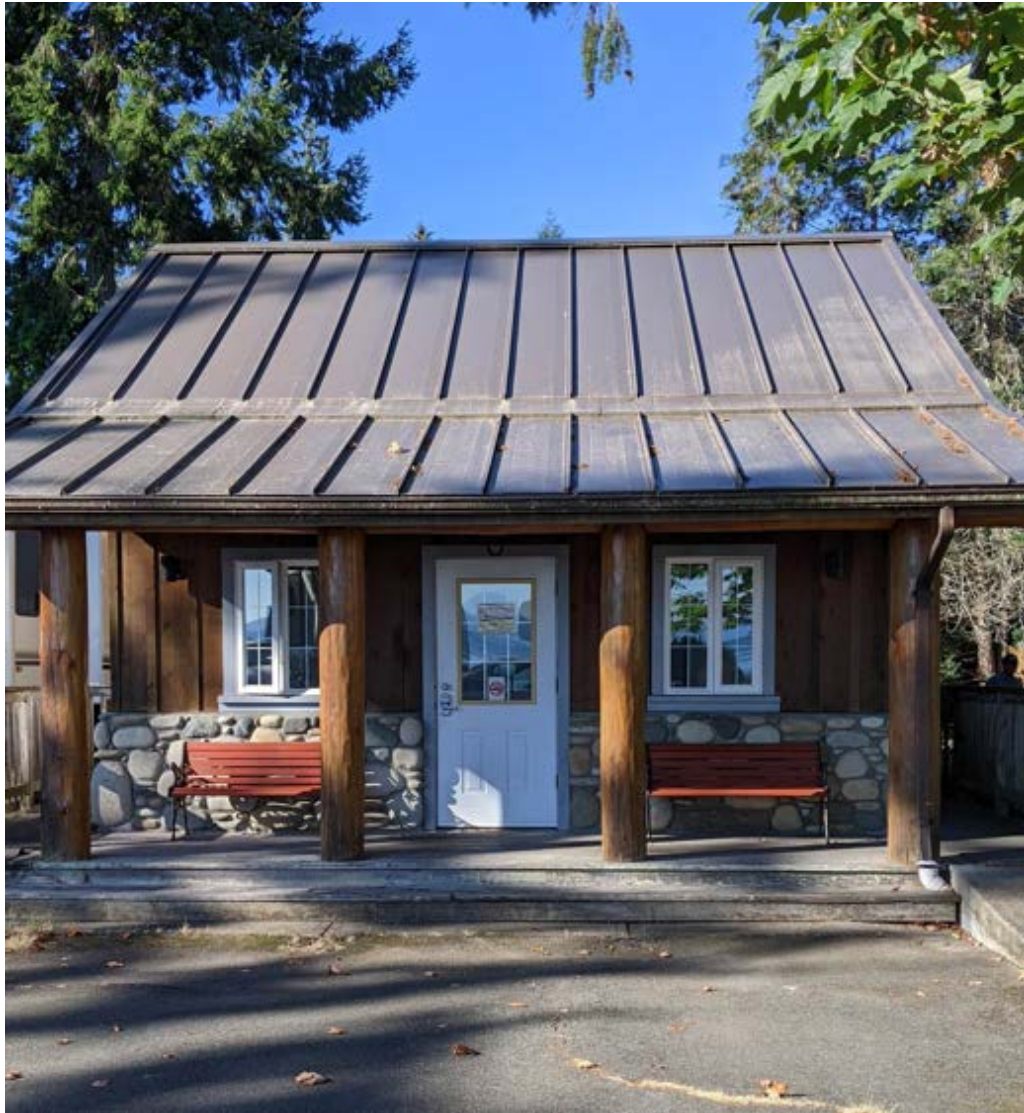
## 7.2 B1-002 Laundry/Washroom Building (Water Side)

Building Component	Observed Ranking	Comments
Roof		Metal Roof is in new condition. Exterior, decks, rails, and facias have been power washed and rotten boards replaced 2022-2023.
Exterior Walls		Exterior, decks, rails, and facias have been power washed and rotten boards replaced in 2022-2023. Exterior has had one coat of stain; second coat may be needed.
Interior		Interior should be painted and a deep clean done.
FF&E		Washer and Dryers are old but working. Consider upgrade to high-capacity units as units fail and require repairs.
Foundation		Observed to be in good condition.

Asset	Overall Assessment	Comments
B1-002 Laundry/Washroom Building		With maintenance and exterior renovations done in 2022/2023, the structure is in good condition. Interior could use a fresh coat of paint. In 2030-2031, the need for upgrade of rails and deck structure/ramp should be assessed for required renewal and/or repairs.

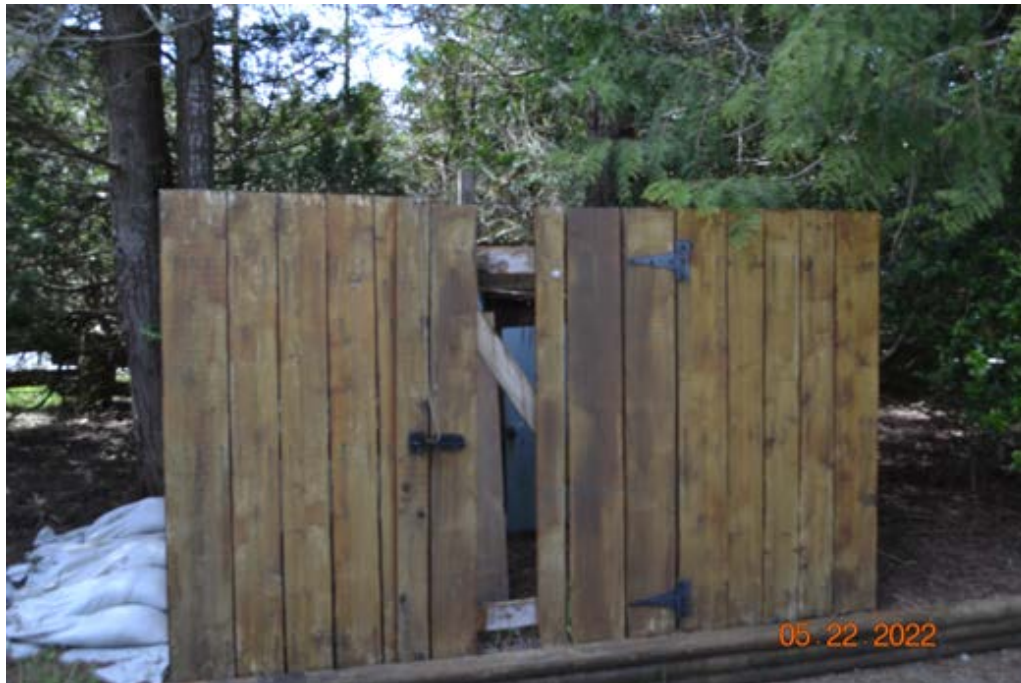
### 7.3 B1-003 Storage Enclosure

Asset	Overall Assessment	Comments
B1-003 Storage Compound		The storage compound is not useable in its current condition. It is recommended that it be repurposed to a covered outside lockable storage for yard equipment, tools, etc. This would extend the life of these assets rather than having them just placed on the back wall of the waterside laundry/washroom building.

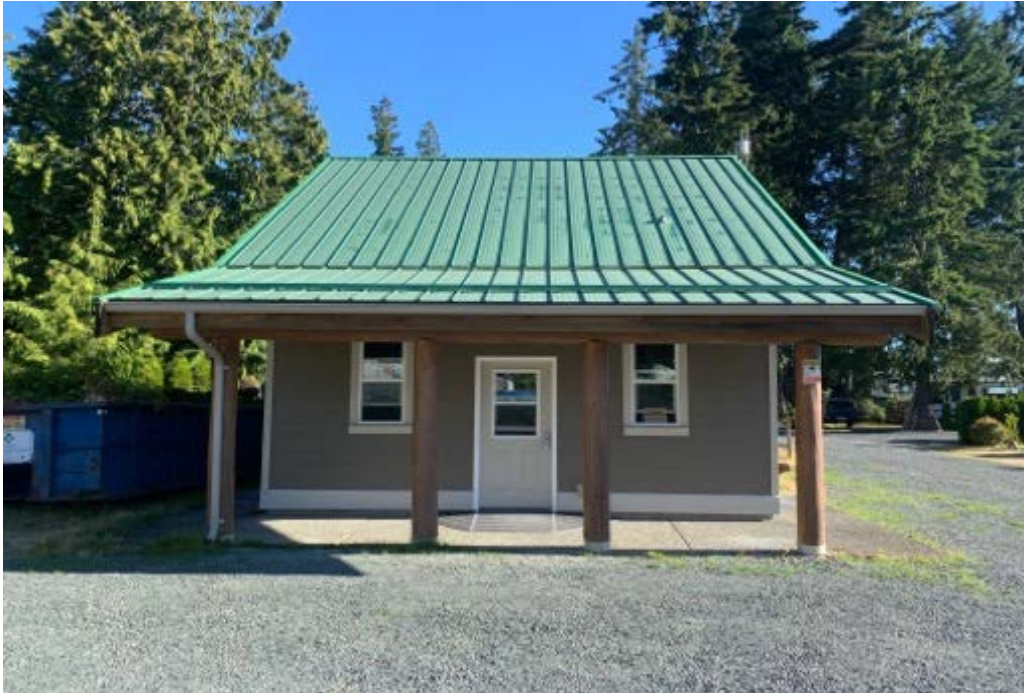
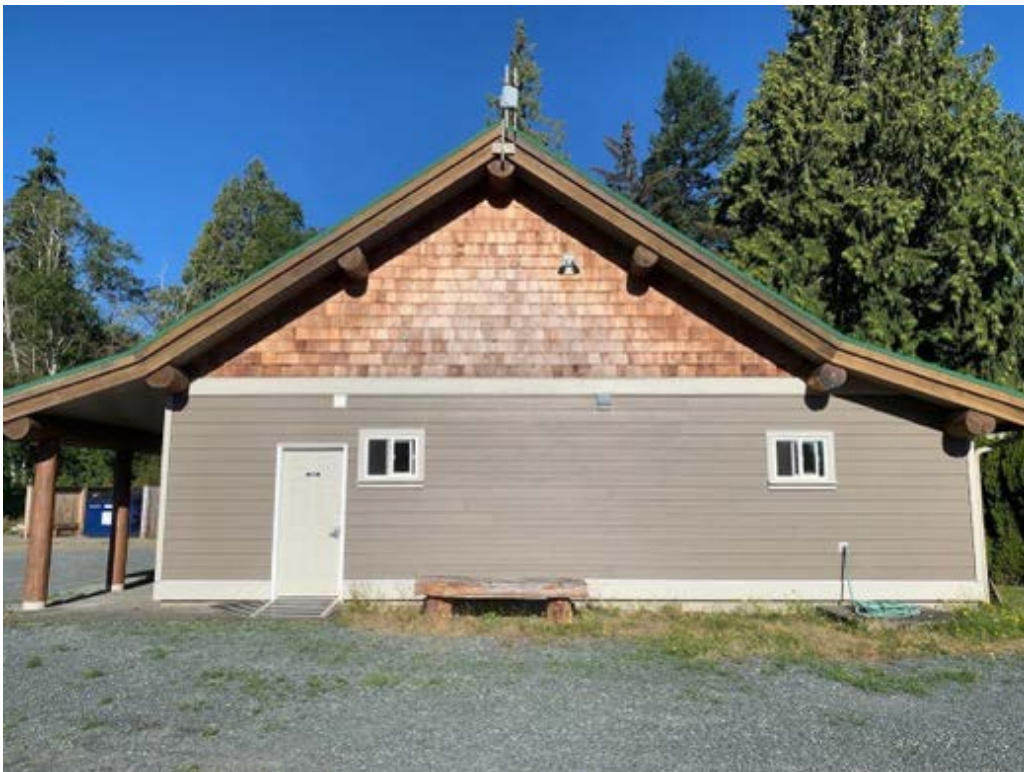
#### 7.4 B2-001 Laundry/Shower Building (Forest Side)

Dryers have been fixed twice; Hot water tank wiring by developer is operational but should be checked to ensure it is optimal (2023 priority item for routine maintenance)
Foundation

Building completed in 2018-2020. In good condition. Recommend application of exterior stain to preserve exterior walls

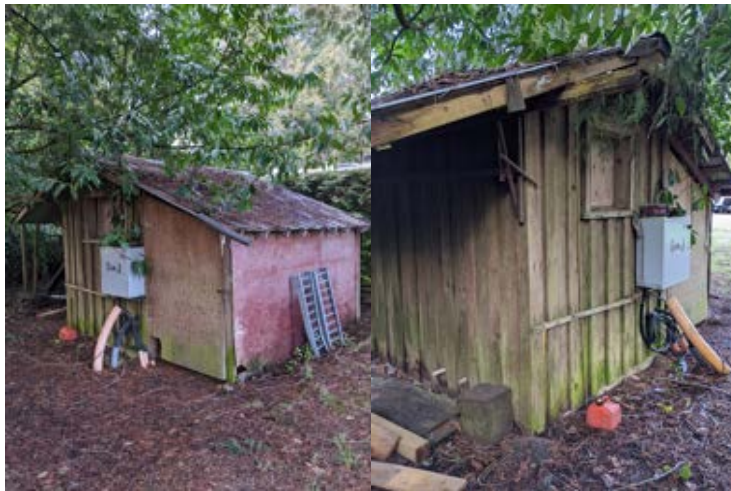
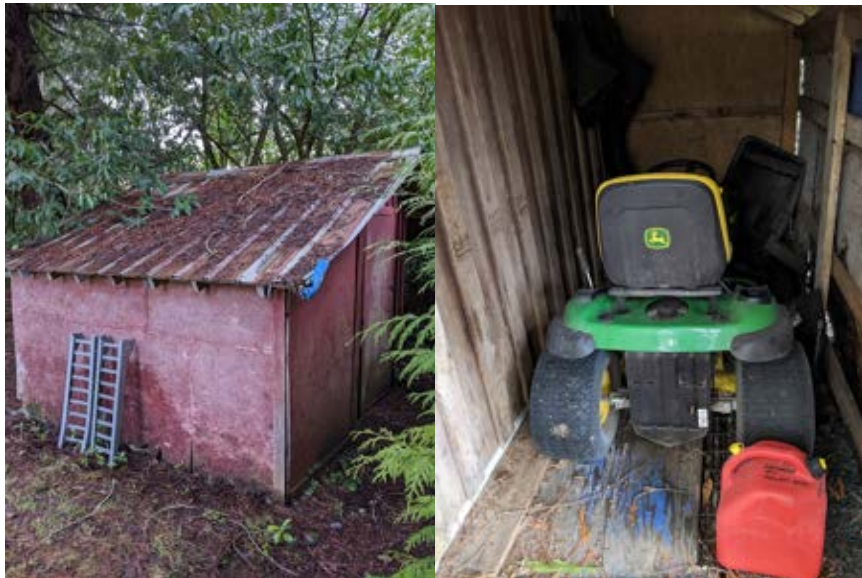
## 7.5 B2-002 Pumphouse

Asset	Overall Assessment	Comments
B2-002 Pumphouse		Shed is in very poor condition. Recommend that options be explored to either replace the shed or rebuild it on same footprint. This structure currently contains the pond water operating tanks/pumps, electrical sub panel (sites 23- 28), the Shaw box and storage of the ride on lawn mower. The new electrical panel installed last year was built so as the shed could be removed around it. The pump assembly and electrical panel needs protection from the weather. This doesn't have to be a shed. The riding mower could be stored in the upper electrical storage room, beside the Gazebo.

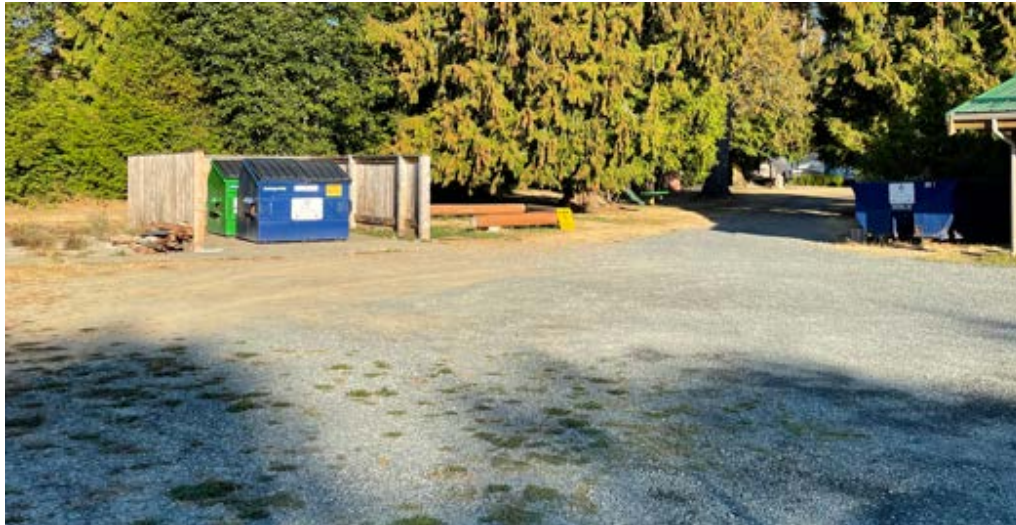
## 7.6 B2-003 Garbage Enclosure

Asset	Overall Assessment	Comments
B2-003 Garbage/Bio Bin Enclosure		Fence for garbage compound was relocated in 2022 and bio bin relocated adjacent to B2-001 (Washroom building). Safety concerns have been voiced for location of the bio bin adjacent to the woman's washroom. Board has approved the relocation of the bio bin to its original location to the cement pad beside the garbage enclosure. Debris and clean-up are required as well as installation of a hedge along south/eastern side to mitigate sight lines.

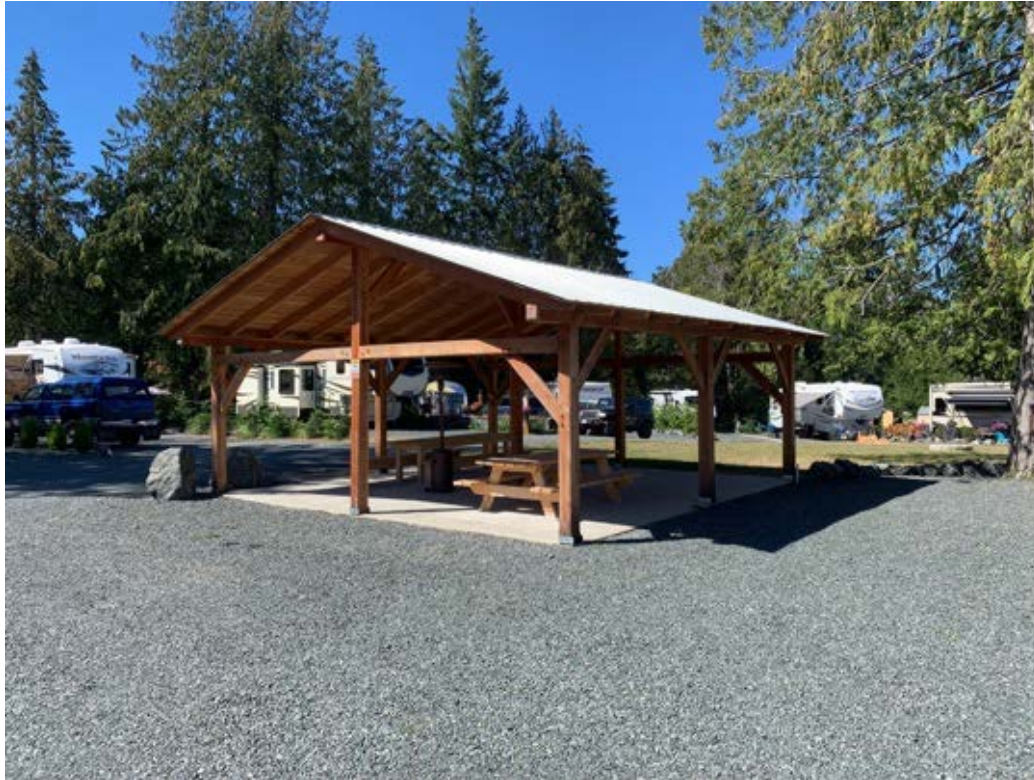
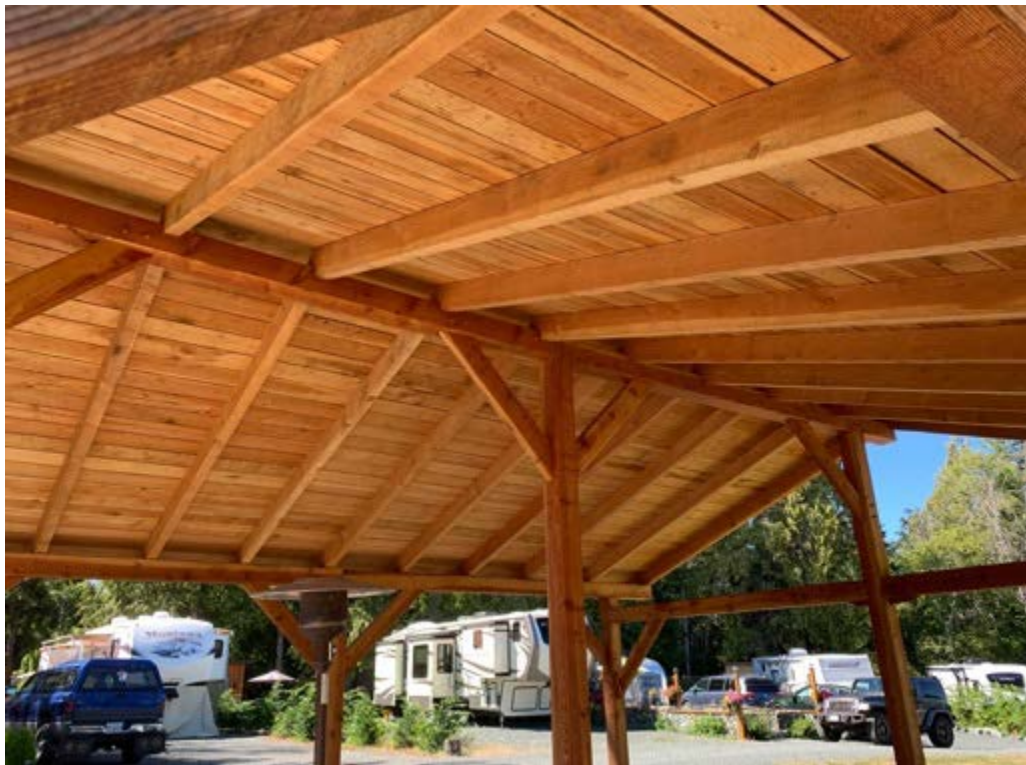
## 7.7 B3-001 Gazebo

Building Component	Observed Ranking	Comments
Roof		New 2020
Exterior Walls		New 2020
Interior		New 2020
FF&E		New 2021; Picnic tables need to be protected from weathering
Foundation		New 2018

Asset	Overall Assessment	Comments
B3-001 Gazebo		New like condition; Picnic tables should be stained for protection from the weather and general use. Upcoming improvements could include potable water connection (hose bib), lighting and electrical connection.

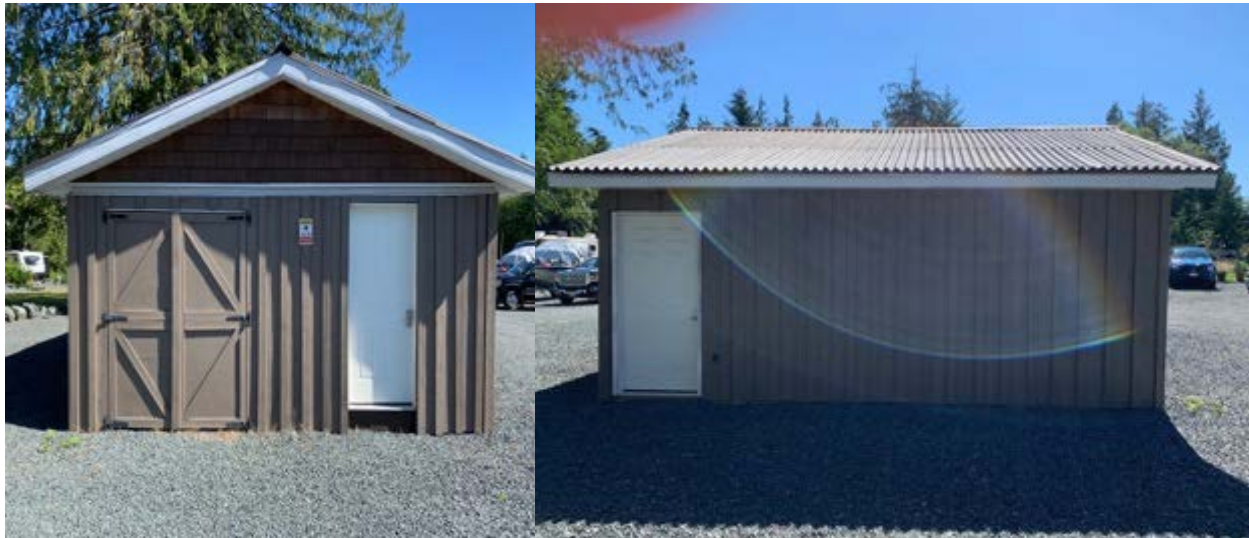
## 7.8 B3-002 Electrical/Storage

Building Component	Observed Ranking	Comments
Roof		New 2018-19
Exterior Walls		New 2019-19; Exterior staining in 2020 remains incomplete and needs to be finished.
Interior		Consideration should be given to locking the storage as common park equipment and tools are kept there. Recommend installing digital lock like other common buildings.
FF&E		Recommend installation of wiring for lights and plugs.
Foundation		New 2018

Asset	Overall Assessment	Comments
B3-002 Electrical/Storage		Developer to provide building permit for this building (still outstanding). Completion of exterior staining, adding of lights/plugs, etc. and lockable doors.

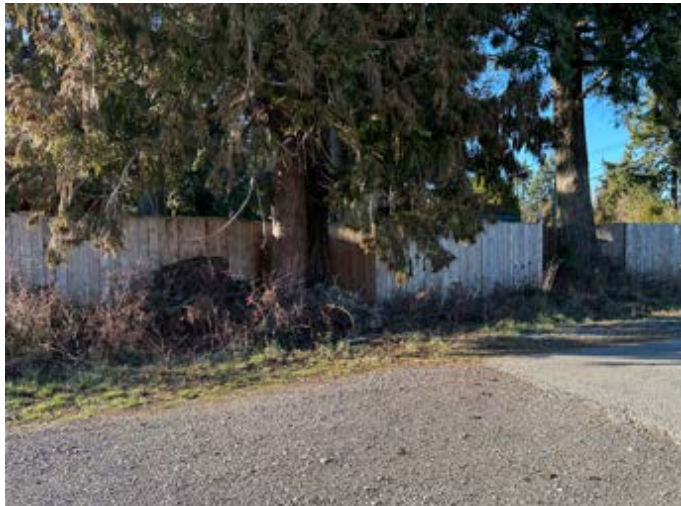
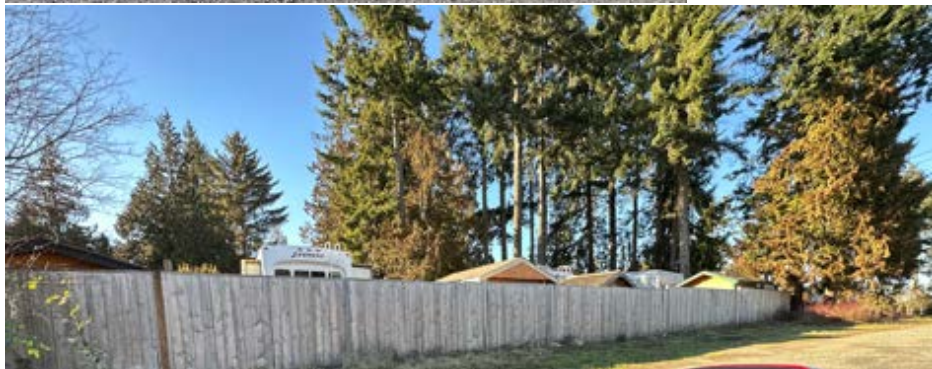
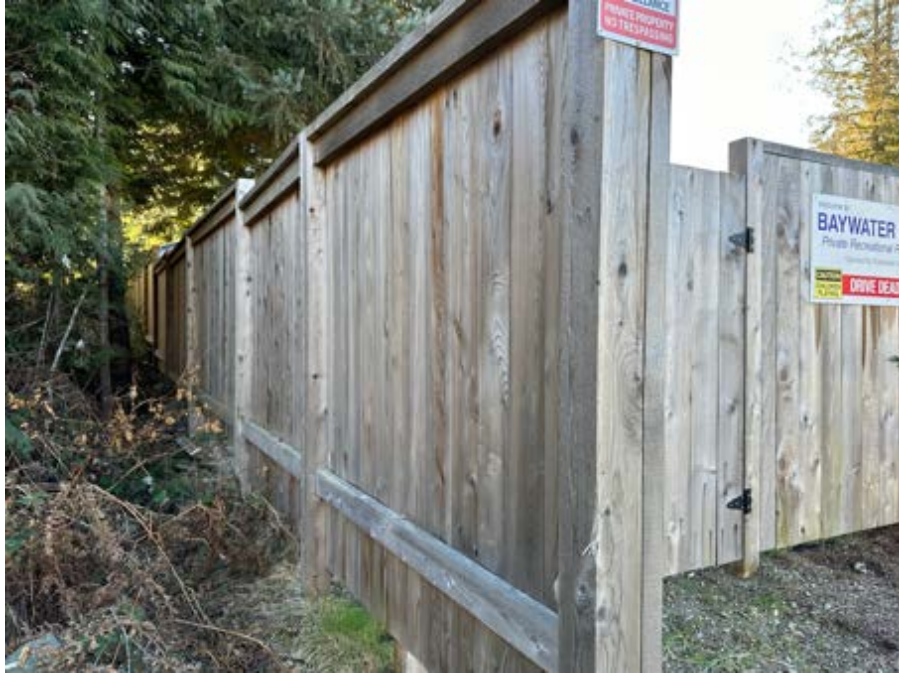
#### East Fencing – Forest Side

Asset	Overall Assessment	Comments
F- Fencing		Perimeter fencing is in good shape. Continued work on post stabilization is recommended to extend life of existing fences along East side and South side (by sites 58-60)
G- Gates		Gates on Highway Forest Side are in good condition. Consideration should be given to upgrading gates on Highway Waterside and adding a gate to the main Baywater Road access. This would enhance security in the park.

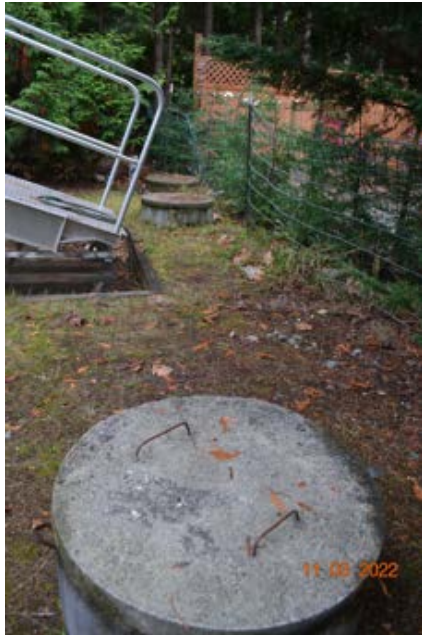
S1-001 Phase 1 Tanks and Lift Station (sites 1-22)

Asset	Overall Assessment	Comments
S1-001- Tanks and Lift Tank in Boat Storage Area		Tanks cleaned out and pump serviced in 2021
S1-002 – Biofilter beds by site #40		Cut back branches and weeded in 2022; consider having beds washed in 2023, ongoing weeding required.
S2-001 – Tanks/pumps by Garbage Enclosure (Lift Station A)		Tanks cleaned out and pump replaced in 2021
S2-002 – Tanks/pumps by site #35 (Lift Station B)		Tanks cleaned out, pump controls replaced and serviced in 2021. Tanks are located under gravel.
S2-003 – Biofilter beds behind sites #55-56		Continue with regular weed maintenance; consider having beds washed in 2023
S3-001 – Tanks and pump across from site #70		Installed in 2019; should be fully inspected and maintained in 2023
S3-002 – Lift Tank and pump by site #52		Installed in 2019; should be fully inspected and maintained in 2023
S3-003 – Biofilter beds behind sites #59-60		Continue with regular weed maintenance; consider having beds washed in 2023

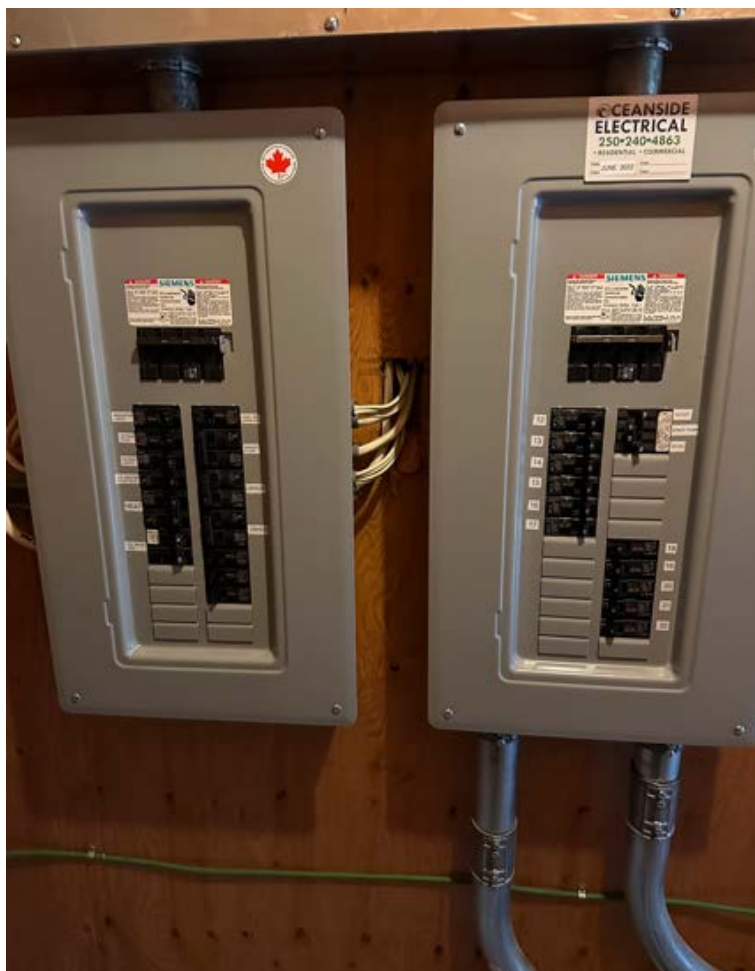
#### Phase 1 – Main Panel

Asset	Overall Assessment	Comments
EL1-001 – Main Waterside Panel		New main panel 2022
EL1-002 – Waterside Sub Panel		New sub panel 2022
EL1-004 – Posts sites 1-22		Posts 2/3, 6/7 replaced 2021. Remainder should be prioritized for replacement as per 2021 electrical report.
EL2-001 – Forest Side Laundry Panel		New main panel 2022
EL2-003 – Pumphouse Sub Panel		New sub panel 2022
EL2-004 – Sub Panel (Hedge #45/46)		Existing Panel- operational. Consider replacing wiring between panel and Main Panel.
EL2-005 – Sub Panel (Hedge #36/37 shed)		Existing Panel – operational
EL2-006 - Posts sites 23-48		Most posts in operable condition, consider replacing posts that are rotten as noted in the 2021 electrical report.
EL3-001 – Main Electrical Room Panel		Panel installed in 2019; cannot add additional 50 amps connections to this panel without violating electrical code, overloading the transformer, and creating a possible fire hazard.

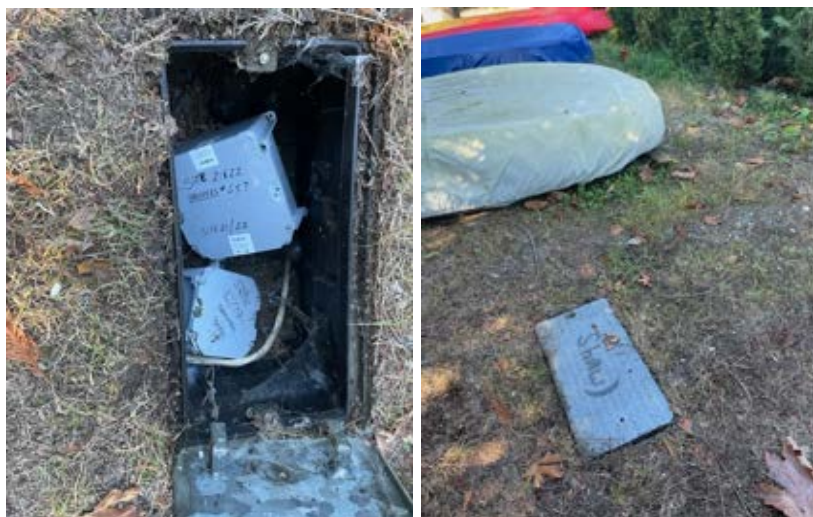
### Phase 1 - Electrical In Ground Junction Box (Boat Storage) – Sites 16/17, 18/19, 20/21, and 22

The above junction box is covered by a Shaw metal plate that has been relabelled as electrical. Immediate work required to install waterproof junction boxes and repair connections as required.

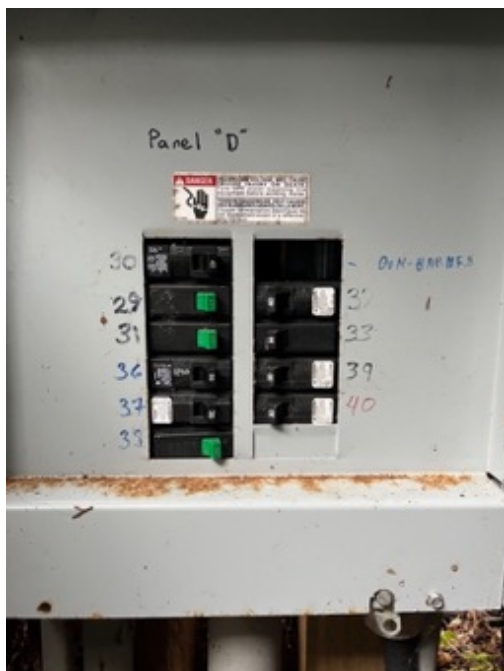
## Phase 2 - Sub Panel (Hedge between Site 36/37) – for sites 30 to 40

Note: Site 35 breaker in electrical room B02-001

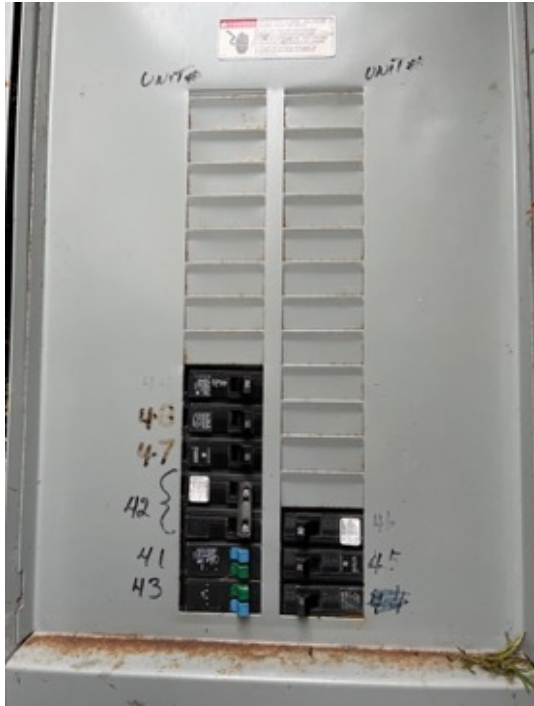
Phase 2 - Sub Panel (Hedge between sites 45/46) – sites 41 to 48

- For safety, electrified sheds should all have a breaker for the power going to them.
- Outside receptable in Phase 3 Electrical Shed is not a CFCI receptable or covered with bare wires showing.
- Multiple sites were identified as requiring need to have the covers repaired for electrical connections at their power post. These exposed connections are subject to the weather causing possible corrosion, thereby causing overheating.
- Extension cords running across sites (i.e., 9, 11 & 13) should be inspected to be sure they are safe.
- Several electrical posts in Phase 1 and 2 should be replaced as they are deteriorating (e.g., site #32 & #37)
- Wiring from new Main panel in Forest Side Laundry Room to sub panel at site 45/46 should be inspected and replaced if required.

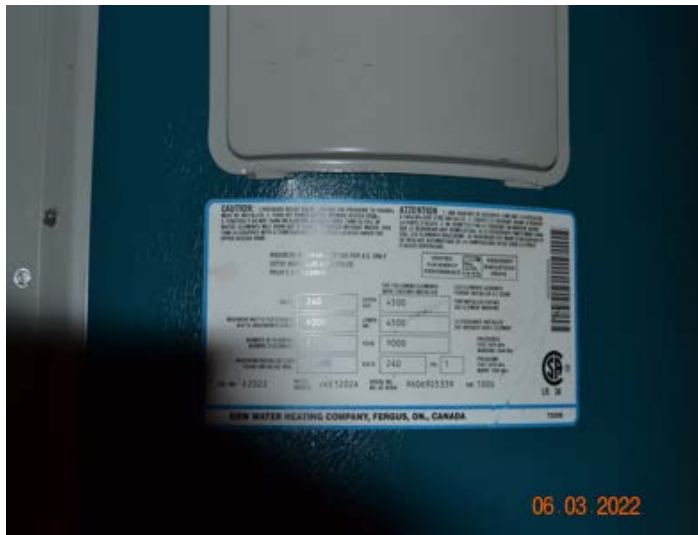
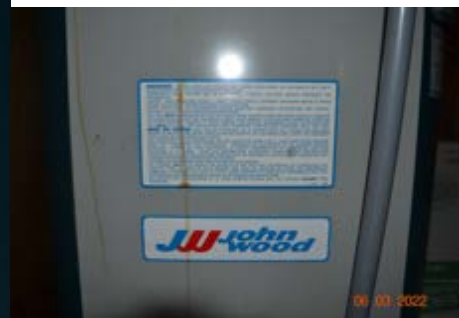
Supply Room (Waterside):

There are three hot water tanks serving the resort plus a small “on demand” 1440-watt heating unit in the Clubhouse. Namely: 1 – 100-gallon tank in the supply room on the waterside, and 2 - 75.7-gallon tanks in the supply room on the forest side.

- Replace water side hot water tank in 2023, Clubhouse tank in 2024 & failing electrical posts as needed
- Inspect, fix and add breakers at electrical posts for all campsites 2023 to 2026
- Repair water shut off gate valve on water side in 2028
- Install septic redundancies for continuous septic service in 2025-2029

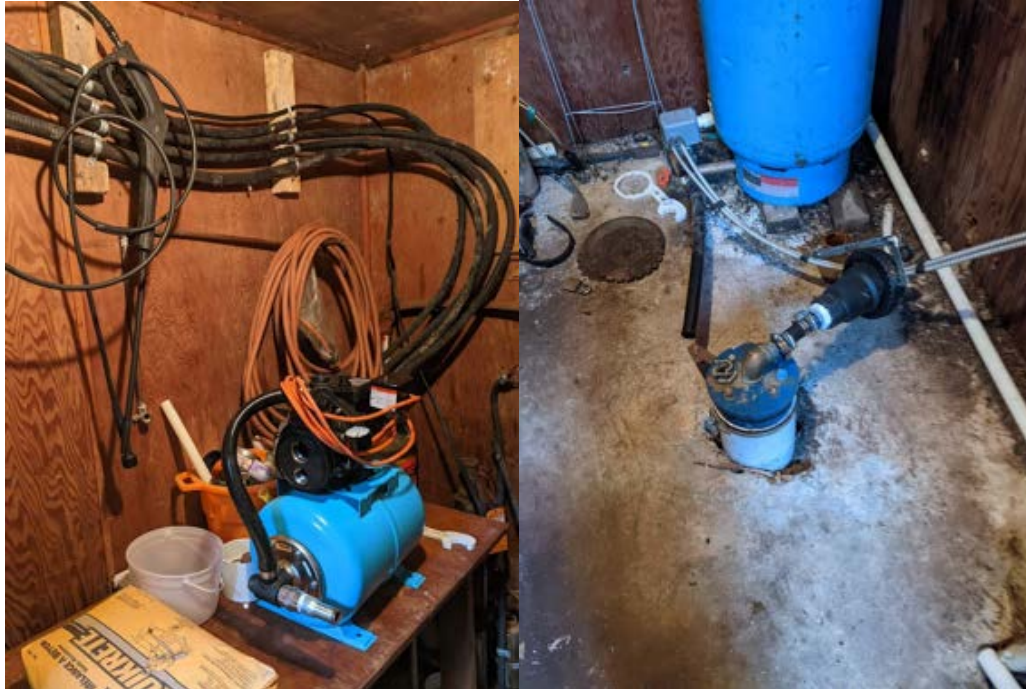
The resort has an independent water system for irrigation that is gravity fed from the pond located in the Southern Development Lands. It is piped from the pond to the pumphouse where water is stored in an underground cistern which overflows into Black Brook along the western property line. A pump supplies pond water to hose bibs at sites 23-33 and 36-51 in phase 2 and 3 and one connection on the Waterside in phase 1 (between Highway and site #20).

The following pictures illustrate the pond water mechanical elements found in the Pumphouse.

The use of pond water (non-potable) is for irrigation of landscaping on individual sites or in common areas which greatly reduces the park's water bills. Expansion of this system to all 72 sites, along with a well and a larger pump, if required, would be a recommended betterment for the park.

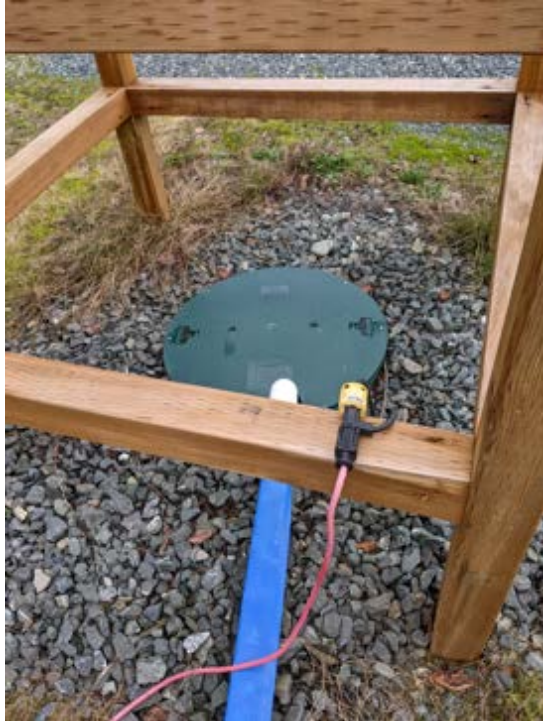
### Storm Water Management - Sump Pump

This sump pump is for seasonal use. It pumps stormwater from the internal road as required adjacent to sites 35-37, 44-46 where flooding has been occurring with winter or summer storms.

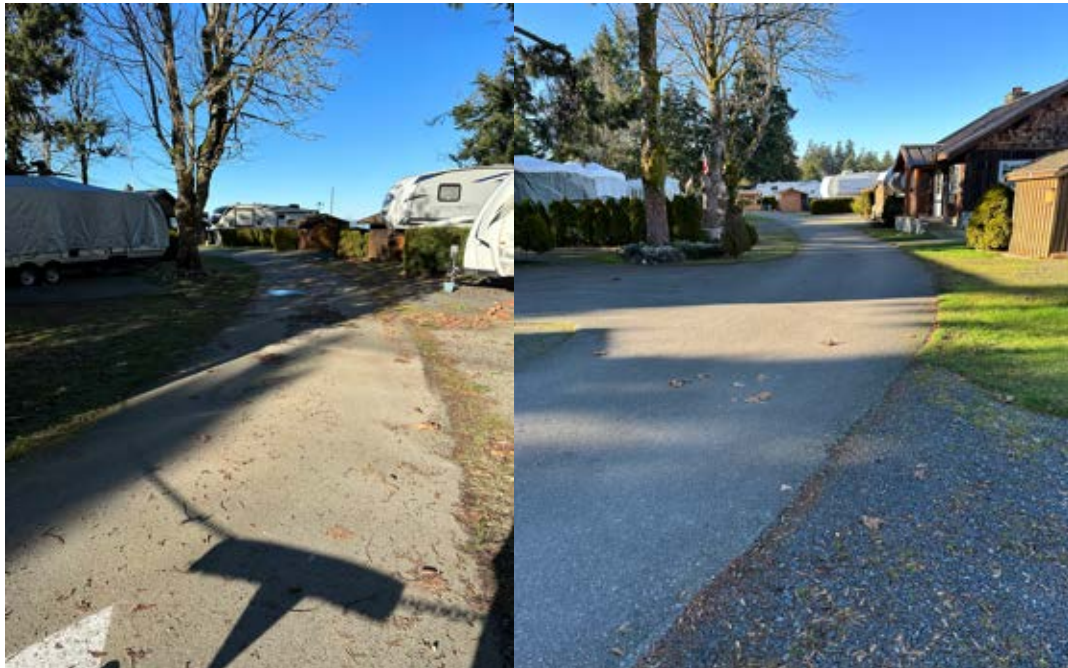
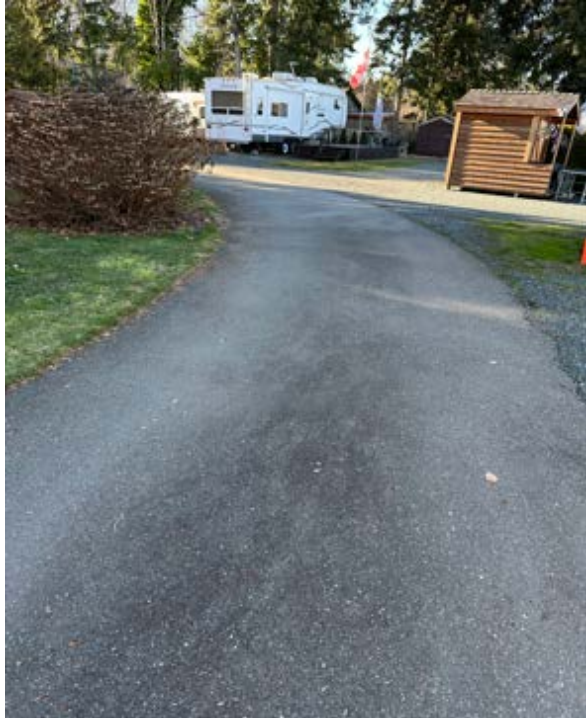
### 12.1 Asphalt

On the Water Side portion of the park, is 5,603 sq. ft. of asphalt paving. This paved road provides access to sites 1 to 22. In addition, there is 870sf of paved walkways.

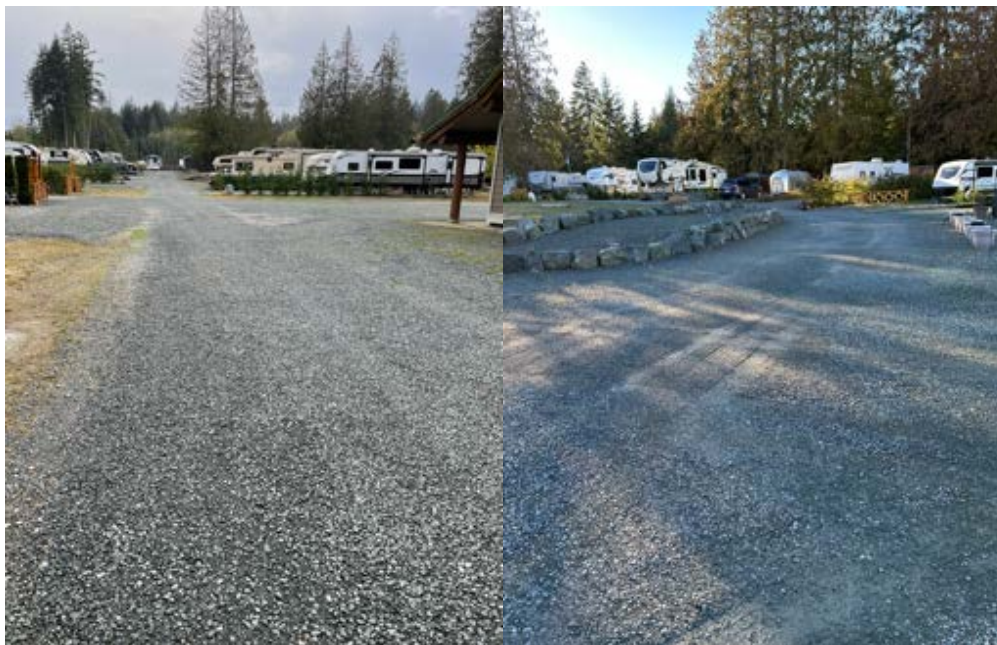
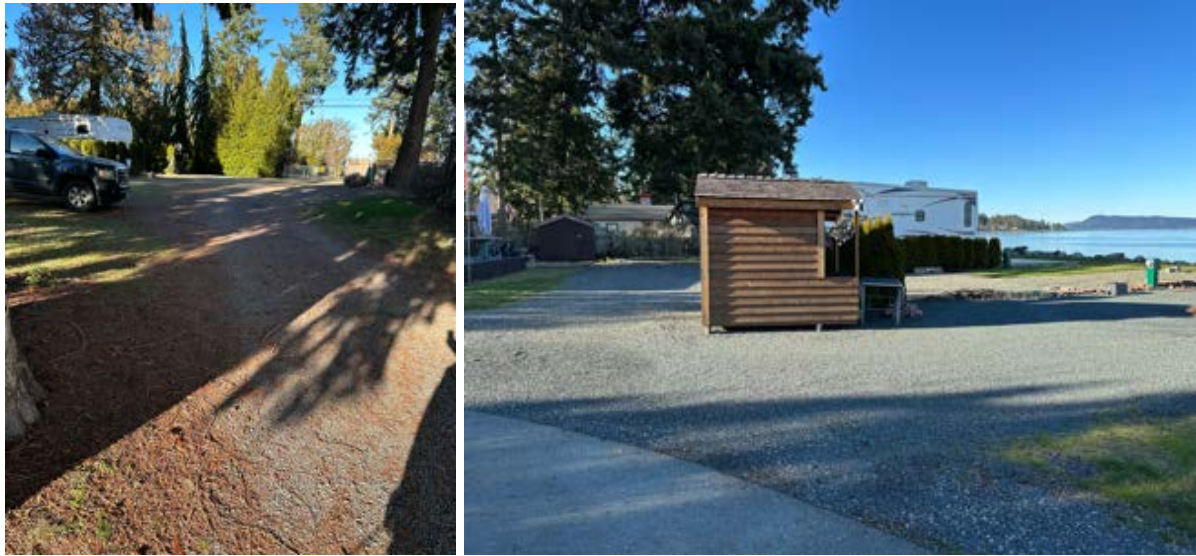
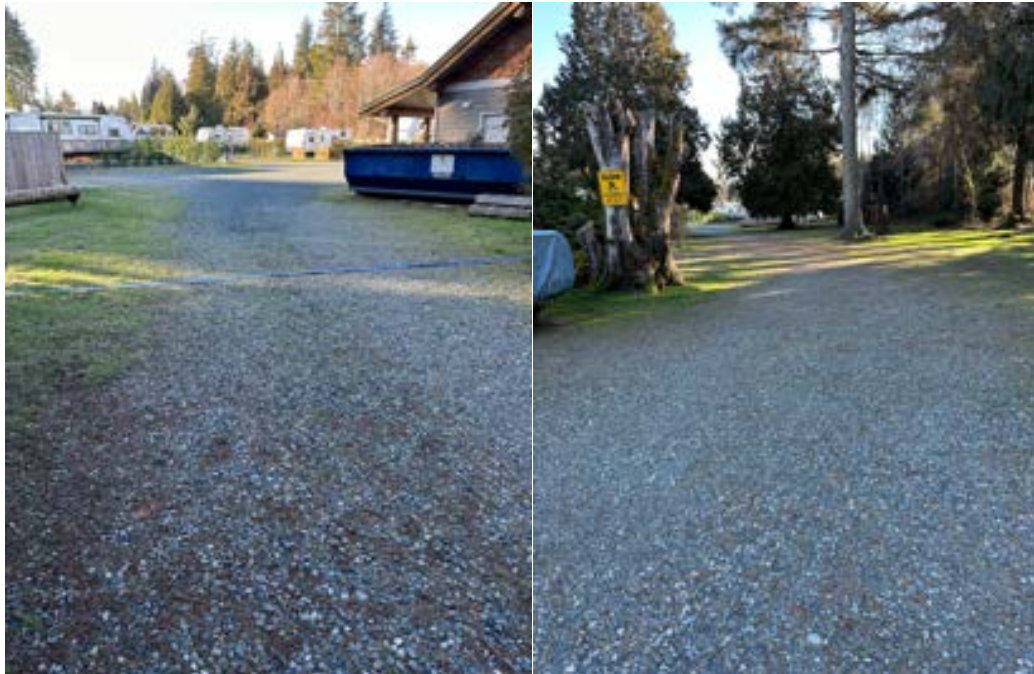
## 12.2 Gravel

On the Forest side of the park, is 19,949 sq. ft. of gravel roadways. These gravel internal roads provide access to sites 23 to 72. In addition, on the Water side, the access road to Site 1, 2 & 22 is gravel (1,462 sq. ft.)

Annual grading is done on some roadways as is the filling of minor potholes. In 2022, additional gravel was installed and graded, and surface drainage installed to address routine flooding in fall/winter months around lot #36 to #47.

Annual dust abatement has been undertaken since 2020. Paving these roads should be considered in the future to reduce noise and dust for campers.

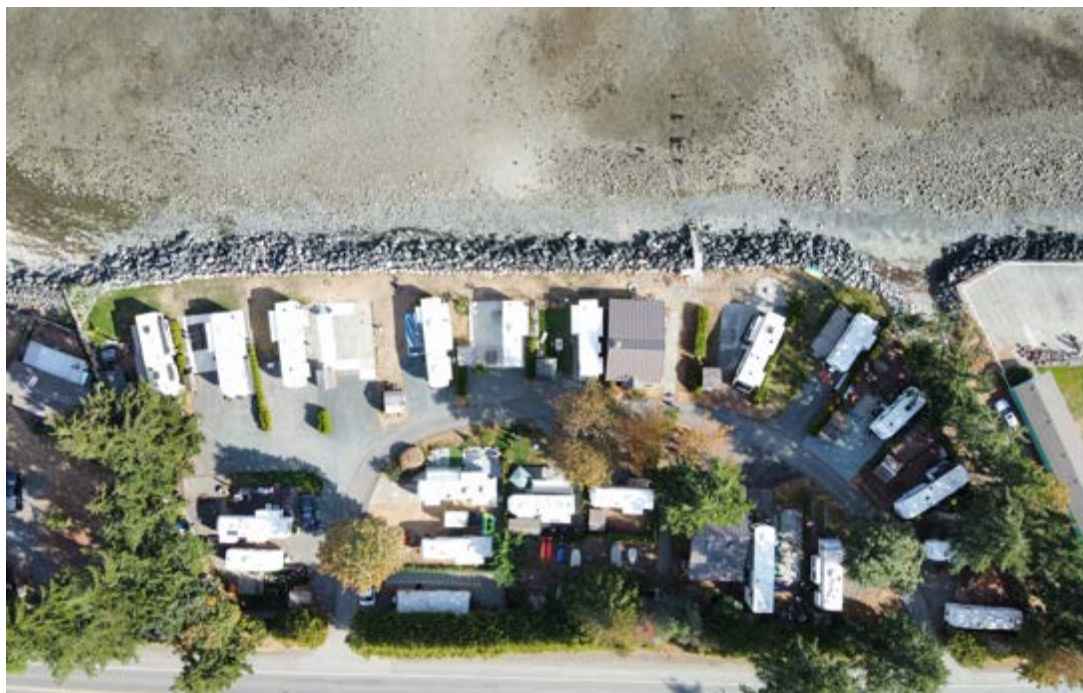
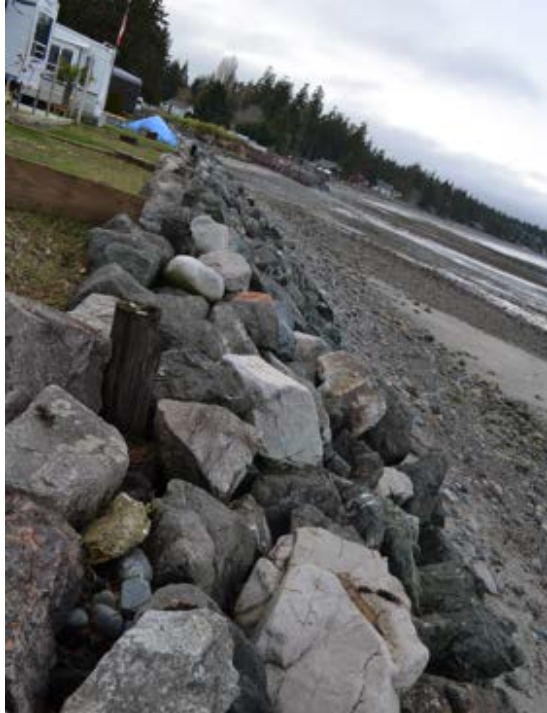
### 13.1 Ph 1 Foreshore lands, Rip Rap/Toe Revetment, Community Fire Pit

Baywater holds a foreshore licence to occupy certain Province of BC Crown lands permitting installation of specific improvements (namely a rock/rip-rap barrier or toe revetment and earth backfill) to protect the waterfront of the Park from erosion of ongoing king tides. This Crown Land is in front of Sites 1 to 9 to the bottom of the rip-rap rocks.

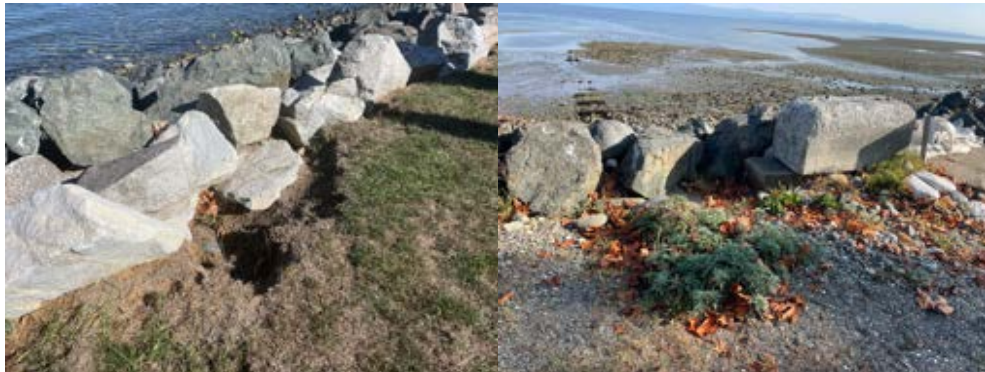
The following pictures illustrate the slight sloughing along the foreshore by the rip rap rock occurring from ongoing tidal pressures and wave action. This may require semi-annual maintenance.

Asset	Overall Assessment	Comments
N1-001 – Foreshore/Rip Rap		Rip Rap inspected and maintained last in 2020. Recommend rip rap and foreshore repairs be inspected and required repairs addressed in 2023 and then go onto a 2-year cycle dependent on King Tides and impacts of them annually. Firepit is new as of 2022.
N1 -002 – Boat Storage		Need to confirm which shareholder's small boats are stored here.
N2 -001 – Playground		While operable, firepit and picnic tables could be replaced soon.
N3-001 – Upper Meadow		Firepit and horseshoe pit new as of 2022.

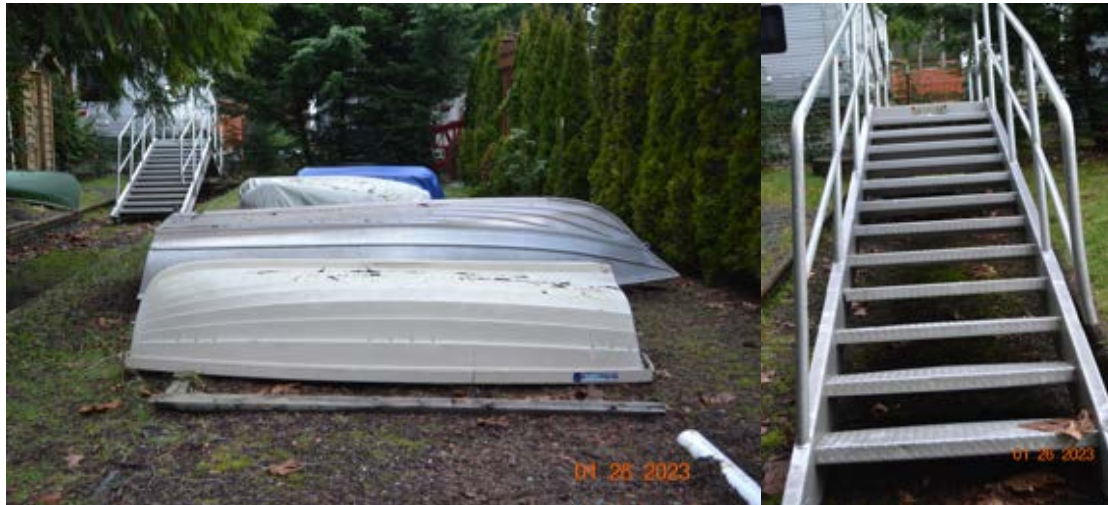
### 13.2 Ph 1 Boat Storage

Located in the common area behind sites 16 & 17. Provides space for small tin boat storage and seasonal winter storage for aluminium water access stairs.

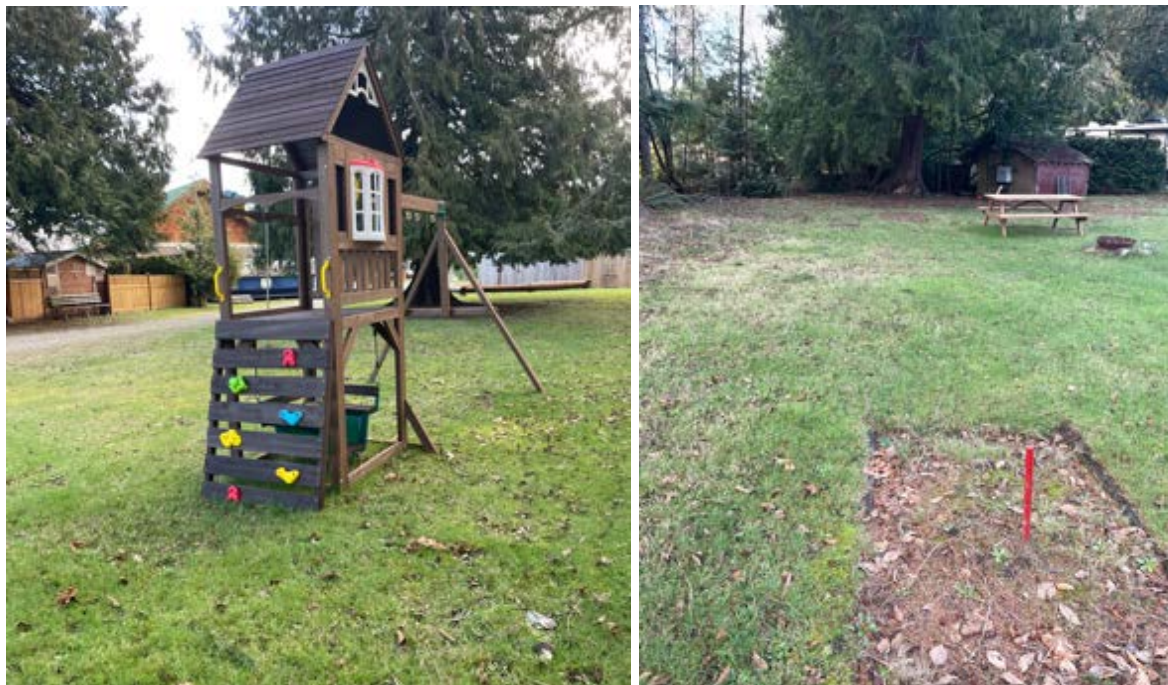
### 13.3 Ph 2 Recreation/Children Play Area/Horseshoe Pitch

Slides and swings for playground should be stored during winter months to extend life of playground components.
