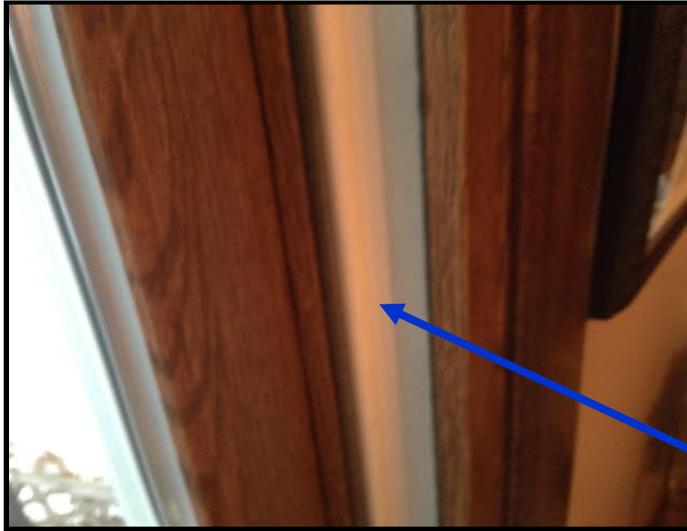
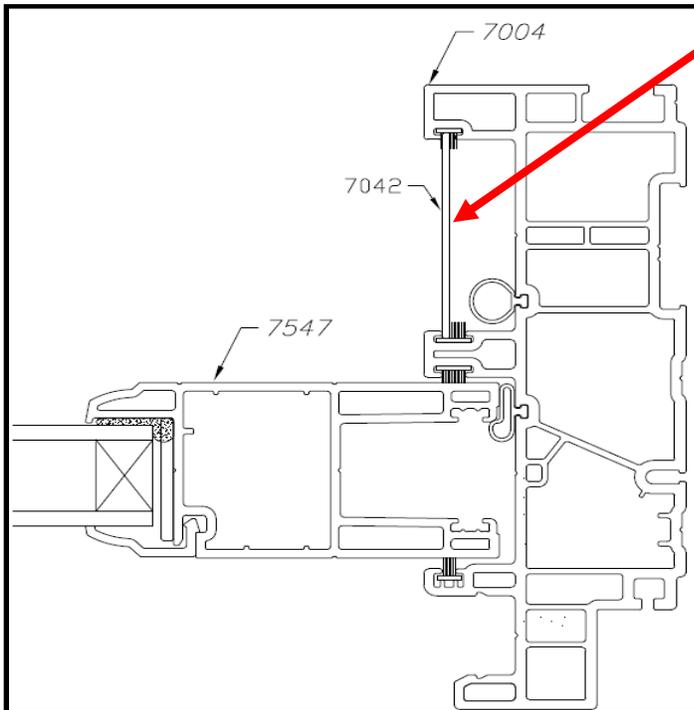
Jamb Cover Missing
Jamb cover location

The white on this jamb is a result of the Patio Door not having the 7402 interior snap jamb cover installed. This jamb cover is sent (un-installed) but with the door. This area is where one is to anchor the door on the fixed side and after anchoring; the cover is then to be put in place to enclose the fasteners and the cover is to be color matched to the interior of the door, which in this case would be woodgrain. If this cover is missing, not on the job, it can be ordered via our inside sales department. This cover is generally taped to the top of the mainframe and may have gone unnoticed...
