# TRUFOCUS HOME INSPECTIONS

## RESIDENTIAL INSPECTION REPORT COPY COPY

1234 Main St  
Paris, TX 75460

# PROPERTY INSPECTION REPORT FORM

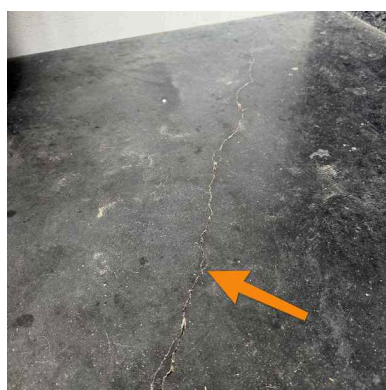
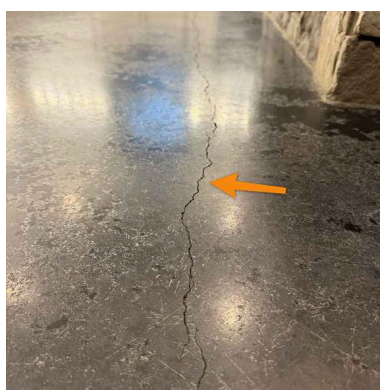
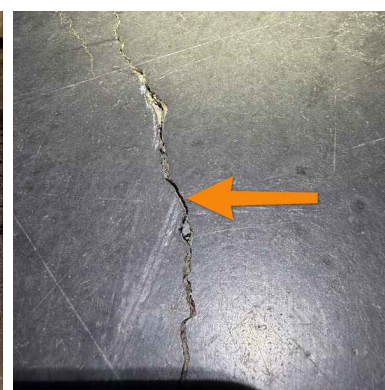
### 1: Minor Concrete Floor Cracking

Minor cracking was observed at areas of the interior concrete floor. This type of non-displaced cracking is common in concrete slabs, and no significant displacement was observed at the areas viewed.

**Recommendation:** Monitor for significant widening, displacement, or other notable changes.

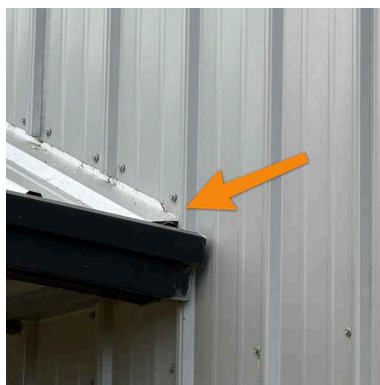
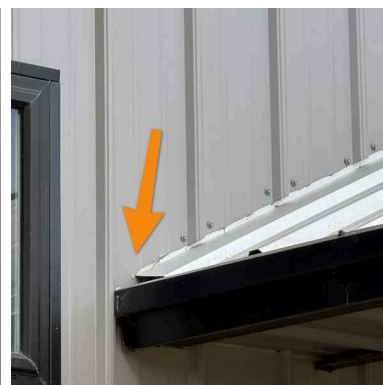
North, Porch Cover

Kick-out/diverter flashing was not observed at the lower termination of the roof-to-wall flashing. Water runoff may be directed against or behind the adjacent wall/structure, increasing the potential for moisture intrusion or deterioration.

**Recommendation:** Improve

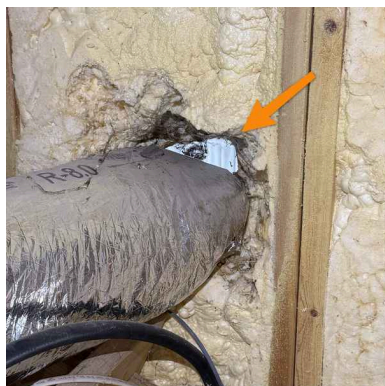
Attic, East Wall

An opening was observed around the duct penetration through the attic wall. The gap may allow uncontrolled air movement and reduce the effectiveness of the building envelope.

**Recommendation:** Improve

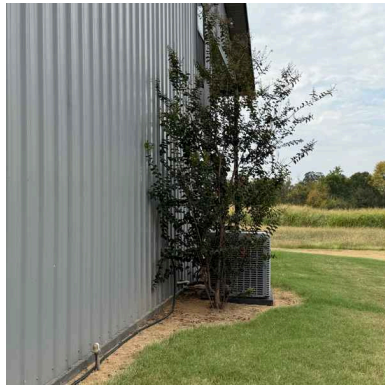
West

Vegetation is growing too close to the home's exterior. This can trap moisture against the siding, damage materials, and provide a pathway for pests.

**Recommendation:** Improve

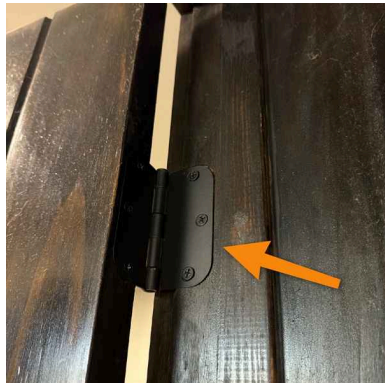
Laundry Room

Loose hinges can cause door to stick or eventually fall out of place.

**Recommendation:** Improve

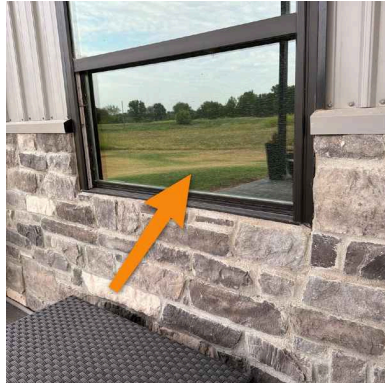
South

Window was observed without a screen. Missing screens can allow insects or debris to enter when the window is open and reduce normal usability. This is a common maintenance item but affects occupant comfort.

**Recommendation:** Improve/Install

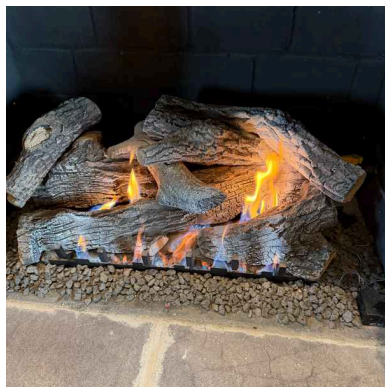
*Gas Logs: Propane -*

The gas log set was operated using normal controls and produced a flame at the time of inspection. The inspection was limited to readily accessible and visible components and does not include determining combustion efficiency or concealed conditions.

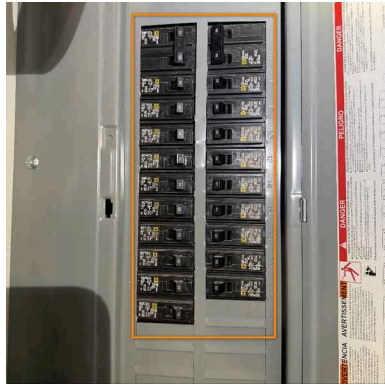
## 2: Panel Missing Labels

The electrical panel and breakers were missing labels or were labeled incorrectly, making it difficult to identify circuits. This can delay emergency shutoffs and complicate future repairs.

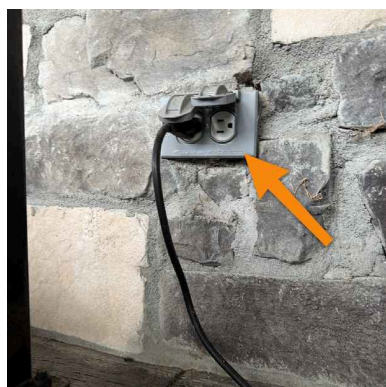
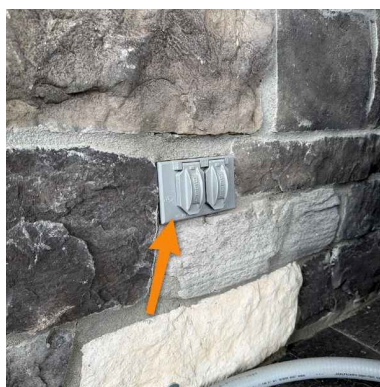
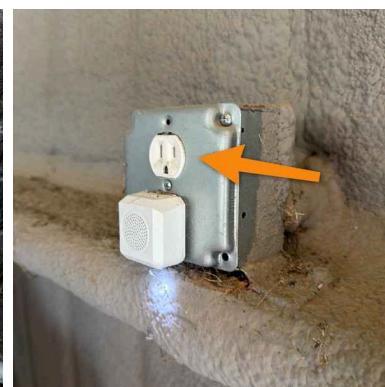
One or more electrical outlets were observed without Ground-Fault Circuit Interrupter (GFCI) protection in areas where water may be present (bathrooms, garages, outdoors, crawl spaces, basements, kitchen countertops, laundry areas, indoor damp and wet locations, kitchen dishwashers, and electrically heated floors, and receptacles located within six feet of the outside edge of a sink, shower or bathtub). GFCI protection is designed to quickly shut off power if a ground fault occurs, which reduces the risk of electric shock. Without this protection, occupants may be exposed to an increased safety hazard.

**Recommendation:** Improve/Install

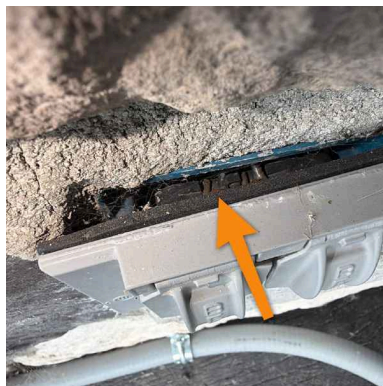
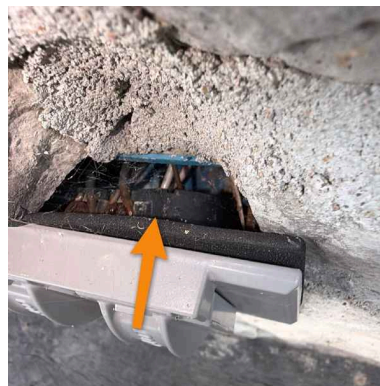
#### 6: Receptacle – Rough Wall Opening / Incomplete Seal

The wall material around the receptacle was irregularly cut, with gaps visible around the electrical box/cover. The opening may allow air, moisture, pests, or debris to enter the wall cavity.

**Recommendation:** Improve

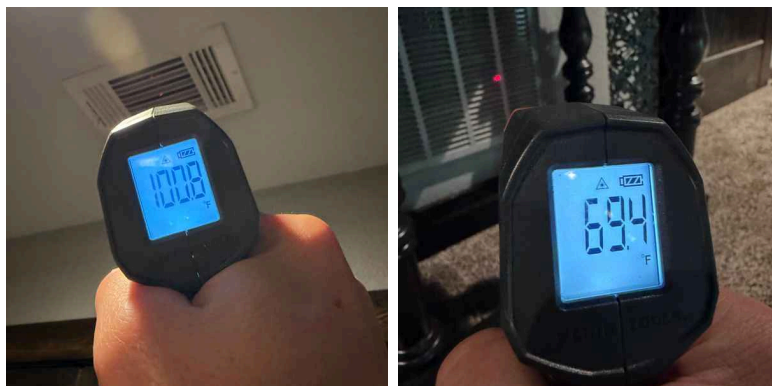
*Temperature Differential:*

There was a temperature difference of 31.4 degrees measuring between the return and supply ducts, achieving a temperature of 100.8 degrees.

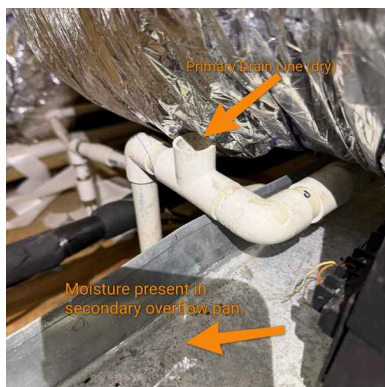
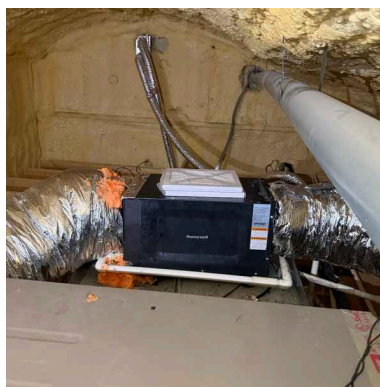
Moisture was present in the dehumidifier overflow pan, while the accessible portion of the primary condensate drain was dry. This suggests the condensate was not draining as intended and may result in overflow or moisture damage if not corrected.

**Recommendation:** Improve, have the dehumidifier condensate drainage system evaluated and corrected as needed by a qualified HVAC technician.

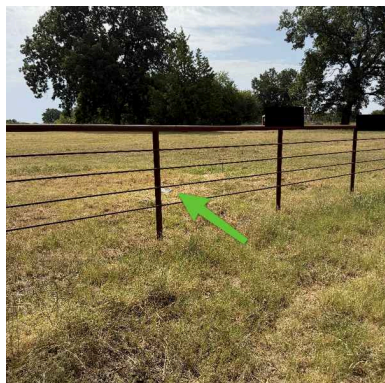
Location of Water Meter: Street, East

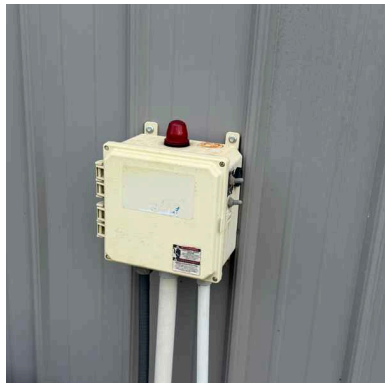
Control Panel

Inspection of the septic system was limited to identifying the system type and the location of visible components. The visible/audible alarm and activation of the aeration sprinklers, where present and accessible, were tested. Further evaluation may be obtained from a qualified septic system inspector or licensed plumber.

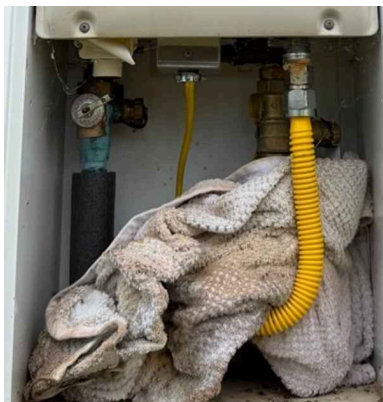
**Limitation - Rag/Cloth Present:**

A cloth/rag was present within the exterior tankless water heater cabinet (possibly to insulate water lines) and obscured portions of the piping and components, limiting visual inspection of these areas. The purpose of the material was not determined.

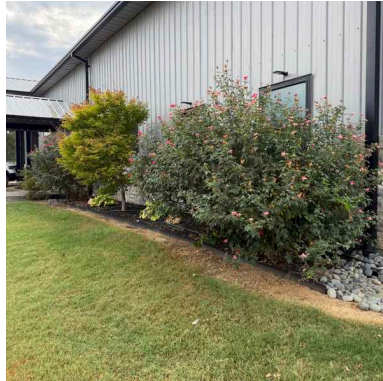
*Limitation - Trees / Shrubs Limited Inspection:*

Trees and/or shrubs limit inspection of walls, foundations, and other areas that are concealed from view.
